Investigation of the Hydrogen Release Incident at the AC Transit Emeryville Facility

May 8, 2013

Chris San Marchi, Aaron Harris and Daniel Dedrick
Sandia National Laboratories

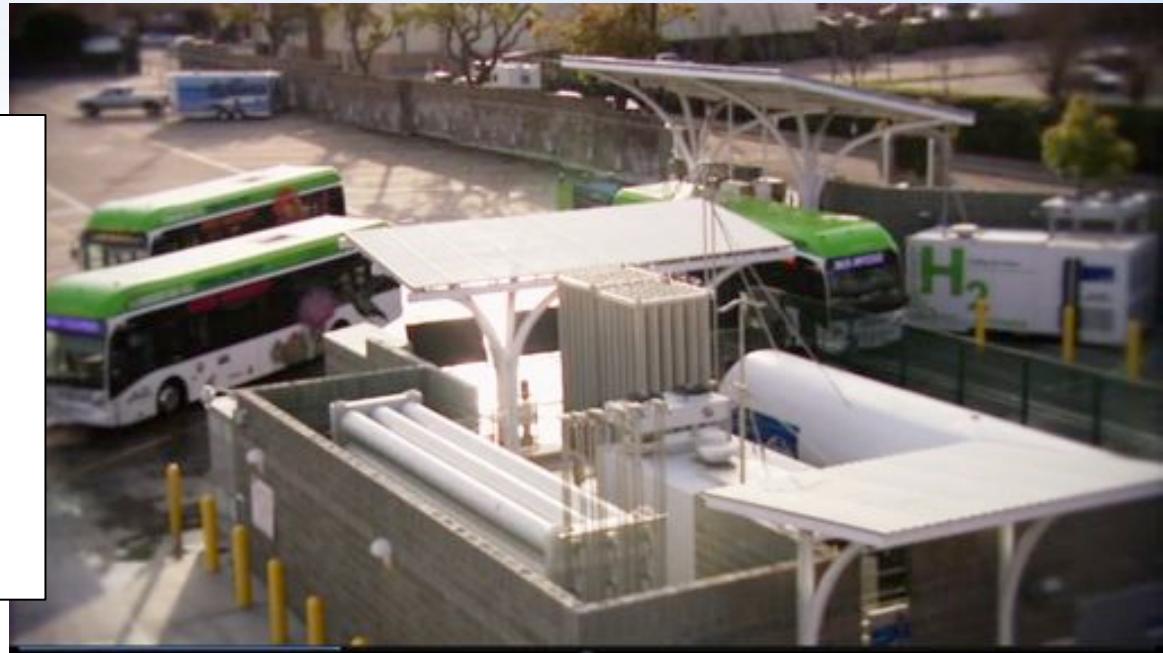
May 4, 7:45 AM
pressure relief valve fails

May 4, 10:12 AM
failed valve isolated

- Vented approximately 300 kg of hydrogen (150 kg in first 15 min)
- Venting hydrogen ignited at vent stack outlet
- Hydrogen flame impinged upon canopy (making flames visible)
- 9th Alarm fire event – local and county police/fire response
- Evacuation of local businesses, including Pixar Studios and two nearby schools

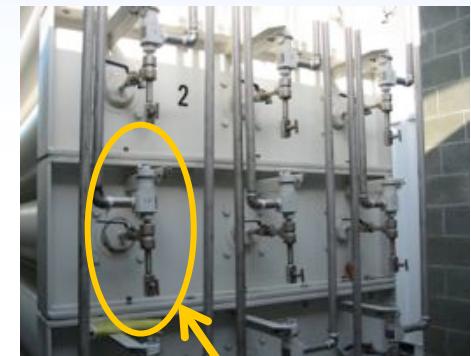
Pressure Relief Valves

- Pressure relief valve fails, releasing hydrogen
- Hydrogen ignites and impinges on nearby canopy
- Employee presses e-stop isolating high pressure gas storage

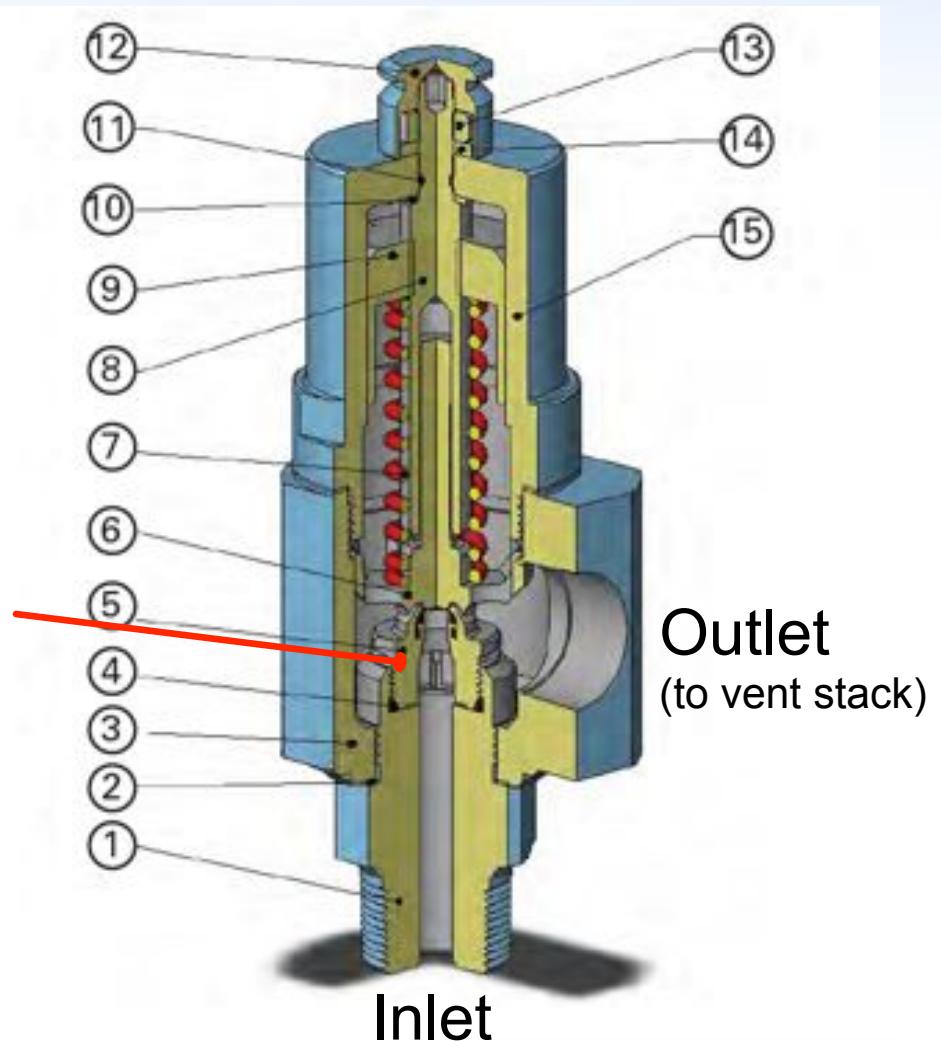
Nozzle Subassembly (5) *failed part*

- *Exposed to hydrogen at pressure*
- Material of construction: type 316 austenitic stainless steel

- *Exposed to hydrogen at pressure*
- *Choice of materials available*
- Material of construction: type 440C martensitic stainless steel

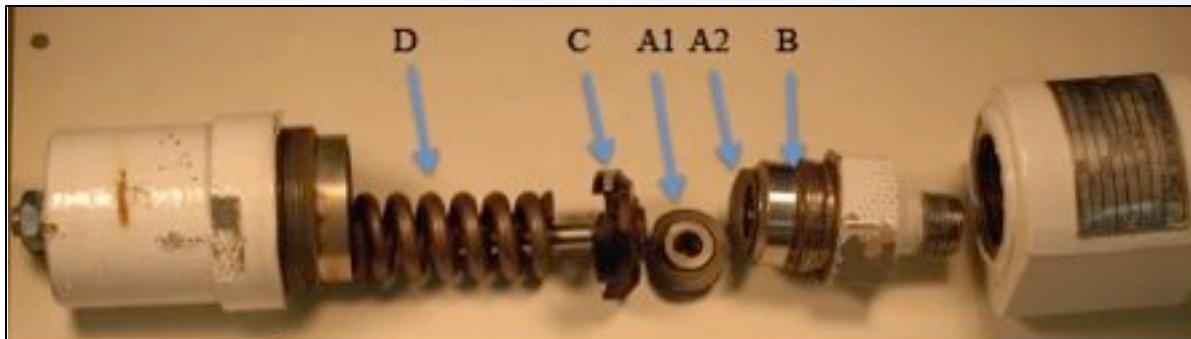
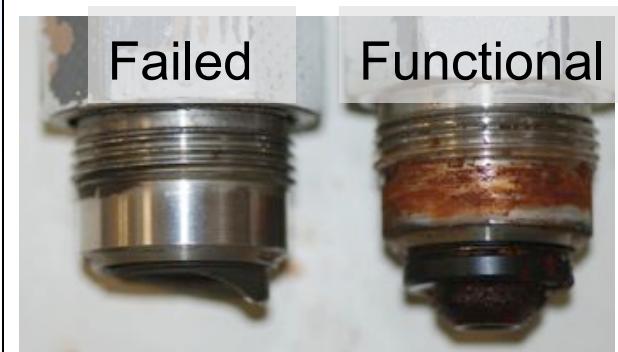
A1/A2 Nozzle subassembly
B Inlet base

- Nozzle seals against base inlet
- Disk subassembly seals against “top” of nozzle
- Nozzle failed at internal corner
 - associated with external thread root and wretch flats

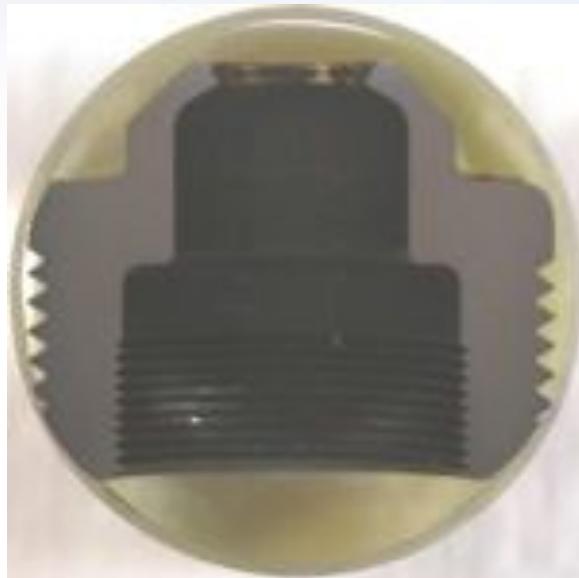
Functional nozzle

Measured hardness: 500 HVN

Estimated: 49 HRC

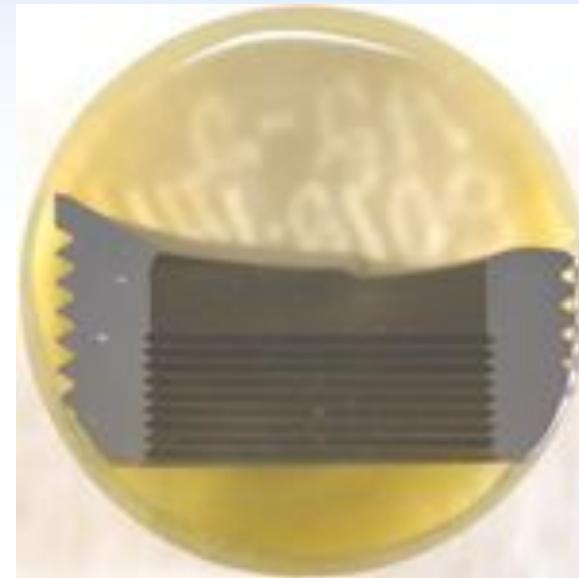
Failed nozzle

Measured hardness: 600 HVN

Estimated: 55 HRC

- Functional nozzle: hardness is consistent with specification
- Failed nozzle: hardness exceeds manufacturer's specification
- Estimated difference in yield strength: ~300 MPa

- Contributing factor: material did not meet manufacturer specification
 - Existing component option for hydrogen service (nozzle can be manufactured from hydrogen compatible type 316 austenitic stainless steel)

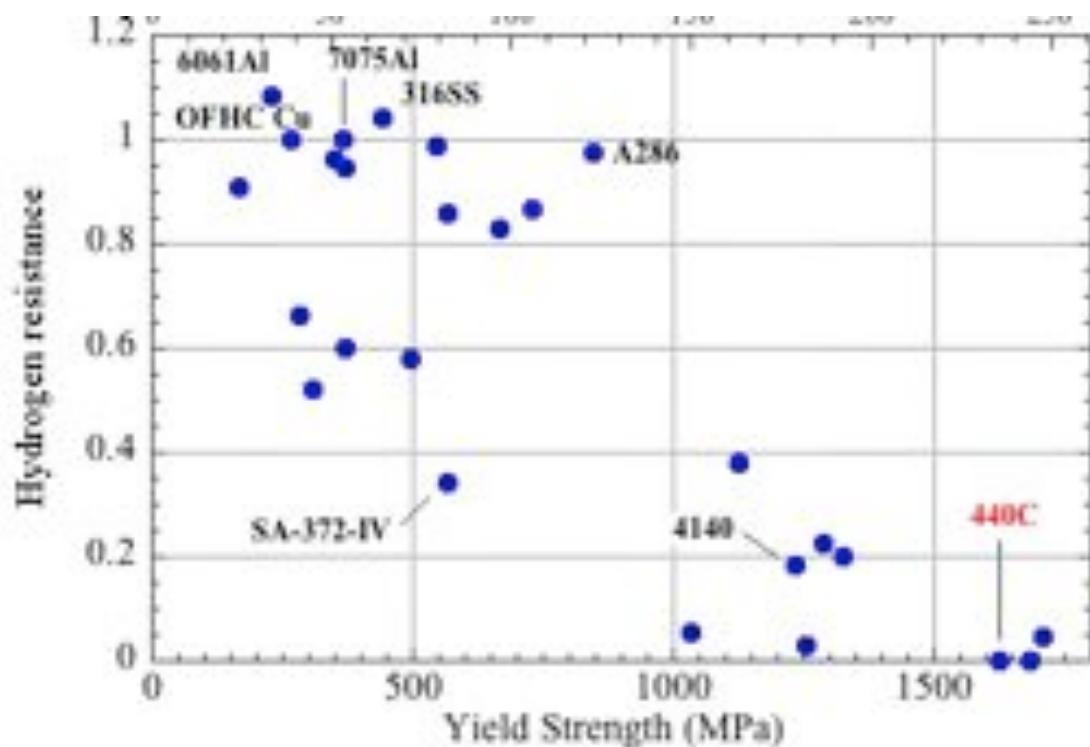
- High-strength steels are very susceptible to embrittlement in gaseous hydrogen
- Type 440C martensitic stainless steel is not recommended for hydrogen service **→ root cause**

HVN of 500-600 represents yield strength of approximately 1600-2000 MPa

- Hydrogen resistance determined from tensile testing
- Ratio of reduction of areas: gaseous hydrogen relative to helium at pressure of 69 MPa
- Ref: Jewitt et al NASA CR-2163

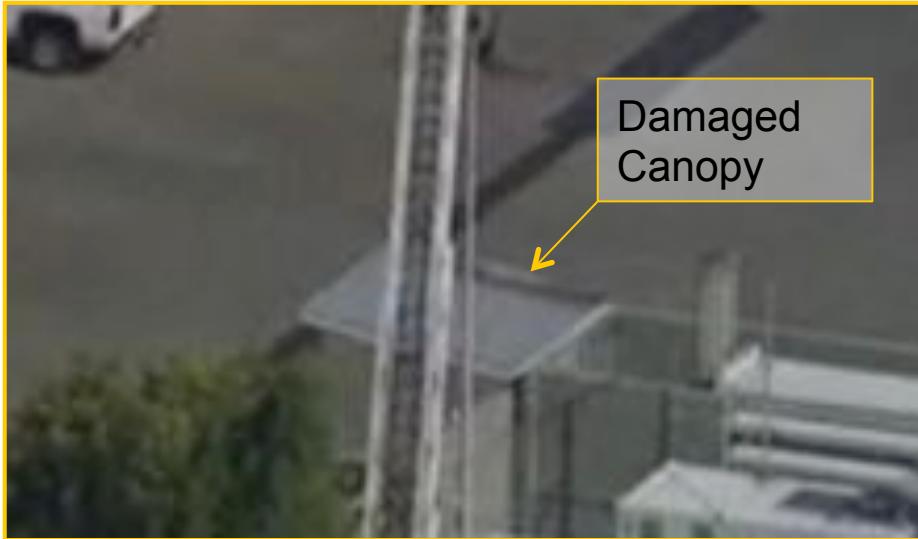
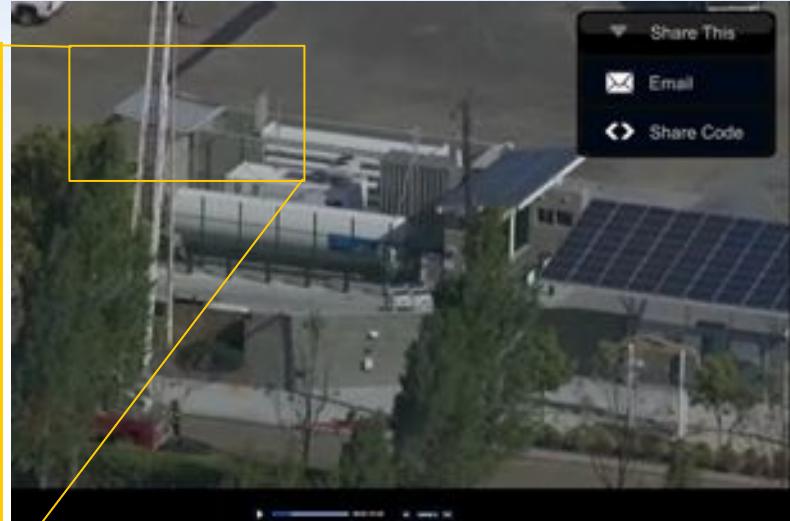
- Vent system was too close to the canopy
- First responders did not tailor the response to the conditions, due to:
 - Poor communication of critical data during the event
 - Poor understanding of written emergency protocols
- No mechanism for subsystem isolation
 - Isolation would have limited the release and shortened the event
