241-AZ Farm Annulus Extent of Condition Baseline Inspection

J.K. Engeman, C.L. Girardot, B.J. Vazquez
Washington River Protection Solutions
Richland, WA 99352
U.S. Department of Energy Contract DE-AC27-08RV14800

Abstract: This report provides the results of the comprehensive annulus visual inspection for tanks 241-AZ-101 and 241-AZ-102 performed in fiscal year 2013. The inspection established a baseline covering about 95 percent of the annulus floor for comparison with future inspections. Any changes in the condition are also included in this document.

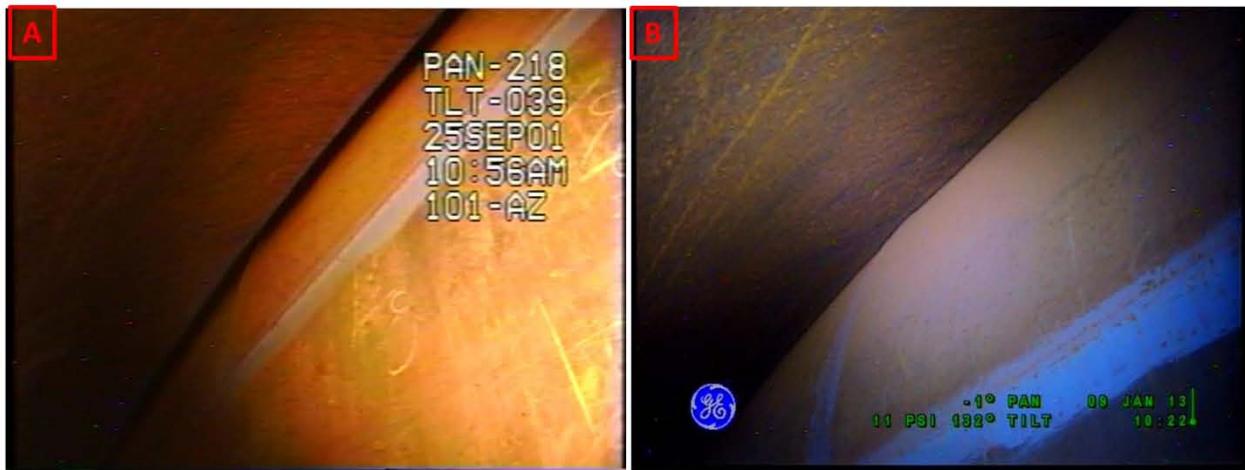
The tank dome and upper haunch area were not visible during the 1993 inspection. Figure 2-1 and Figure 2-2 show comparisons of the upper haunch area between inspections performed in 2001 and 2013. Since the camera was lower in the 2001 inspection, it is difficult to make any comparisons with the 2013 inspection of the top knuckle area. However, there appears to be no significant changes in the condition of this area from 2001 to 2013. No areas of interest were identified in the top knuckle region during the 2013 inspection.

Figure 2-1. Riser 78 Upper Haunch Comparisons Between Inspections on September 25, 2001 (A) and January 9, 2013 (B) Looking Towards Riser 93

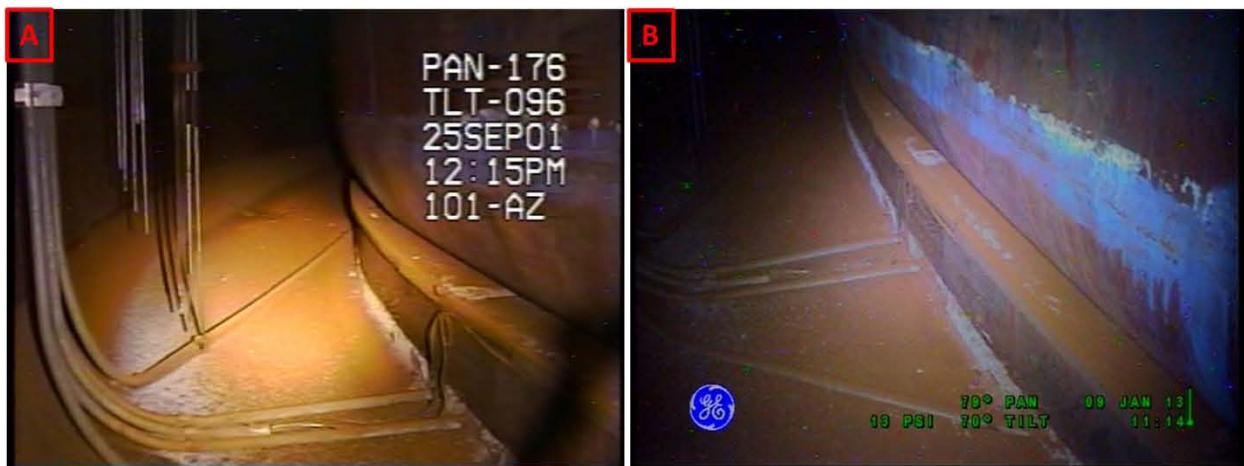
Figure 2-3 and Figure 2-4 show comparisons of the lower knuckle and annulus floor between inspections performed in 2001 and 2013. There appears to be no significant change in the condition of this area between 1993 and 2013. A beachline can also be seen along the annulus floor in Figure 2-3 and Figure 2-4 which is likely the result of evaporated couplant water used during UT examinations. Figure 2-5 shows the general condition of the refractory slots in 2013 and no anomalies were noted. No anomalies were identified on the lower knuckle of the primary tank, insulating refractory, refractory slots, stiffener ring, or annulus floor during the 2013 inspection.

Figure 2-3. Riser 78 Lower Knuckle and Annulus Floor Comparisons Between Inspections on September 25, 2001 (A) and January 9, 2013 (B) Looking Towards Riser 93

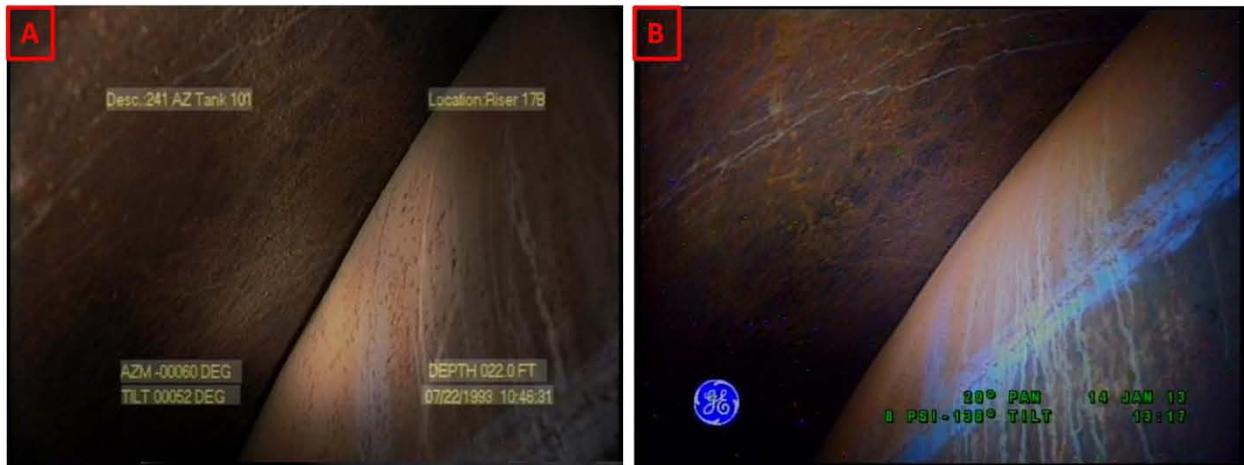
Figure 2-6 and Figure 2-7 show comparisons of the upper haunch area between inspections performed in 2001 and 2013. In both of these figures, white streaks can be seen on the primary tank. These white streaks, which are commonly seen among the DSTs, are referred to as laitance flow attributed to the pouring of the concrete dome during construction. There were no significant changes in the condition of this area from 2001 to 2013. No areas of interest were identified in the top knuckle region during the 2013 inspection.

Figure 2-6. Riser 79 Upper Haunch Comparisons Between Inspections on July 22, 1993 (A) and January 14, 2013 (B) Looking Towards Riser 80

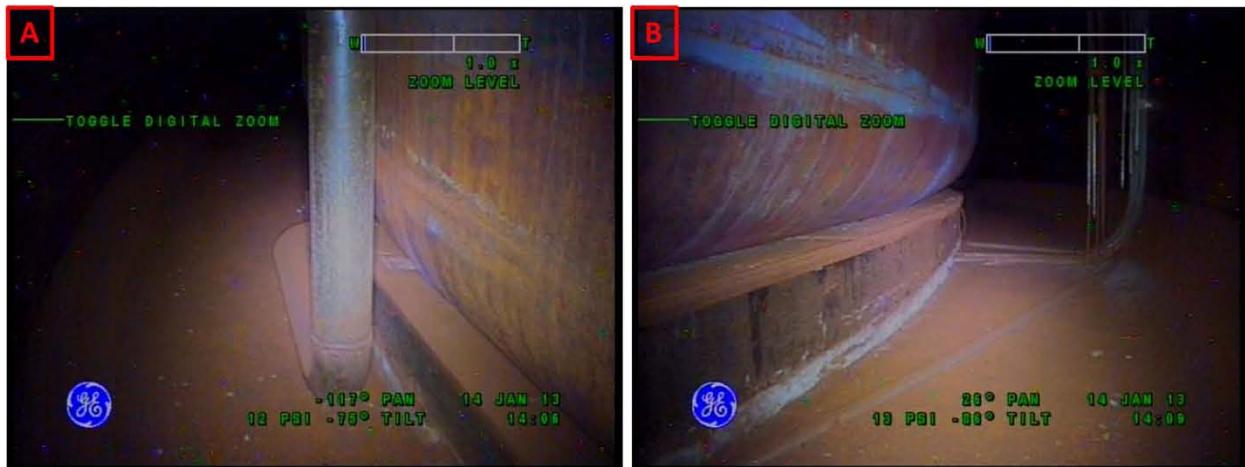
The lower knuckle and annulus floor were not visible during the 1993 inspection. Figure 2-8 shows the general condition of the lower knuckle and annulus floor in 2013. A beachline can be seen along the annulus floor in Figure 2-8 which is likely the result of evaporated couplant water used during UT examinations. Figure 2-9 shows the general condition of the refractory slots in 2013 and no anomalies were noted. No anomalies were identified on the lower knuckle of the primary tank, insulating refractory, refractory slots, stiffener ring, or annulus floor during the 2013 inspection.

**Figure 2-8. Riser 79 Lower Knuckle and Annulus Floor Condition on January 14, 2013
Looking Towards Riser 80 (A) and Looking Towards Riser 99 (B)**

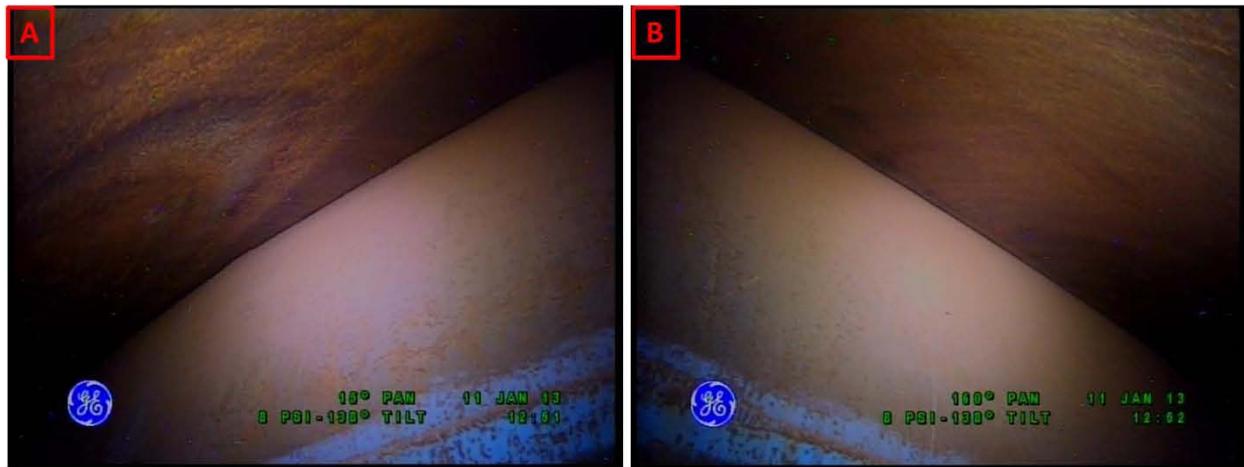
Figure 2-10 shows the general condition of the top knuckle area in January 2013. No areas of interest were identified in the top knuckle region during the 2013 inspection.

Figure 2-10. Riser 81 Upper Haunch Condition on January 11, 2013 Looking Towards Riser 105 (A) and Looking Towards Riser 100 (B)

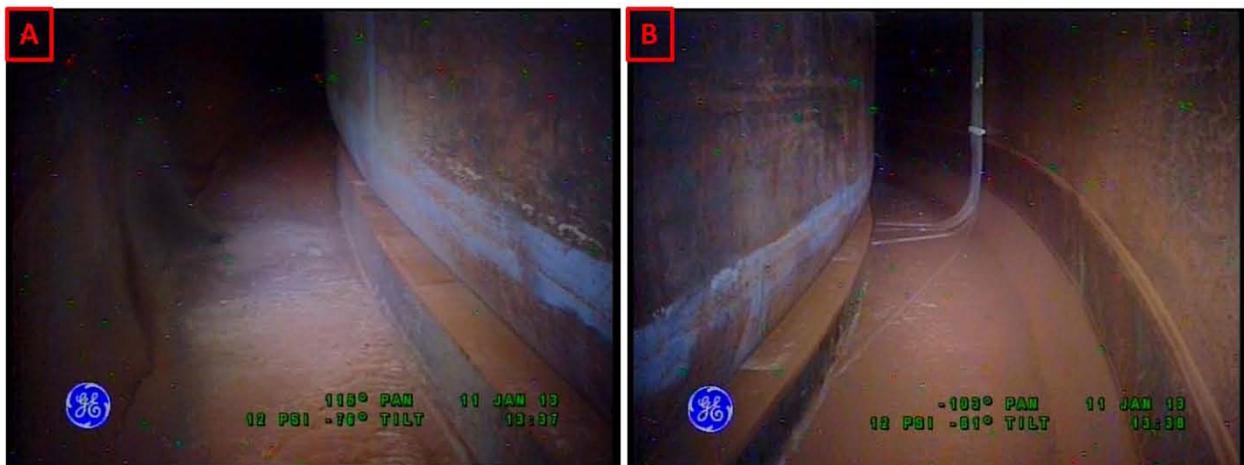
Figure 2-11 shows the general condition of the lower knuckle and annulus floor in January 2013. A beachline can also be seen along the annulus floor in Figure 2-11 which is likely the result of evaporated couplant water used during UT examinations. In Figure 2-11A, there appears to be signs of previous intrusion coming from Riser 105, the annulus pump pit. There is currently no pump installed in the AZ-101 annulus pump pit. The debris seen in Figure 2-11A is most likely remnants of past dirt and moisture which migrated into the pit and eventually into the annulus space. Figure 2-12 shows the general condition of the refractory slots in 2013 and no anomalies were noted. No anomalies were identified on the lower knuckle of the primary tank, insulating refractory, refractory slots, stiffener ring, or annulus floor during the 2013 inspection.

Figure 2-11. Riser 81 Lower Knuckle and Annulus Floor Condition on January 11, 2013 Looking Towards Riser 105 (A) and Looking Towards Riser 100 (B)

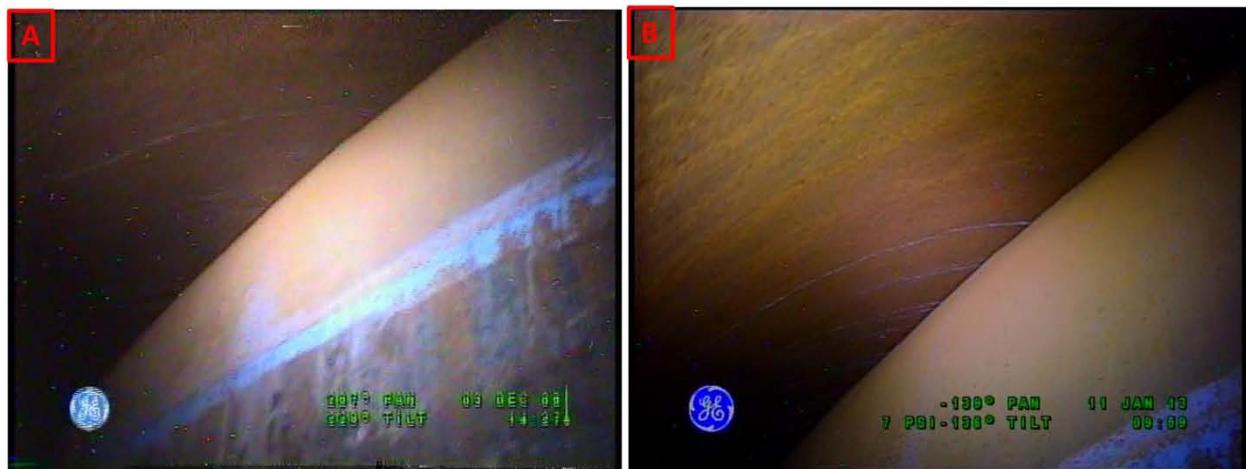
Figure 2-13. Riser 82 Upper Haunch Comparisons Between Inspections on December 3, 2008 (A) and January 11, 2013 (B) Looking Towards Riser 95

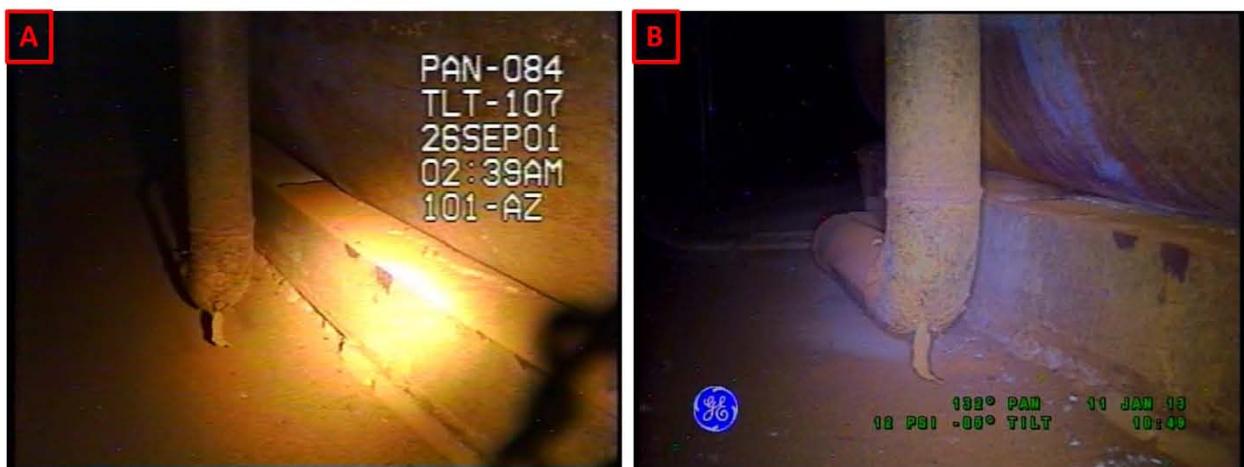
Figure 2-15. Riser 82 Lower Knuckle and Annulus Floor Comparisons Between Inspections on September 26, 2001 (A) and January 11, 2013 (B) Looking Towards Riser 95

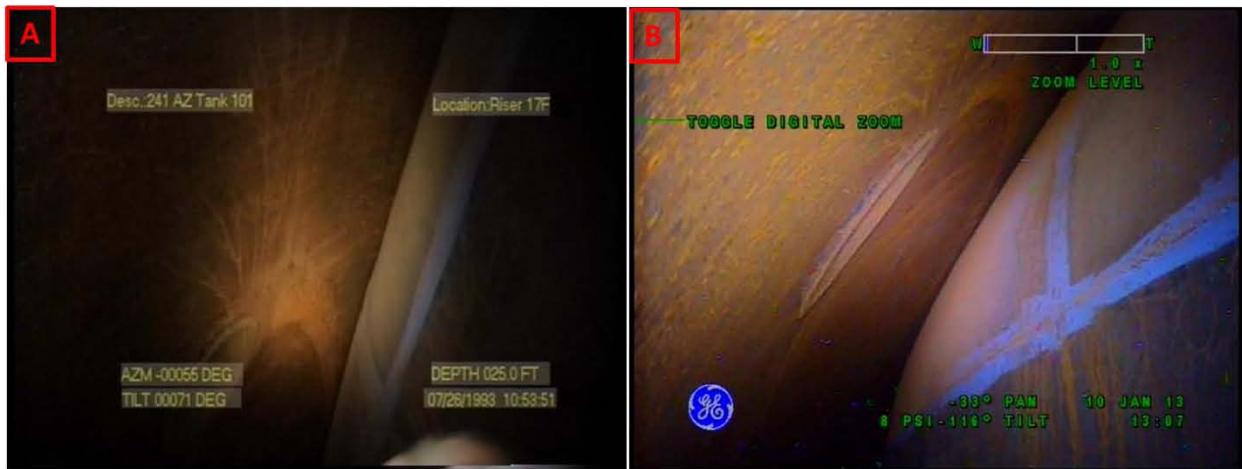
Figure 2-18. Riser 83 Upper Haunch Comparisons Between Inspections on July 26, 1993 (A) and January 10, 2013 (B) Looking Towards Riser 96

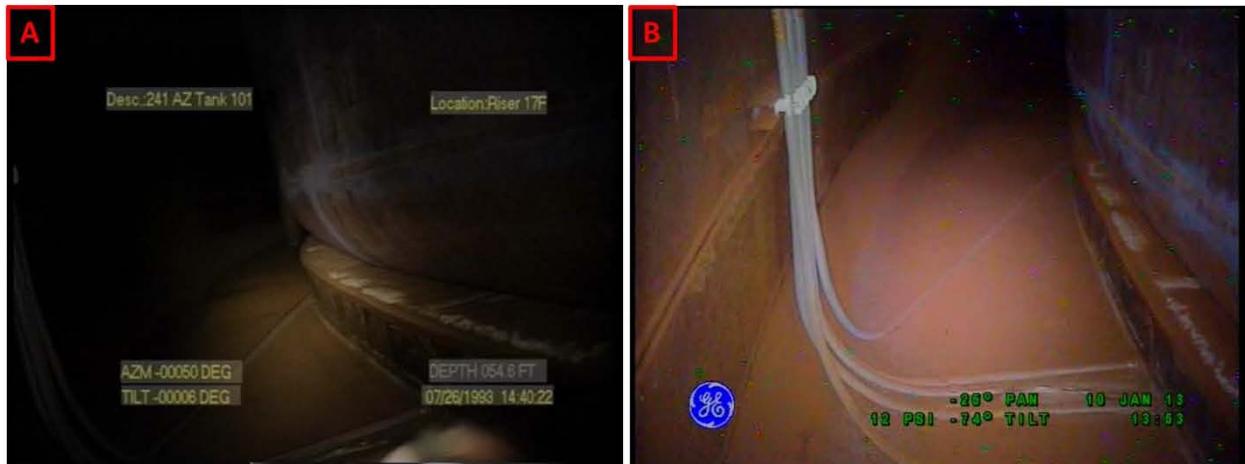
Figure 2-20. Riser 83 Lower Knuckle and Annulus Floor Comparisons Between Inspections on July 26, 1993 (A) and January 10, 2013 (B) Looking Towards Riser 96

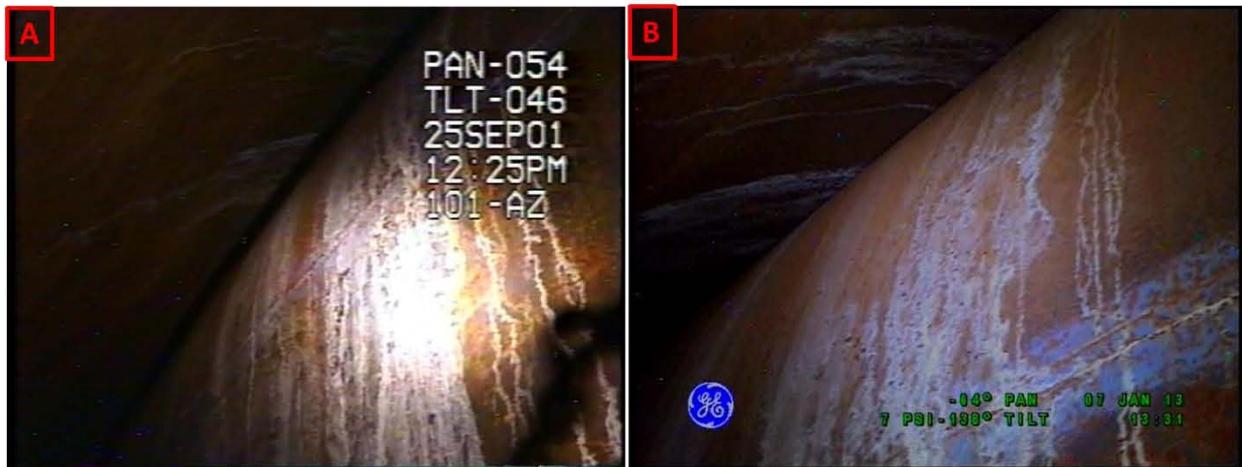
Figure 2-26. Riser 86 Upper Haunch Comparisons Between Inspections on September 25, 2001 (A) and January 7, 2013 (B) Looking Towards Riser 87

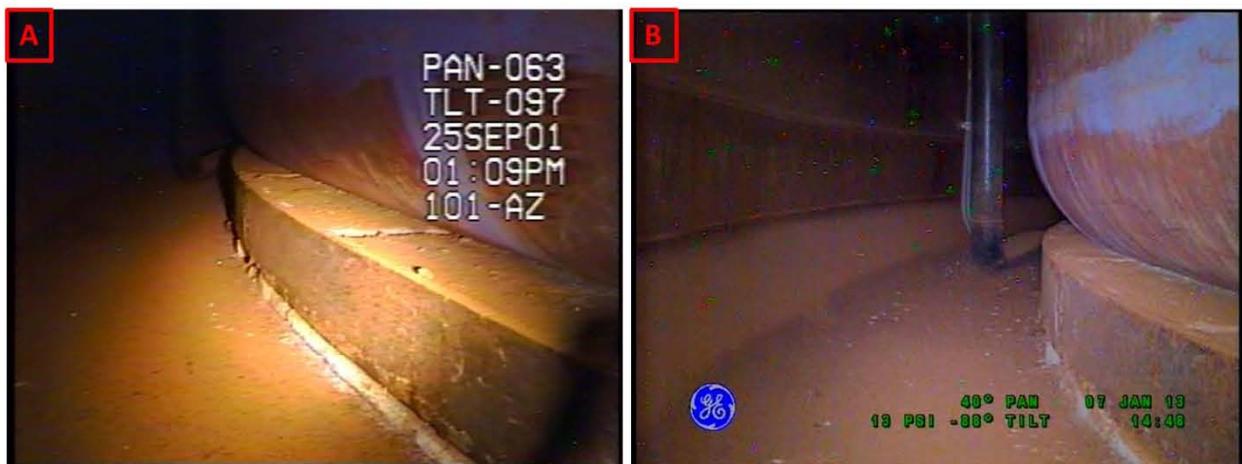
Figure 2-28. Riser 86 Lower Knuckle and Annulus Floor Comparisons Between Inspections on September 25, 2001 (A) and January 7, 2013 (B) Looking Towards Riser 87

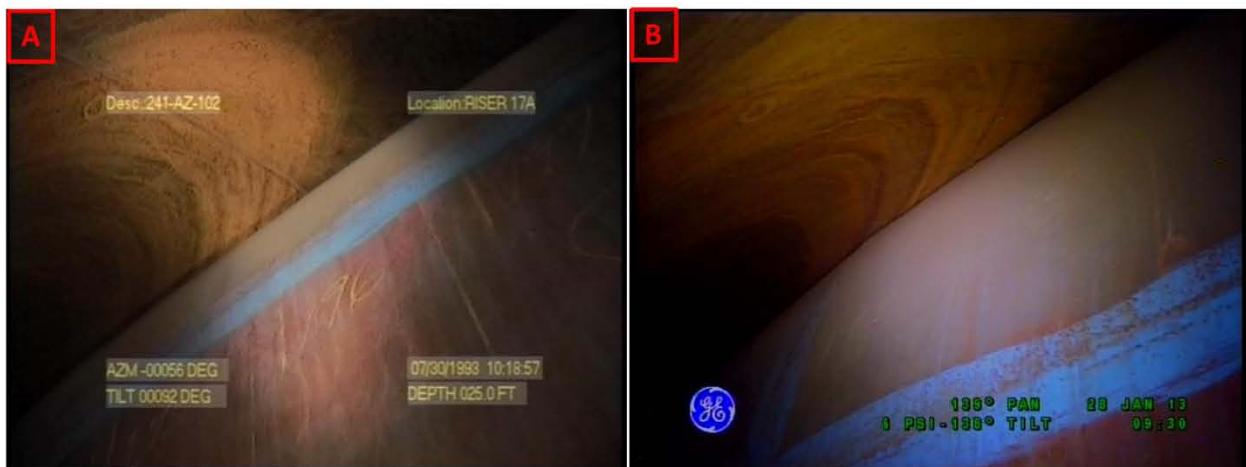
Figure 3-1. Riser 78 Upper Haunch Comparisons Between Inspections on July 30, 1993 (A) and January 28, 2013 (B) Looking Towards Riser 93

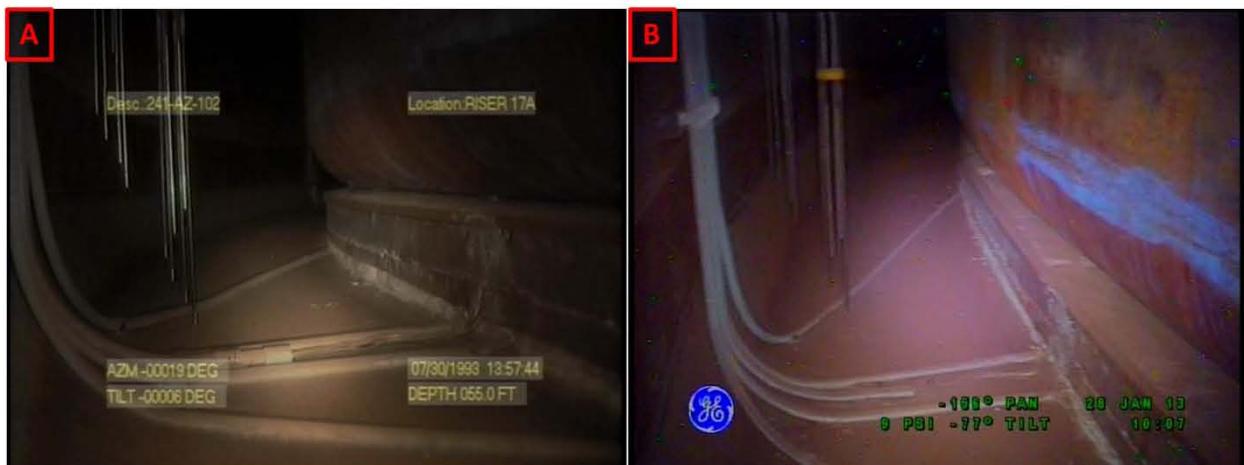
Figure 3-3. Riser 78 Lower Knuckle and Annulus Floor Comparisons Between Inspections on July 30, 1993 (A) and January 28, 2013 (B) Looking Towards Riser 93

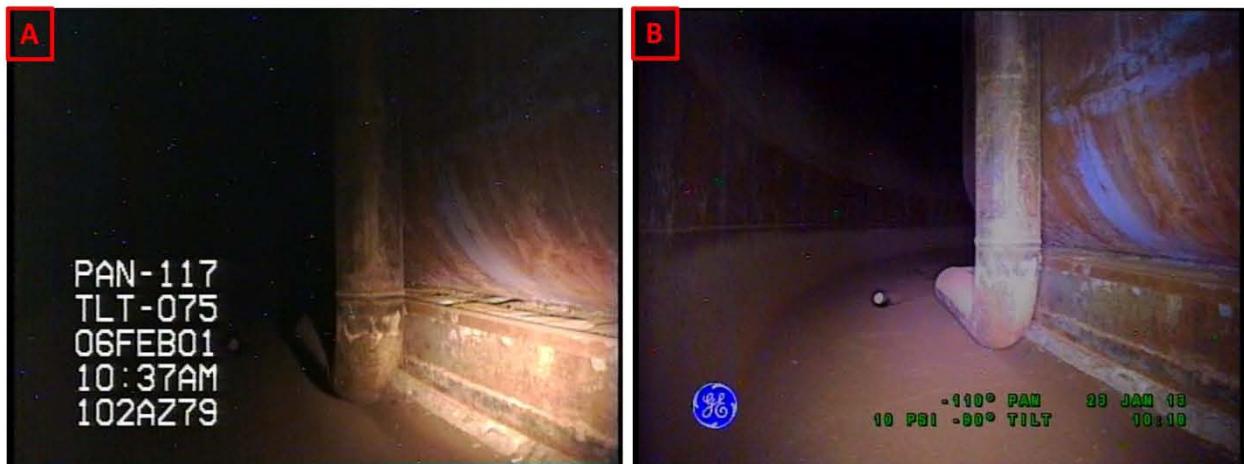
Figure 3-7. Riser 79 Lower Knuckle and Annulus Floor Comparisons Between Inspections on February 6, 2001 (A) and January 23, 2013 (B) Looking Towards Riser 80

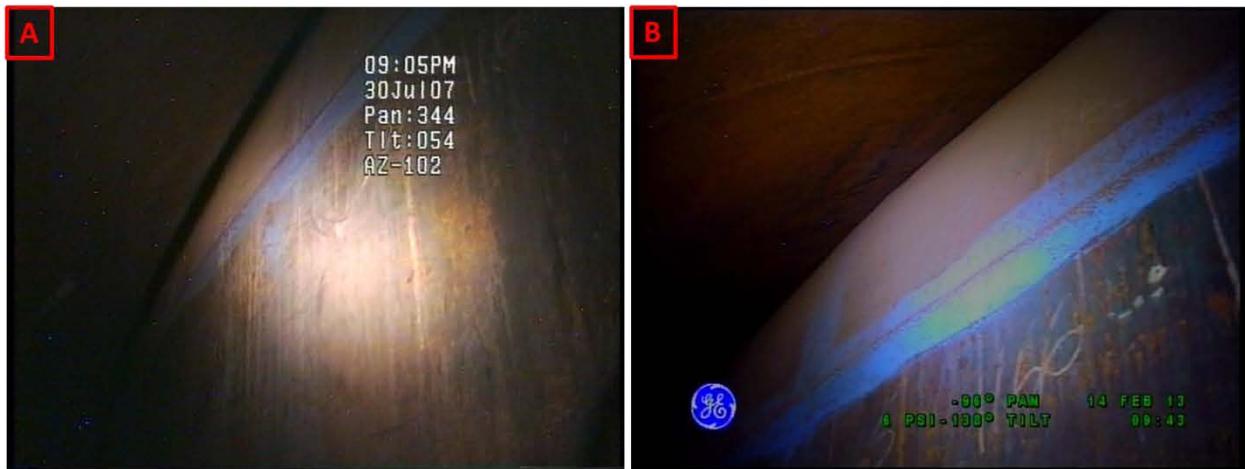
Figure 3-10. Riser 80 Upper Haunch Comparisons Between Inspections on July 30, 2007 (A) and February 14, 2013 (B) Looking Towards Riser 91

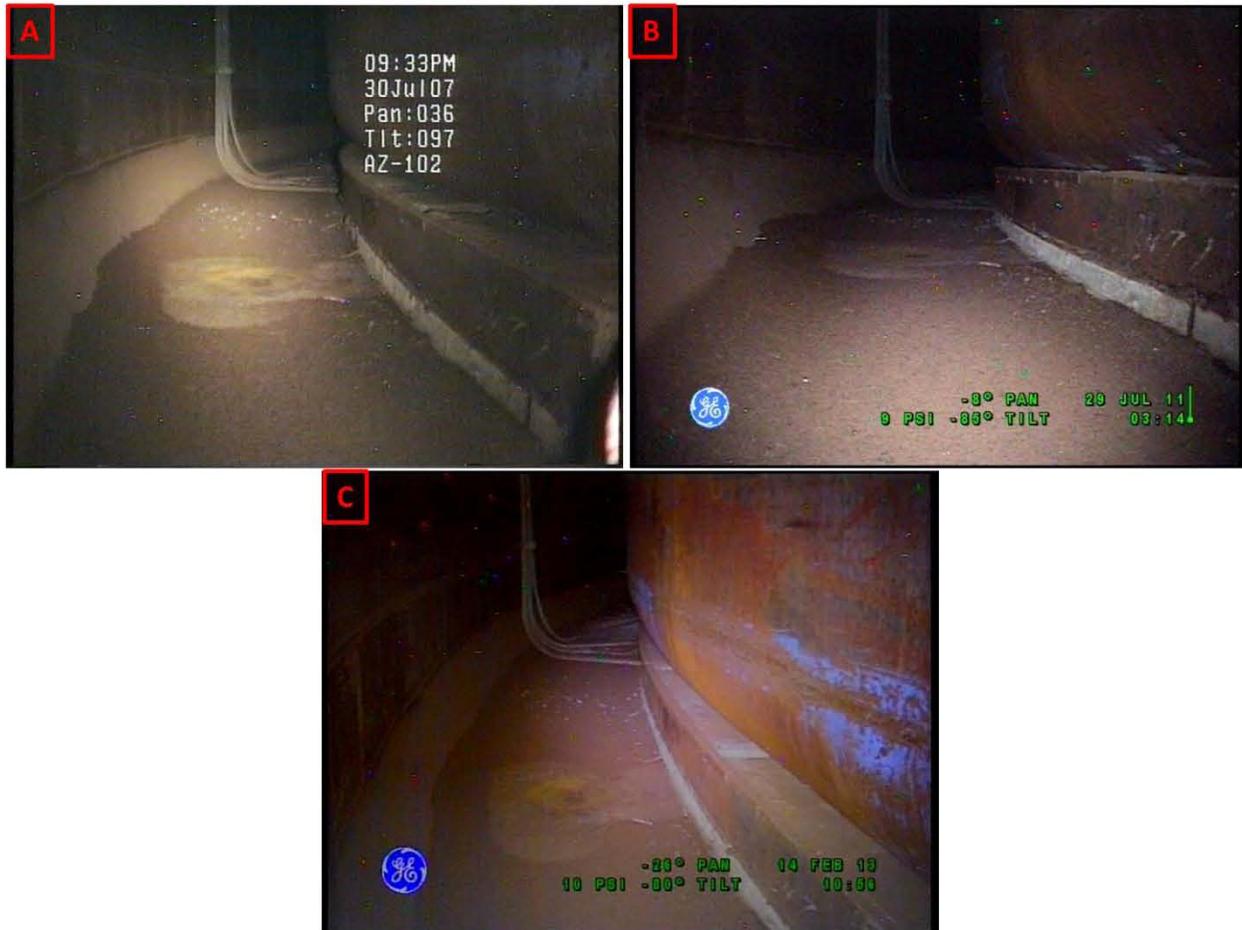
Figure 3-12. Riser 80 Lower Knuckle and Annulus Floor Comparisons Between Inspections on July 30, 2007 (A), July 29, 2011 (B), and February 14, 2013 (C) Looking Towards Riser 91

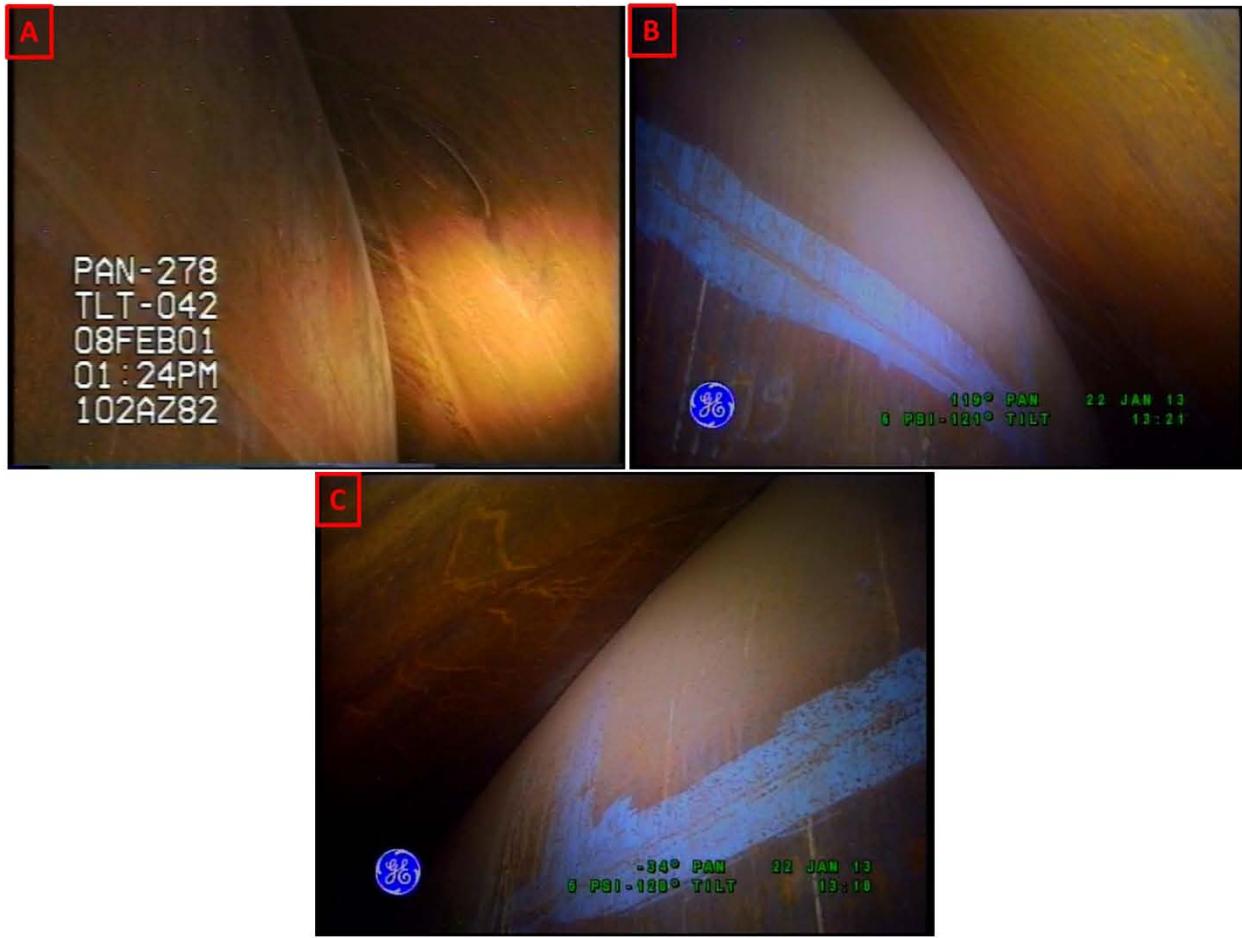
Figure 3-18. Riser 82 Upper Haunch Comparisons Between Inspections on February 8, 2001 (A) and January 22, 2013 (B) Looking Towards Riser 105 and on January 22, 2013 Looking Towards Riser 95 (C)

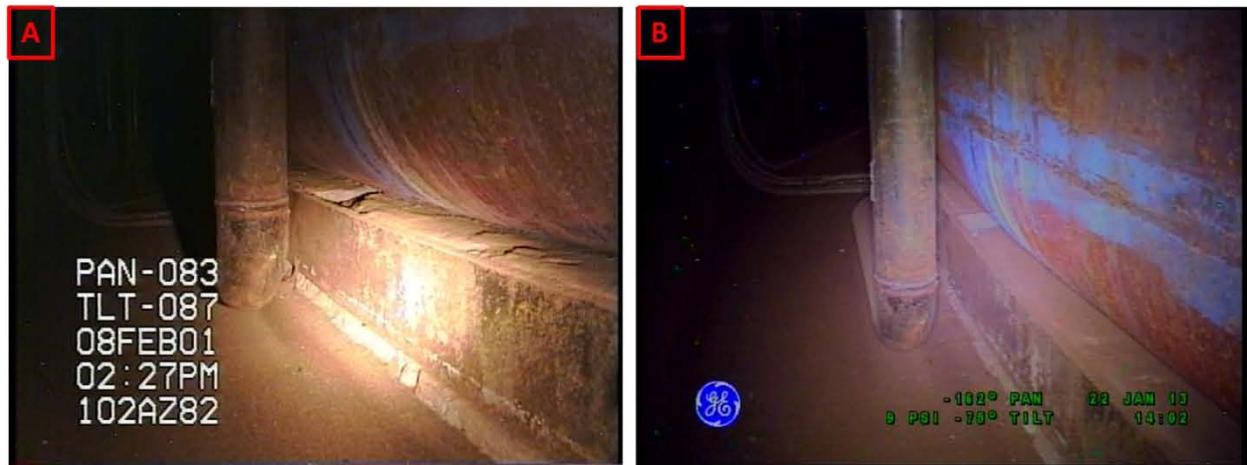
Figure 3-19. Riser 82 Lower Knuckle and Annulus Floor Comparisons Between Inspections on February 8, 2001 (A) and January 22, 2013 (B) Looking Towards Riser 95

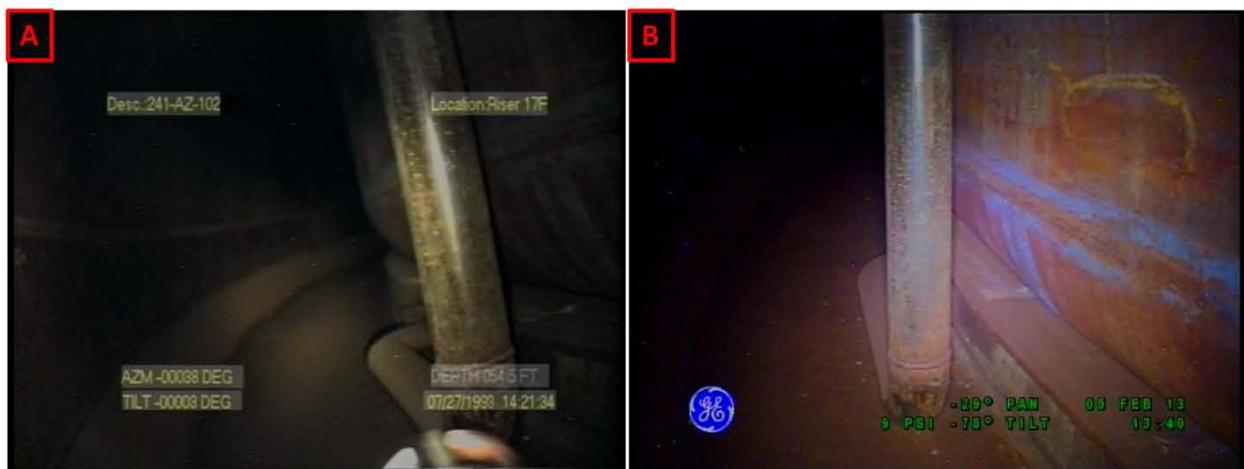
Figure 3-26. Riser 84 Lower Knuckle and Annulus Floor Comparisons Between Inspections on July 27, 1993 (A) and February 5, 2013 (B) Looking Towards Riser 85
