ABSTRACT

The research presented within this paper focuses on two 9-meter CX-100 wind turbine blades, designed by Sandia National Laboratories (SNL) and manufactured by TPI Composites Inc.. The key difference between the blades was that the one blade contained no known defects, while the other blade had wave defects of controlled geometry inserted at specified locations along the blade length. The defect-free blade and defect blade were tested at the National Renewable Energy Laboratory (NREL) National Wind Technology Center (NWTC) using a schedule of cycles at increasing load level until failure was detected. Digital image correlation (DIC) was used as a structural health monitoring (SHM) technique, along with several other methods including: shearography, acoustic emission, fiber optic strain sensors, foil strain gages, thermal imaging, and PZT sensors for comparison. The paper compares the sensing results of the different SHM approaches to detect the defects and subsequent damage from the initial fatigue cycle to final failure.

Christopher Nizrecki, Peter Avitabile, Julie Chen, James Sherwood, and Troy Lundstrom, University of Massachusetts Lowell, Lowell, MA; Scott Hughes and

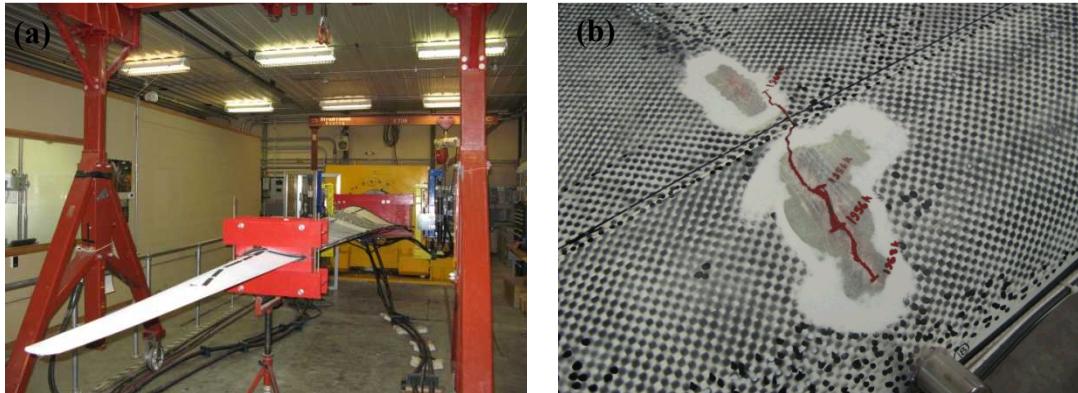
Figure 1 (a) NREL-NWTC flapwise fatigue test setup for 9-meter CX-100 defect blade; (b) structural failure near wave defect at 5m location, after approximately 1.9 million cycles at increasing load levels (the surrounding pattern applied is used for DIC).

An accelerated 1-million cycle design life fatigue load was applied to the blade before increasing loads in discrete steps up to 130% of the target fatigue loads, at which point a 2.5-cm long crack was observed at the 5-m station on the HP surface spar cap, biased towards the leading edge (LE) as shown in Figure 1b. The test ran for approximately 1.9-million cycles before the failure. Full details of the loading levels and duration applied can be found in [2]. A suite of sensor measurements were either made continually or intermittently throughout the fatigue test until and after failure. The different sensor results are now discussed.

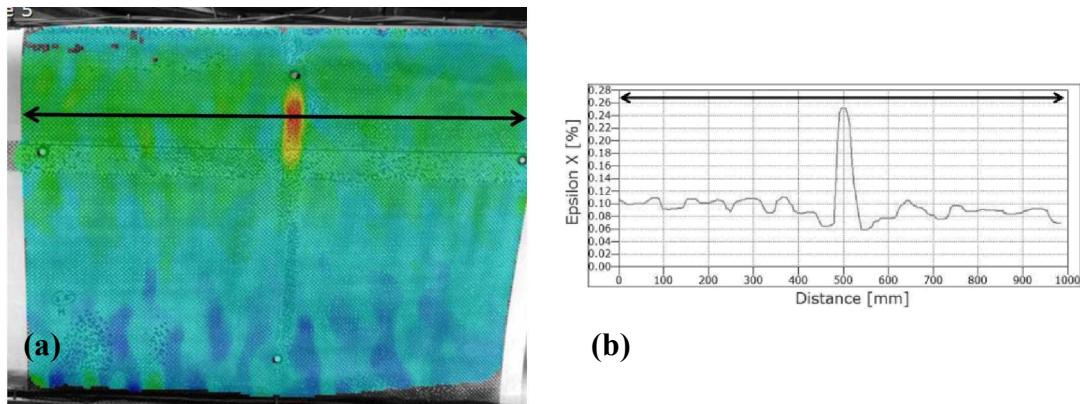
Figure 3 shows an example of a representative DIC measurement at the 5.0-m location along the low pressure (LP) side of the CX-100 (virgin blade). The strain across the surface of the blade as indicated by the double-arrow line in Figure 3a is plotted in Figure 3b where the nominal strain away from the defect is compared to the magnitude of the amplified strain at the location of the defect. The results reveal that the defect locations are readily discernible. Each of the locations near the defect has larger than nominal strain.

Figure 3 (a) DIC measurement of strain at the 5.0-m location along the LP side of the blade; (b) corresponding strain in a section line passing through the defect location

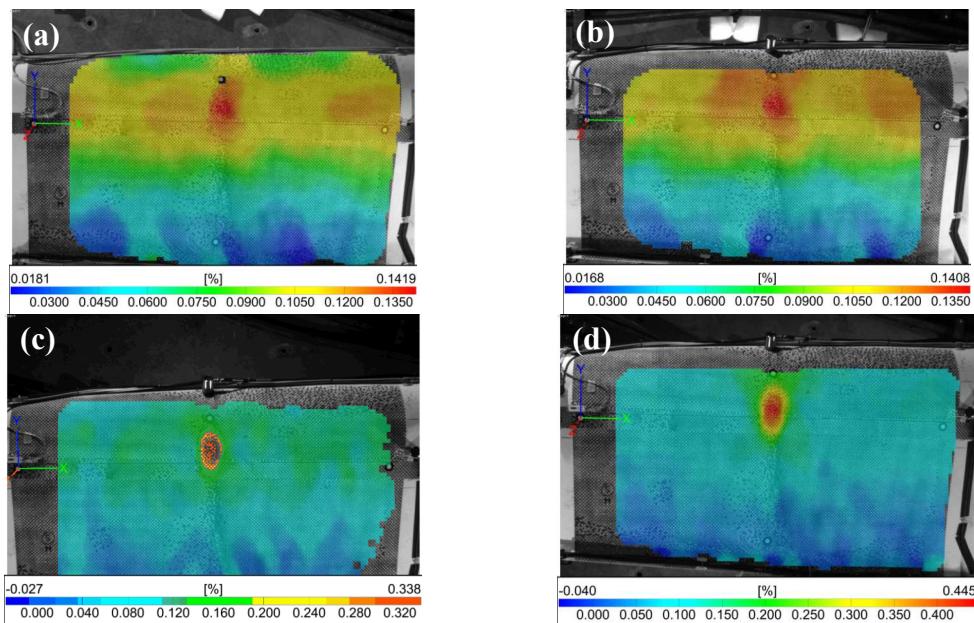
Figure 4 DIC strain contour plots for the 5.0-meter HP section at (a) 0 cycles; (b) 25,603 cycles; (c) 755,049 cycles; (d) 1,803,350 cycles

As the blade was cycled, the strain amplification in the vicinity of the defect became more apparent as is shown in Figure 4 for the 5m HP side, defect location

(area where failure first occurred). The images for the other regions are similar and have been omitted for brevity. The results of the work confirm DIC is an effective method of measuring full-field displacement, strain, and locating cracks and wave defects on wind turbine blades.

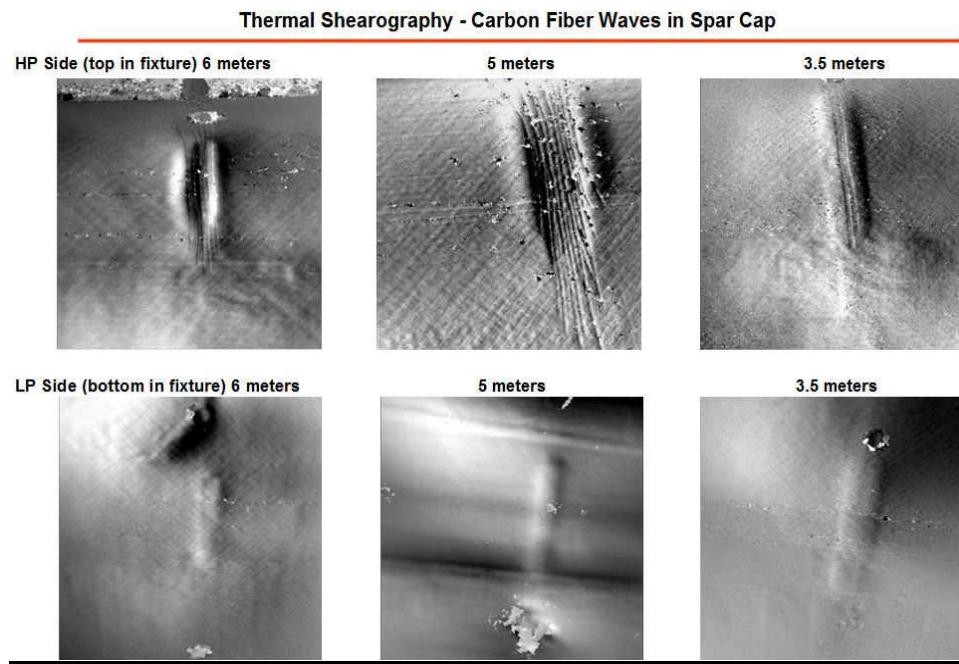
Shearography testing was performed twice during the fatigue cycling at 120,000 cycles and 820,000 cycles. The thermal shearography testing was accomplished using a shear vector of 0.5 inch (12.7mm) orthogonal to the trailing edge. The thermal stress was applied after capturing the reference image. The final image was taken when the real-time phase map fringe order reached zero. All embedded wave defects were detected using shearography prior to the start of the fatigue tests. Shearography tests of all the embedded wave defects taken at 120,000 cycles revealed extensive crack formation on the HP side fiber waves, with no such crack formation detected on the LP side. The crack at 5m on the HP side, as seen in Figure 6, shows extensive crack formation considerably beyond the axial (chord-wise) length of the defect. The blade ultimately failed at this 5 m location. The results demonstrate that thermal shearography has excellent capability to detect out-of plane fiber wave defects and the capability to detect low cycle fatigue damage.

Figure 6 Thermal shearography inspection of all HP and LP fiber wave defects after 120,000 fatigue cycles. Cracks are seen at all three defects on the HP side.

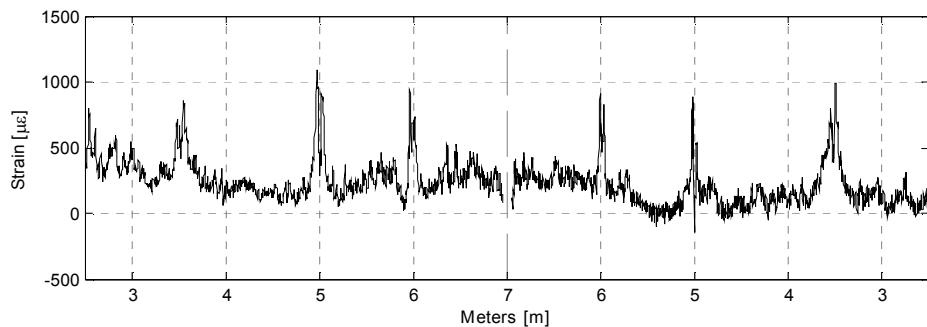
The embedded optical fibers were monitored during the manufacturing process of the blade. The defects were evidenced by regions of concentrated strain immediately upon pulling vacuum during the Vacuum Assisted Resin Transfer and Molding (VARTM) process. The completed blade was interrogated to determine residual strain, shown in Figure 7. Localized regions of tension on the order of $1000\mu\epsilon$ are apparent at each of the defect locations in the blades as the fiber runs out from 2.5m to 7m and back.

Figure 7. Residual strain in fiber embedded under the defects in the HP side of the blade.

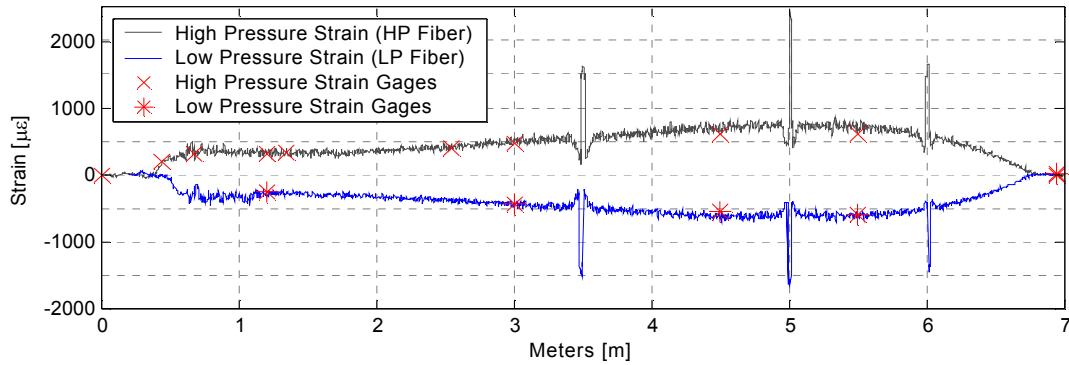
Prior to fatigue cycling, the blade was mounted in a test stand for static testing under a ~ 500 lb load. Figure 8 shows corresponding distributed fiber optic strain data compared with co-located electrical foil gages for the HP and LP spar cap from 0.5m to 7m locations. Readily apparent in the fiber optic strain data are regions of

high localized strain at blade locations that correspond to the known internal defects introduced in the blade during manufacture. Local strain in these regions is approximately three times in amplitude that of the surrounding strain field. The widths of the peaks correlate well with the widths of the defects. Regions of large strain gradients on either side of the defect indicate the extreme stress concentration caused by the simulated 3mm out-of-plan waviness and the ability of the distributed optical measurement technique to resolve critical small scale features that might go undetected with single point sensors.

Figure 8. Surface Mounted Fiber Optic Strain Data with Co-Located Foil Strain Gages on CX-100 under 500lb Load Prior to Fatigue Test along Spar

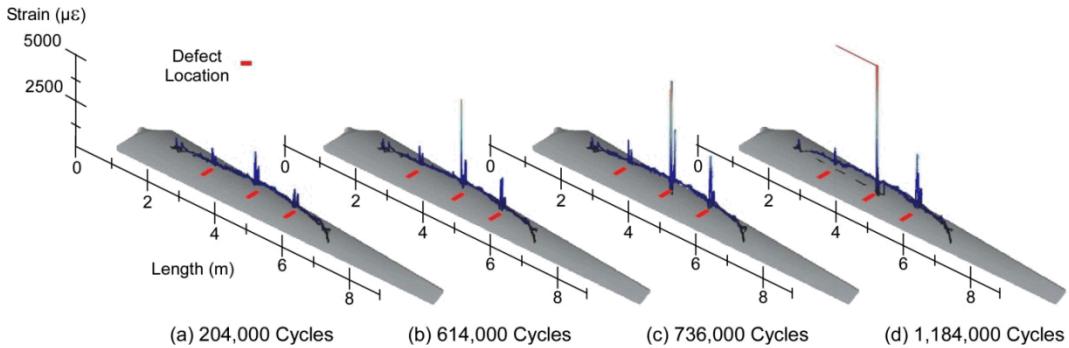
Distributed strain was measured, under various load conditions, at intervals during the fatigue testing. The blade failed at 1.968 million cycles due to a defect on the high-pressure side of the blade. Luna's no-load measurements identified significant growth in the critical defect by cycle 614,000, which correlates with the time that low-level acoustic emission was first detected from the blade. Damage was not visible on the surface of the blade until 1.95 million cycles (see Figure 9).

Figure 9. Distributed strain measured at four different cycle counts during fatigue testing. The data presented are for strain in the sensing fiber embedded under the defects within the carbon fiber spar cap. The growth of the defect located at 5 meters on the high pressure side of the blade broke the sensing fiber sometime between (c) 736,000 cycles and (d) 1,184,000 cycles. The blade ultimately failed at this location at 1,968,000 cycles.

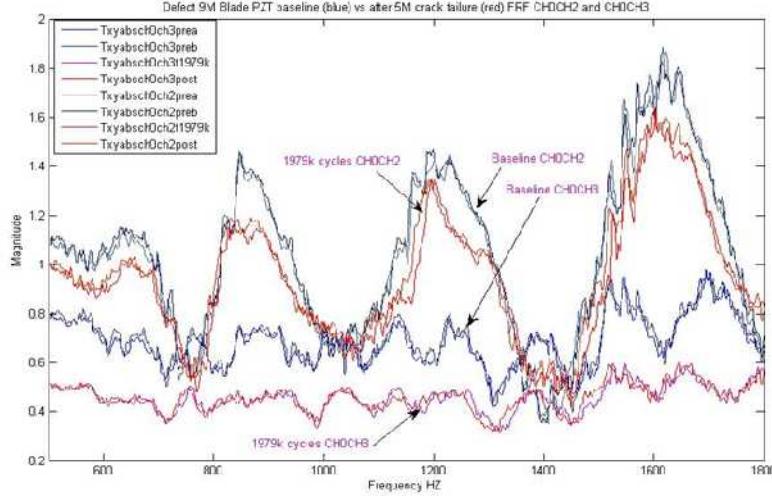
The frequency response functions (FRFs) between the PZT sensors and actuator are shown in Figure 11 revealing differences in modal peaks before (blue traces) and after (red traces) occurrence of the fatigue crack at the 5 meter location. Unfortunately, the cracking occurred on the opposite side of the blade from the

sensors. The crack was closest to sensor 4 (ch3). The nearly identical traces of the same color were taken at different time windows.

Figure 11. FRF of the PZT sensor/actuators demonstrating a change in the signature past 1979 k-cycles compared to the baseline

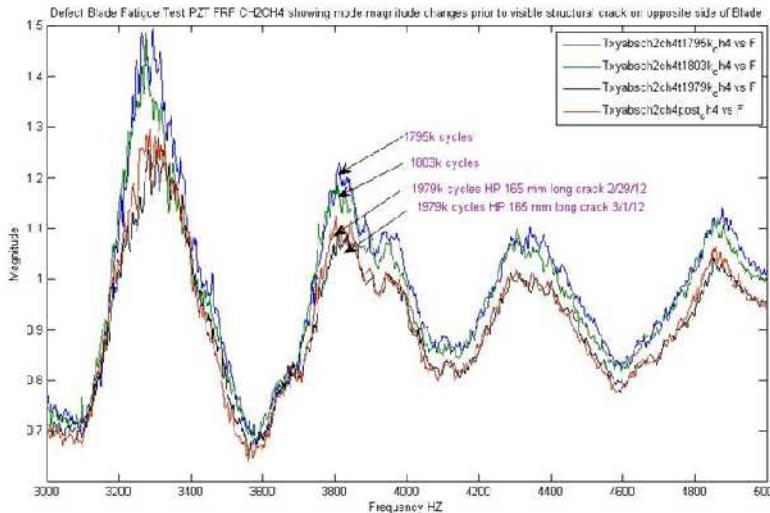
Shown in Figure 12 are the FRFs of ch 2 to ch 4 which span the 5m 164 mm long crack showing slight differences in modal peak frequency just before the detection of the surface crack. It should be mentioned that the crack was on the opposite side of the blade (HP side) from the PZT actuator and sensors (LP side) which greatly decreased detect ability. It is recommended that subsequent monitoring should attach a set of actuators and sensors on both sides of a blade to provide an adequate signal. Still, very small changes to the stiffness were detected as indicated by slightly lower frequencies, as seen in Figure 12. Prior blade fatigue test results have shown very detectable frequency shifts due to flaws with an adequate signal (actuator and sensors on the same side of the blade as the defects).

Figure 12. FRF of the PZT sensor/actuators (channel 2 and 4) demonstrating a change in the signature near failure.

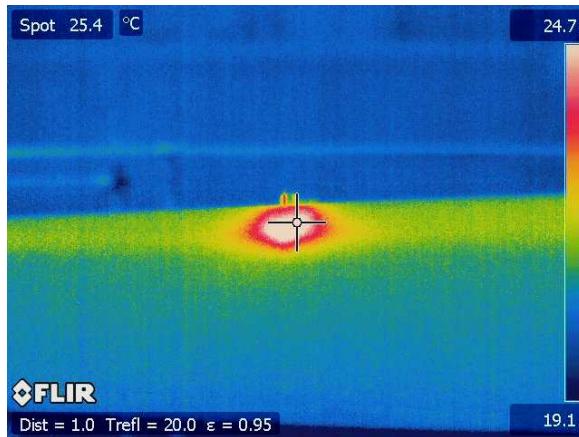
The results of the thermal imaging performed are shown in Figure 13 for the wave defect under fatigue loading. It can be seen that the defects emit a clearly detectable amount of thermal energy, on the order of 6°C warmer than the surrounding regions. Although the defect locations were known in this case, it should be clear how thermal imaging can be a useful tool for detecting and locating thermal hot spots and defects. While the exact nature of the defect may not be obvious, having known locations for performing additional non-destructive inspections is very valuable.

Figure 13 – Thermal Image of Out-of-Plane Wave Defect under Fatigue Loading

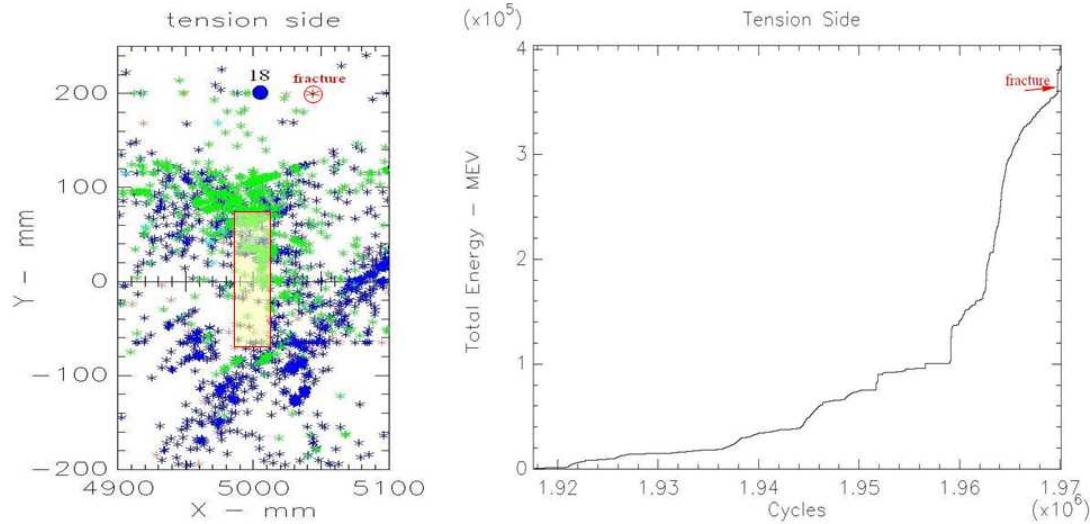
The blade failed after an accumulation of 1,968,186 fatigue cycles. Blade failure occurred near the 5.0-meter flaw when a resultant 5-inch long crack started near the leading edge on the high-pressure tension side of the loaded blade. Most of the AE energy released during the last 20,000 cycles of the test came from the region around the 5 meter defect on the high pressure surface. A map of the AE events and

the AE energy released in the mapped area are shown in Figure 15. The point labeled **fracture** is the AE event which occurred closest in time to the crack initiation. The light-yellow box indicates the approximate location of the blade 5 m defect.

Figure 15 – AE events near the 5 m defect (left) and the corresponding AE energy

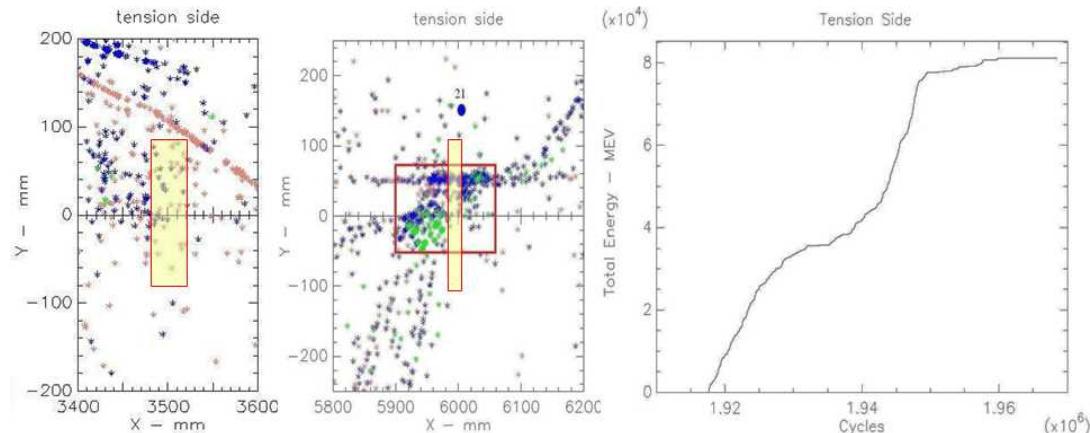
For comparison, all the AE events that occurred near the defects at 3.5-meters and 6.0-meters are shown in Figure 16, during this last load block. The light-yellow boxes shown in the left two figures outline the approximate areas of the defects. The figure on the right shows the AE energy released in the rectangular bold-outlined area near the 6-meter defect.

Figure 16 – AE events near the 3.5 m and 6m defects (left) and the corresponding AE energy emitted near the 6 m location.

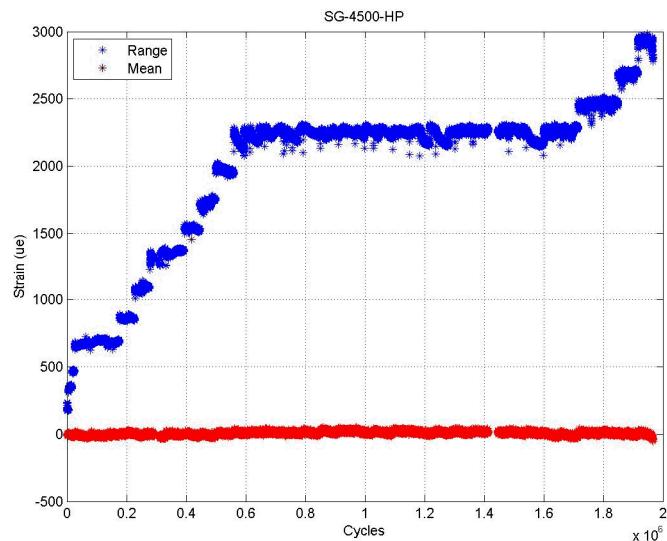
A representative timeline of the flapwise fatigue test is provided in Figure 17 for a single strain gage. Prior to the primary failure at the 5-m defect location, no significant structural changes were observed.

Figure 17 – Representative Strain of Single Foil Gage during Fatigue Testing
