Purpose of Document: Identifies leak causes and locations for B Farm tanks

# Hanford Single-Shell Tank Leak Causes and Locations - 241-B Farm

**Abstract:** This document identifies 241-B Tank Farm (B Farm) leak cause and locations for the 100 series leaking tank (241-B-107) identified in RPP-RPT-49089, Hanford B-Farm Leak Inventory Assessments Report. This document satisfies the B Farm portion of the target (T04) in the Hanford Federal Facility Agreement and Consent Order milestone M-045-91F.

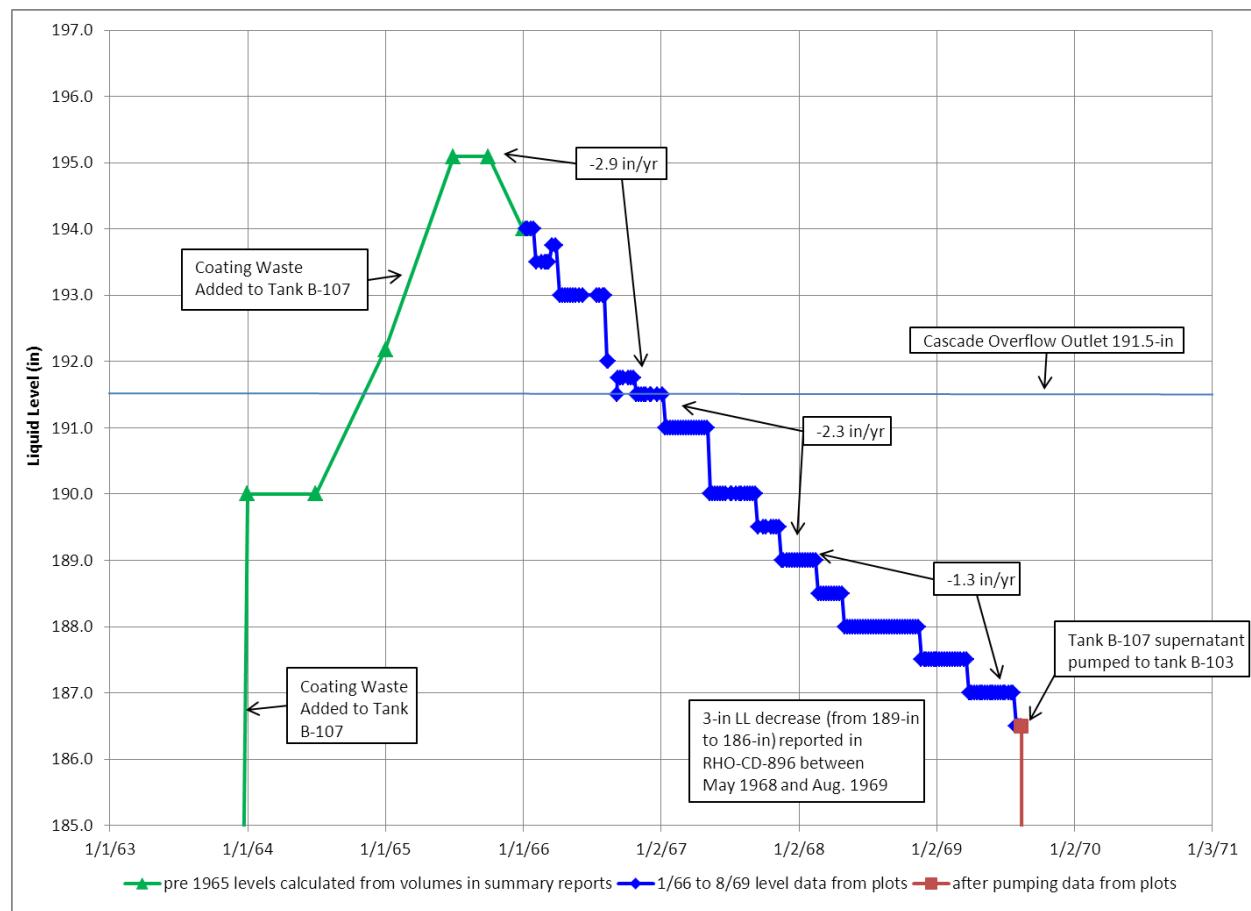
**Figure 4-4. Tank B-107 Liquid Level 1963-1969 with Leak Rates**

Tank B-107 was first suspected of leaking due to a 3-in liquid level drop between May 1968 and August 1969 with a reported leak loss of 8 kgal (RHO-CD-896, *Review of Classification of Nine Hanford Single-Shell "Questionable Integrity" Tanks*). However, after reviewing historic liquid level charts for tank B-107, it appears there was only a 2 1/2-in decrease during this time. It also appears that the liquid level began decreasing before May 1968, as early as the fourth quarter of 1965, which is shown in Figure 4-4. It is not clear why RHO-CD-896 selected May 1968 through August 1969 for the leak determination when a plot indicates the liquid level was decreasing much earlier.

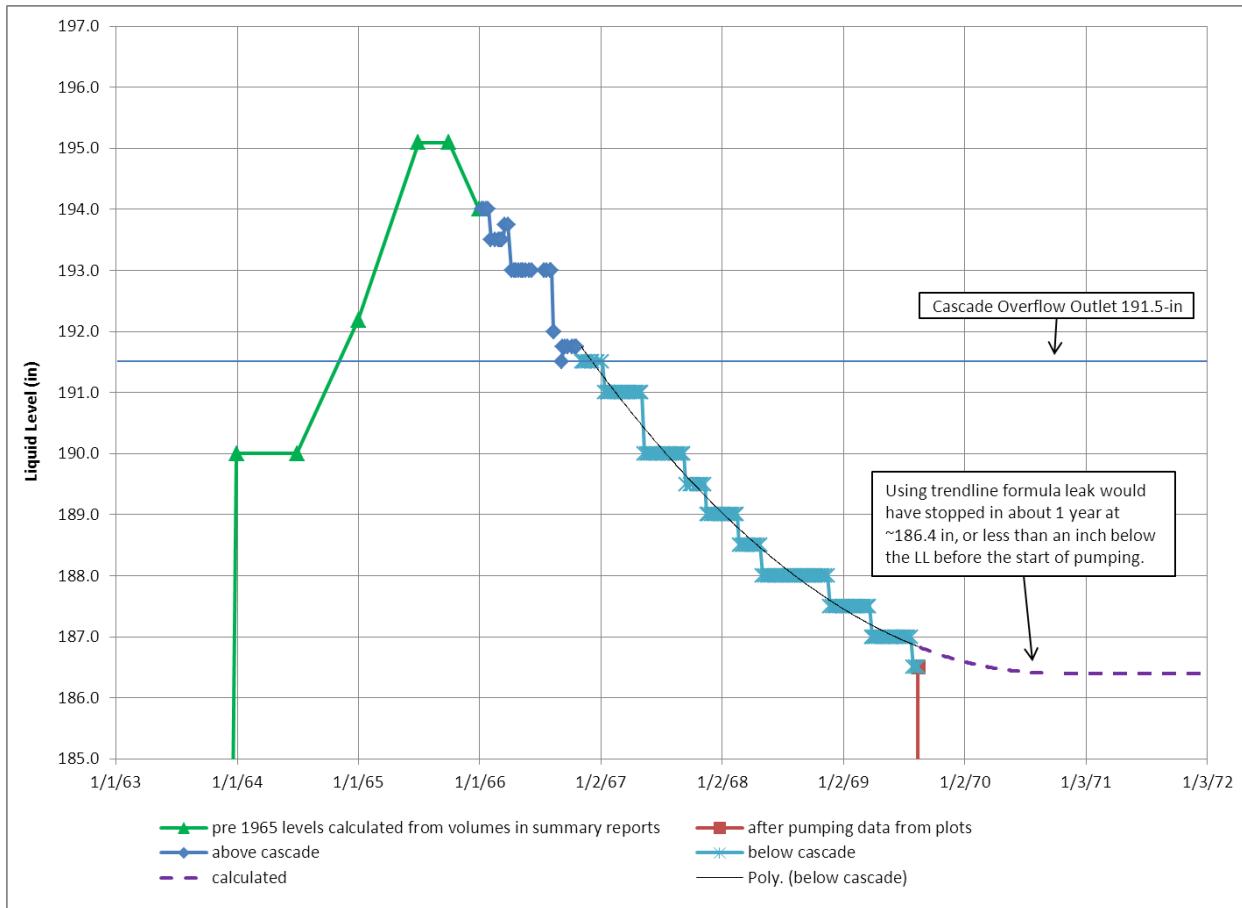
**Figure 4-5. Tank B-107 Liquid Level 1963-1969 with Projected Level if Tank Not Pumped**

The tank B-107 leak may have started as early as the fourth quarter of 1965, or over three years earlier than what was reported in RHO-CD-896. It appears there was minimal leakage through the cascade line or any connections as the liquid levels in tanks B-108 and B-109 were holding steady during the time the tank B-107 levels were decreasing. Thus, it appears the leak is greater than the 8 kgal reported in RHO-CD-896 and could be as large as 22 kgal disregarding evaporation, hydrostatic pressure, and possible leakage through the cascade line or inlet wall connection seals.

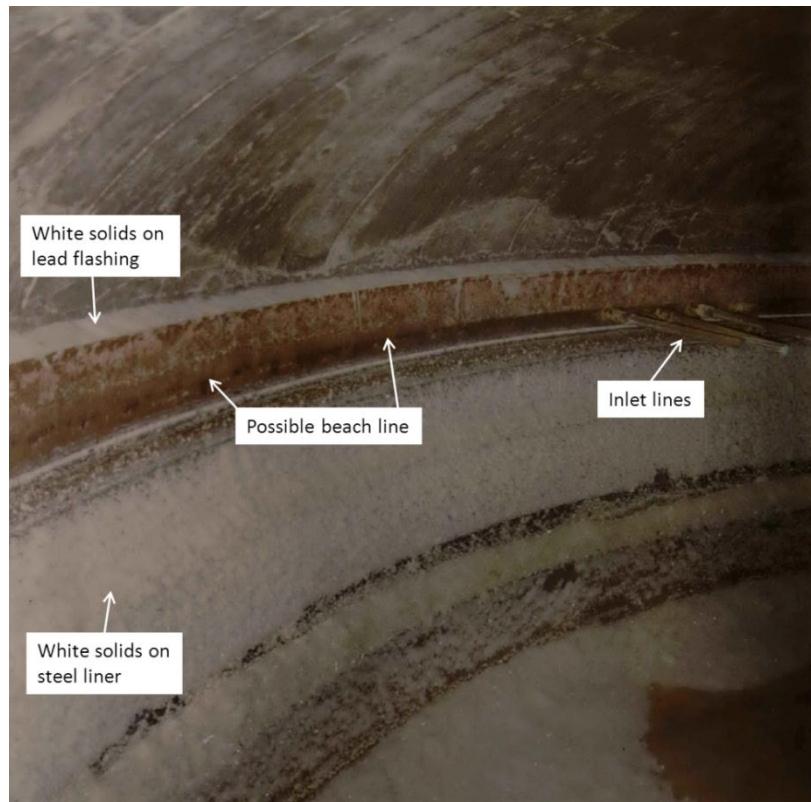
**Figure 4-7. Tank B-107 Photograph March 19, 1970 (701322-6 CN)**

Tank B-107 photographs do not show any evidence pointing to a tank leak.

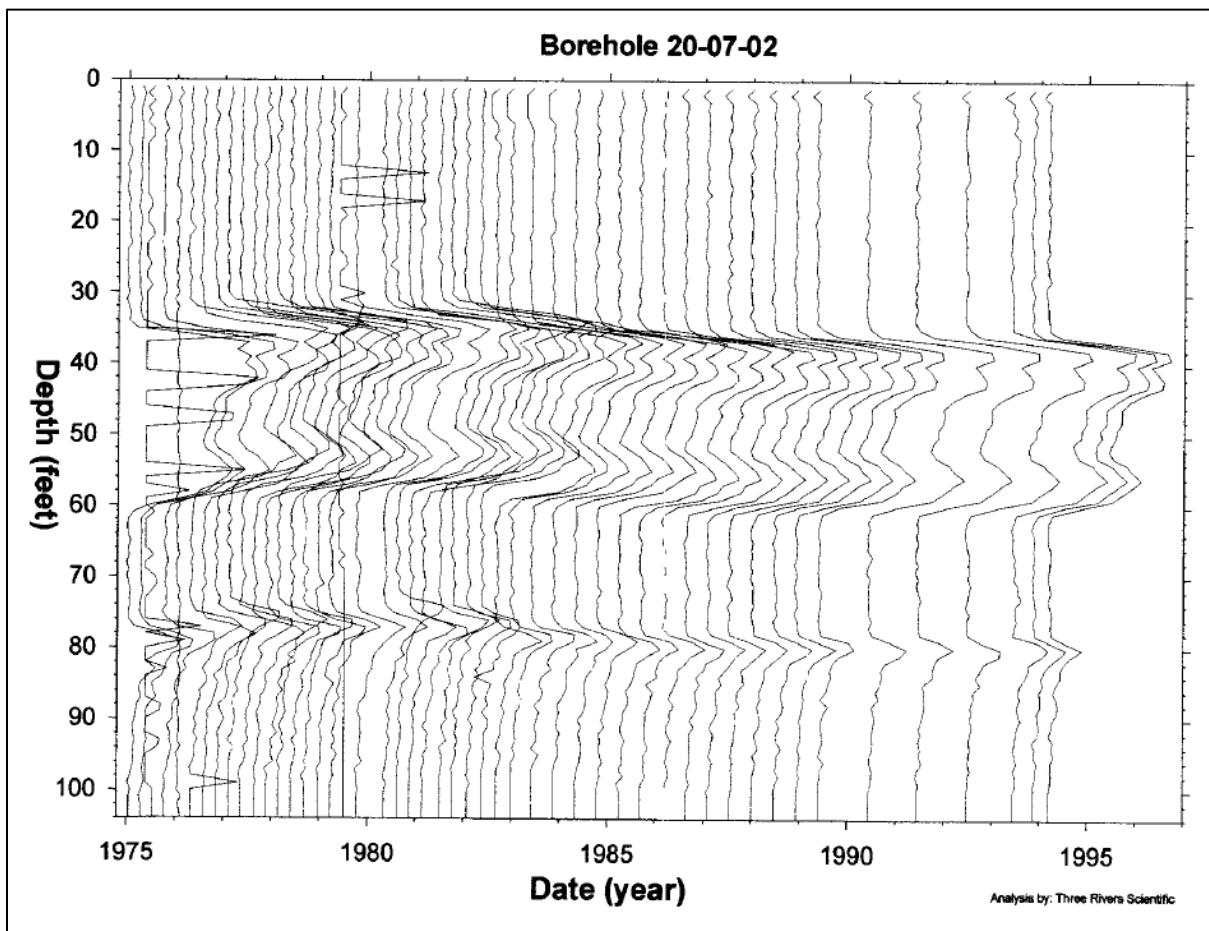
**Figure 4-9. Tank B-107 Drywell 20-07-02 (HNF-5433)**

In August 1999, Cs-137, Co-60, Eu-154, and Eu-152 were detected in this drywell with the highest concentrations forming a plume that occupies the region directly below the base of the tank farm excavation (GJ-HAN-128). Thick zones of continuous Cs-137 contamination were measured from 35.5 to 59.5-ft BGS and from 77 to 99-ft BGS with the maximum concentration of 1147 pCi/g at 42-ft BGS. Document GJ-HAN-128 reports, “The Cs-137, Co-60, Eu-154, and Eu-152 plume detected by the SGLS between 35 and 60 ft probably originated from a leak from tank B-107 that occurred prior to 1973.” Figure 4-9 shows the depths of radioactivity from 1975 to 1995 (HNF-5433).

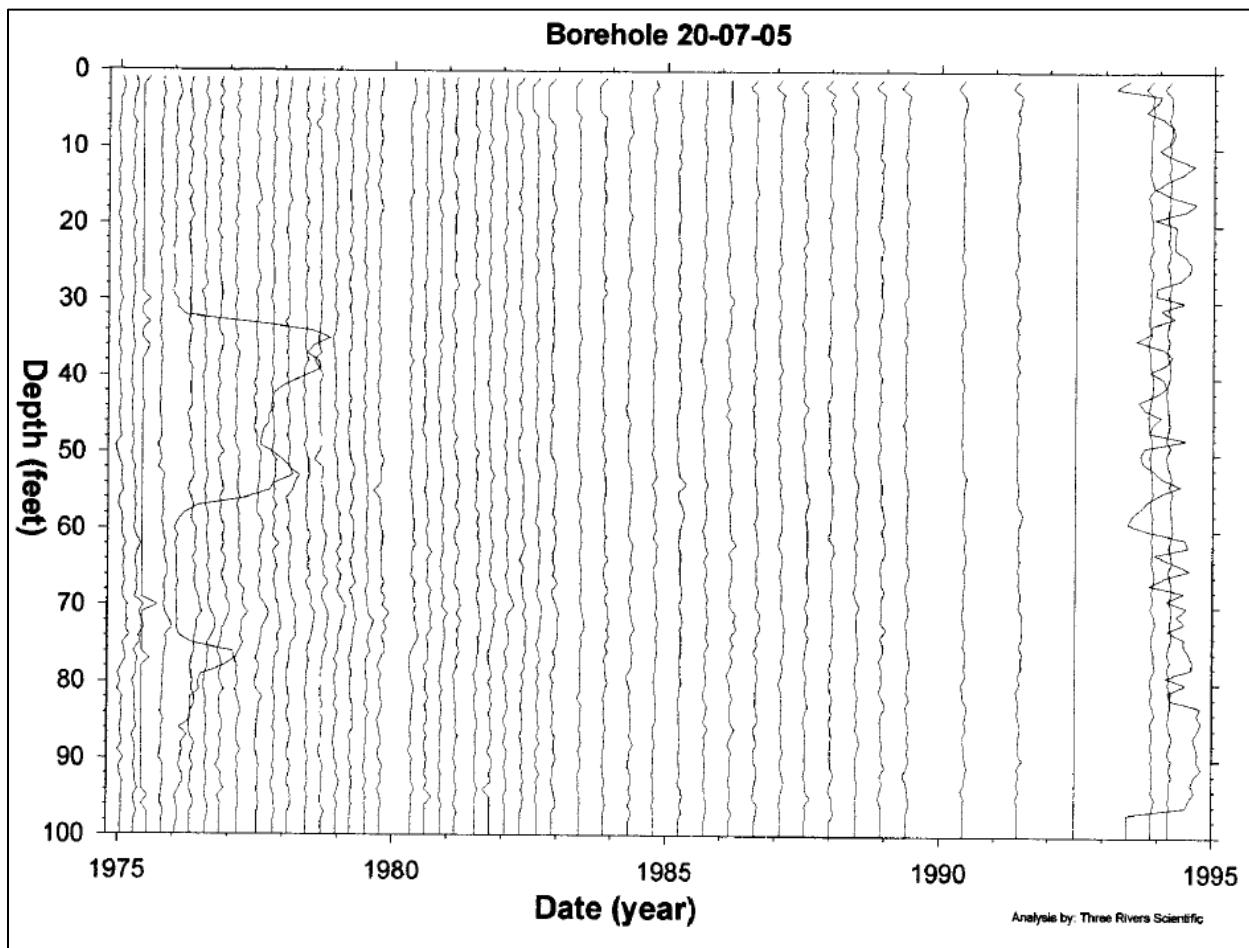
**Figure 4-10. Tank B-107 Drywell 20-07-05 (HNF-5433)**

In August 1999, Cs-137 was the only man-made radionuclide detected in drywell 20-07-05 (GJ-HAN-128). From the ground surface to 7-ft BGS, from 62 to 65.5-ft BGS, and at 85.5-ft BGS, Cs-137 concentrations were below 2 pCi/g. Document GJ-HAN-128 states, "The Cs-137 contamination detected between the ground surface and 7 ft may have originated from a surface spill that invaded the backfill material or has been dragged down during drilling. The minor occurrences of Cs-137 contamination deeper in the borehole may also be the result of drag down by drilling." Therefore, drywell 20-07-05 is not included as part of the leak location for tank B-107. Figure 4-10 shows the depths of radioactivity from 1975 to 1995 (HNF-5433).

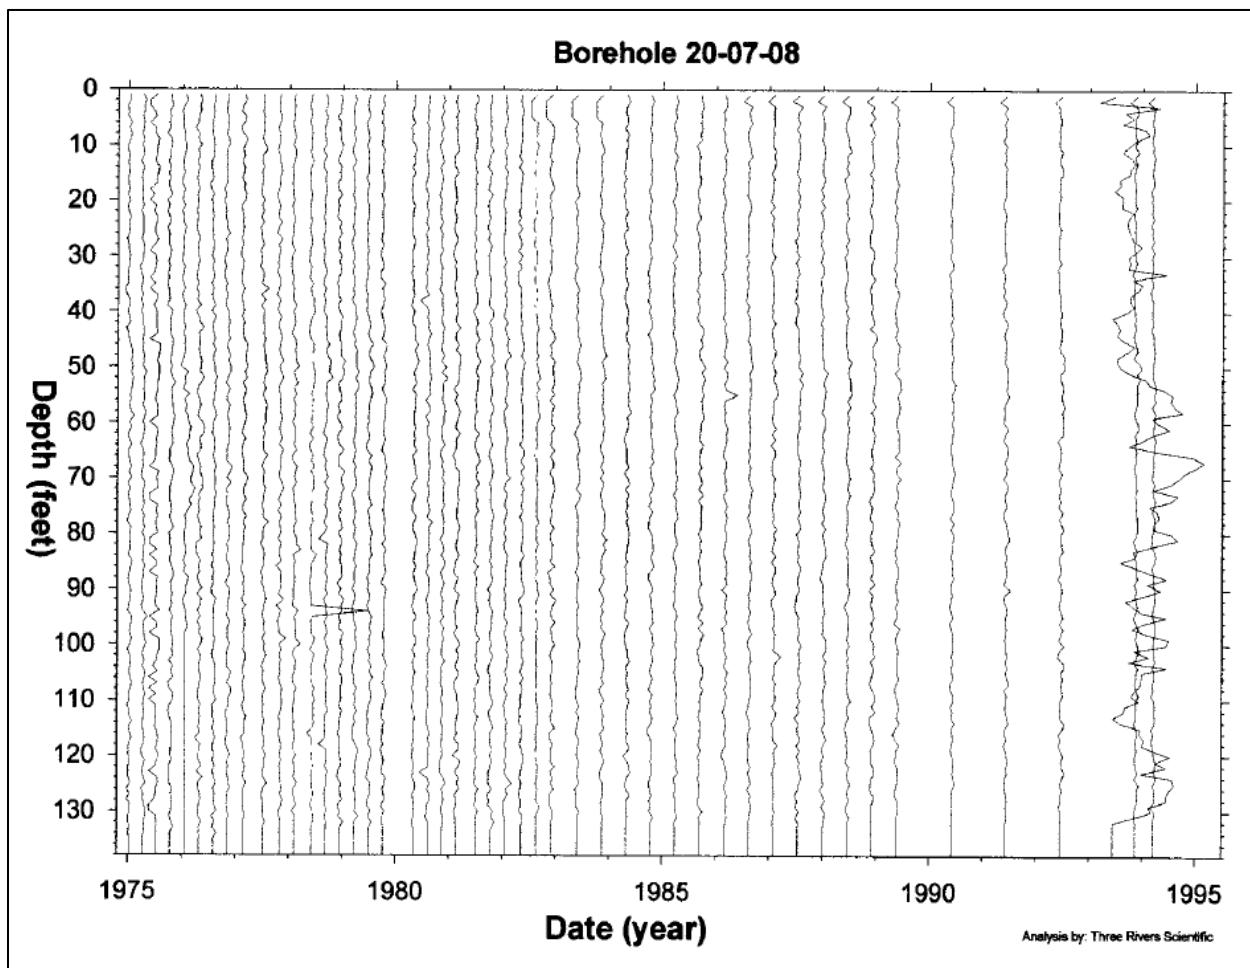
**Figure 4-11. Tank B-107 Drywell 20-07-08 (HNF-5433)**

In August 1999, Cs-137 was the only man-made radionuclide detected in drywell 20-07-08 from the ground surface to 8-ft BGS at concentrations ranging from 0.3 to 2.2 pCi/g (GJ-HAN-128). Document GJ-HAN-128 reports “The zone of Cs-137 contamination detected between the ground surface and 2-ft may be the result of a surface spill that migrated downward into the shallow backfill around this borehole....The lower concentrations of Cs-137 contamination detected below this zone were probably carried down during drilling.” Therefore, drywell 20-07-08 is not included as part of the leak location for tank B-107. Figure 4-11 shows the depths of radioactivity from 1975 to 1995 (HNF-5433).

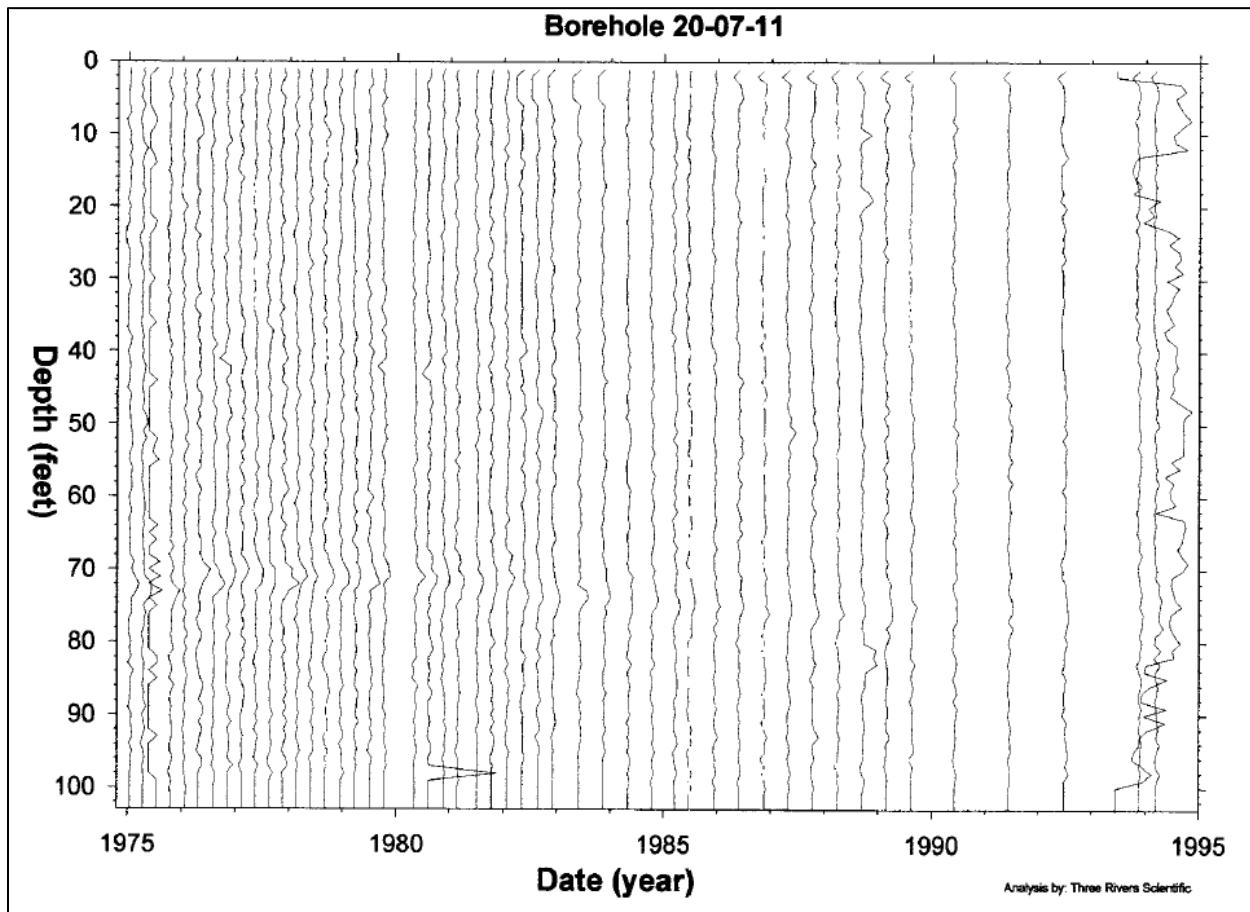
**Figure 4-12. Tank B-107 Drywell 20-07-11 (HNF-5433)**

In August 1999, Cs-137 was the only man-made radionuclide detected in drywell 20-07-11 and was detected from the ground surface to 13.5-ft BGS at concentrations less than 1 pCi/g (GJ-HAN-128). Document GJ-HAN-128 reports, “Some of the low Cs-137 concentrations detected by the SGLS from the ground surface to about 13.5 ft may be the result of a surface spill that has dispersed downward into the backfill and/or the result of contaminated near-surface material being dragged down during drilling to lower depths.” Therefore, drywell 20-07-11 is not included as part of the leak location for tank B-107. Figure 4-12 shows the depths of radioactivity from 1975 to 1995 (HNF-5433).

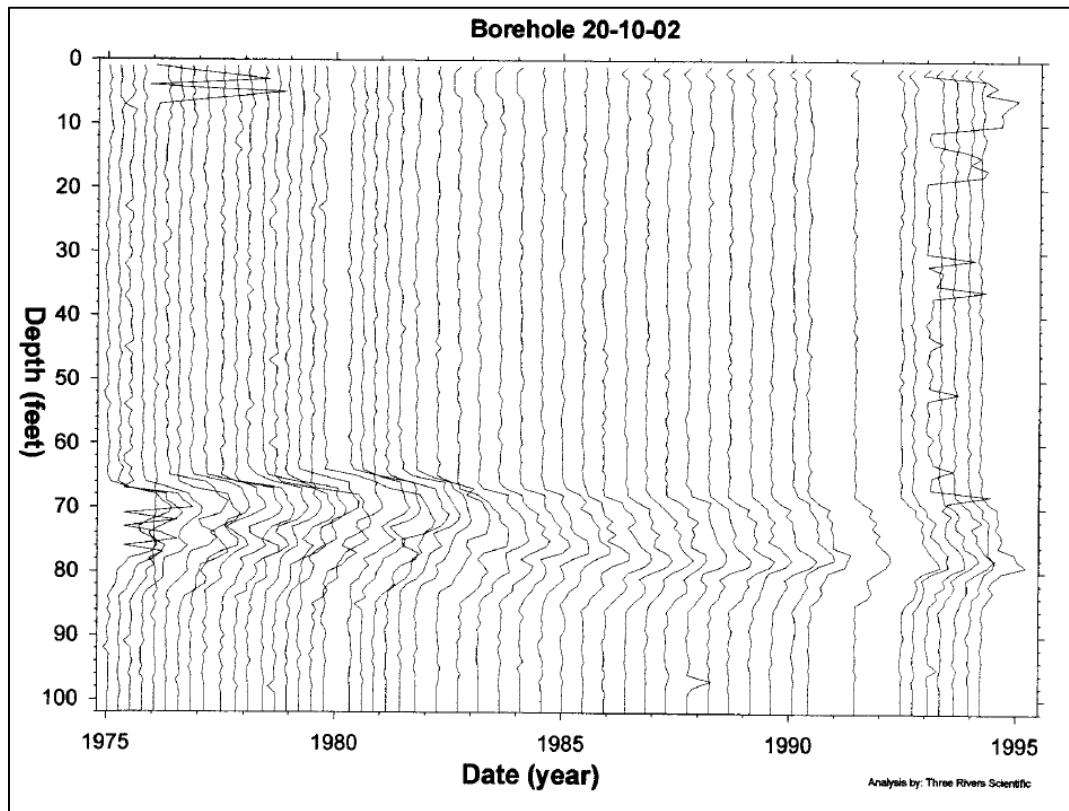
**Figure 4-13. Tank B-107 Drywell 20-10-02 (HNF-5433)**

In August 1999, Cs-137 and Co-60 were the only man-made radionuclides detected in drywell 20-10-02 (GJ-HAN-128). From the ground surface to 18-ft BGS and from 20.5 to 43-ft BGS, Cs-137 concentrations were recorded at concentrations ranging between 1 to 3 pCi/g. From 67 to 73.5-ft, Co-60 contamination was detected at concentrations ranging from 0.2 to 1.6 pCi/g. An anomalous SGGS detected zone occurred between 70-ft and 85-ft which had been recorded in the historical gross gamma data. It was determined that a decay curve of Ru-106 and Sr-90 closely matched the decrease in gross gamma activity between 1981 and 1994. The most likely source of the contamination was from the northern side of tank B-110 (GJ-HAN-128). Drywell 20-10-02 is 3-ft from tank B-110 where highly concentrated contamination intersects drywell 20-10-12. Drywell 20-10-02 is ~27-ft from tank B-107. Document GJ-HAN-128 indicated that the radioactivity detected above the anomalous zone in this drywell is likely associated from surface spills that migrated down into the backfill around this drywell and/or dragdown. Therefore, drywell 20-10-02 is not included as part of the leak location for tank B-107. Figure 4-13 shows the depths of radioactivity from 1975 to 1995 (HNF-5433).

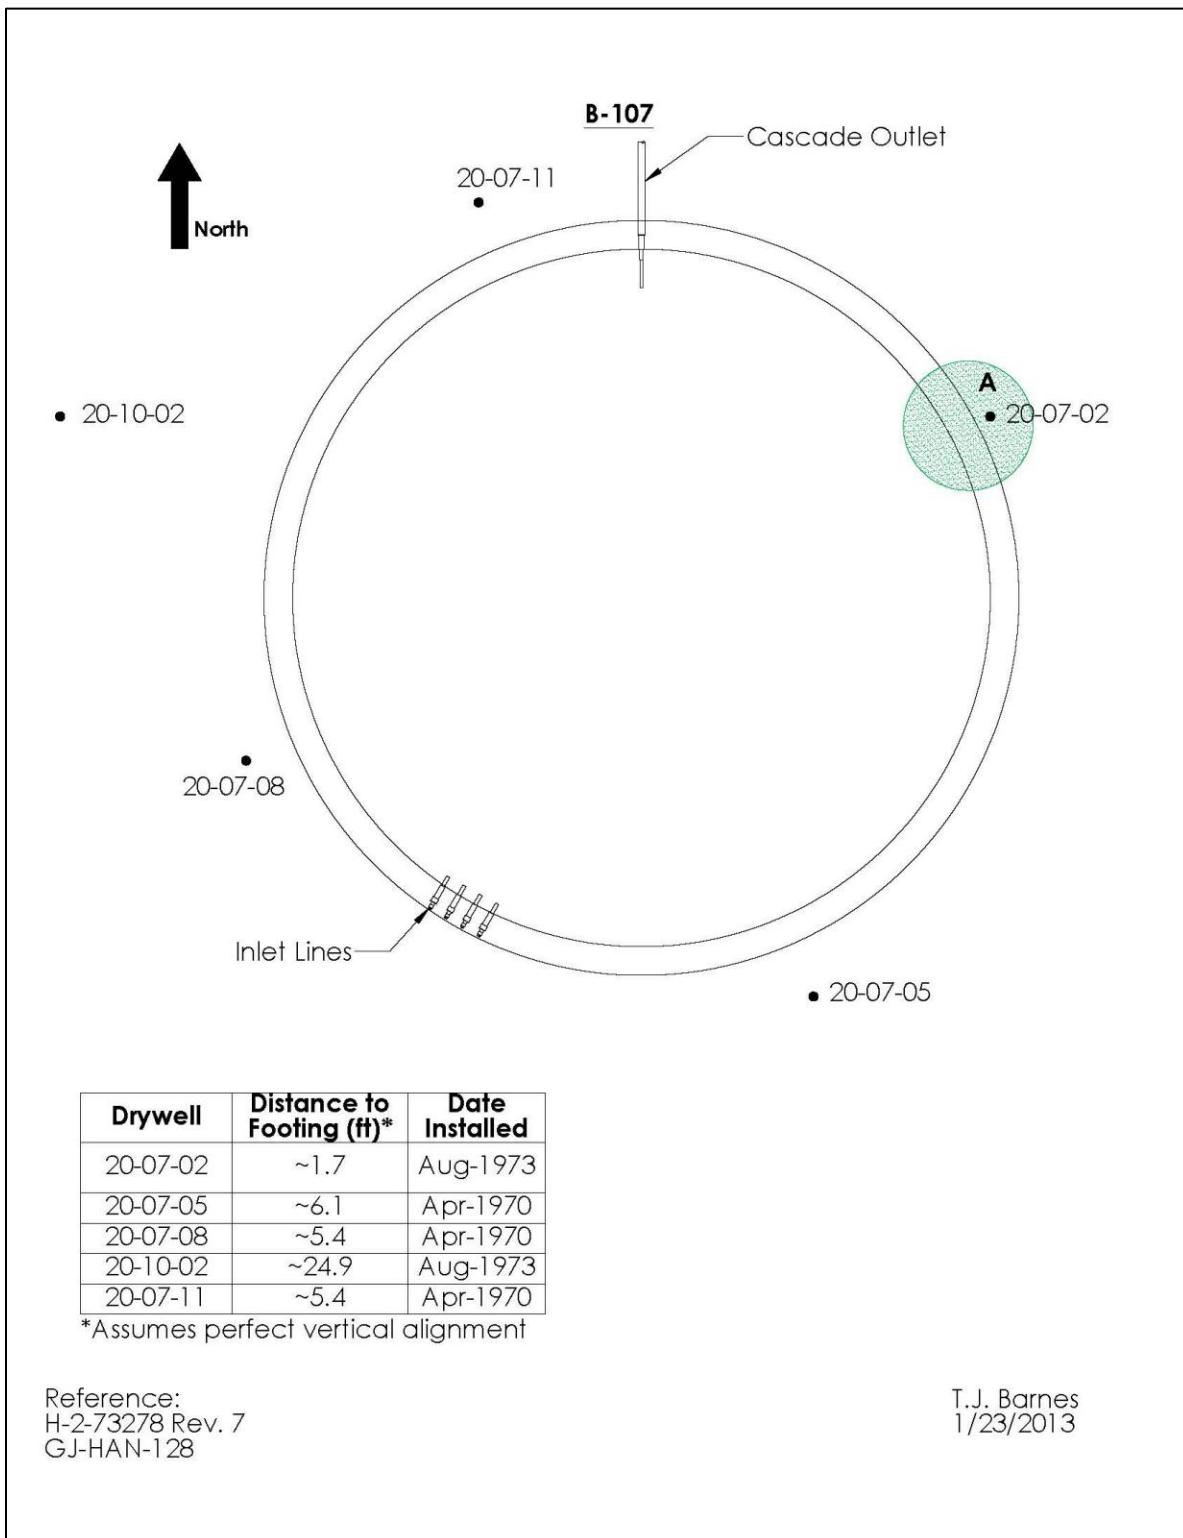
**Figure 4-14. Tank B-107 Possible Leak Location (1965-1973)**  
 Tank inner ring is steel liner; outer ring is outer edge of tank footing

Tank B-107 was first reported as leaking due to a 3-in liquid level drop between May 1968 and August 1969 (RHO-CD-896). However, it appears the tank B-107 leak could have started as early as the fourth quarter in 1965 due to the liquid level decreasing from October 1965 until August 1969, when the supernatant was pumped out of the tank (see Section 4.4.1). The liquid level was above the cascade outlet line level in October 1965 when the liquid level initially started to drop. A review of liquid levels for tanks B-108 and B-109 indicated no increases or decreases during the time the tank B-107 was above the cascade line and decreasing. Based on a polynomial projection of the liquid level data, there appears to be a sidewall leak located at or below 186.4-in. The leak was detected in drywell 20-07-02 in the northeast portion of the tank when the drywell was drilled in 1973. No other drywells indicated a tank B-107 leak.
