241-AZ Tank Farm Construction Extent of Condition Review for Tank Integrity

T.J. Barnes, K.D. Boomer, J.R. Gunter, T.J. Venetz
Washington River Protection Solutions, LLC
Richland, WA 99352
U.S. Department of Energy Contract DE-AC27-08RV14800

Abstract: This report provides the results of an extent of condition construction history review for tanks 241-AZ-101 and 241-AZ-102. The construction history of the 241-AZ tank farm has been reviewed to identify issues similar to those experienced during tank AY-102 construction. Those issues and others impacting integrity are discussed based on information found in available construction records, using tank AY-102 as the comparison benchmark. In the 241-AZ tank farm, the second DST farm constructed, both refractory quality and tank and liner fabrication were improved.

July 2013

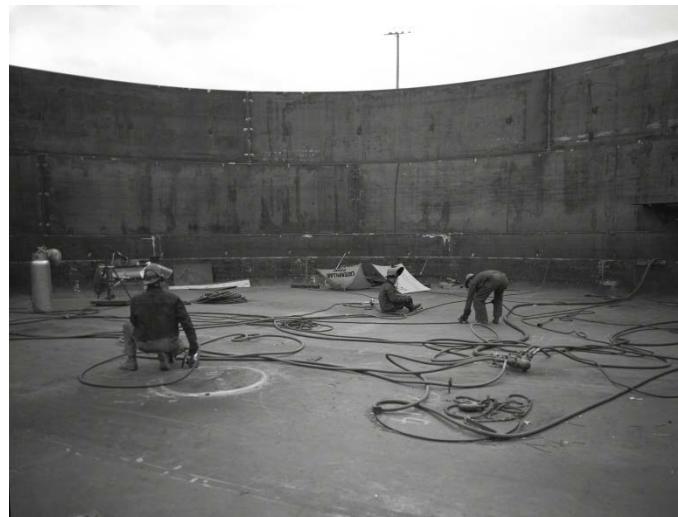
Figure 4-14. Welders Repairing Welds on the Primary Tank Bottom Sections Looking South, Tank AZ-101 (56272-6 Photo) (Taken 10/26/71)

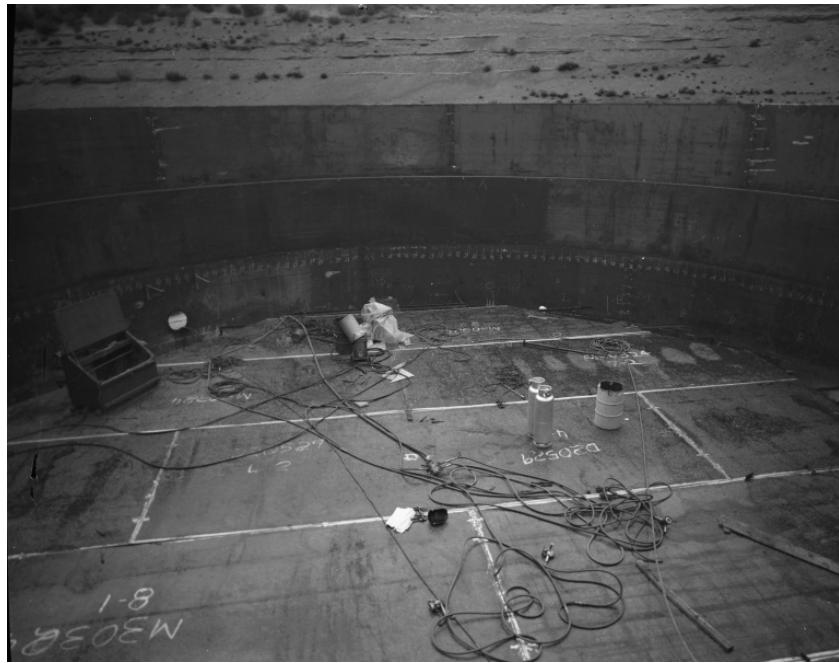
Figure 4-15 Weld Repairs in Progress on Tank AZ-102 – Looking South (56272-4 Photo) (Taken 10/26/71)

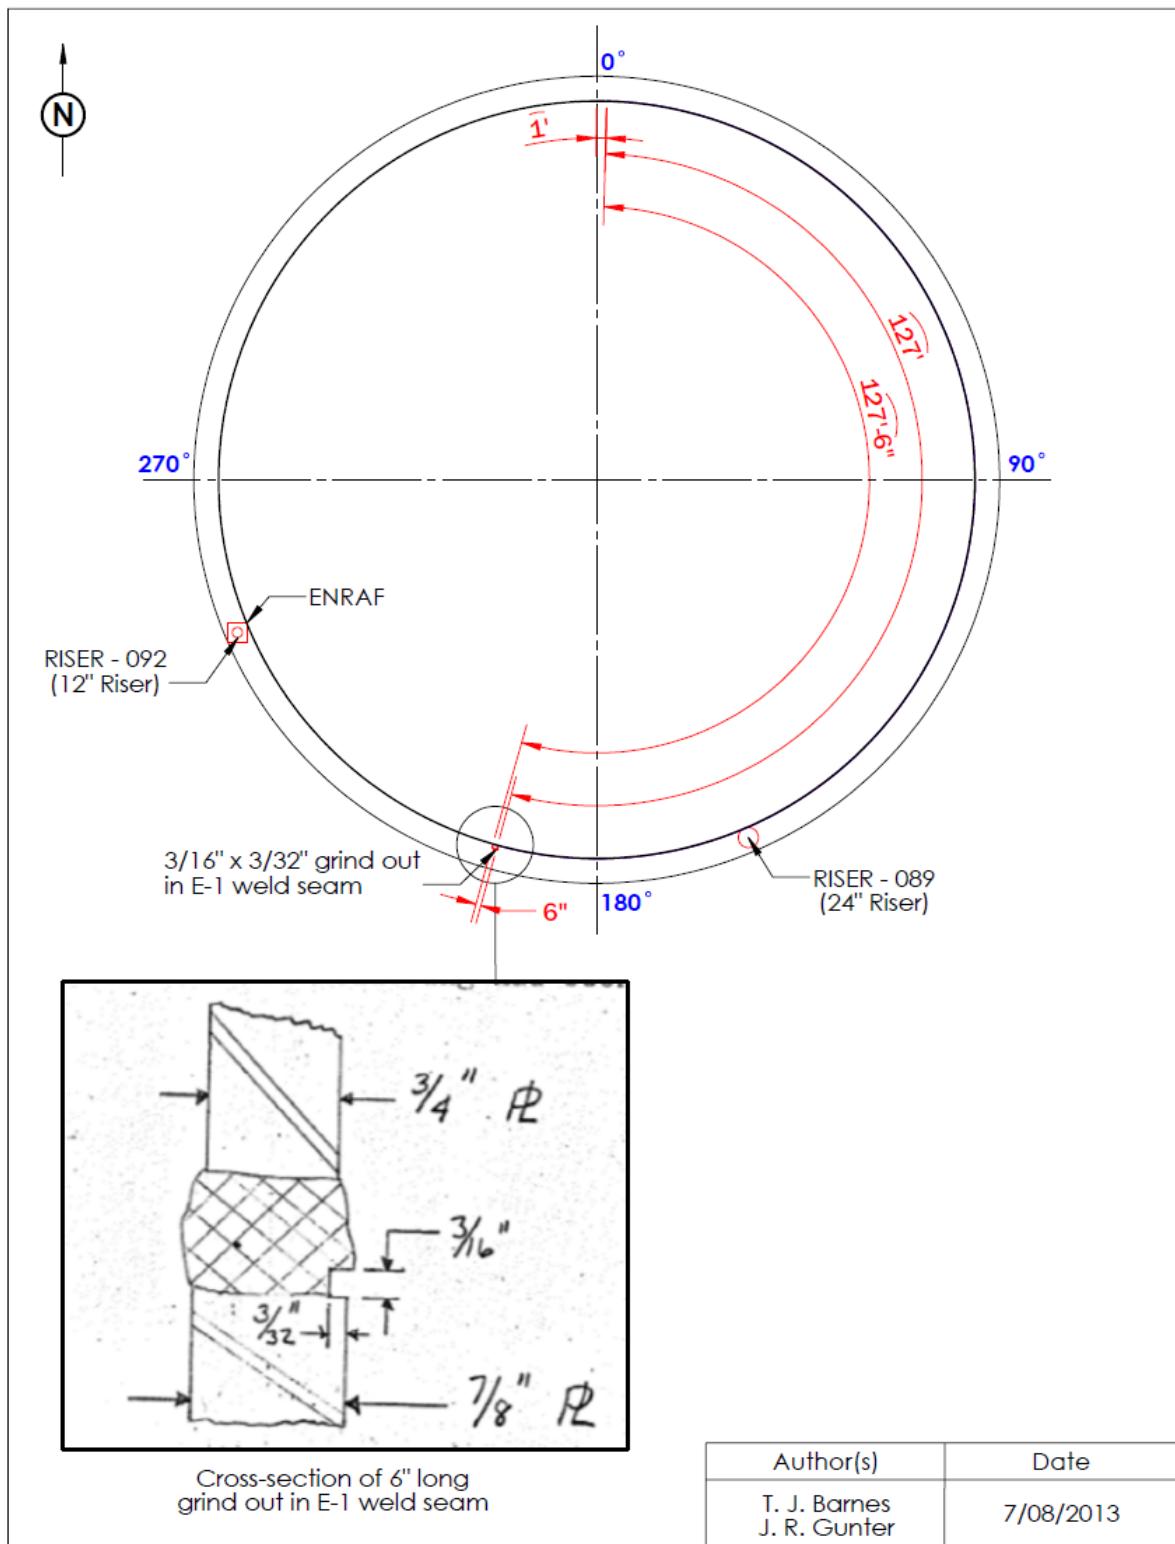
The final decision to leave the unrepainted weld grind out was based upon review by the ARCHO structural expert with conclusion that no structural threat to the tank existed. Liquid penetrant testing revealed that there was no crack emanating from the base of the groove and, as a matter of practicality, any repair attempted could impart additional stresses that would not have been relieved since post-weld stress relieving had already occurred. No similar condition was recorded for tank AZ-102.

Figure 5-1. Tank AZ-101 Weld Grind Out in E-1 Seam

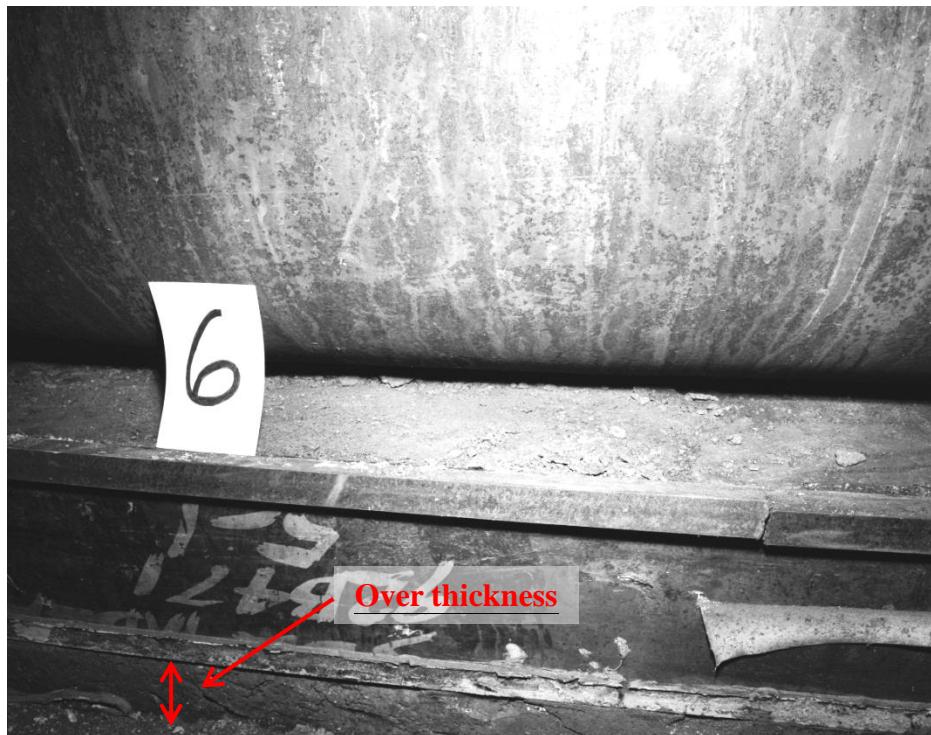
This increased thickness is apparent in Figure 4-9, which shows a worker pouring a section of refractory. On March 24, 1972, inspection photographs, such as Figure 5-2, were taken of the refractory and the over-thickness can be seen where several inches of material extend below the retainer ring. The primary tank bottom was installed at a higher elevation than originally planned as a result of this design variation, but does not create conditions for any potential failure mechanism.

Figure 5-2. Refractory Over-Thickness (57482-20 Photo) (Taken 3/24/72)

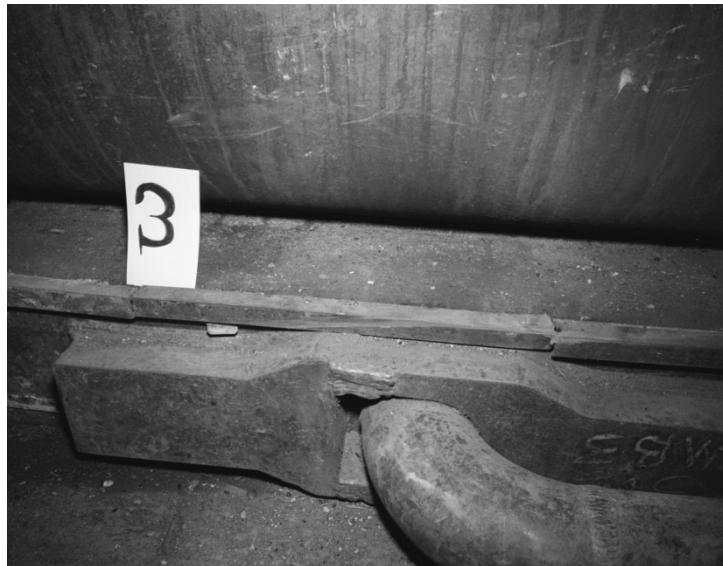
One of the four 2 in. bars that were installed to stabilize the air distribution piping through the retaining band in the modified configuration is shown in Figure 5-3.

Figure 5-3. 2 in. Bar Welded to the Retainer Ring to Support Air Distribution Piping (57482-17 Photo) (Taken 3/24/72)

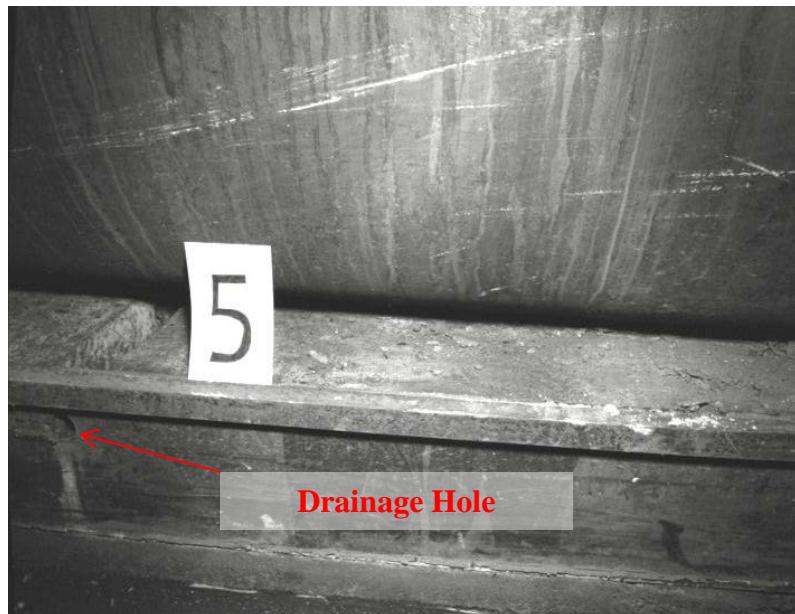
These modifications to the retaining band served to provide adequate pathways to protect thermocouple wiring and for waste to drain to the annulus to reach leak detection equipment in a leak scenario. In Figure 5-4, shown below, one of the 1 in. diameter drainage holes is shown. Refer to Appendix C, App Figure C-11, for a diagram of the air slots where these holes were drilled. Regarding the thermocouple wiring penetrations, Figure 5-5 was the best available photo representing this variation, showing the thermocouple wiring coming out of the air slot in the refractory and entering into a protective metal channel along the top of the Kaolite retaining ring.

Figure 5-4. Kaolite Retaining Ring with 1 in. Drainage Hole Drilled at Air Channel

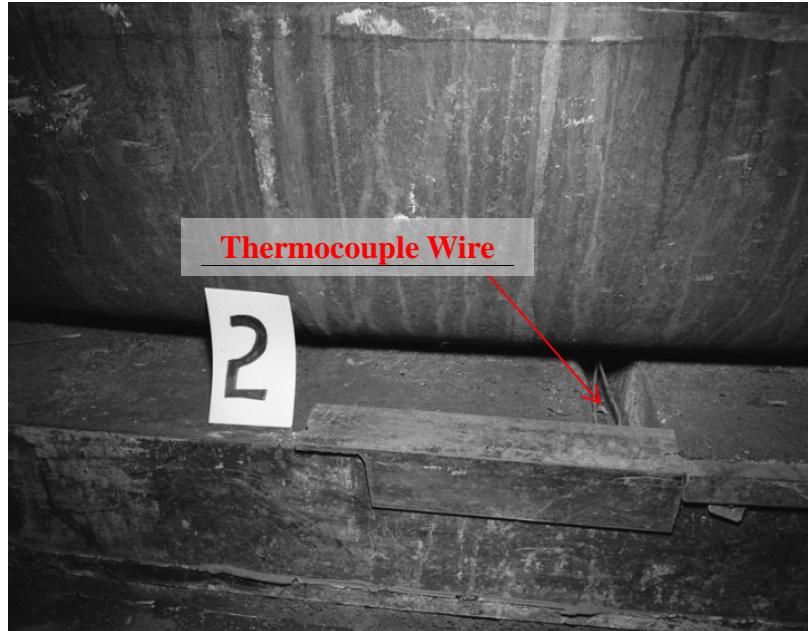
Figure 5-5. Thermocouple Wiring Protection. (57482-16 Photo) (Taken 3/24/72)

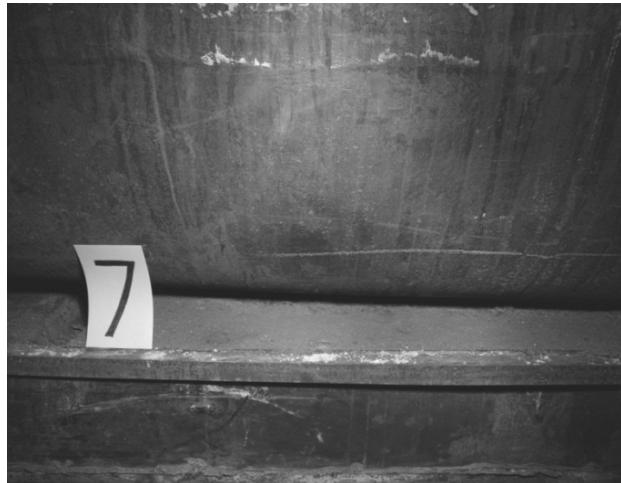
No post-hydrostatic test refractory deficiencies were recorded. However, several photos of the refractory before heat treatment were found with captions indicating it being damp, soft, soggy, or mushy to a depth of 1/8 in., or having a crust that was 1/8 in. deep. Several of these photographs have been included within this section as Figure 5-6, Figure 5-7, and Figure 5-8. No records following heat treatment indicated that these conditions resulted in repair or replacement.

Figure 5-6. Kaolite Condition (Damp, Soft for 1/8 in. Depth) (57482-18 Photo) (Taken 3/24/72)

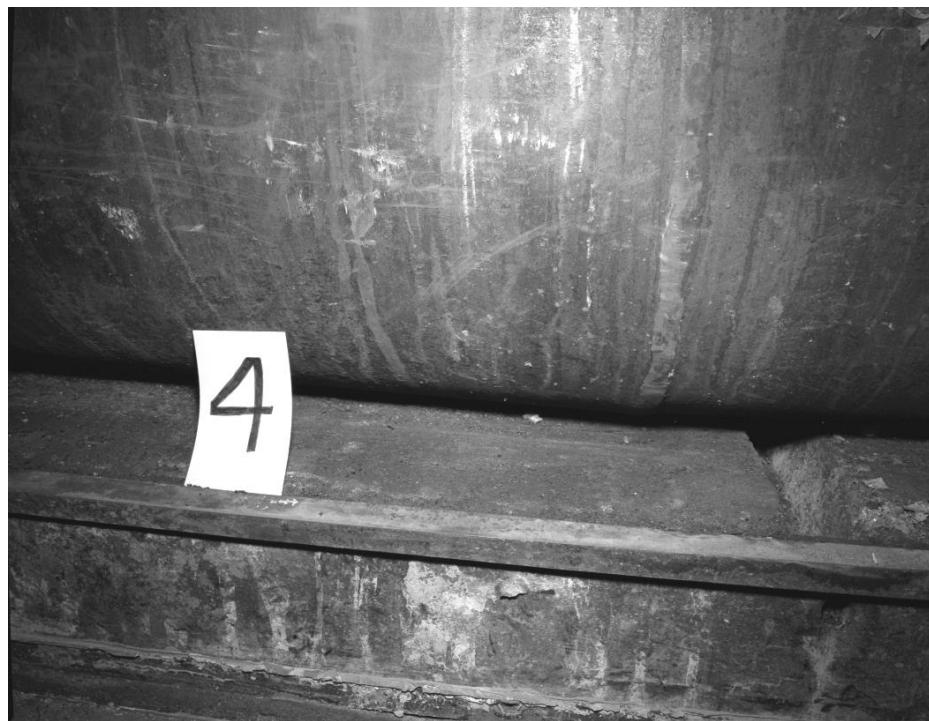
**Figure 5-7. Kaolite Condition (Soggy and Mushy for 1/8 in. Depth)
(57482-21 Photo) (Taken 3/24/72)**

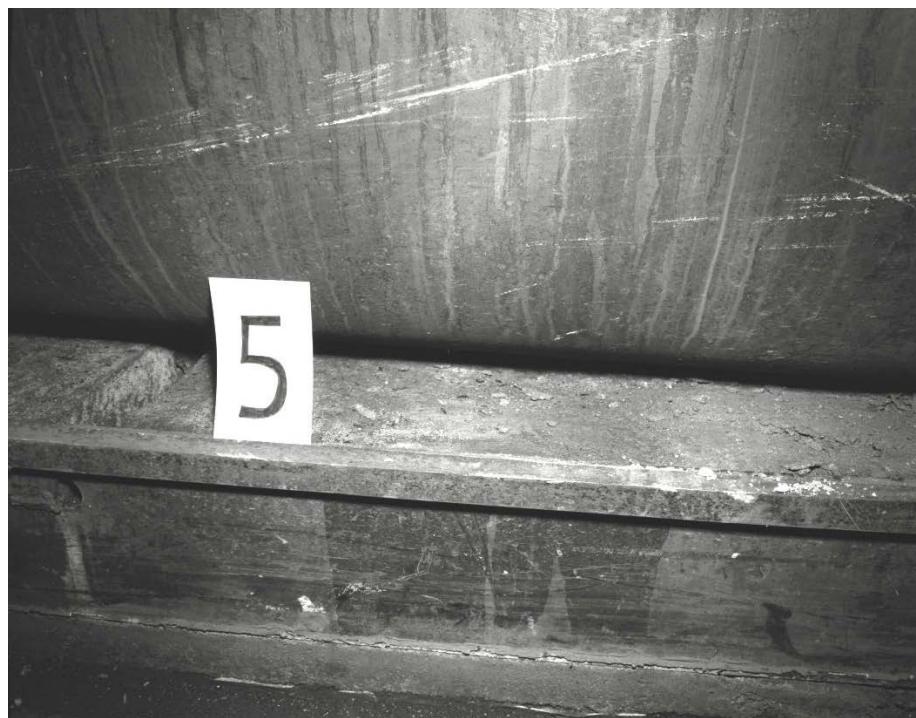
Figure 5-8. Kaolite Condition (1/8 in. Crust) (57482-19 Photo) (Taken 3/24/72)
