WELD REPAIR OF A STAMPED PRESSURE VESSEL IN A RADIOLOGICALLY CONTROLLED ZONE

G. R. Cannell
CH2M HILL Plateau Remediation Company

Date Published
November 2013

To be Presented at
Nuclear Power International Conference -2013

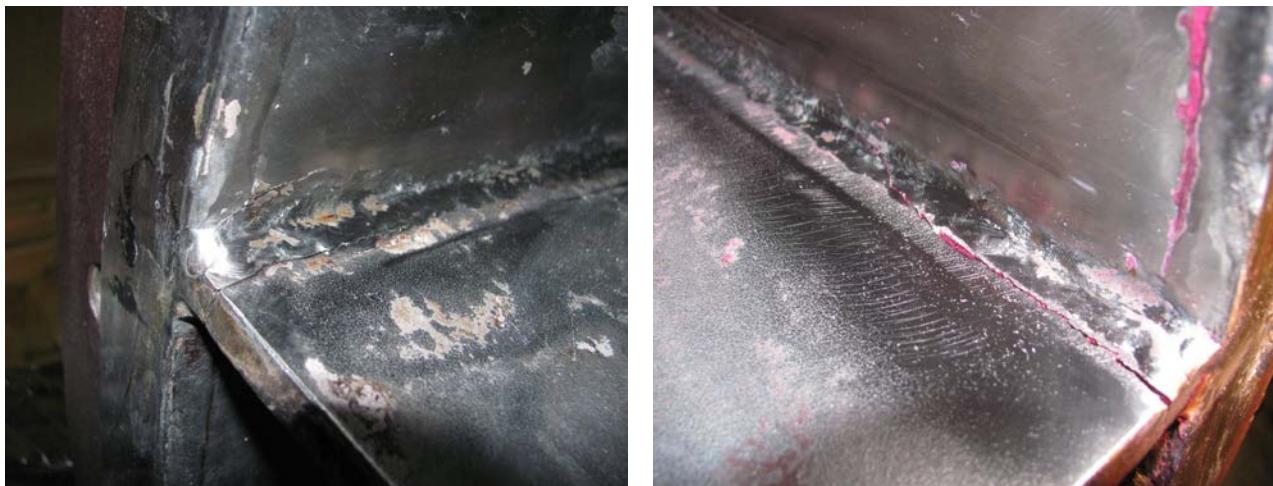
Figure 2. Cracking at the shell / pass partition plate welds.

Cracking extended from the end of the pass partition plate (at the blind) four to six inches along the weld passing through base, HAZ and weld metal. In addition, a linear region of affected base material, running in a circumferential direction near the end of the shell was noted (Figure 3).

ID (two sides) and to the tube sheet. The remaining side butts against the Channel Blind, but is not secured or supported, leaving it free to flex when loaded by the incoming 6,000 gpm brine flow through the inlet nozzle. Failure (cracking) occurred in the plate-to-shell welds and in the partition plate as shown in Figure 2. Cracking extended along the toe of the welds, into the plate, veered out into the plate and then back into the weld. UT examination (along with subsequent visual inspection of the shell ID) indicated that neither general nor localized corrosion processes were active. No physical deformation (material strain) was observed at the area where cracking was observed.

Material fatigue, resulting from cyclical loading, appears to have been the cause of cracking. Impingement of the brine flow against the plate is believed to have set up flow induced vibration and cyclical stress, especially at the “free” end. Fatigue cracks tend to initiate at stress risers, which would include the notch at the root of the fillet weld (inherent in the joint design) and the undercut at the toe of the weld. The cracks observed are associated with these features and are consistent with classic fatigue crack travel and propagation. As noted a formal failure analysis was not performed; however, given the nature of the failure, appearance of the cracking, location of the cracking, absence of localized corrosion and an understanding of materials performance, it is believed the most likely cause of failure was fatigue.

Given the initial examination, along with the failure evaluation discussed above, it was believed that cracking was limited to the shell / plate weldment area along both sides of the plate for a distance of about nine inches. Because cracking could have propagated immediately behind the plate edge, it was decided to remove a portion of the pass partition plate. Several additional reasons justified plate removal, as follows:

Defects identified by PT examination were weld repaired using the Fluor-certified R-Stamp program. Repair consisted of removing the defects by grinding and defect removal was confirmed by PT. Once confirmed, the excavated area was prepared (with a groove sufficient to

Accommodate a stringer bead(s)) and welded using the Gas Tungsten Arc Welding (GTAW) process. Care was exercised to ensure the shell was restored to its original thickness. Through-wall defects were welded from both the interior and exterior sides of the shell.

On several occasions, PT of the repaired areas disclosed indications adjacent to the repair; indications that were not identified by PT prior to weld repair. It is believed the new indications were “incipient”, and along with the other identified cracking, the result of fatigue loading. These “new” cracks opened up, sufficient to be disclosed by PT, as a result of shrinkage stress caused from repair welding. All defects were removed, verified by PT, weld repaired and PT examined for acceptance.

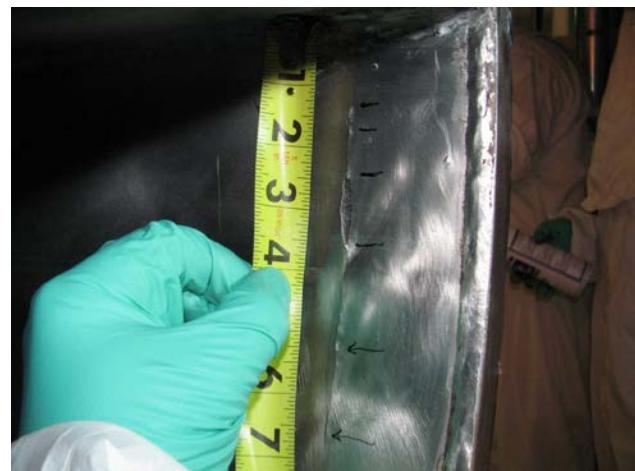
Figure 3. Circumferential, linear indication – affected base metal.

The “linear” region of affected base material noted above, appeared to be weld metal burn through; this region lined up directly behind the OD flange to shell fillet weld. It is believed this condition originated during initial fabrication welding of the vessel.

It was noted above that a linear region of affected base material (approximately 7 inches in length), running in a circumferential direction near the end of the shell, was visually identified – see Figure 3. The condition is believed to have been caused by weld metal burn through during initial vessel fabrication - this area lined up directly behind the fillet weld attaching the OD flange to the shell. This area was prepared by grinding (light blending) and welded by depositing a stringer bead(s) sufficient to restore the shell to its original specified thickness.

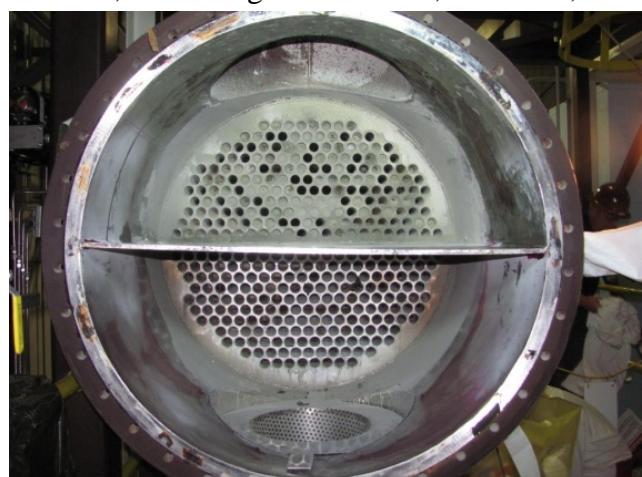
Figure 4 shows the 3/8-in thick, Alloy 625 pass partition plate welded to the 3/16-in thick shell

Figure 4. View into the open end of the vessel showing the pass partition plate and tubes.

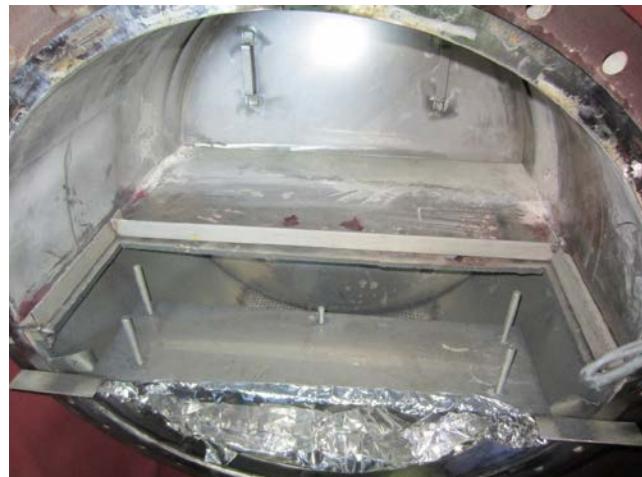
Figure 5. Section of pass partition plate removed – leaving a 3/4-in piece along the shell.

A section of the plate, measuring approximately 9-inches deep by 35-inches wide, was removed using a plasma arc cutting torch. The cut line on the plate running parallel to the shell axis was placed approximately 3/4 of an inch inward from the shell – see Figure 5. This was done to avoid any potential impact (wall thinning) on the shell thickness. The remaining piece of plate and the two attachment fillet welds were completely removed by grinding. The shell ID surface was now fully accessible for evaluation and was examined (on both sides of the shell) by VT and PT to establish the extent of cracking – see Figure 6. Visual examination revealed no indications of corrosion at the plate / shell interface. Liquid penetrant examination disclosed numerous linear indications on both the exterior and interior shell surfaces where the plate was attached to the shell.

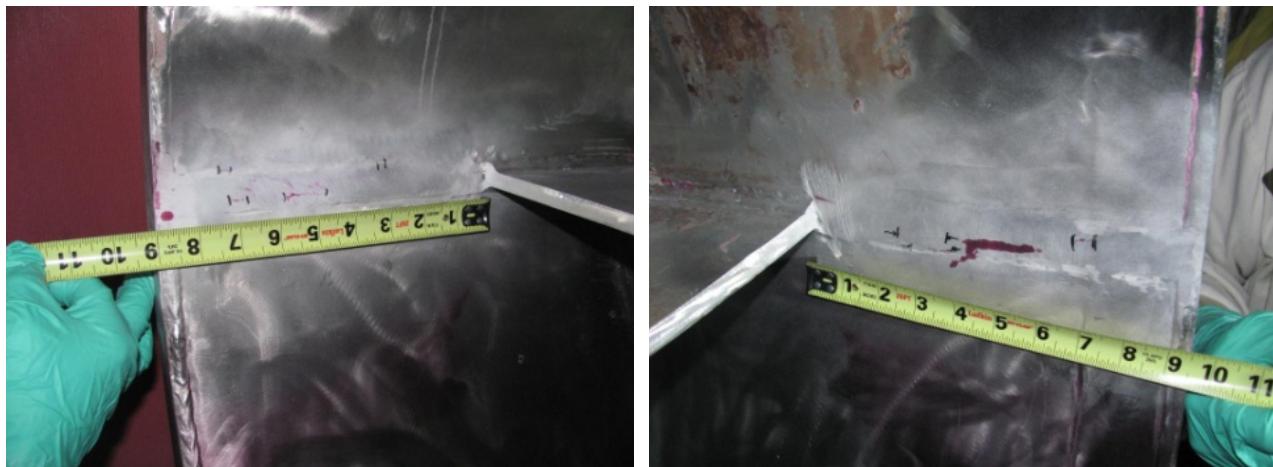
Figure 6. Shell ID after pass partition plate removal.

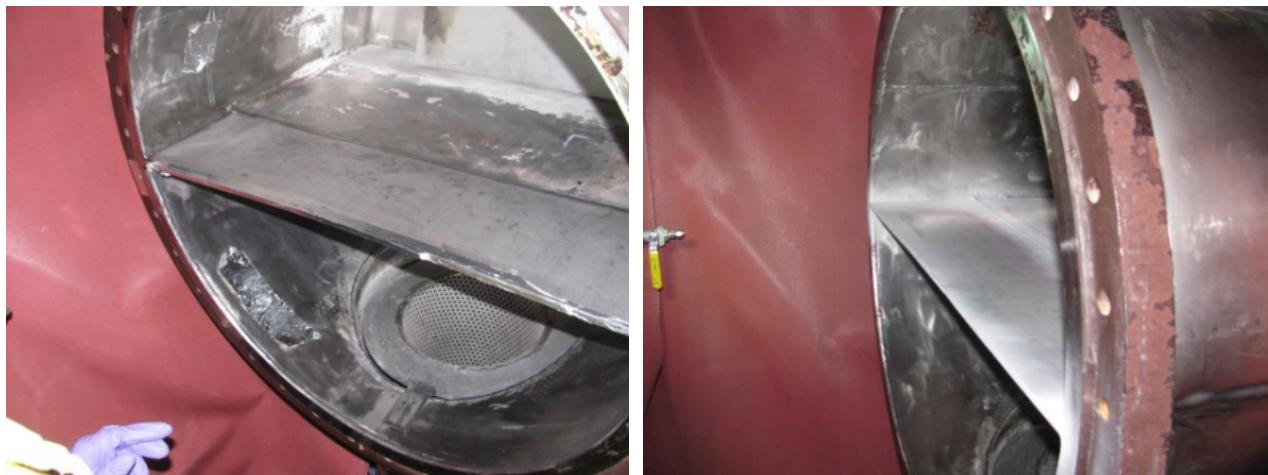
Figure 7. New piece of Inconel plate installed and inspected.

With weld repairs complete, including acceptable VT and PT inspections of the repaired areas, a section of new Inconel plate was installed to restore the pass partition plate to its original dimensions. The new plate was machined with a K-bevel for full-penetration welding to the remaining piece of installed plate and the two sides, attaching to the shell, were given a square end prep to accommodate the two fillet welds. The new plate piece was installed and inspected by VT and PT – see Figure 7.
