Novel Defect Detection Using Laser-Based Imaging and TIVA with a Visible Laser

International Symposium for Testing and Failure Analysis

San Jose, California
November 3-7th, 2013

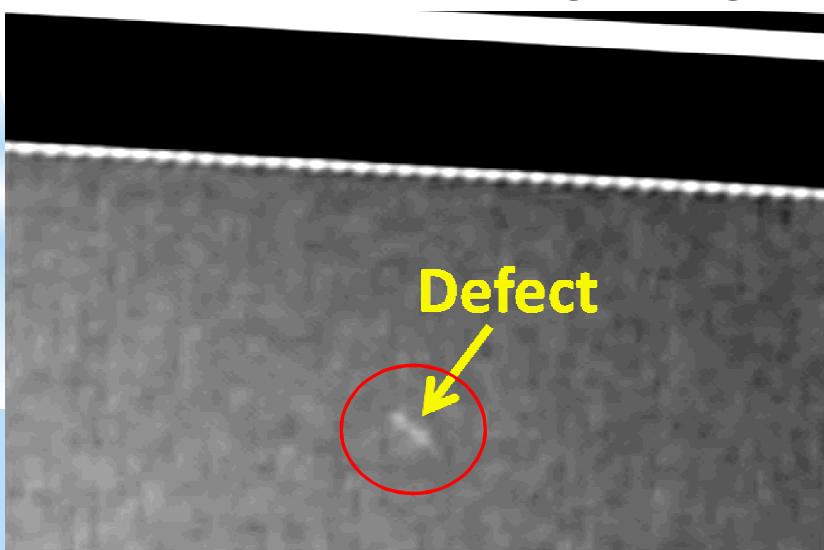
1340-nm Reflected Light Image

- Metal comb structures used as process monitors for back end of the line defects
- TIVA easily indicates current path but resolution is poor
- Reflected-light images more clearly define size and shape of defect sites than TIVA

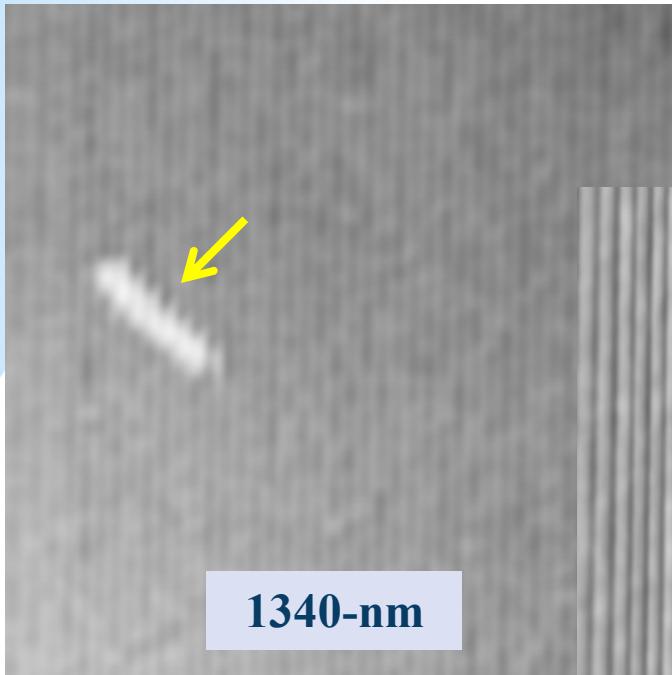
At lower magnifications,
the bright contrast of the
1340-nm reflected light
image is the easiest to see

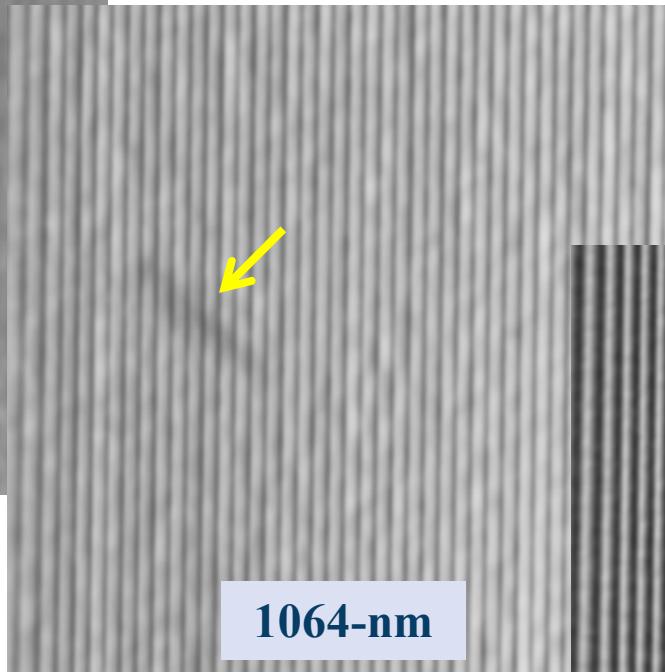
Contrast of the defect site varies
with incident laser wavelength

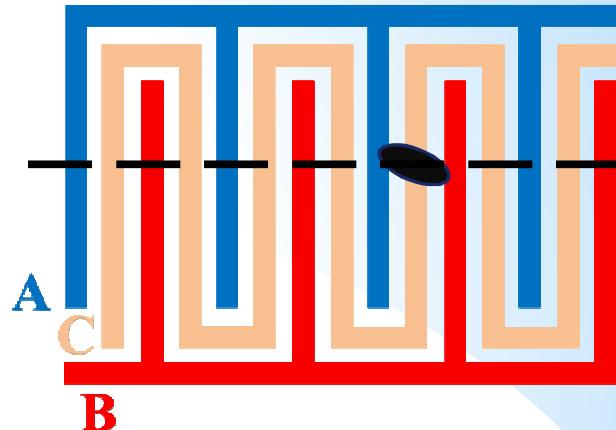
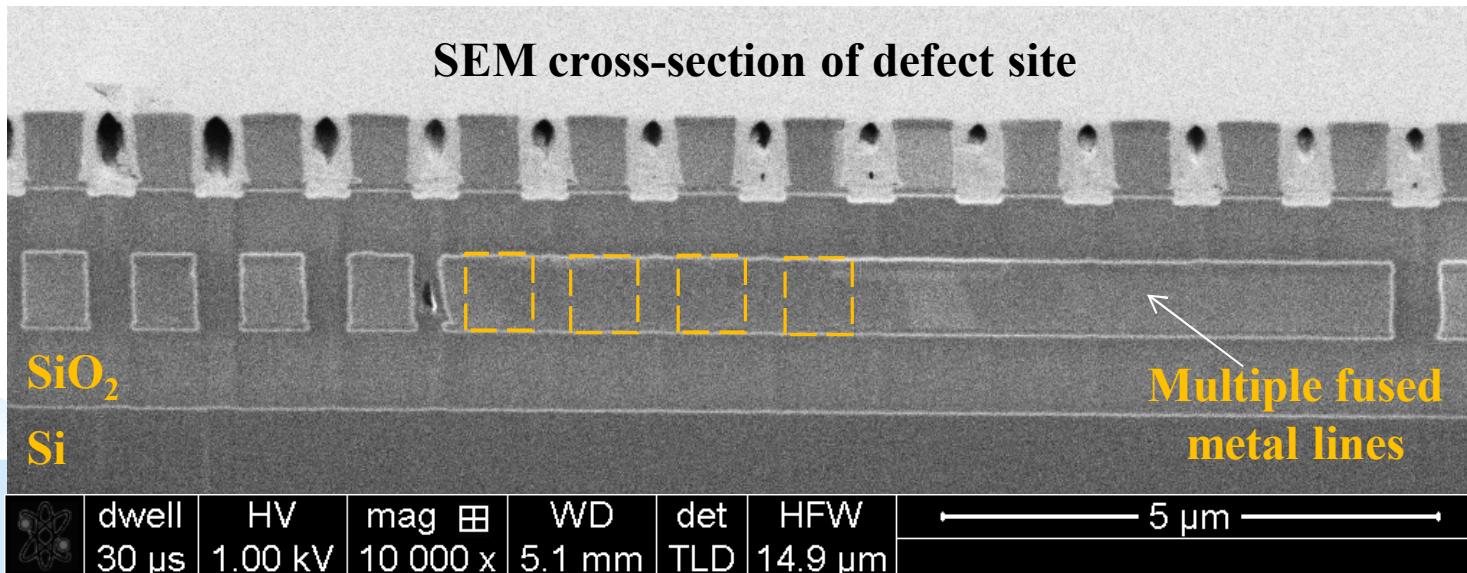
- Multiple metal lines fused together
- Uniform, complete stack formation
- No indication of particle/contamination on top of stack
- Defect/particle likely fell on to patterned lines and was cleaned away with post-etch cleans

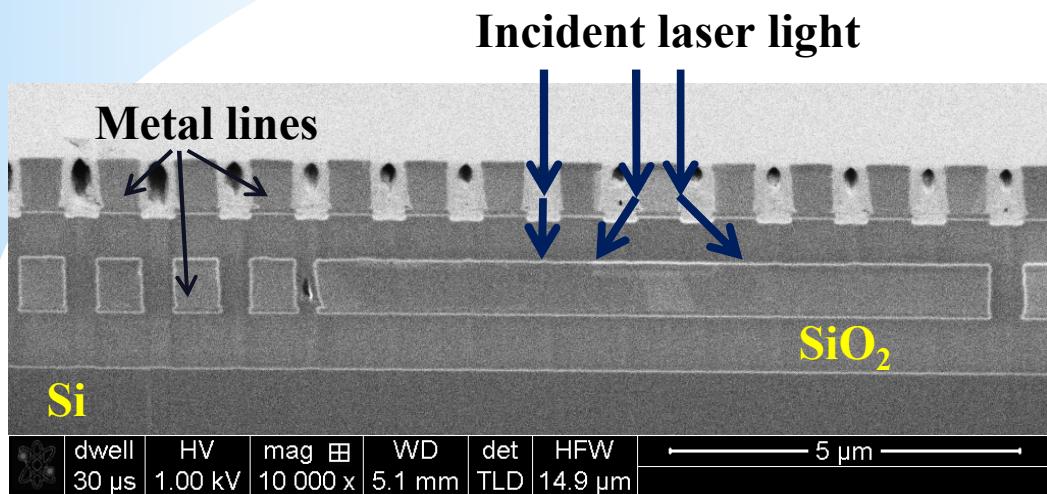
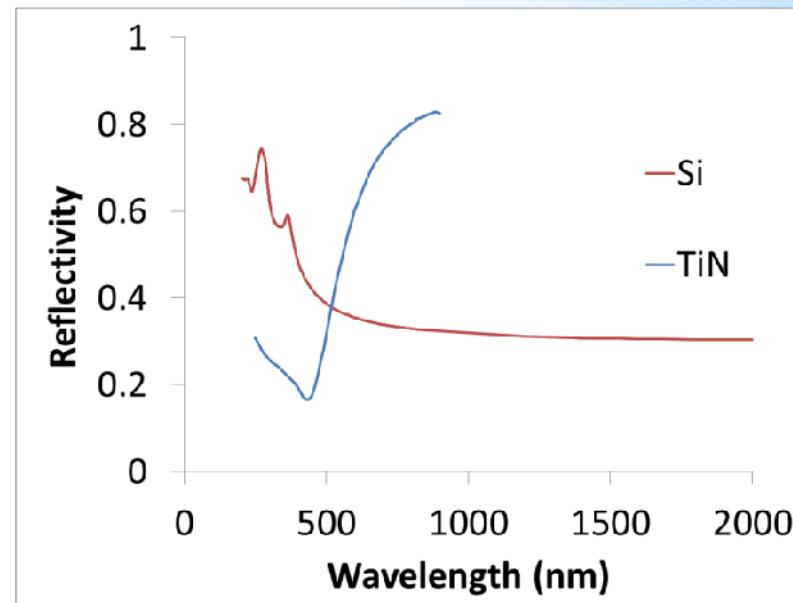
Contrast differences between laser wavelengths...

- Reflectivity drops slightly for 532-nm laser wavelengths
- Index scattering with heat

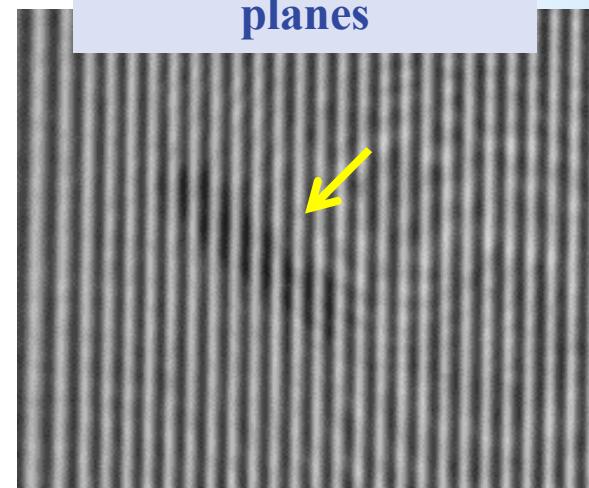
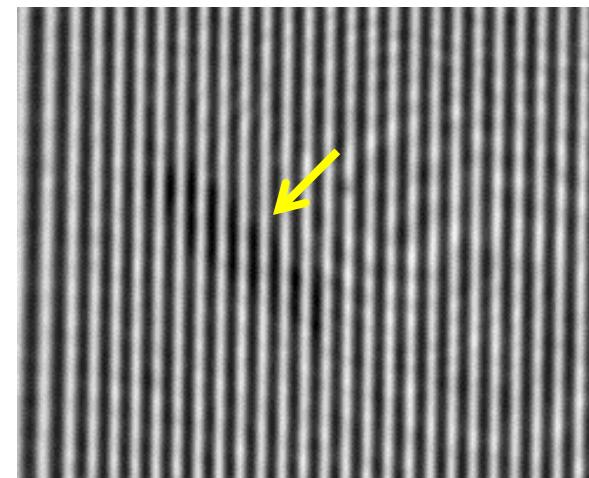
532-nm Reflected Light images at different focal planes

- Focus up and down did not change contrast of defect
- Likely constructive and deconstructive interference and resolution of incident wavelength

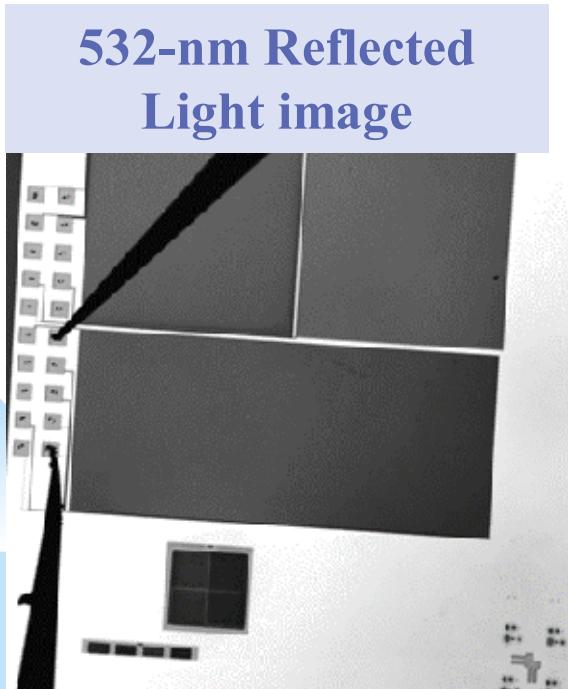
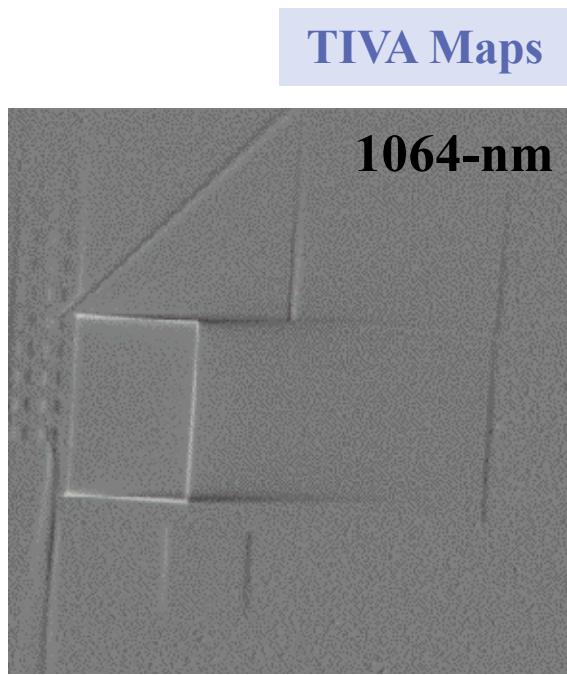
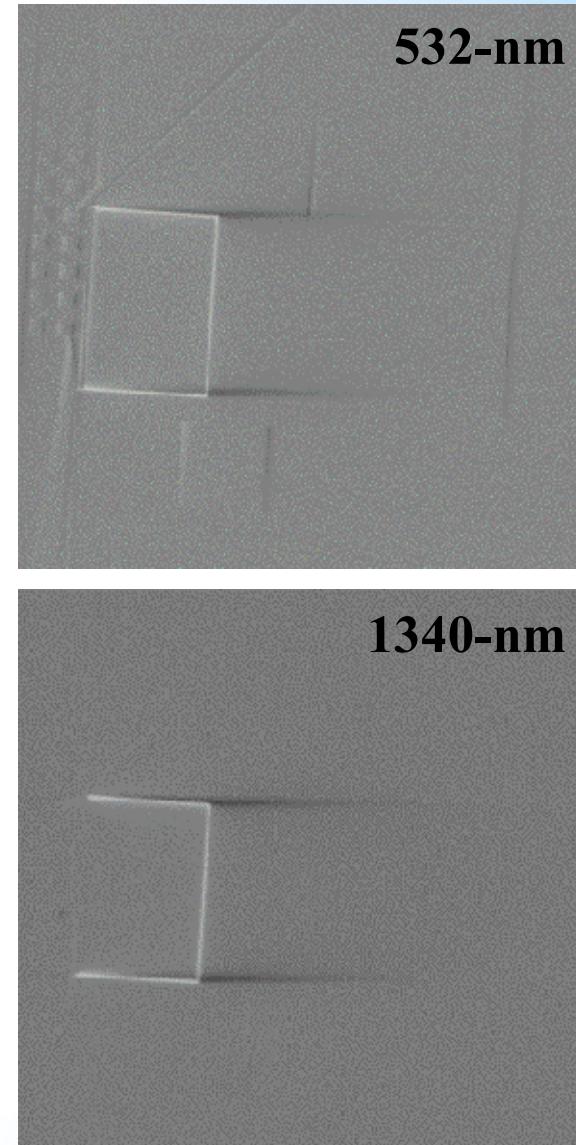
- Defect site creates metallic short, circuit made only of metal wiring
- The 532-nm laser causes increase in temperature in defect circuit → TIVA map
- Little electron-hole pair contrast swamping

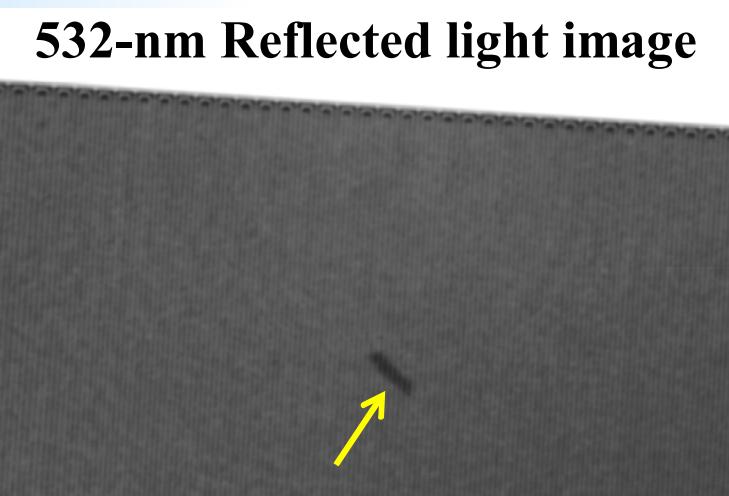
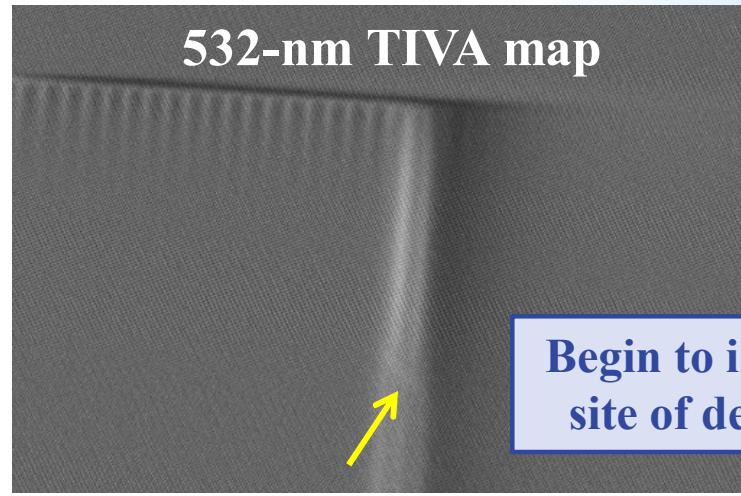
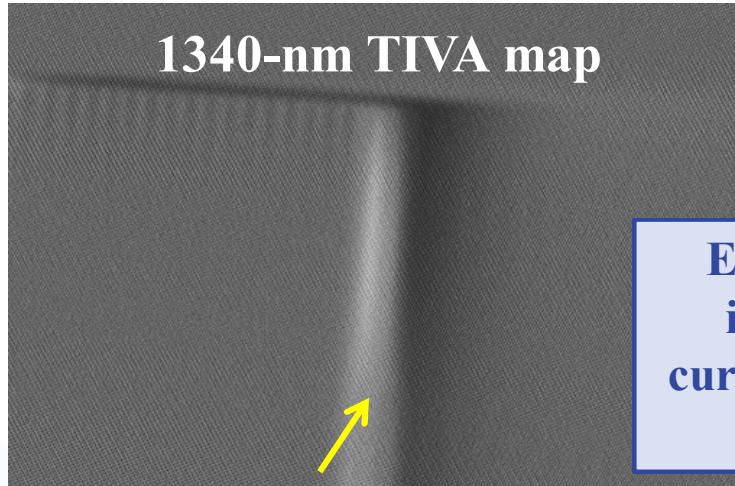
- Increased resolution of 532-nm TIVA image makes localization easier
- Reflected light image still provides the easiest path for localization

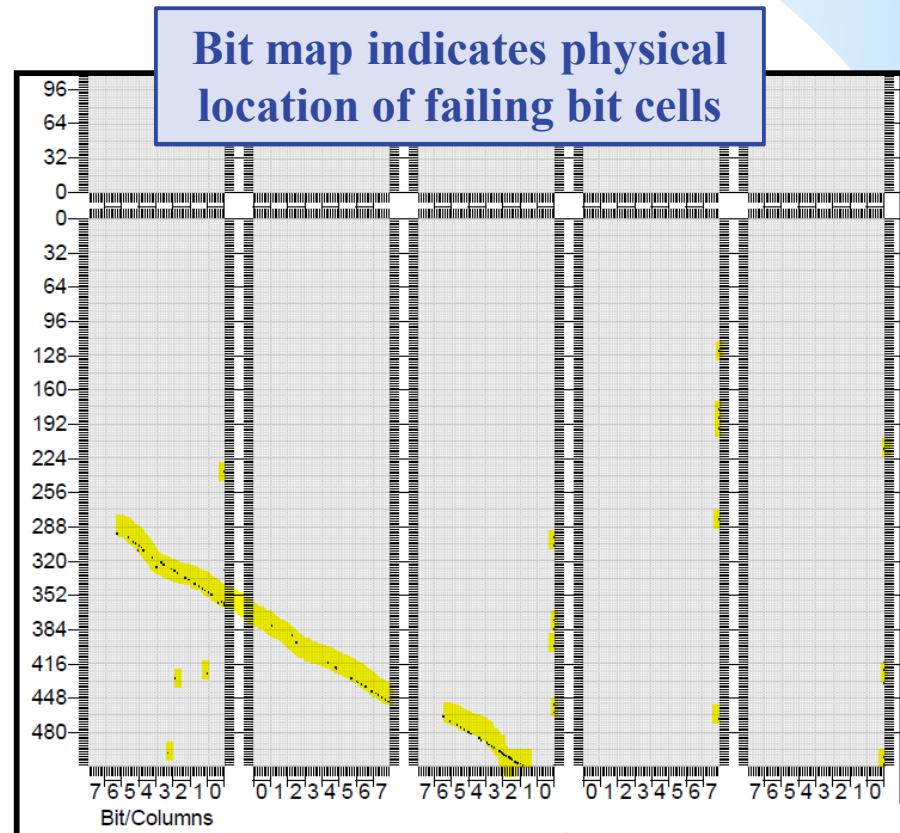
- Clean optical inspection
- Inconsistent light emission
- No TIVA signals under operating voltages
- LIVA signals at low currents matched the bitmap signature

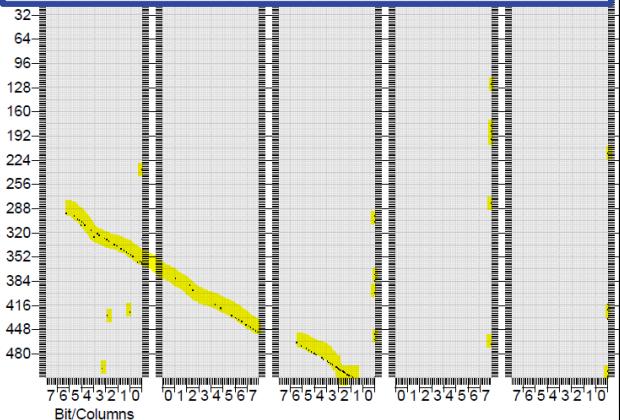
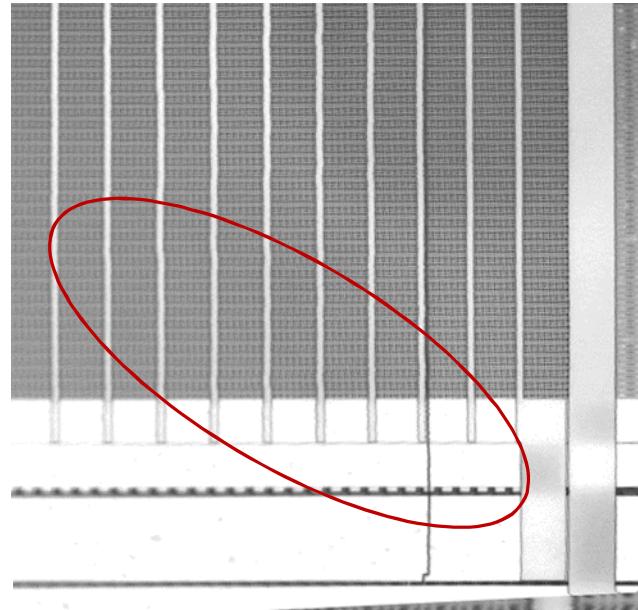
Bit map indicates physical location of failing bit cells

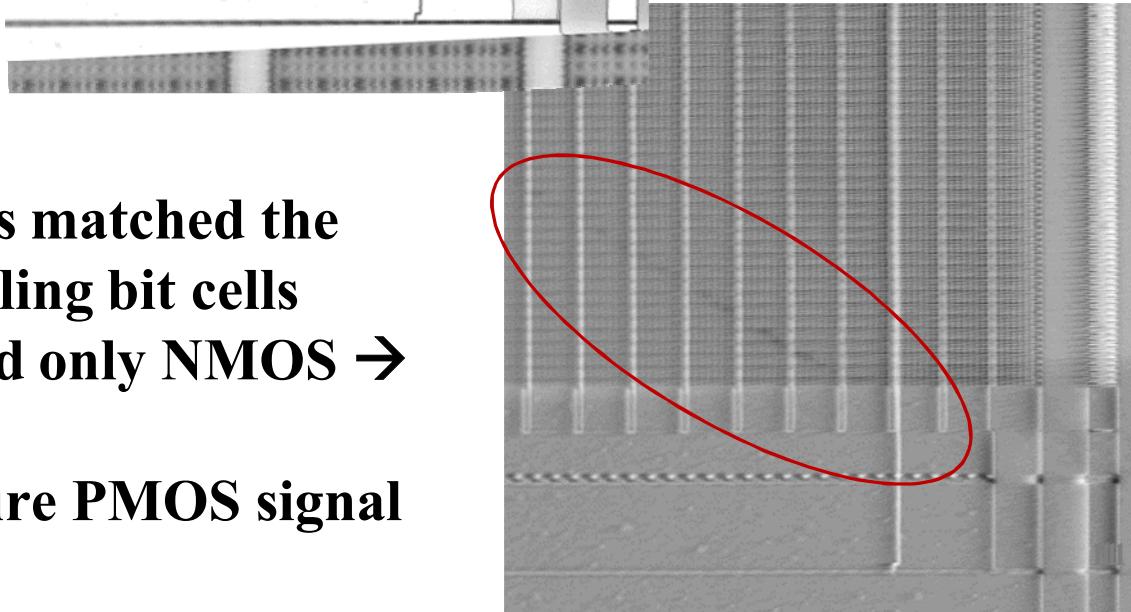
Frontside 532-nm
Reflected light image
(left) and LIVA image
(below) at 100nA

- Dark discrete LIVA signals matched the physical location of the failing bit cells
- Top-side analysis suggested only NMOS → implant?
- Metal coverage may obscure PMOS signal

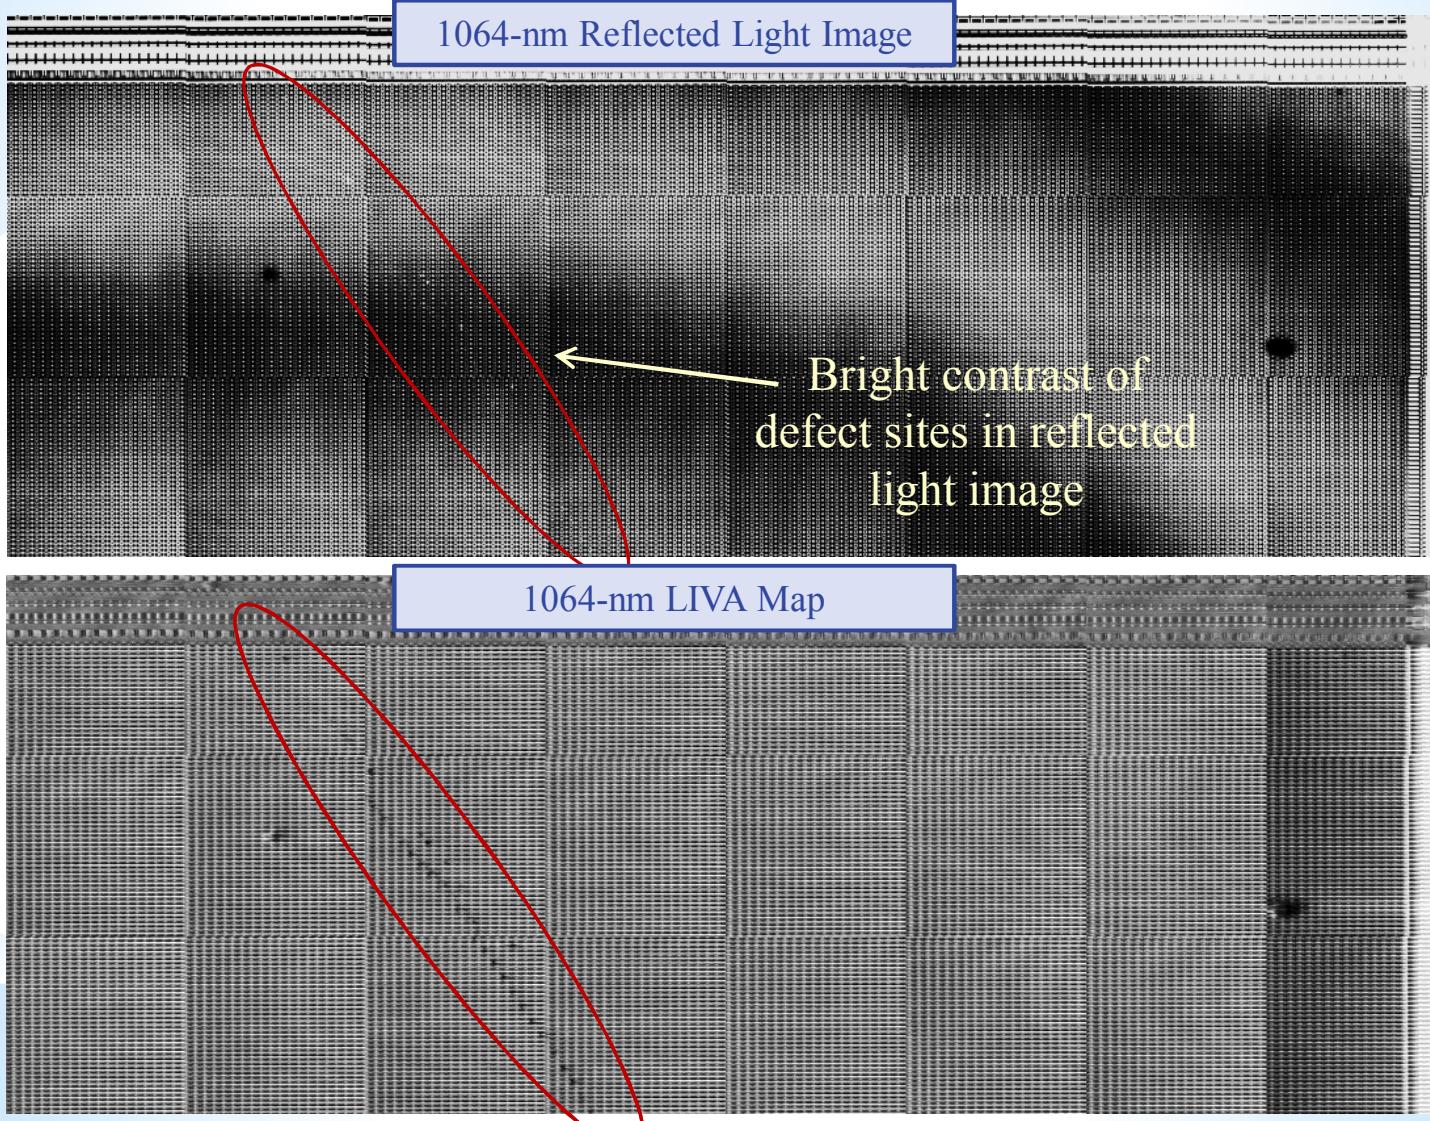
Backside imaging revealed good tracking of both the reflected light images and the LIVA map to the failing bit pattern.

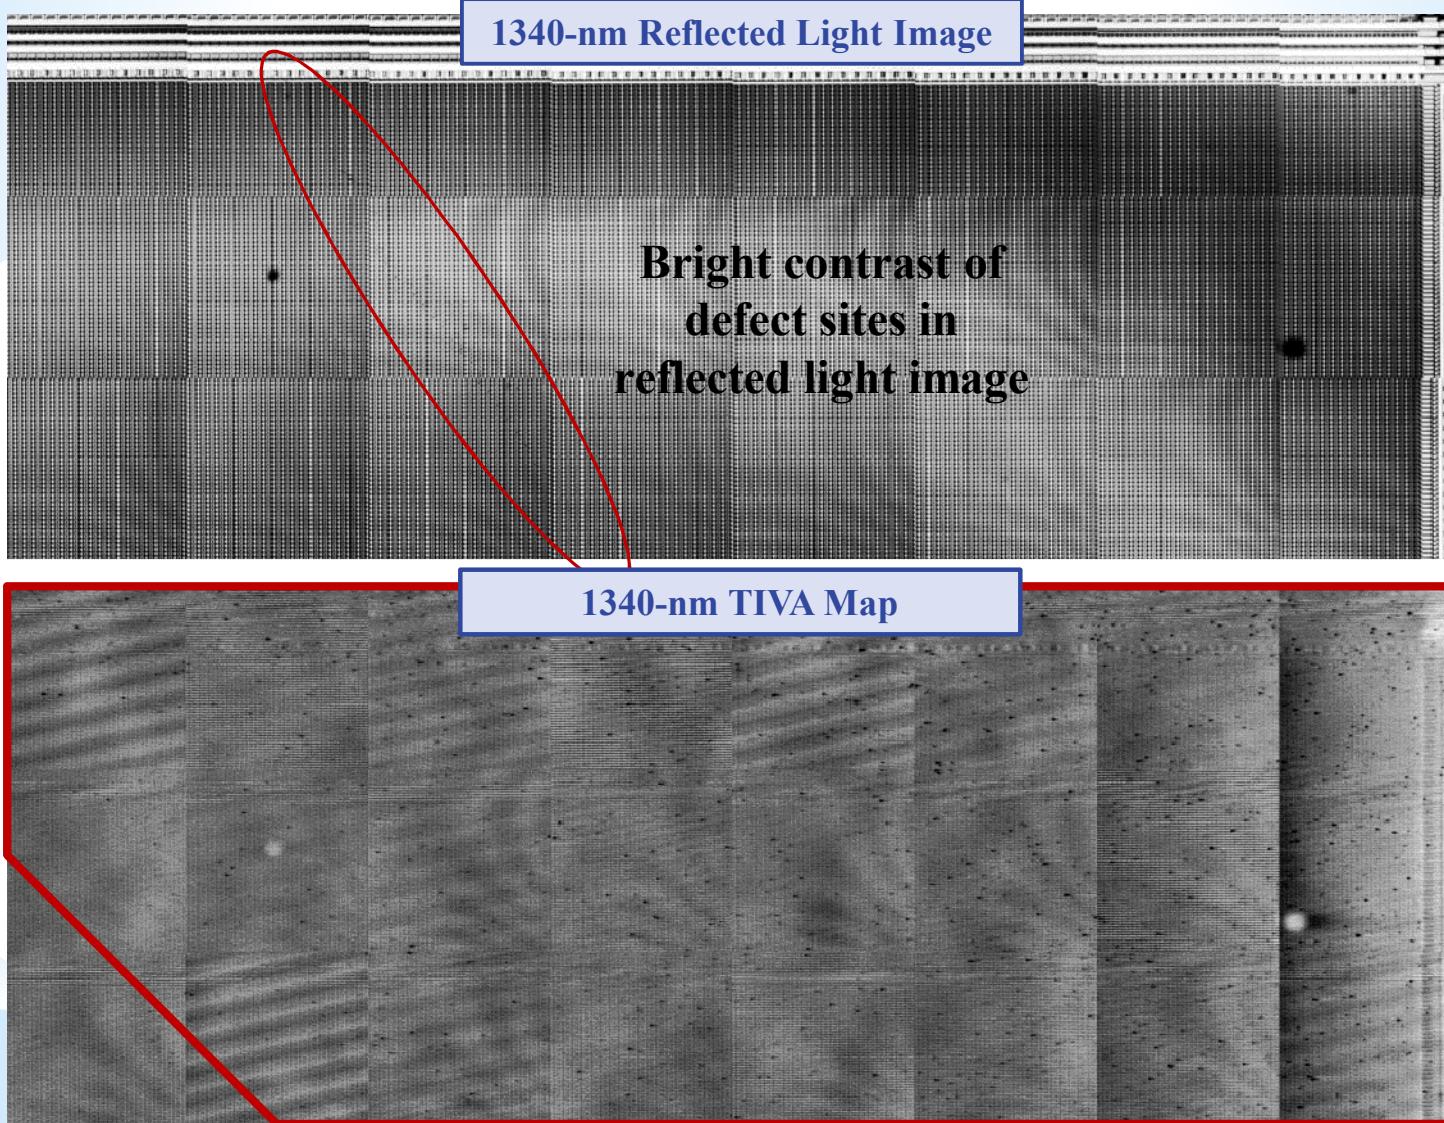
The TIVA map showed a high density of dark discrete signals

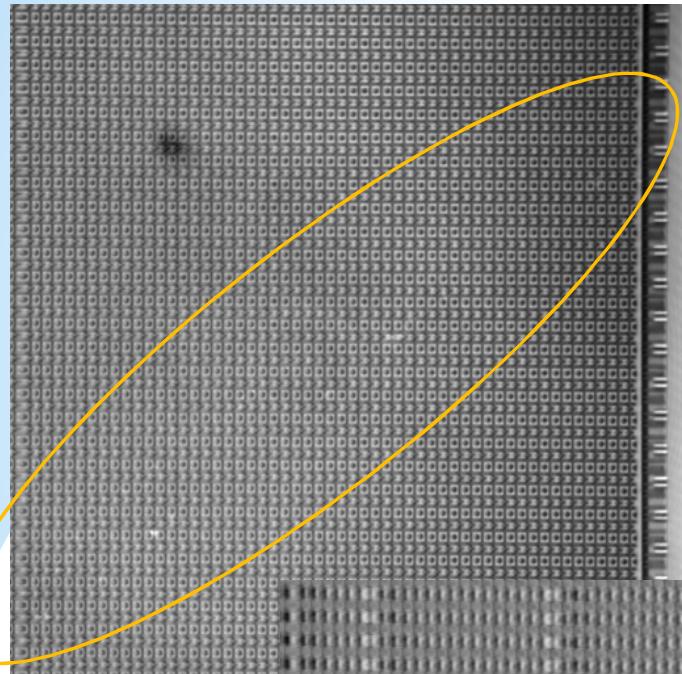
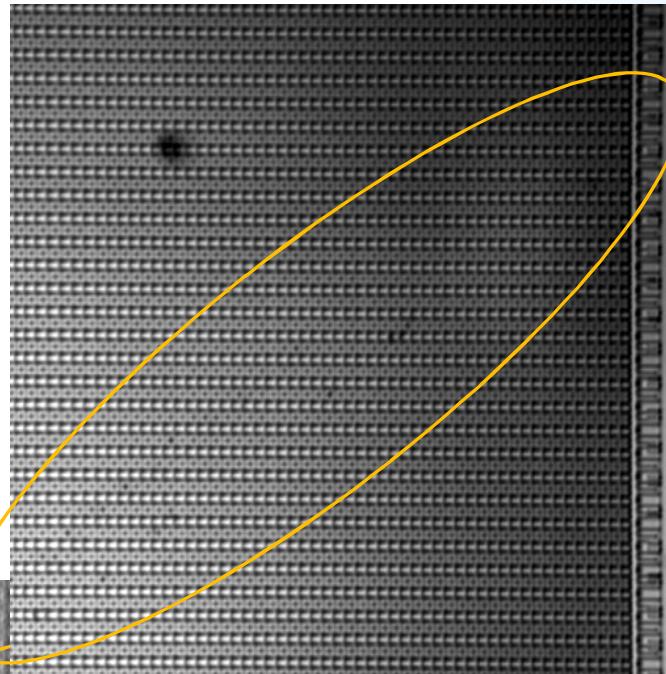
1064-nm
Reflected light image
(above) and
LIVA map
(right)

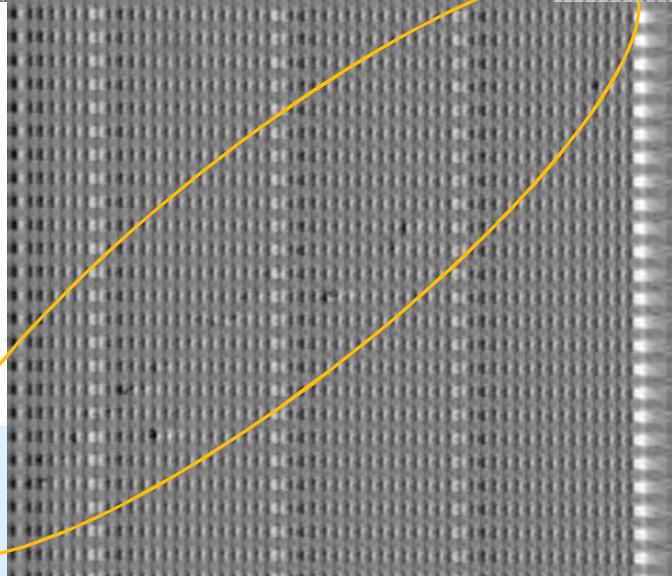
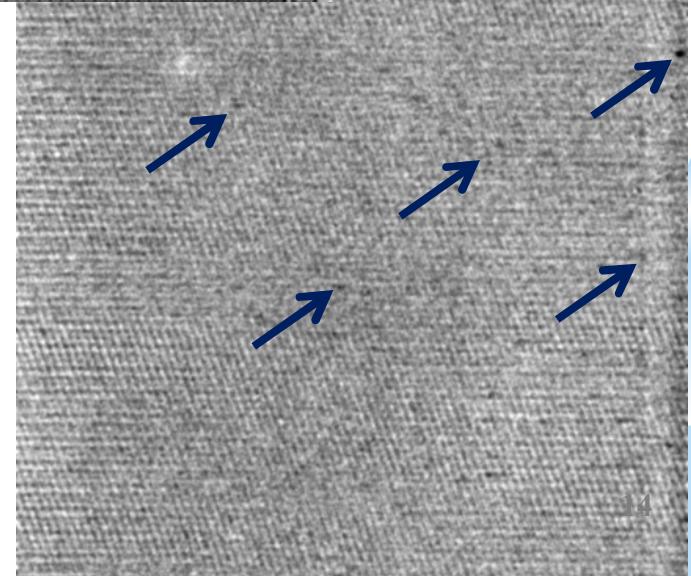
1340-nm
Reflected light
image (left)
and TIVA
map (below)

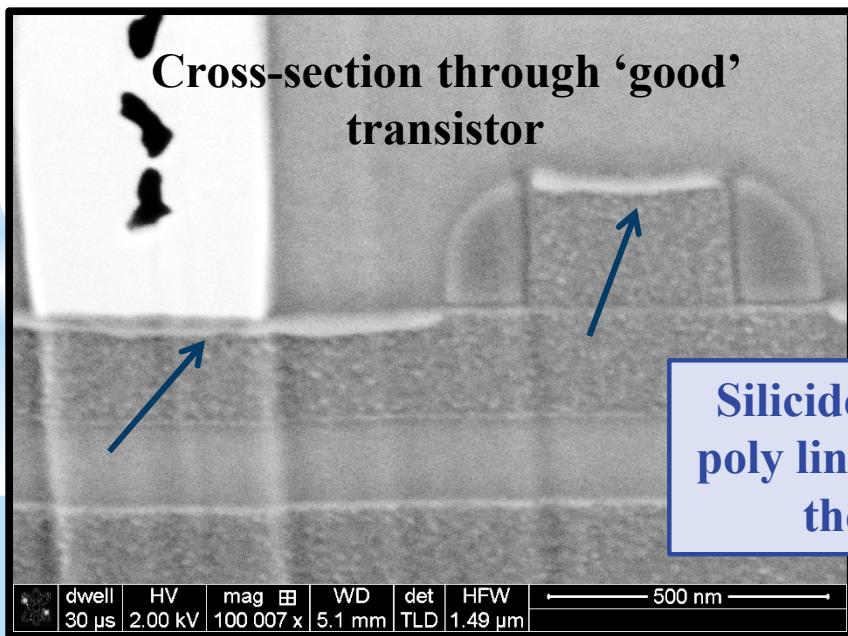
- Source of the scratch was found to be extra spacer nitride
- The nitride stopped the formation of Ti-silicide increasing the resistance of the contact
- The electrical response is suspected to come from differing contact resistance within a single bit cell

Silicide is visible on poly line and beneath the contact

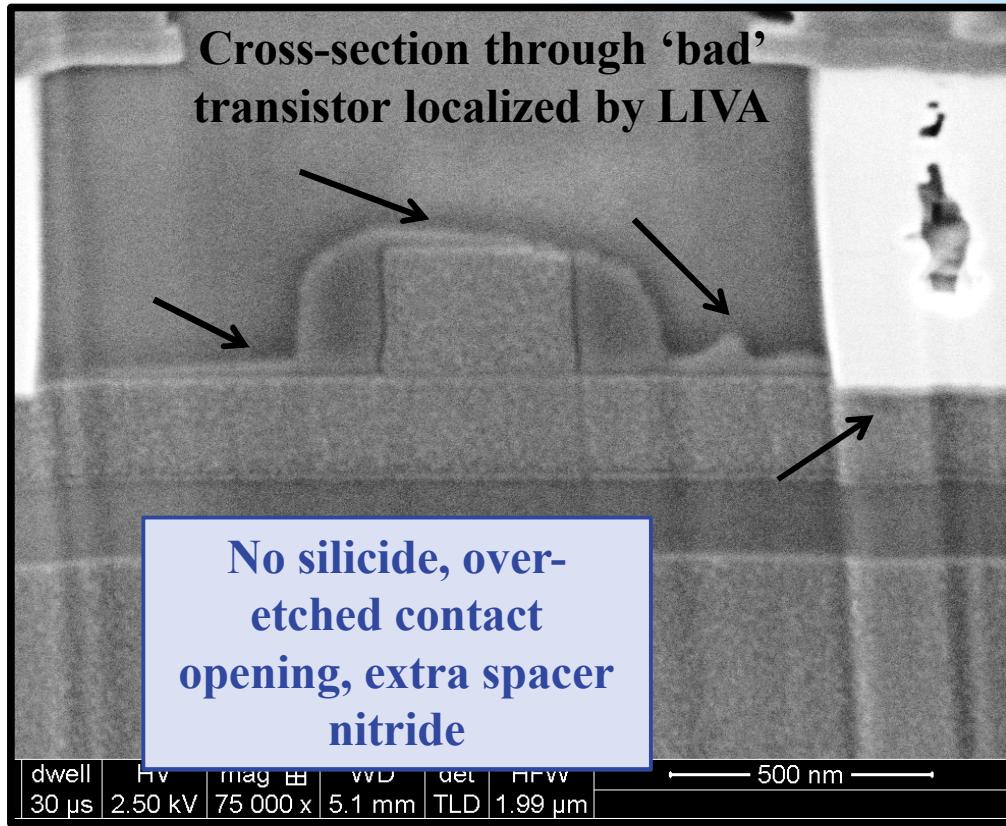
No silicide, over-etched contact opening, extra spacer nitride

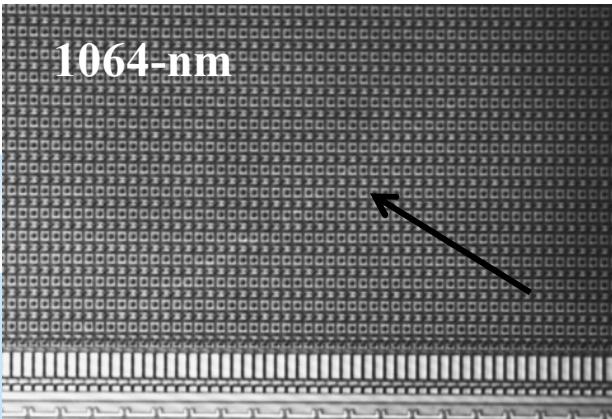
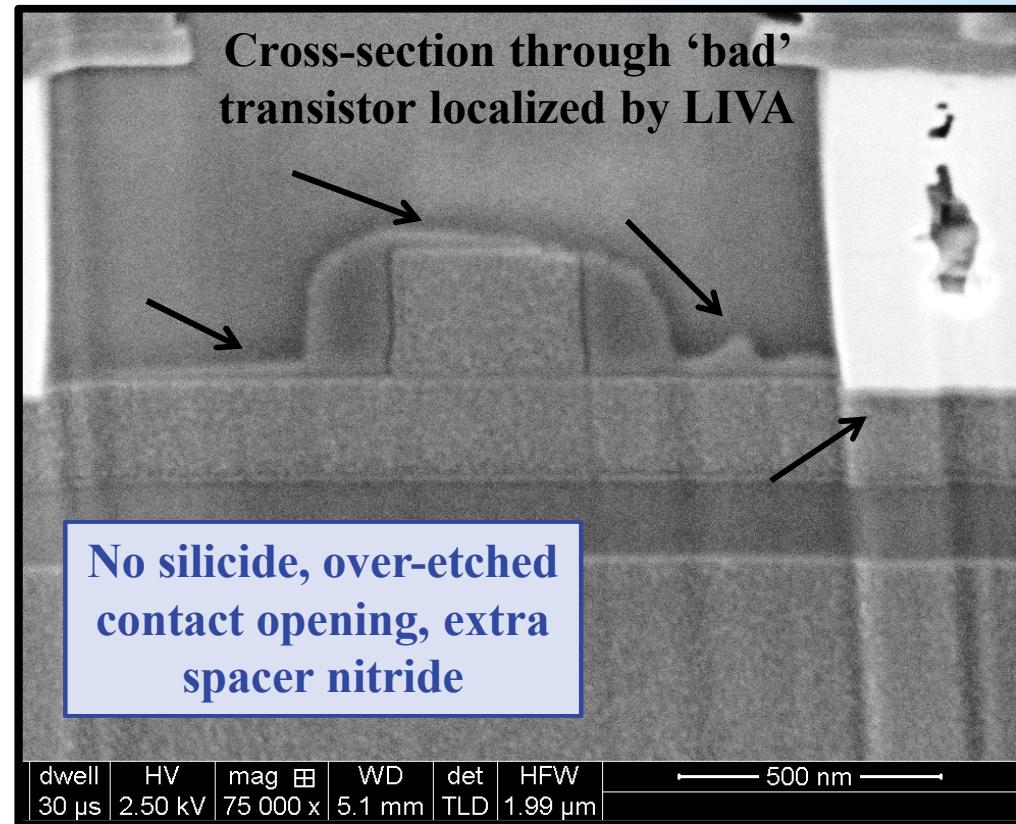
Reflected Light Image

- FIB cross-sections through discrete TIVA signals did not show anything obvious → decorated dislocations
- Dark contrast in 1340-nm reflected light image from missing silicide
- Bright contrast in 1064-nm culmination of scattering (density of pattern) and reduced reflection
