Hanford Single-Shell Tank Leak Causes and Locations - 241-BY and 241-TY Farm

C.L. Girardot, D.G. Harlow

Washington River Protection Solutions
Richland, WA 99352
U.S. Department of Energy Contract

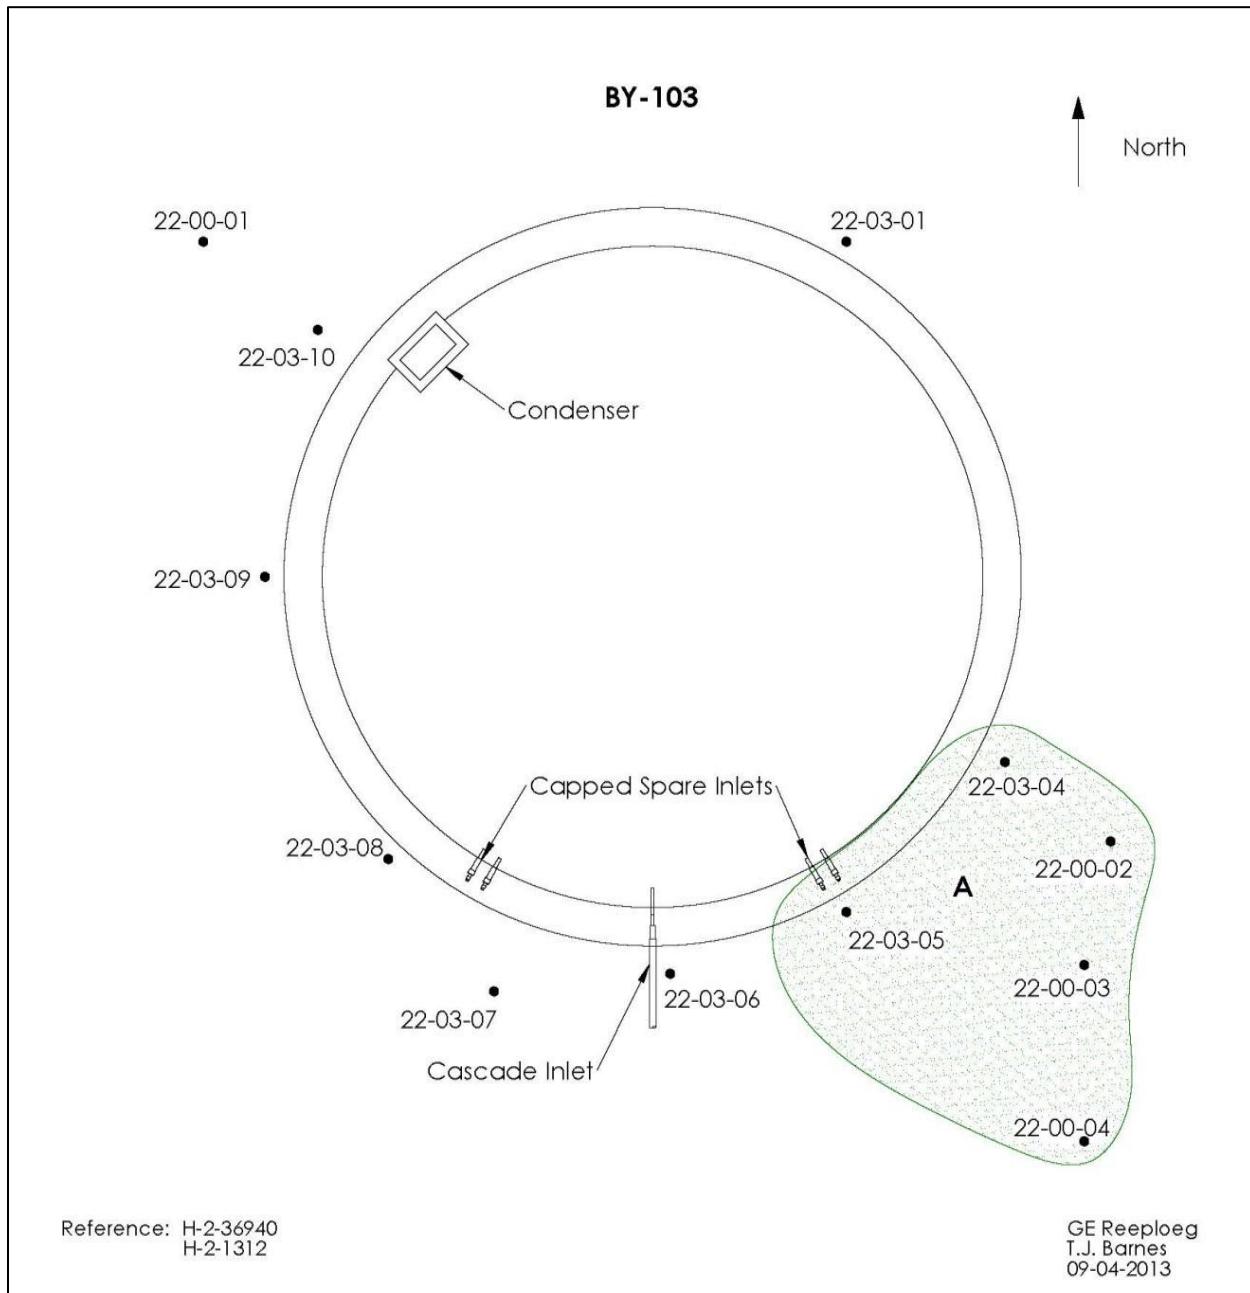
Figure 4-17. Tank BY-103 Possible Leak Location (1959-1974)
Tank inner ring is steel liner, outer ring is outer edge of tank footing

Tank BY-103 was first suspected of leaking in 1969 due to radioactivity being detected in drywell 22-00-03; however, the leak may have begun as early as 1959.

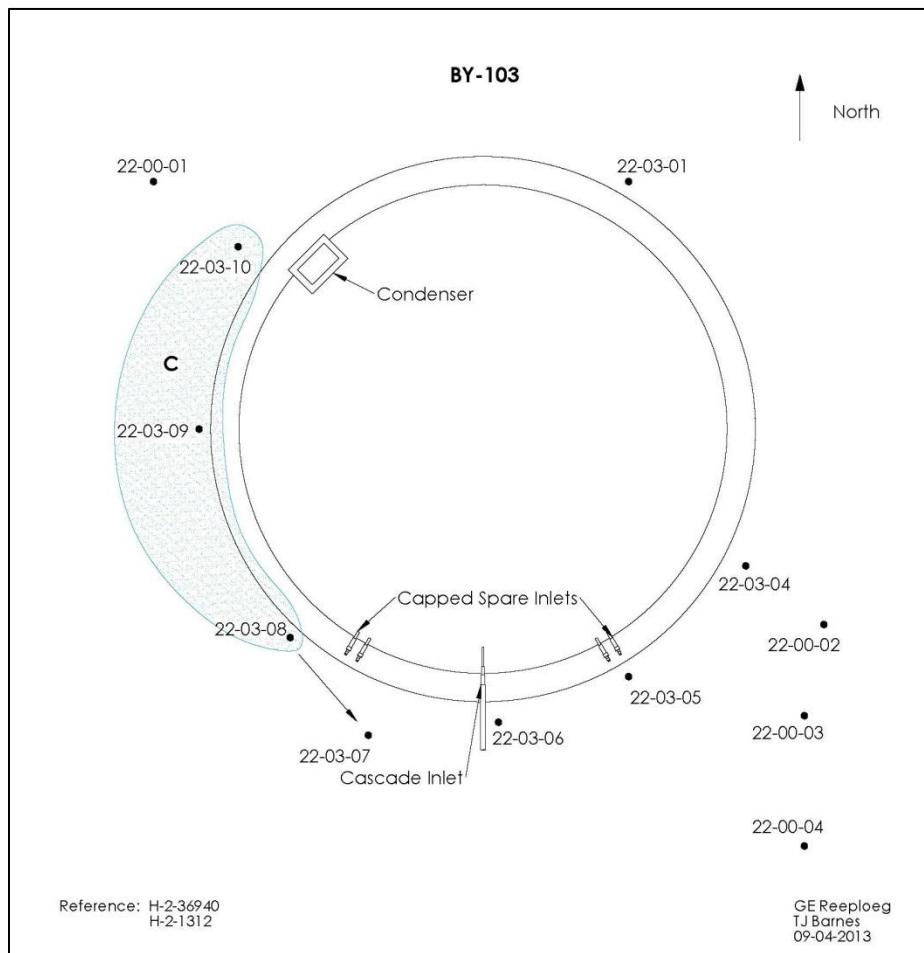
Figure 4-19. Tank BY-103 Possible Leak Location (1972-1974)
Tank inner ring is steel liner, outer ring is outer edge of tank footing

Tank BY-103 was first suspected of leaking in 1969 due to radioactivity being detected in drywell 22-00-03; however, the leak may have begun as early as 1959.

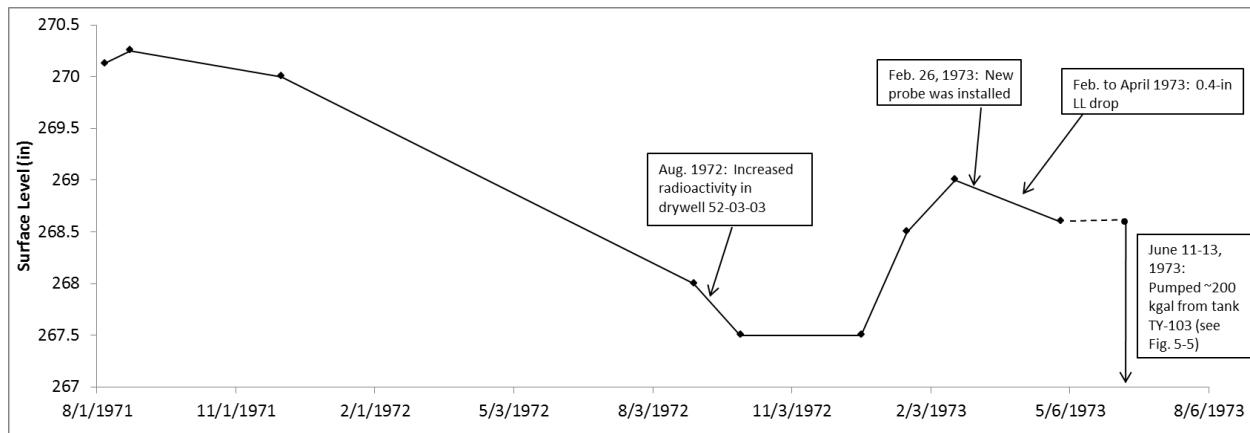
Figure 5-4. Tank TY-103 Liquid Level August 1971 to August 1973

On October 26, 1973 a review was performed on tank TY-103 leak events. The review states that liquid level readings from January through December 1972 indicate a loss of 3½-in (9,600 gal) by the end of 1972 with subsequent increases in radioactivity in the drywells (Draft memo Compton 1973, *Tank 241-TY-103 Review*). However, it was reported in this draft memo that liquid levels also had an unexplained increase in January 1973 of >2-in. Drywell 52-03-03 radioactivity continued to increase indicating a continuing leak. A new probe was installed February 26, 1973 (LET-ARHCO-TY-103, *Status of Tank 241-TY-103*). The next reported liquid level drop was two months later in April 1973 when a 0.4-in liquid level drop was reported (see Figure 5-4) with increased radiation readings in the drywell through May 28, 1973 when the tank was declared a suspect leaker (Draft memo Compton 1973).

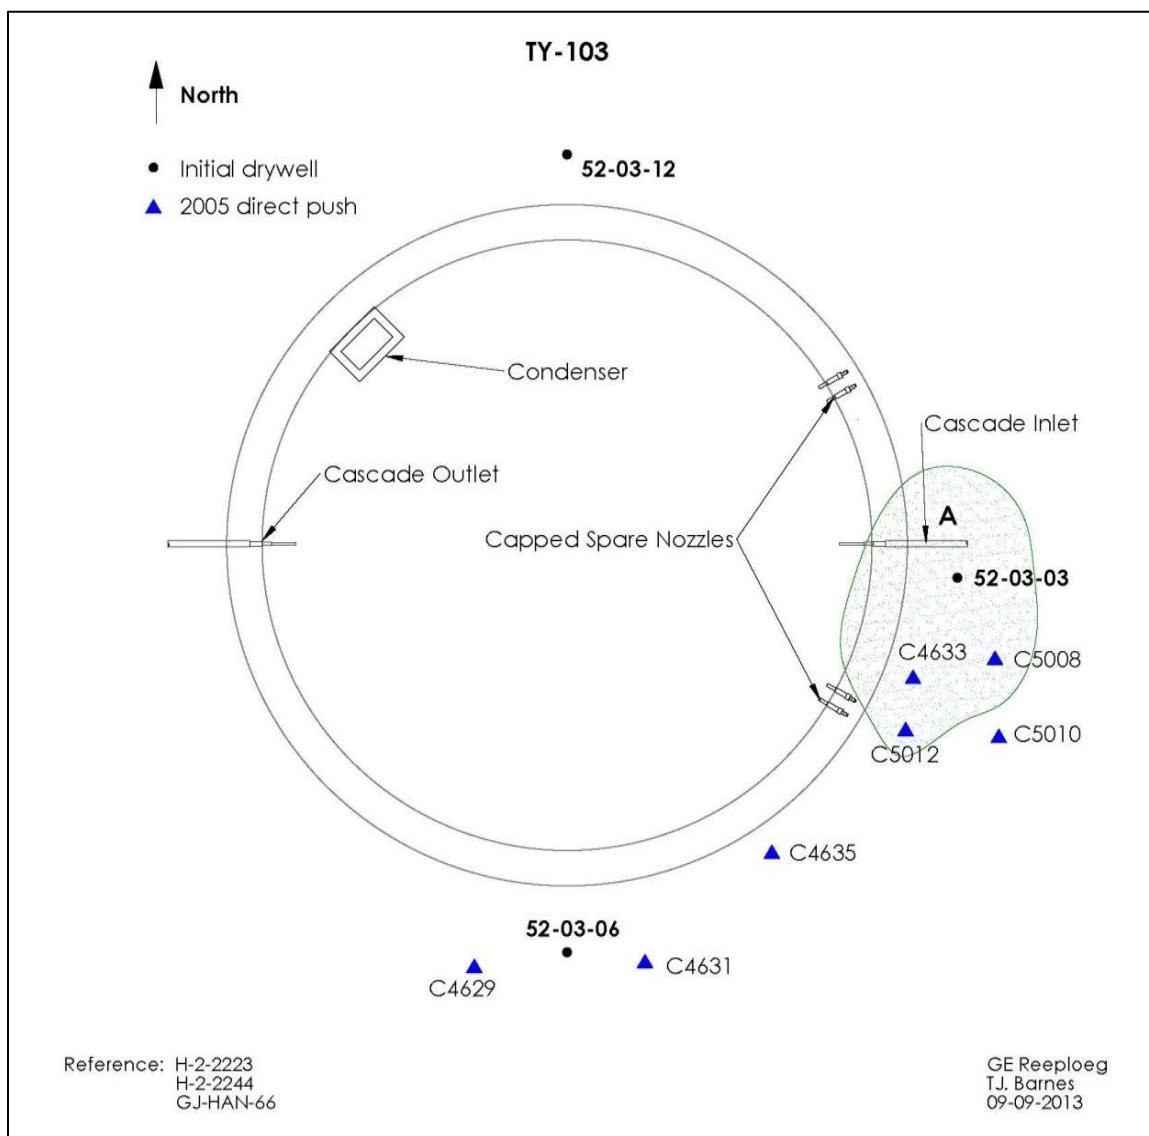
Figure 5-9. Tank TY-103 Possible Leak Location (August 1972 & 2005)
Tank inner ring is steel liner, outer ring is outer edge of tank footing

The leak from tank TY-103 was first detected in August 1971 due to a liquid level decrease and subsequent radioactivity detected in drywell 52-03-03

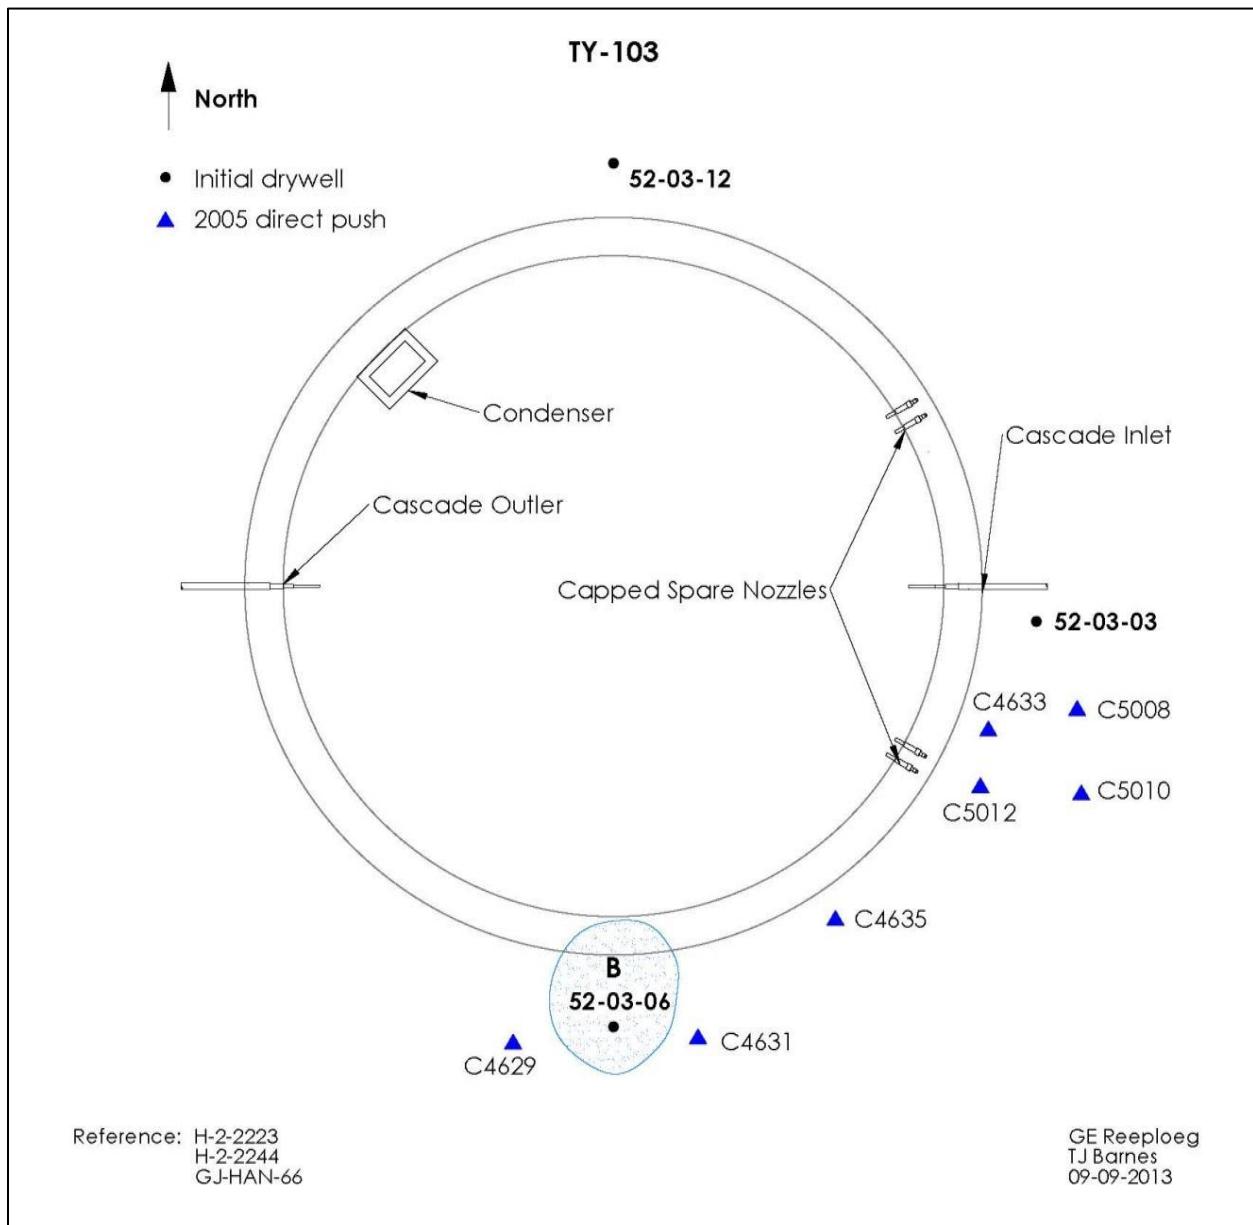
Figure 5-10. Tank TY-103 Possible Leak Location (July 1973)
Tank inner ring is steel liner, outer ring is outer edge of tank footing

The leak from tank TY-103 was first detected in August 1971 due to a liquid level decrease and subsequent radioactivity detected in drywell 52-03-03

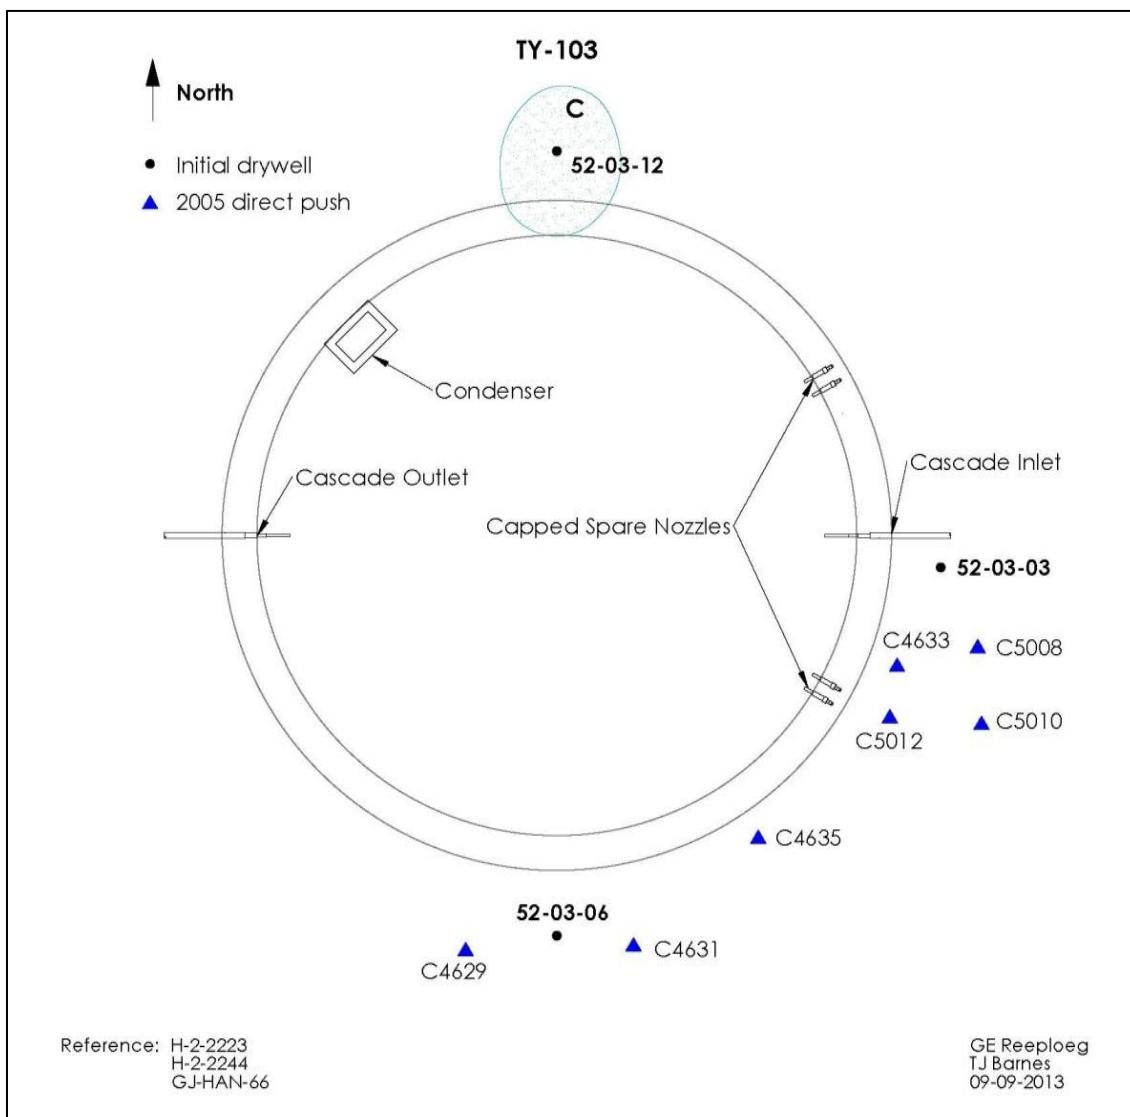
Figure 5-11. Tank TY-103 Possible Leak Location (July 1973)
Tank inner ring is steel liner, outer ring is outer edge of tank footing

The leak from tank TY-103 was first detected in August 1971 due to a liquid level decrease and subsequent radioactivity detected in drywell 52-03-03

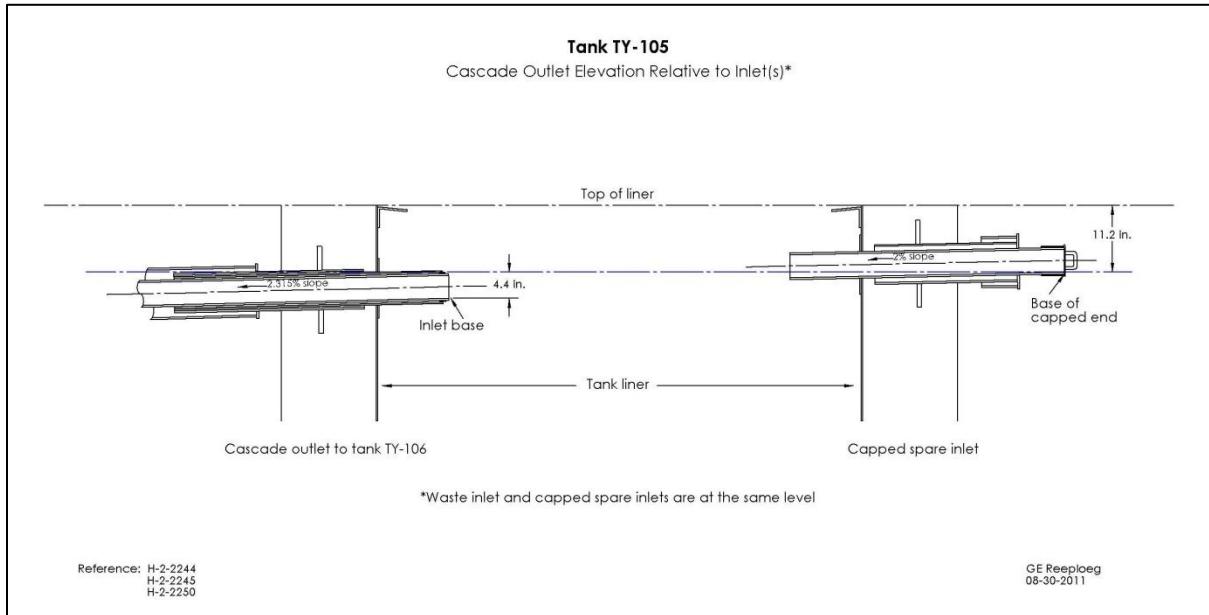
Figure 7-11. Tank TY-105 Cascade Outlet Relative to Inlet(s)

The TBP waste was batch transferred from 221-U Plant to the WR Vault and pumped at a nominal 50 gpm to tank TY-105 which cascaded to tank TY-106. There is no record of overfilling tank TY-105 or plugging of the overflow cascade to tank TY-106 using the recovered quarterly liquid level data. No other liquid level data relative to the two year cascade period has been found. Over 5,000 kgal of TBP waste was transferred to tank TY-105 in batches which cascaded to tank TY-106. The possibility of backing up the liquid level ~ 4.4-in to the base of the spare inlet lines may exist (see Figure 7-11).

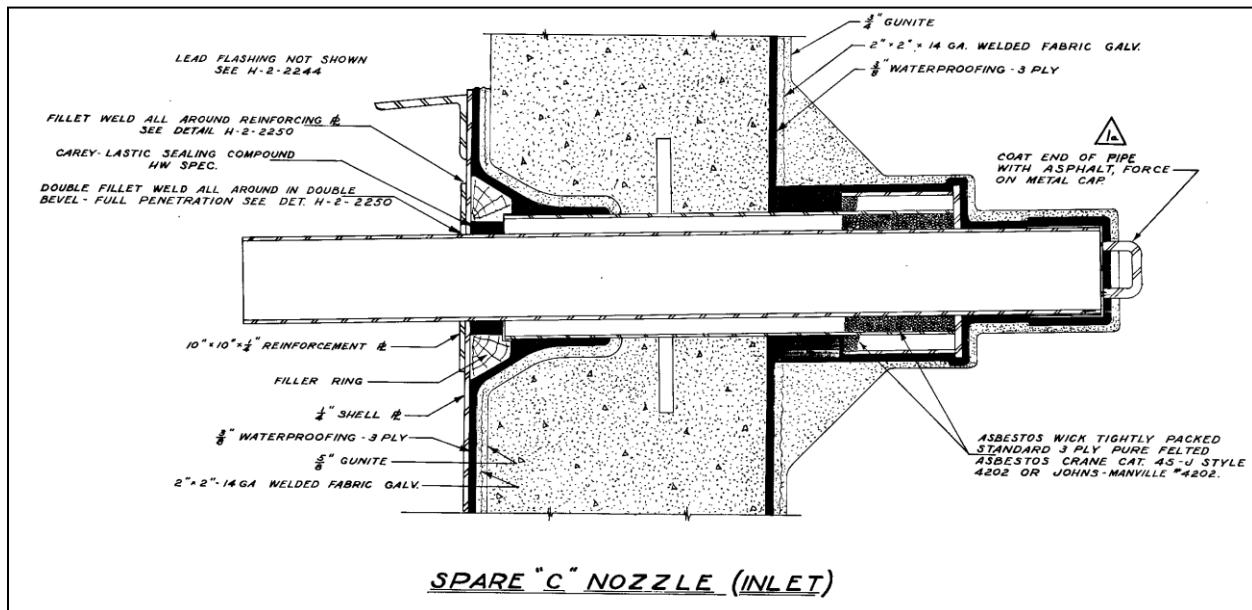
Figure 7-12. Tank TY-105 Spare Inlet Line Asphalt - Gunite Seal (H-2-2277)

The slip fit capped spare inlet lines are sealed with a coating of asphalt which is covered with gunite (see Figure 7-12). Poor quality of the capped spare inlet seal system or damage during construction/backfilling could have compromised the seal resulting in the possibility of a leak should waste be backed up into the spare inlet at least to the base of the capped end.

The leakage of the spare inlet lines seems possible; however, a number of conditions as indicated need to take place for this to happen. The other possibility is that the liner leaked above the

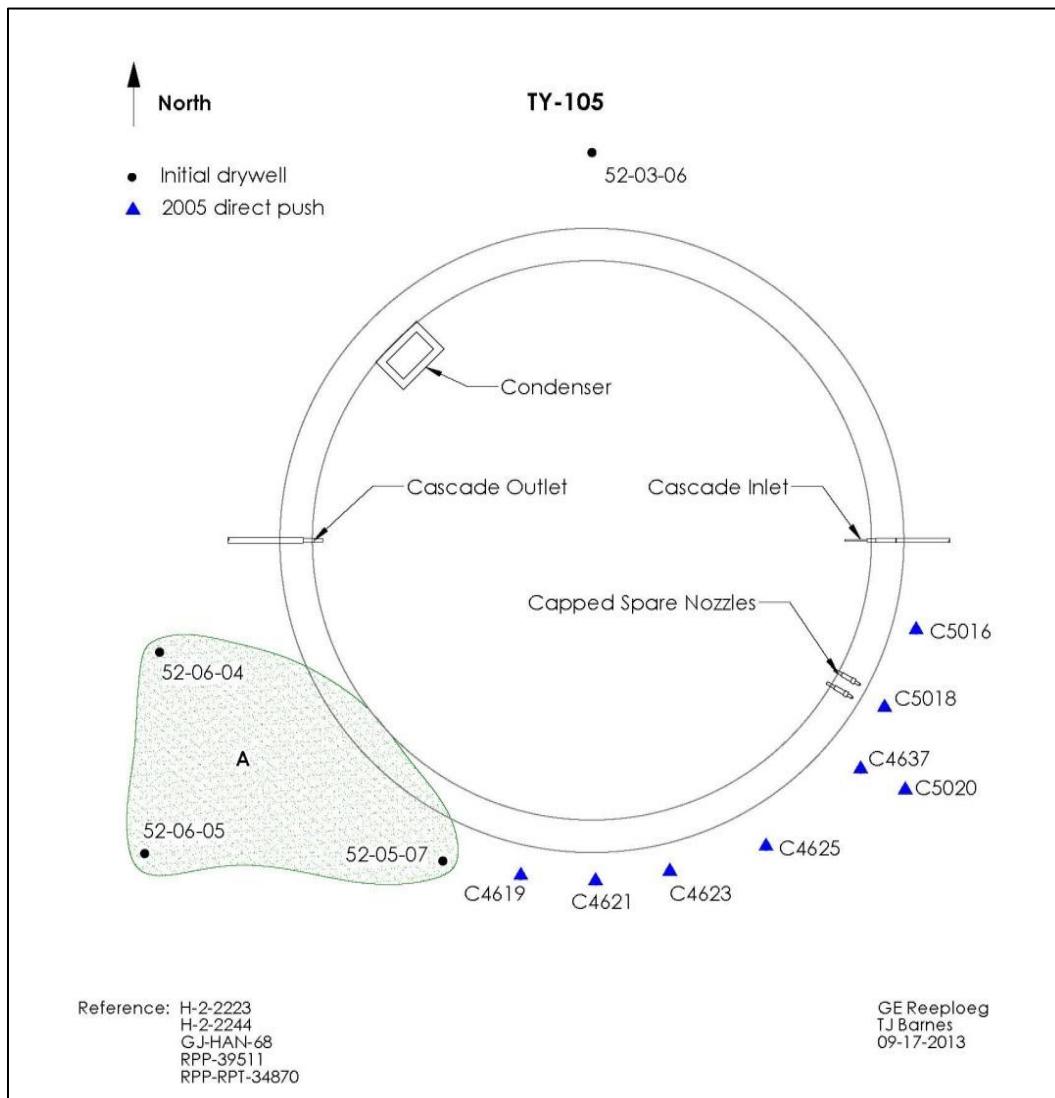
Figure 7-13. Tank TY-105 Possible Leak Location (1973-1974)
Tank inner ring is steel liner, outer ring is outer edge of tank footing

The leak from tank TY-105 was first detected in September 1960 due to liquid level decreases; however, the leak may have started as early as July 1959.

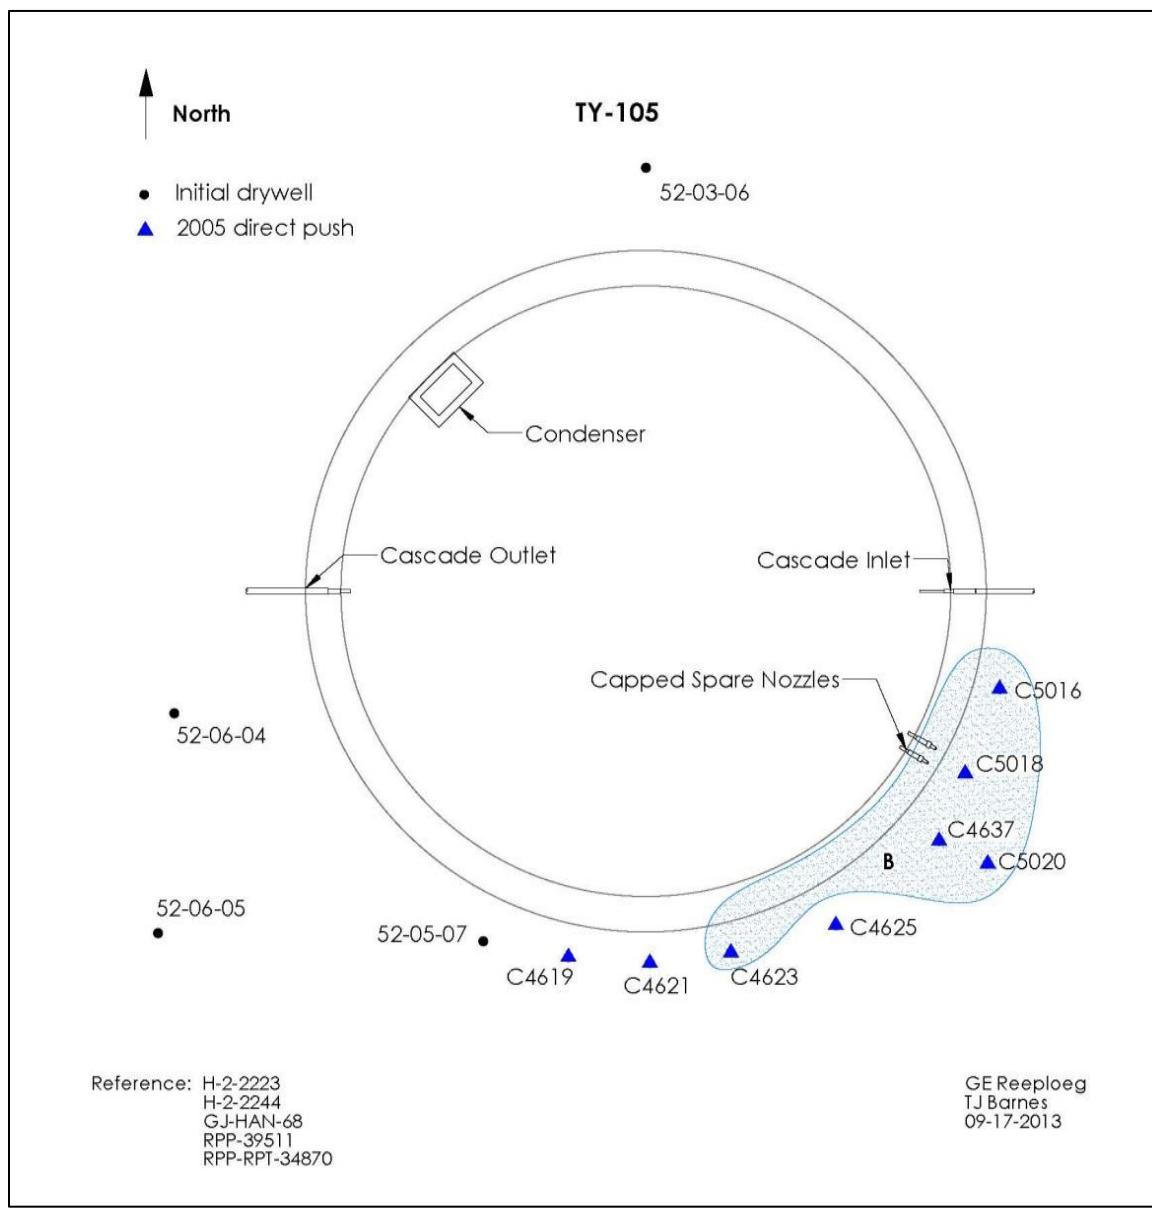
Figure 7-14. Tank TY-105 Possible Leak Location (2005)
Tank inner ring is steel liner, outer ring is outer edge of tank footing

The leak from tank TY-105 was first detected in September 1960 due to liquid level decreases; however, the leak may have started as early as July 1959.

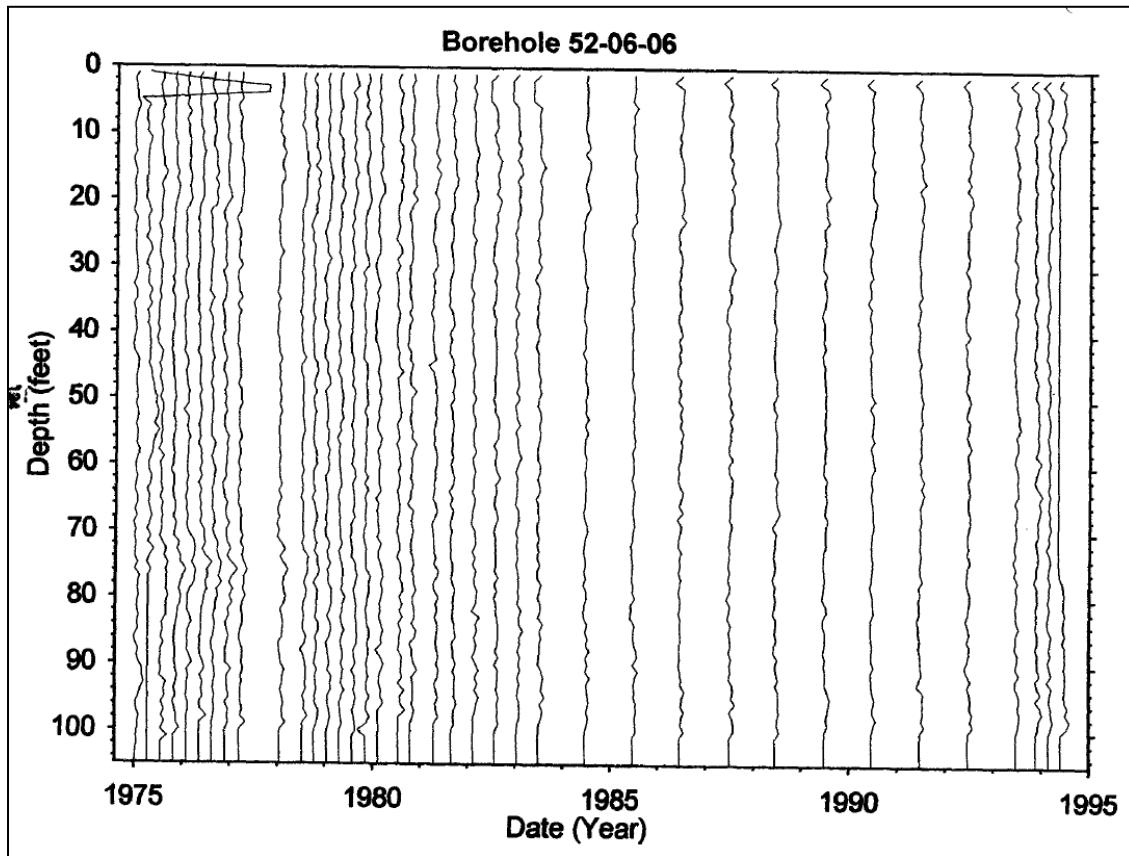
Figure 8-10. Tank TY-106 Drywell 52-06-06 (HNF-3831)

Also stated in GJ-HAN-69, “the Co-60 contamination most likely originated from a leak in either tank TY-103, TY-105, or TY-106...” It seems likely the Co-60 radioactivity detected in this drywell at the lower BGS levels was the result of some of the tank TY-106 leak as supported by the 2005 direct pushes (see Section 8.5.3). Figure 8-10 shows depths of radioactivity from 1975 to 1994 (HNF-3831).

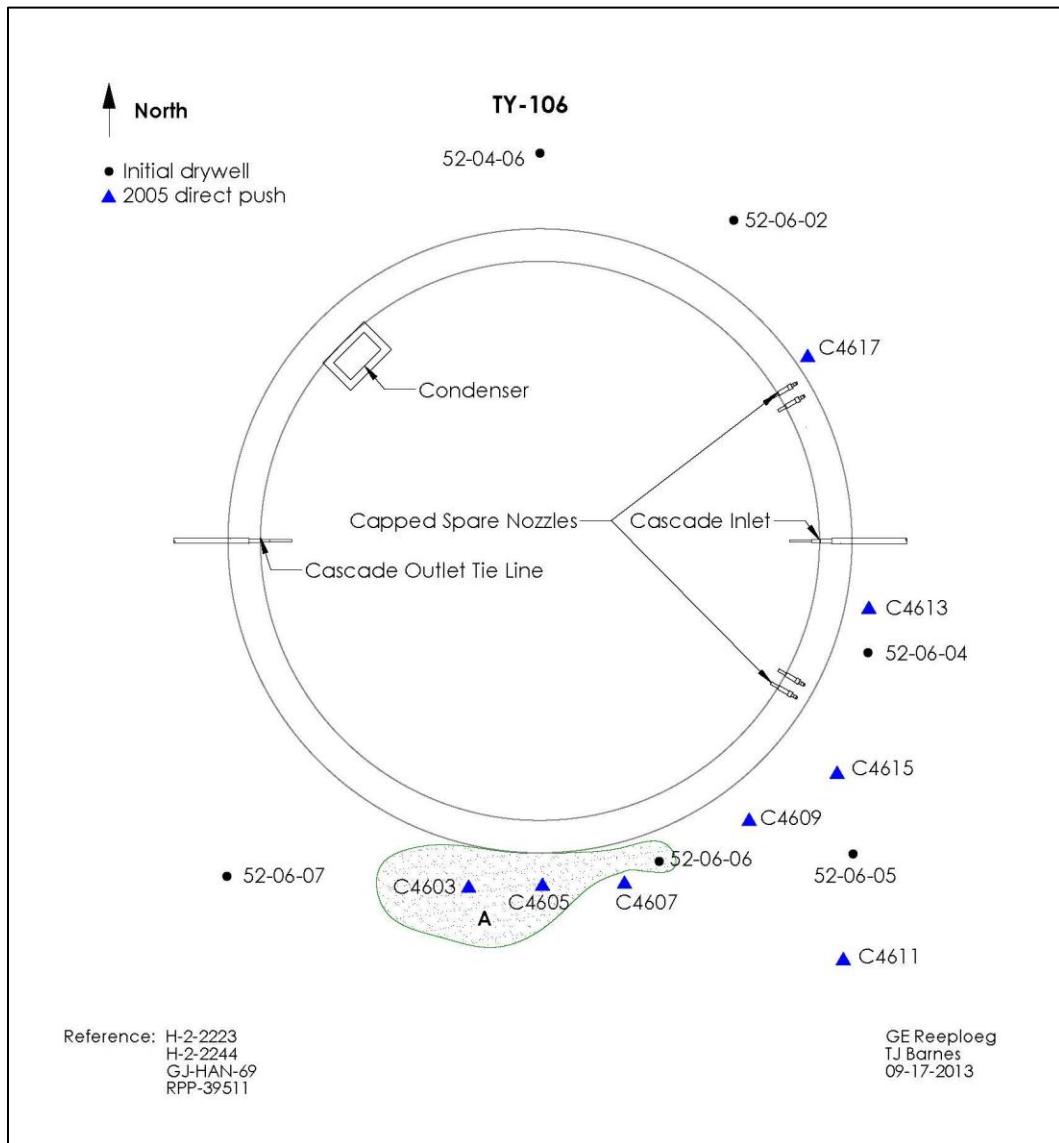
Figure 8-12. Tank TY-106 Possible Leak Location (1974 & 2005)
Tank inner ring is steel liner, outer ring is outer edge of tank footing

The leak from tank TY-106 was first detected in August 1959 due to liquid level decreases.
