## Failure Analysis of Crimp Connectors

P.T. Vianco, A.C. Kilgo, R. Grant

Sandia National Laboratories  
Albuquerque, NM 87185

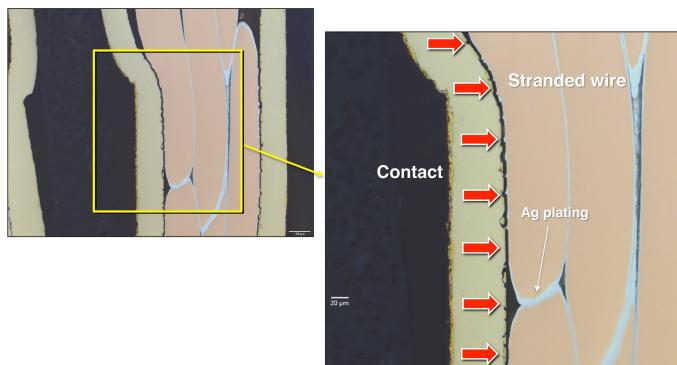
The high magnification images in Fig. 1 show one of the crimp joints. The red arrows in Fig. 1a indicate a gap between the wire strands and the contact surfaces. The optical micrograph in Fig. 1b shows a periodicity of two fracture morphologies. One morphology was separation between the Au plating and the Ag plating on the contact and stranded wire, respectively (green arrow). The second morphology was separation between the Ag finish of the wire and bare Be-Cu of the contact (orange arrow). In the case of the first failure site, it is recognized that Au and Ag surfaces are susceptible to contamination from exposure to the air environment. Such contamination, whether on one or both surfaces, can interfere with the formation of the cold-weld bond.

**Fig. 1** (a) Optical micrographs shows the absence of a bond (red arrows). (b) The green and orange arrows indicate Au/Ag interface failure and bare Be-Cu/Ag interface failure, respectively.

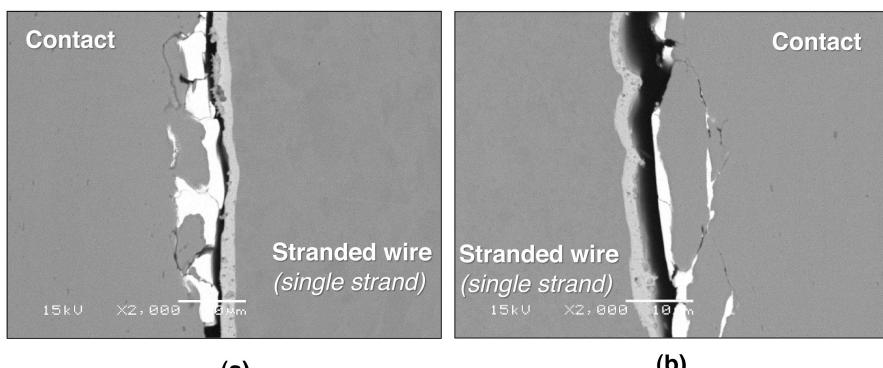
In the second case (orange arrow), the damage originated from the forming process used to make the crimp structure. There was Au as well as Ni plating layers *within* those near-surface crack that confirmed that the damage occurred prior to the electroplating process as shown in Fig. 2. The pressure of the crimping process loosened or fragmented the damaged segments. Then, upon the elastic rebound, those fragments separated from the contact surface and were lost during the metallographic cross section preparation process.

**Fig. 2** SEM photographs show the damage to the contact material surface and sub-surface regions as indicated by by the electroplating of Au within the cracks and gaps.
