# Hanford Single-Shell Tank Leak Causes and Locations - 241-U Farm

C.L. Girardot, D.G. Harlow

**Key Words:** leak location, leak cause, tank, integrity assessment, U Farm, U-104, U-110, U-112, leak assessment

**Abstract:** This document identifies 241-U Tank Farm (U Farm) leak causes and locations for the 100 series leaking tanks (241-U-104, 241-U-110, and 241-U-112) identified in RPP-RPT-50097, Rev. 0, Hanford 241-U Farm Leak Inventory Assessment Report. This document satisfies the U Farm portion of the target (T04) in the Hanford Federal Facility Agreement and Consent Order milestone M-045-91F.

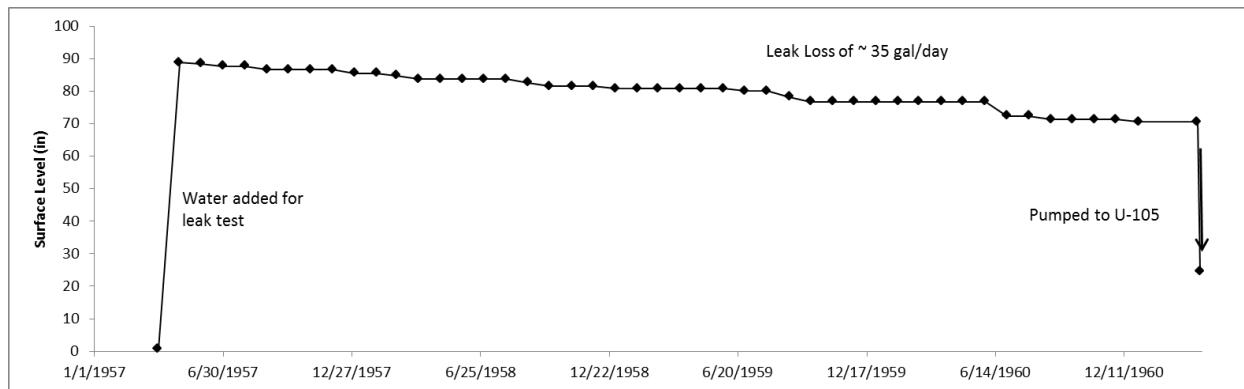
**Figure 4-4. Tank U-104 Liquid Level April 1957 through March 1961**

Tank U-104 was first suspected of leaking during sluicing operations of the MW sludge in July 1956 (HW-44024-RD). During this time there were no reports indicating an unknown decrease in the liquid level; however, a tank liner bulge was suspected. In-tank photographs and a periscope confirmed a liner bulge in tank U-104 (see Section 4.4.3).

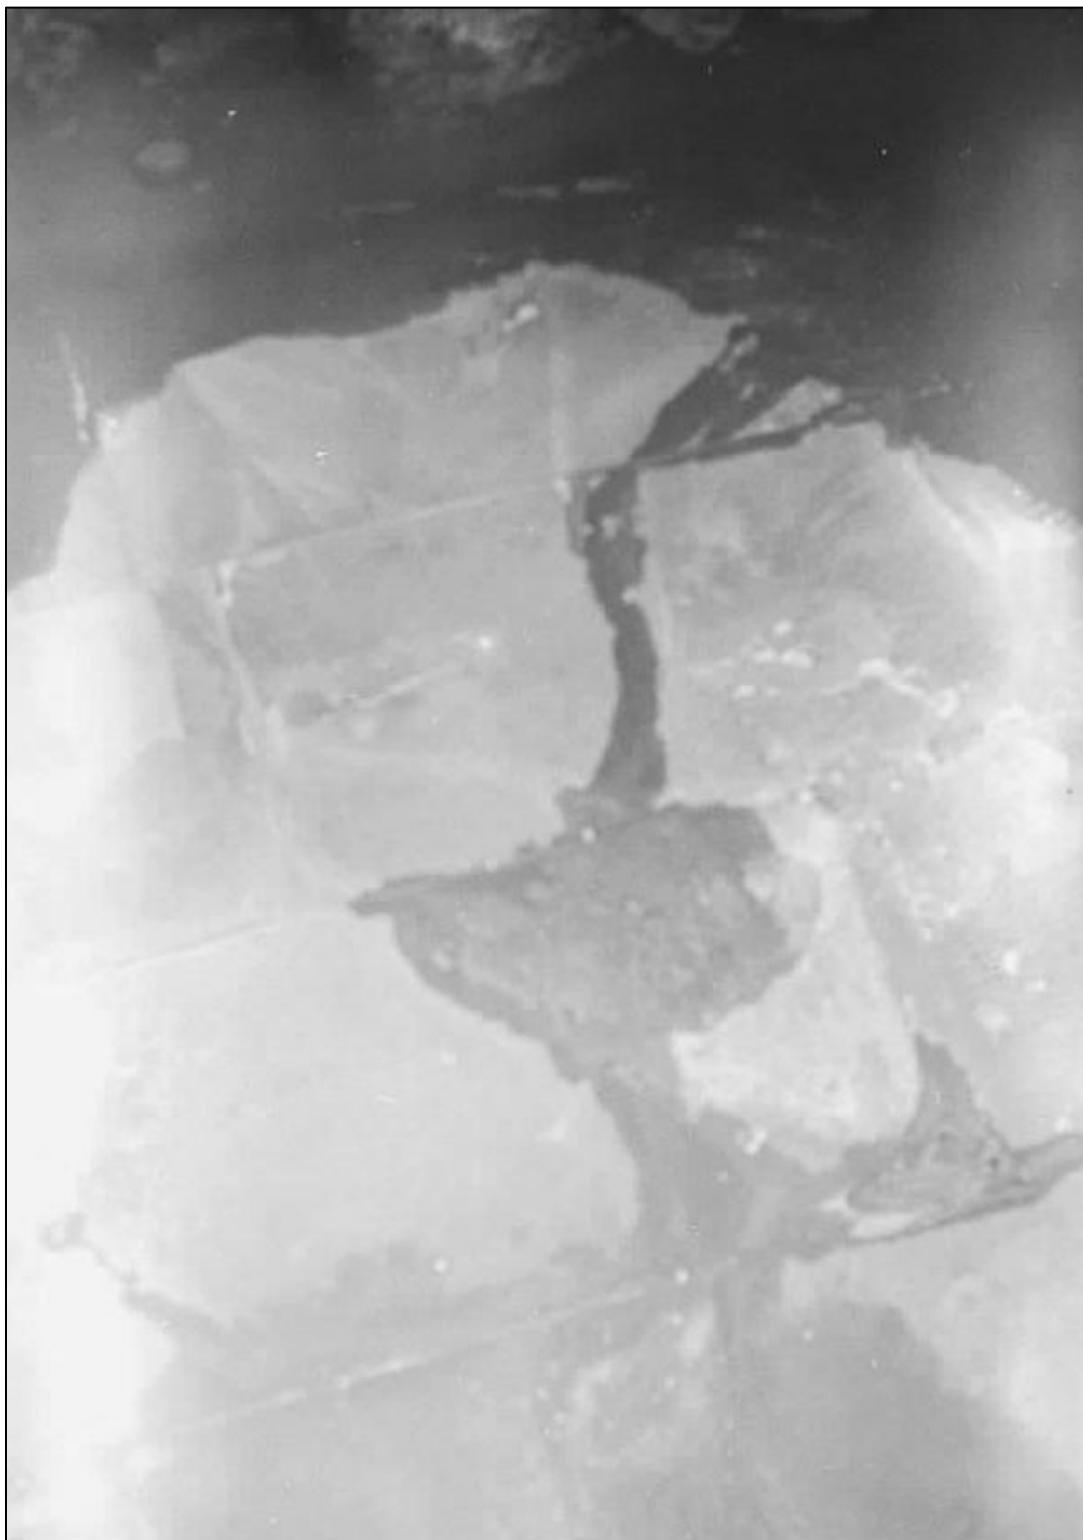
**Figure 4-5. Tank U-104 Bulged Bottom Liner August 15, 1956**  
**(Photograph 5BN1D0021185)**

A bulge, typically caused by rapid vaporization of moisture under the tank liner, may result in the direct failure of the liner or cause enough stress or thinning on the steel liner plates and welds that they become more susceptible to the effects of corrosion without producing a permanent bulge. Experience indicates that bulging tends to be a dynamic phenomenon, and it is possible that a tank with no measured bulge at one point in time may actually have had a displaced liner that was not detected at another time.

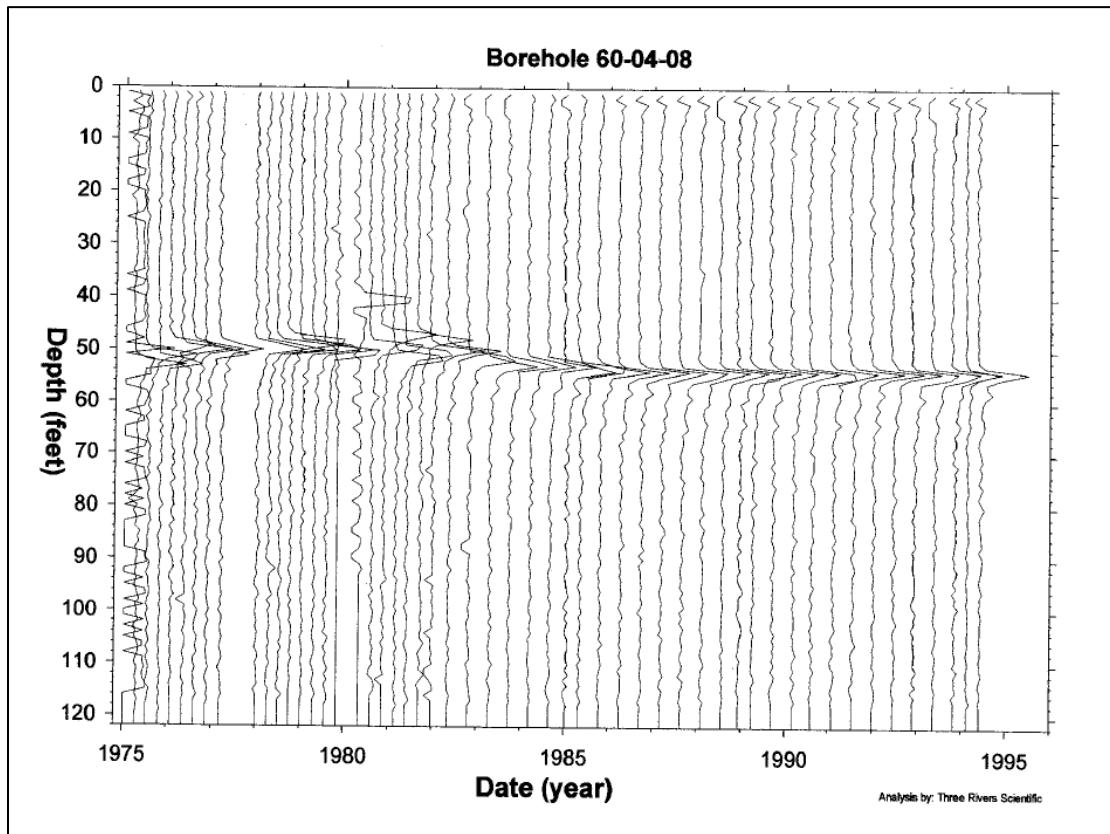
**Figure 4-9. Tank U-104 Drywell 60-04-08 (RPP-7729)**

Drywell 60-04-08 is located approximately 5.2-ft from the tank U-104 footing. Drywell 60-04-08 was drilled in 1974 with the first recoverable reading on June 4, 1974 with a peak 15-ft below the bottom base of the tank of 70.8K cpm at 53-ft BGS (see Appendix B1). The next reading reported on July 1, 1974 reported the peak at 17.8K cpm at 49-ft BGS. Radioactivity remained relatively stable at this BGS depth through September 1986.

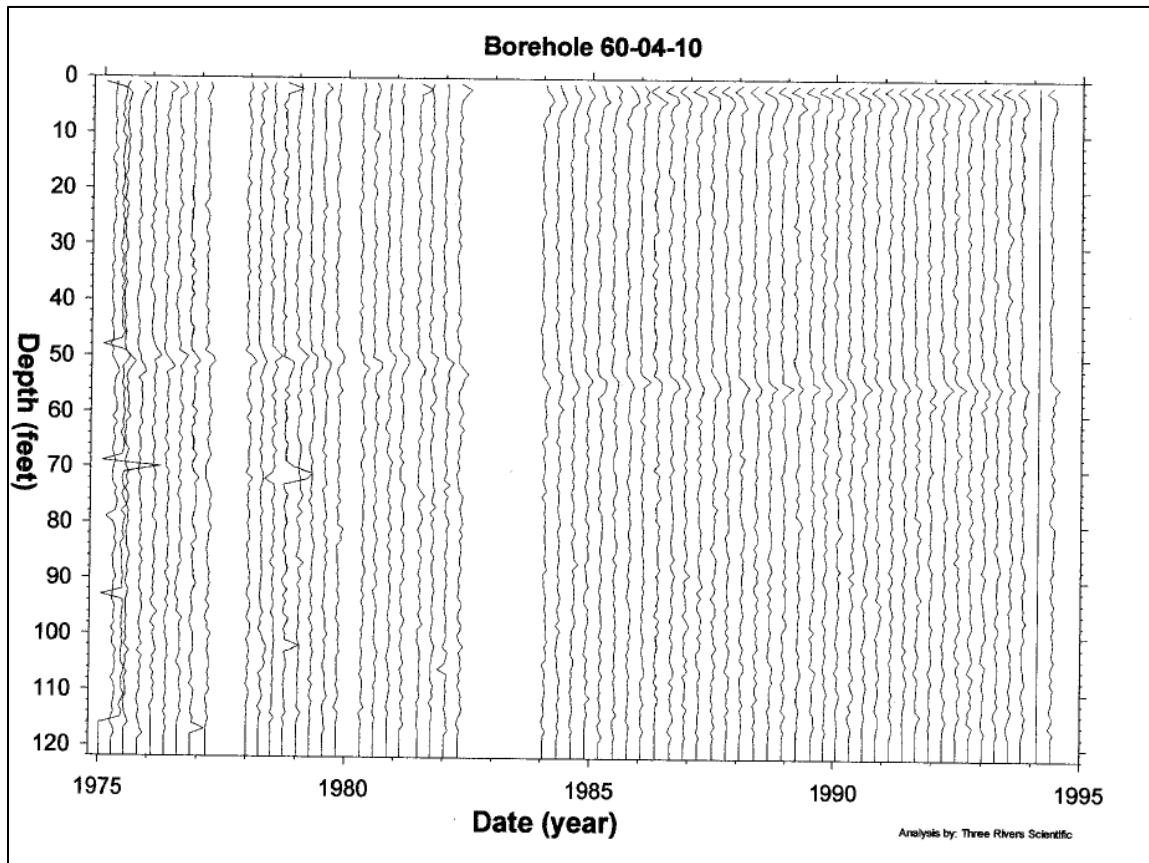
**Figure 4-10. Tank U-104 Drywell 60-04-10 (RPP-7729)**

Drywell 60-04-10 is located approximately 6.2-ft from the tank U-104 footing. Drywell 60-04-10 was drilled on 1974 with the first recoverable reading on April 18, 1974 with a peak of 15.6K cpm at 56-ft BGS (see Appendix B1). The next recorded reading on June 4, 1974 reported a peak 15-ft below the bottom base of the tank of 13.8K cpm at 53-ft BGS. Four days later, the radioactivity peak at 49-ft BGS was reported at approximately 3K cpm. Radioactivity remained relatively stable through November 1986 at this BGS depth.

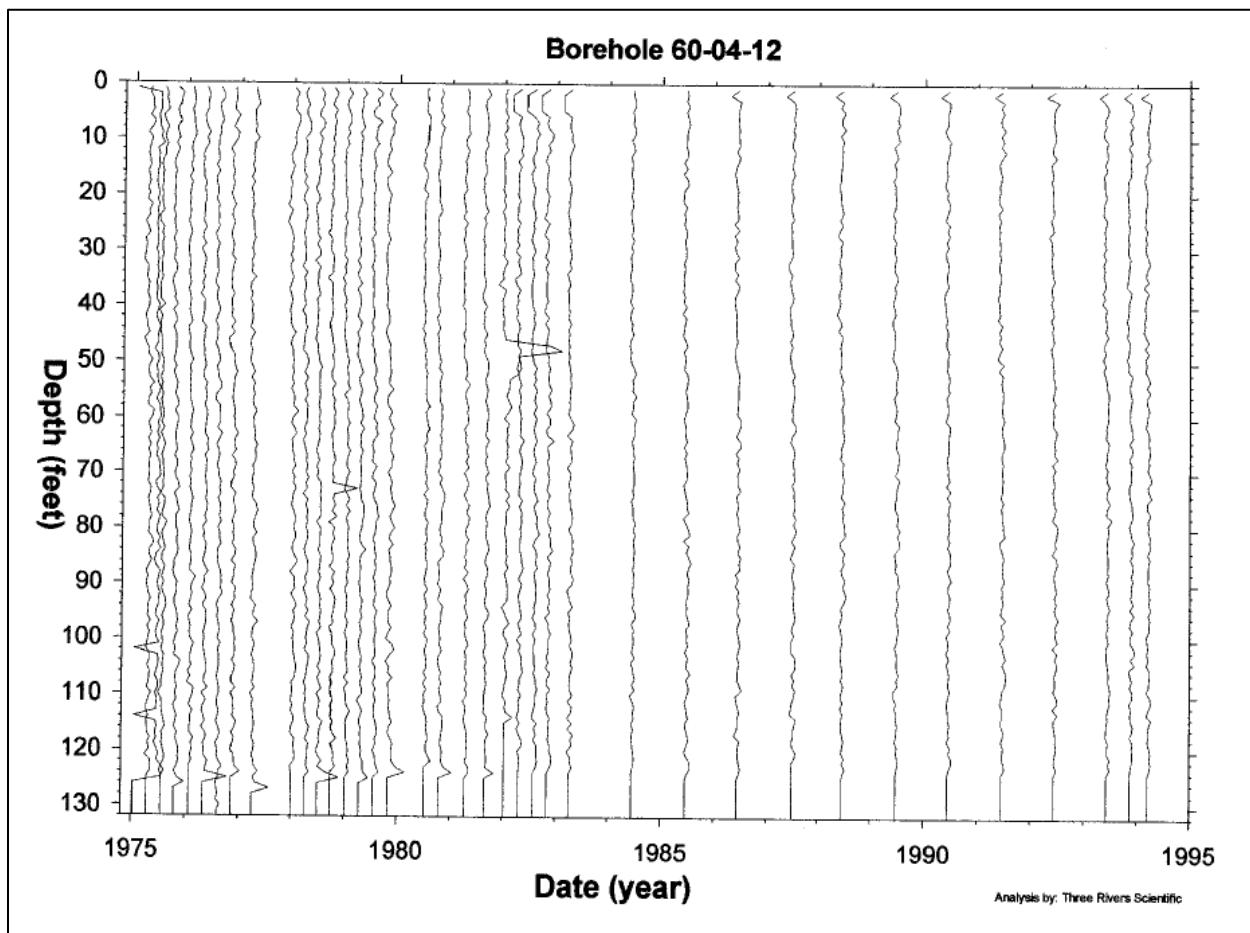
**Figure 4-11. Tank U-104 Drywell 60-04-12 (RPP-7729)**

Drywell 60-04-12 is located approximately 6.6-ft from the tank U-104 footing. Drywell 60-04-12 was drilled in 1974 with the first recoverable reading on April 18, 1974 reported as less than values (see Appendix B1). Readings continued to be reported as less than values through June 1986.

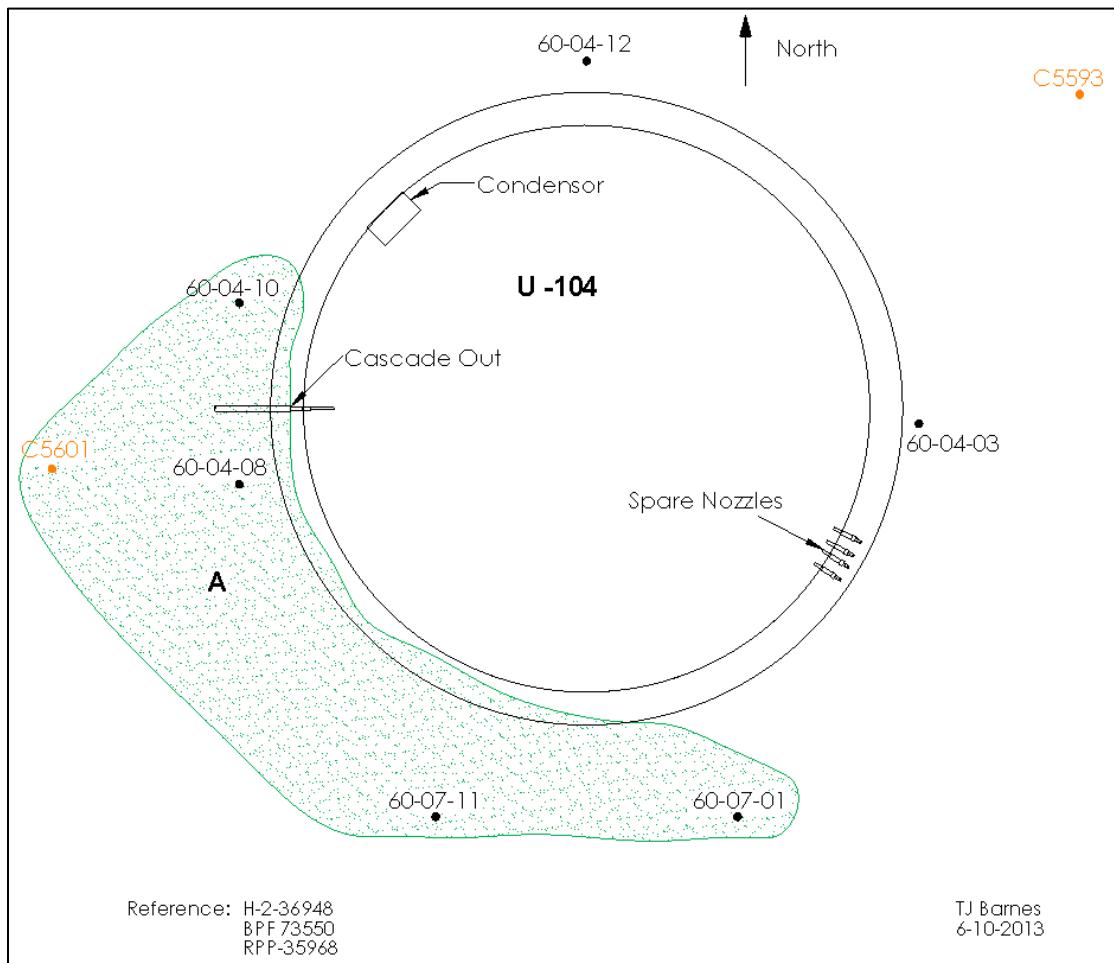
**Figure 4-12. Tank U-104 Possible Leak Location (1974-1976)**  
Tank inner ring is steel liner; outer ring is outer edge of tank footing

Tank U-104 was first suspected of leaking during sluicing operations in July 1956 (see Section 4.4.1).  
Drywells were not installed near tank U-104 until 1974.

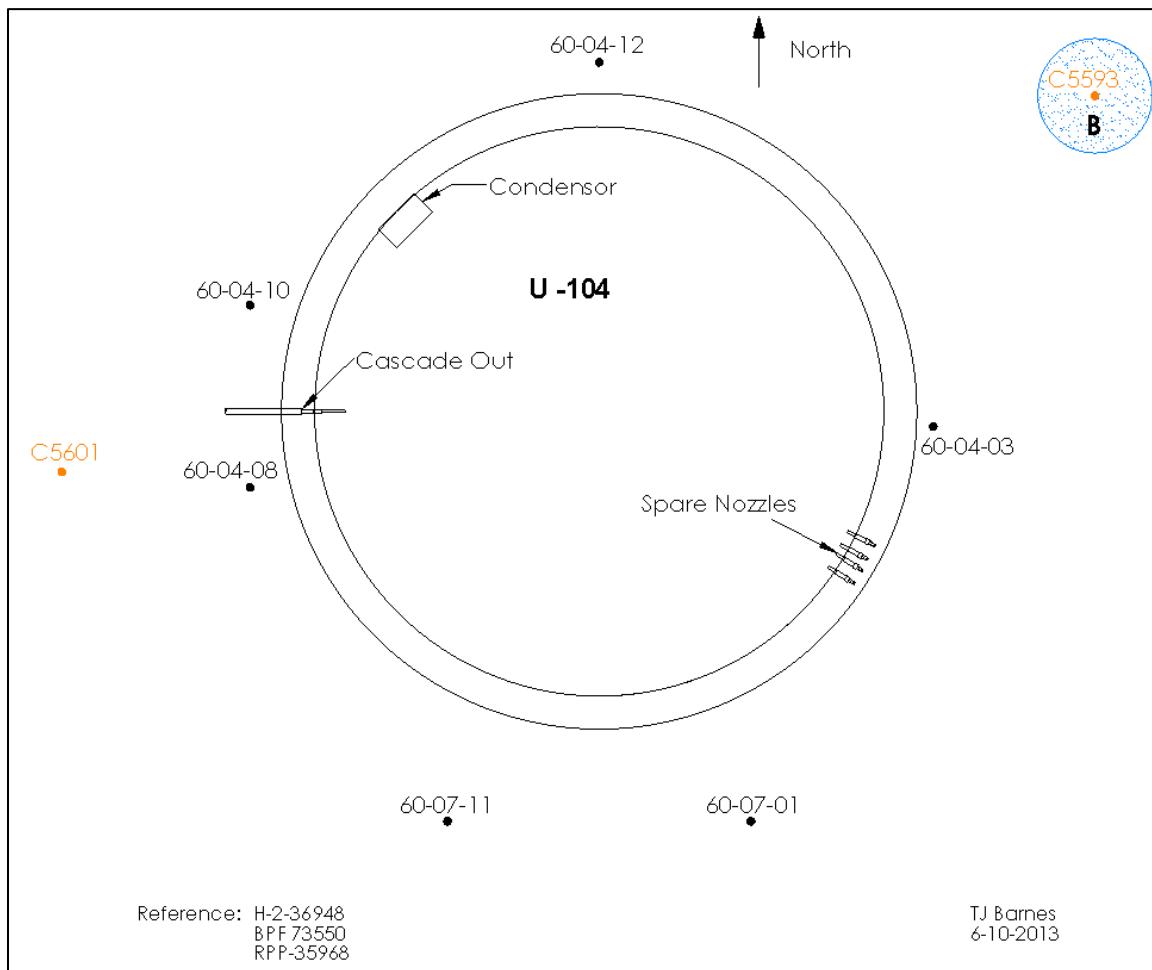
**Figure 4-13. Tank U-104 Possible Leak Location (2007)**  
Tank inner ring is steel liner; outer ring is outer edge of tank footing

Tank U-104 was first suspected of leaking during sluicing operations in July 1956 (see Section 4.4.1).  
Drywells were not installed near tank U-104 until 1974.

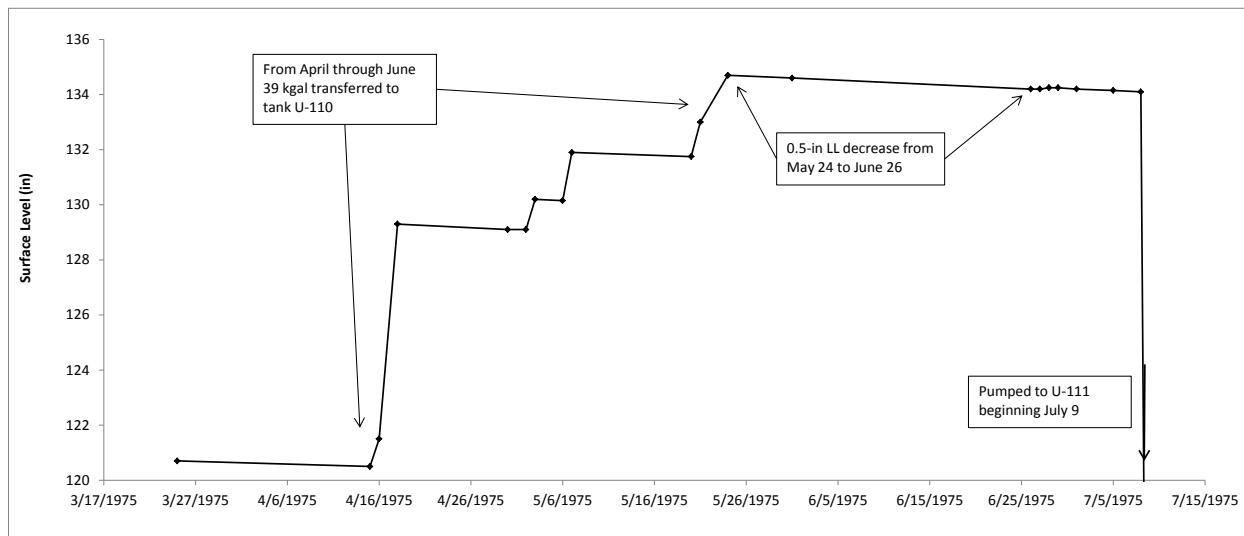
**Figure 5-4. Tank U-110 Liquid Level March 25, 1975 to July 9, 1975**

Tank U-110 was first suspected of leaking due to a 0.5-in liquid level decrease that was reported between May 24, 1975 and June 26, 1975 (OR 75-67). The last transfer before this unexplained liquid level decrease occurred in the second quarter of 1975 and a total of 39 kgal was transferred to tank U-110 (ARH-CD-336B, *Production and Waste Management Division Waste Status Summary April 1, 1975 through June 30, 1975*). The liquid level was reported to be 134.7-in on May 24, 1975 and down to 134.2-in by June 26 (see Figure 5-4). Psychometric data taken June 11, 1975, gave no assistance in explaining the liquid level drop. Photographs taken on June 26, 1975, were reported to give no additional information on the cause of the liquid level drop.

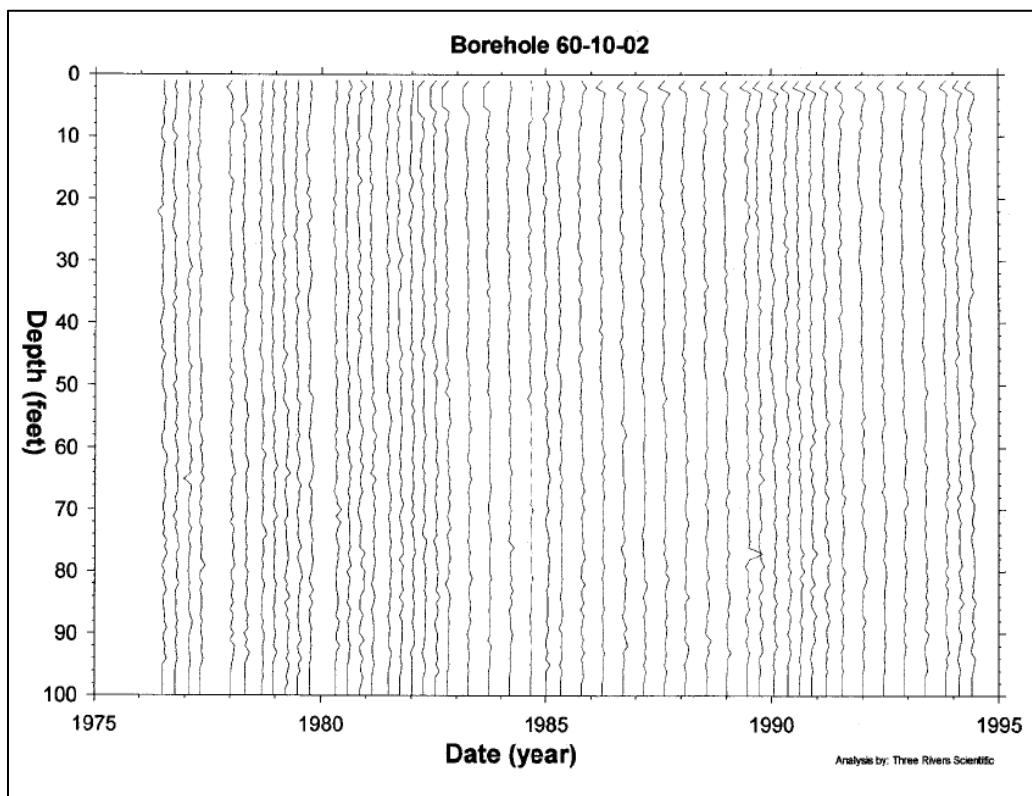
**Figure 5-6. Tank U-110 Drywell 60-10-02 (RPP-7729)**

Drywell 60-10-02 is located approximately 5-ft from the northeast side of tank U-110. Drywell 60-10-02 was drilled in 1976 with the first recoverable reading on May 12, 1976 reported as a less than value (see Appendix A2). Readings continued to be reported as less than values through September 1986.

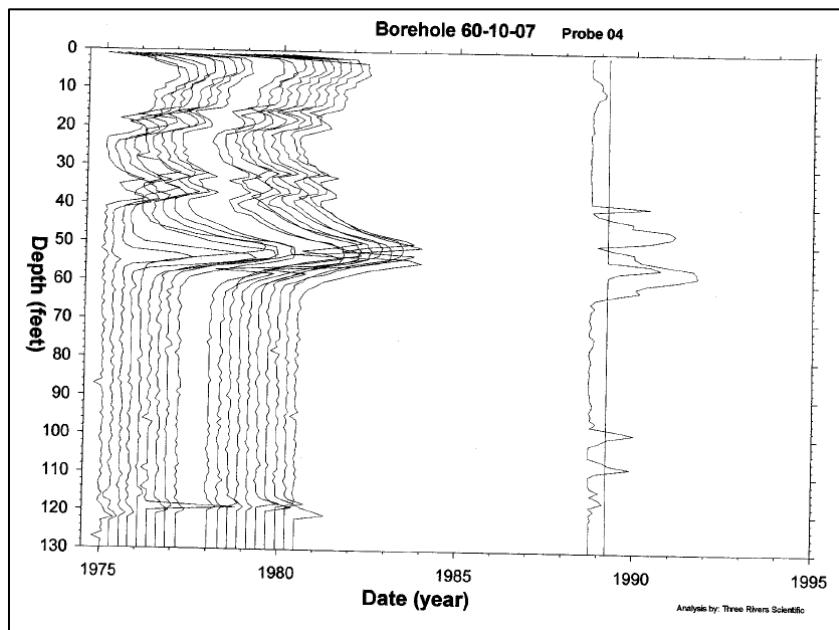
**Figure 5-9. Tank U-110 Drywell 60-10-07 NaI Probe (RPP-7729)**

Drywell 60-10-07 is located approximately 7-ft from the south southwest side of tank U-110. Drywell 60-10-07 was drilled on 1974 with the first recoverable reading on April 12, 1974 with a peak of 6.96K cpm at 33-ft BGS (see Appendix A2). The early measurements were made immediately following completion of the drywell and indicate that the contamination at this depth occurred before the detected liquid level decrease in 1975. In June 1975 radioactivity began to be detected at ~53-ft BGS and peaked near this level with increasing radioactivity even after pumping the tank.

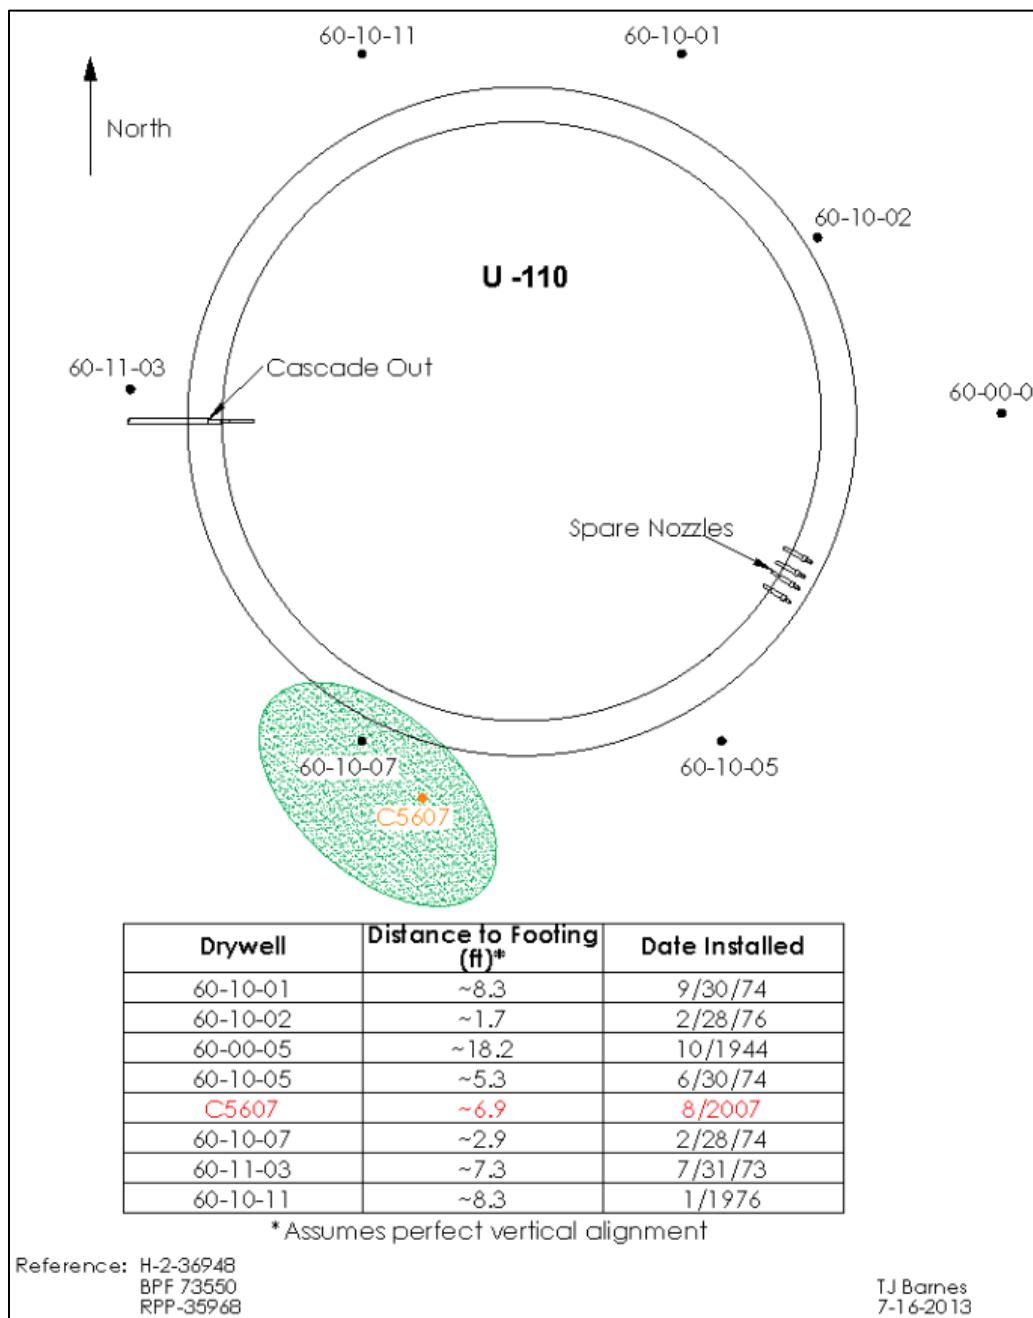
**Figure 5-17. Tank U-110 Possible Leak Location (1974-1975)**  
Tank inner ring is steel liner; outer ring is outer edge of tank footing

Tank U-110 was first suspected of leaking due to a 0.5-in liquid level decrease from May 24 to June 26, 1975, radioactivity increased in drywell 60-10-07 during this time.

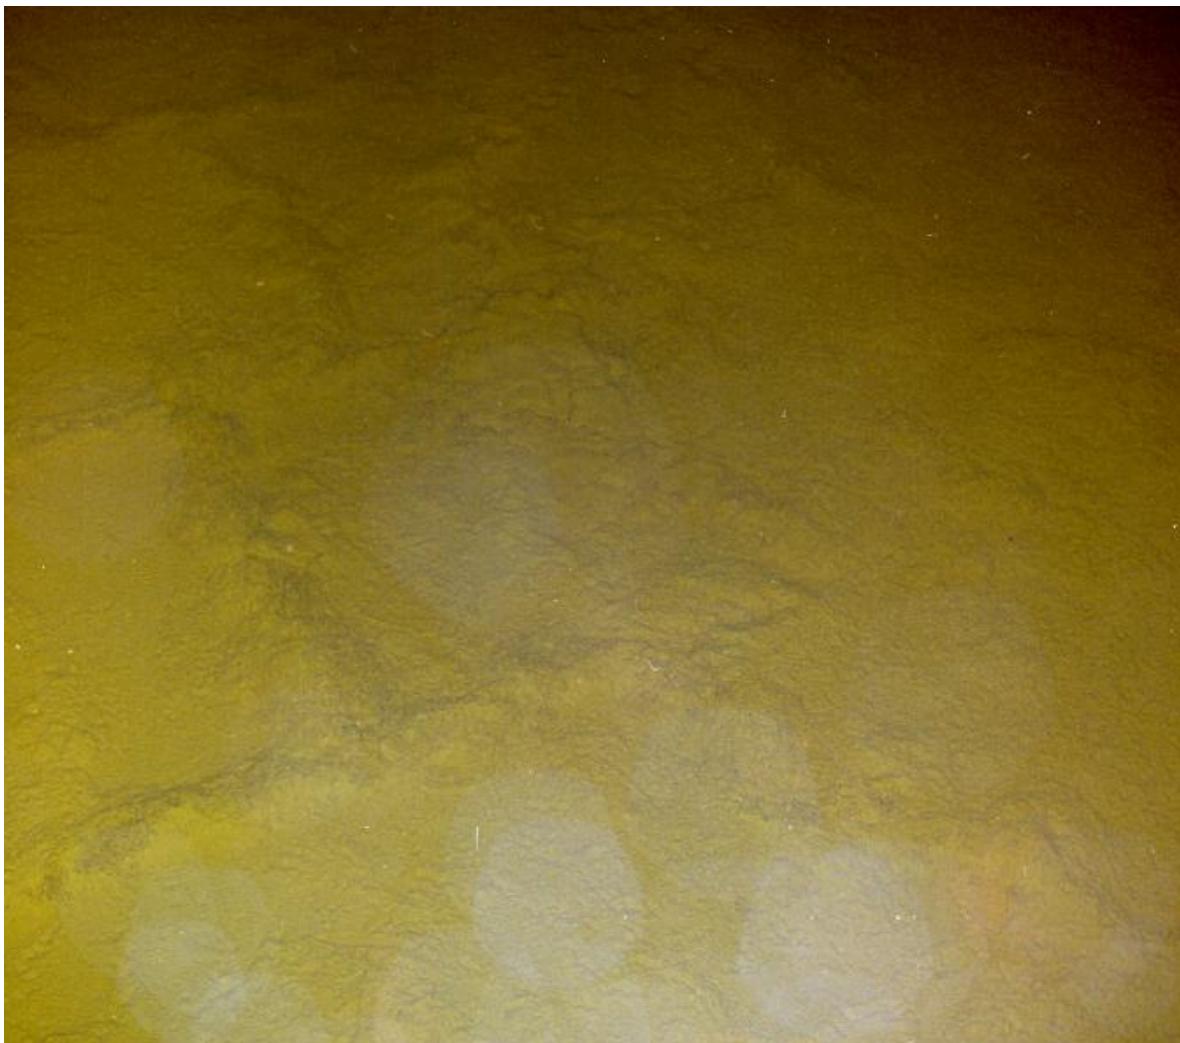
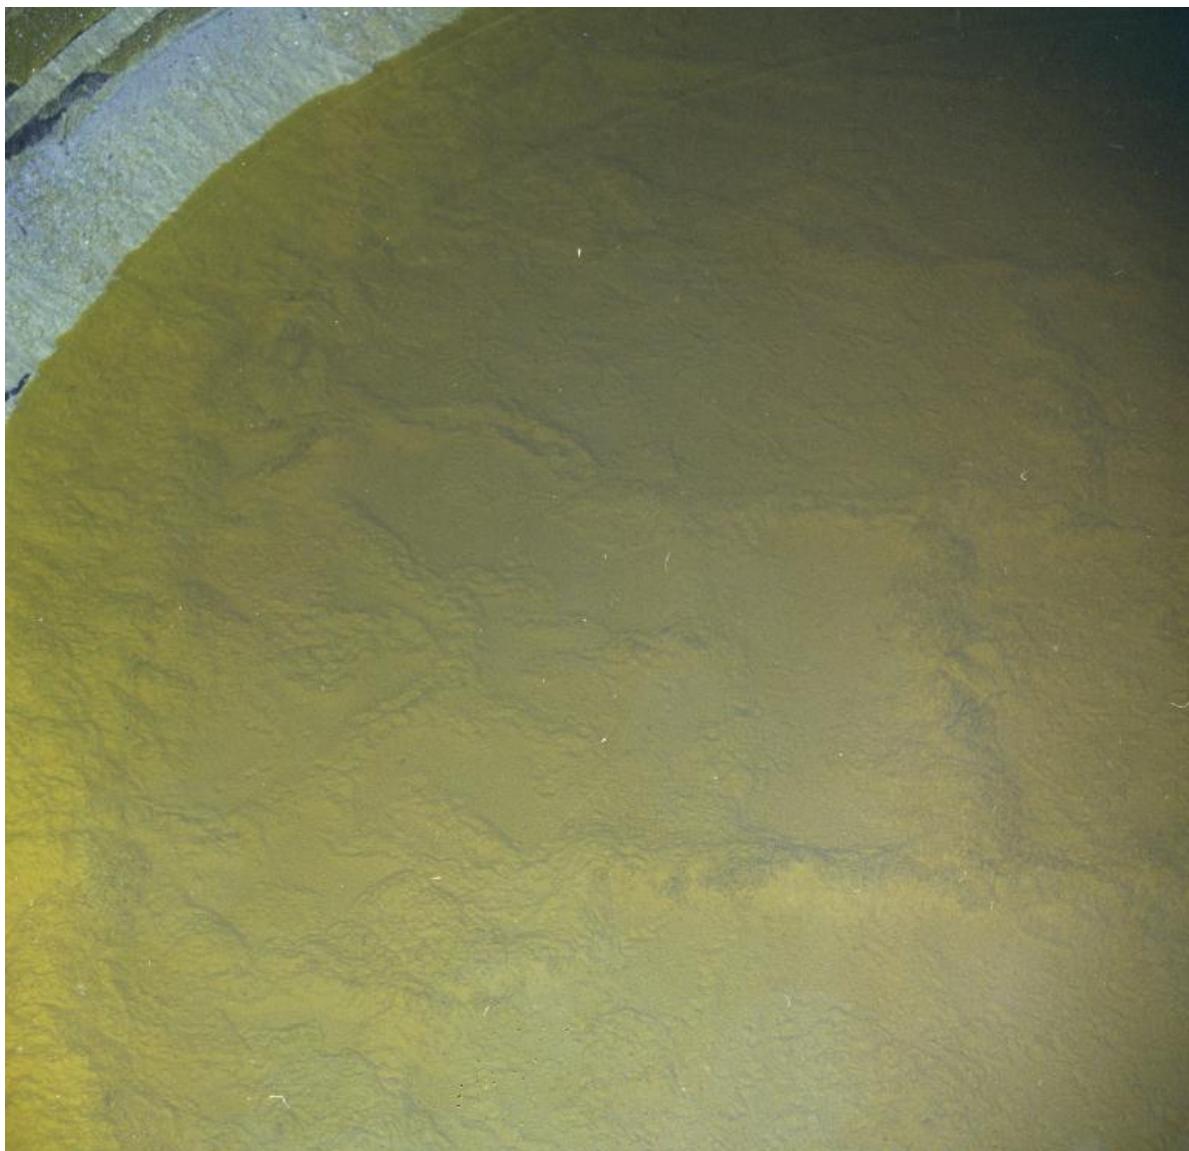
Photographs of the tank U-112 were taken on March 12, 1970 after pumping the tank to ~80 kgal with ~46 kgal of sludge. The photographs in Figure 6-6 and Figure 6-7 show a pattern of solids below the liquid surface that appears to follow plate weld lines on the bottom tank liner. This could possibly be related to deformation of the bottom plates creating stresses in the plates and welds as the weight of waste increased during filling and emptying. The 241-T Farm tanks experienced buckling of the bottom liner during construction of the tanks (see Figure 6-8) and all of the 241-T Farm tank bottom liners required replacement (HW-7-103, *Hanford Engineering Works Monthly Report April 1944*). A similar buckling of some or all of the U Farm tanks may have occurred and was either not as severe or not recognized which may have resulted in the pattern seen in Figure 6-6 and Figure 6-7 for tank U-112.

**Figure 6-6. Tank U-112 Photograph March 12, 1970  
Apparent Weld Ridge Pattern  
(701199-4CN)**

**Figure 6-7. Tank U-112 Photograph March 12, 1970**  
**Apparent Weld Ridge Pattern**  
**(701199-5CN)**
