Hanford Double-Shell Tank Inspection Annual Report - Calendar Year 2012

Hanford Double-Shell Tank Inspection Annual Report – Calendar Year 2012

T.M. Petermann
Washington River Protection Solutions, LLC

Date Published
December 2013

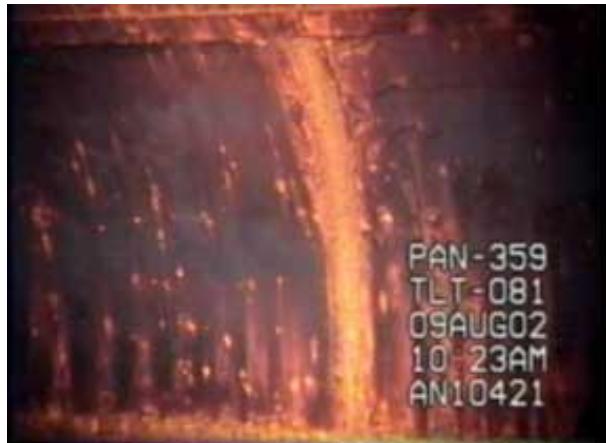
Figure 4. Tank AN-104 Dome Knuckle Bright Metal

The visual inspections of the primary tank interior found surface corrosion and light pitting on the interior dome with no cracking. There are localized areas of the dome that appear bright in the reflected light, indicating the metal may not be passivated there (Figure 4). In-tank piping and equipment are lightly corroded.

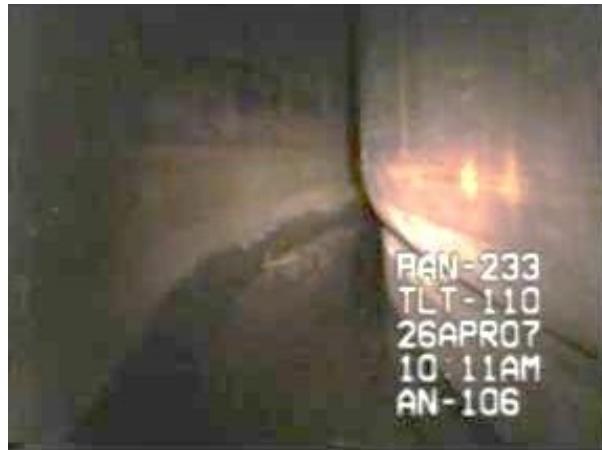
Figure 5. Tank AN-106 Annulus Floor Stain

UT couplant water has accumulated on the annulus floor and evaporated (Figure 5). Corrosion is increased in the region where the couplant water was in contact with the steel.

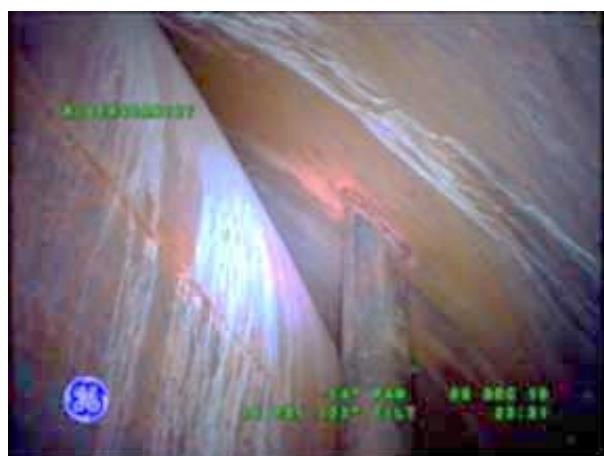
Figure 6. Tank AN-107 Top Knuckle Laitance Flow

Visual inspections were performed in 1992, 2002, 2006, and 2011. The UT inspections were performed in 1998, 2006, and 2011. There has been no change in appearance since 2002 (Figure 6).

The visual inspections of the annulus found moderate corrosion and mill scale with minor pitting. The top knuckle is covered by laitance flow. There is no degradation of the dome area, haunch, primary tank or secondary liner walls, welds, or knuckle.

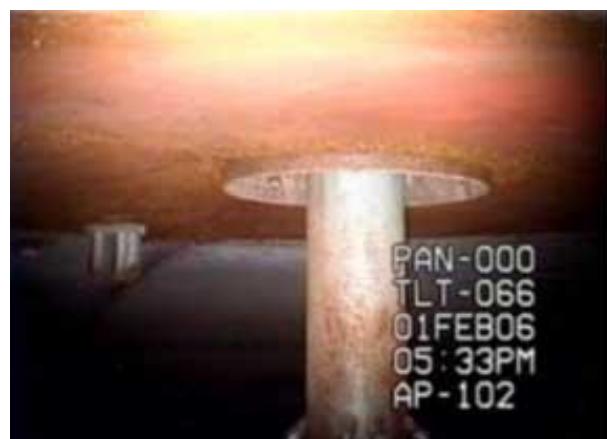
Figure 7. Tank AP-102 Dome Dollar Plate Corrosion

The visual inspections of the primary tank interior found light to moderate corrosion along the dome and top knuckle sections and no cracking. Riser penetrations through the dome are associated with the more concentrated regions of corrosion. The dome dollar plate located below the tank's central pump pit has a light layer of corrosion that is more widespread than found on other 241-AP tank dome plates (Figure 7). In-tank piping and instrumentation are lightly corroded.

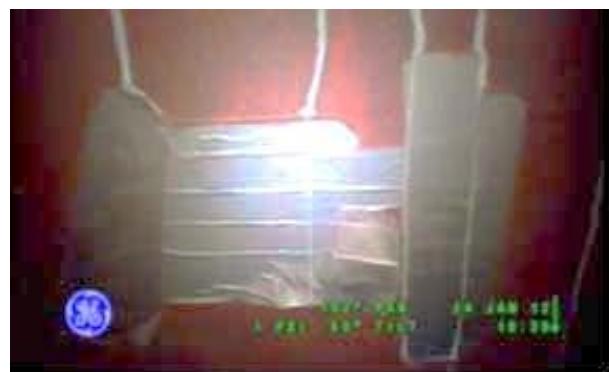
Figure 8. Tank AP-105 Tape on Annulus Wall

The visual inspections of the annulus found light corrosion. Areas of the primary tank wall are covered with strips of tape left from construction (Figure 8). These areas have shown no change in appearance between inspections. There was no degradation of the dome area, haunch, primary tank or secondary liner walls, welds, or knuckle.

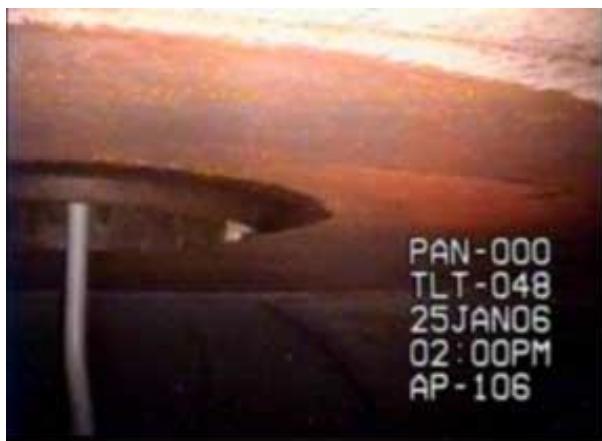
Figure 9. Tank AP-106 Dome Dollar Plate Corrosion

The visual inspections of the primary tank interior found pitting on the dome and no cracking. Corrosion appears along the dome welds and the center tank dollar plate located below the central pump pit (Figure 9).

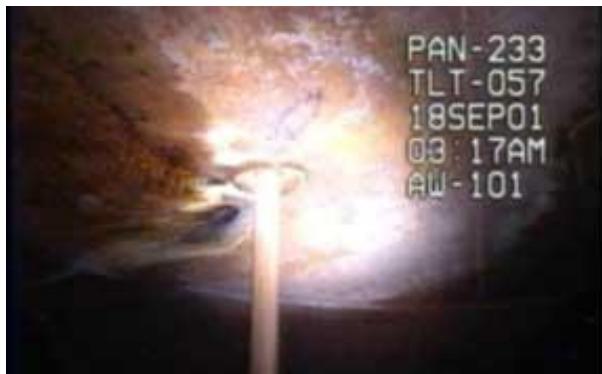
Figure 10. Tank AW-101 Dome Corrosion

The visual inspections of the primary tank interior found light corrosion. Along the top section of the tank dome, directly below the central pump pit, there is isolated corrosion (Figure 10). The likely cause is condensation or liquid from the pump pit draining from the nearest riser penetrations and repeatedly wetting the surface.

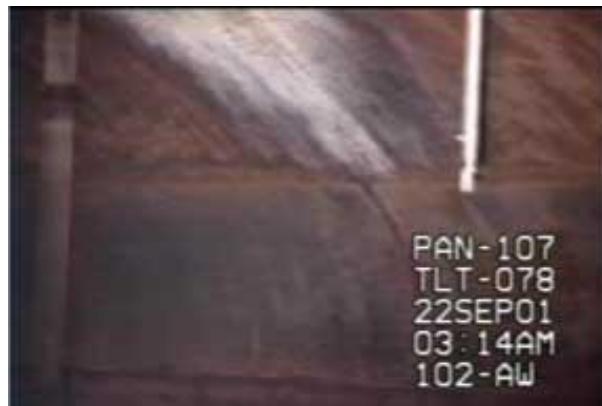
Figure 11. Tank AW-102 Dome White Deposit

The visual inspections of the primary tank interior found light corrosion on the wall. There is a white deposit originating from the central pump pit (Figure 11). The appearance of the metal surface involved with the deposit has not changed between inspections. In-tank piping and instrumentation are lightly corroded.

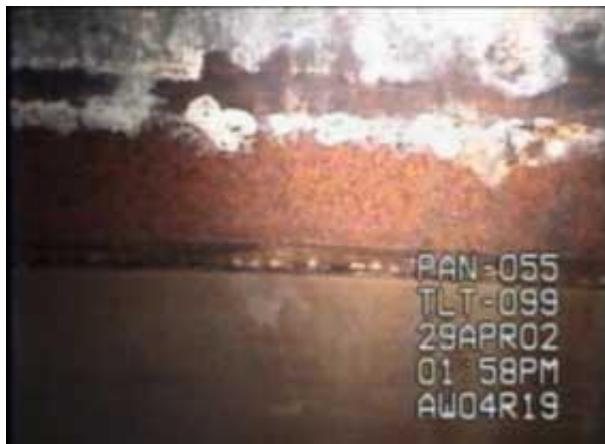
Figure 12. Tank AW-104 Dome Knuckle White Deposit

The visual inspections of the primary tank interior found surface corrosion on the dome and no cracking. The knuckle surface contains a white deposit which is not typically seen at that level (Figure 12). In-tank piping and instrumentation are lightly corroded.

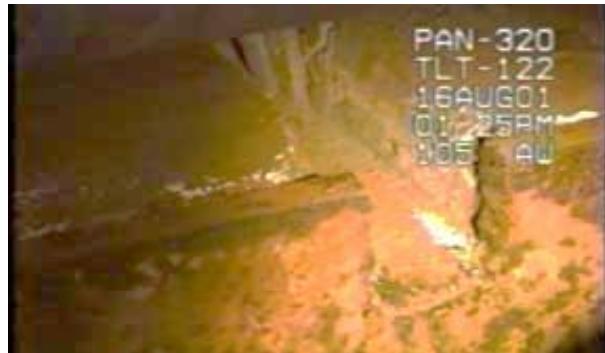
Figure 13. Tank AW-105 Refractory Degradation

The insulating refractory is cracking in multiple regions (Figure 13). Cracking is more concentrated in the illustrated area than in others. There has been no change in appearance between inspections.

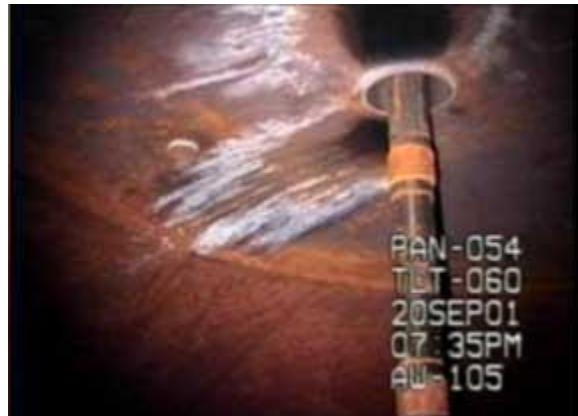
Figure 14. Tank AW-105 Dome White Deposits

The visual inspections of the interior found light surface corrosion. The top section of the dome, directly below the central pump pit, has a white deposit (Figure 14) similar to Tank AW-102 deposit. This type of deposit is visible in other DSTs in the region of the central pump pit. Its origin is typically drainage or condensation from the nearest penetrations wetting the dome surface.

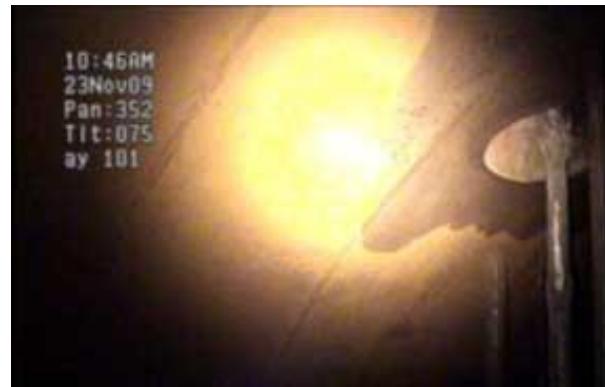
Figure 15. Tank AY-101 Dome Moisture

The visual inspections of the primary tank interior found moderate corrosion and moisture on the tank dome with no cracking. Corrosion is evident primarily in the weld heat affected zones. In 2006, the inspection showed significant amounts of condensation on the dome (Figure 15) and on walls. A water droplet was seen falling from a tank dome stain (Figure 16).

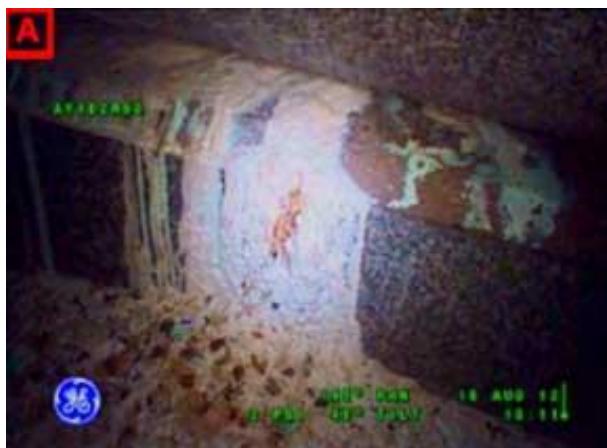
Figure 17. Tank AY-102 Tank Waste near Riser 90 in Annulus

During the 2012 annulus inspection, tank waste was discovered on the annulus floor near Riser 90 (Figure 17). Additional tank waste material was discovered on the annulus floor near Riser 83. The primary tank was declared an “assumed leaker – primary tank” in October 2012.

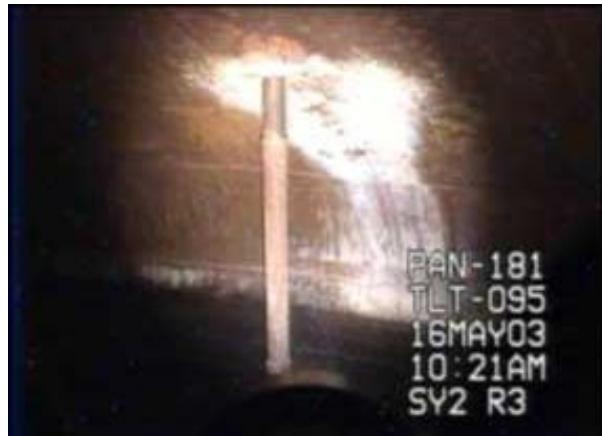
Figure 19. Tank SY-102 Dome White Deposits

The visual inspections of the primary tank interior found light corrosion on the primary tank wall. White deposits layered along the tank dome originate from a riser (Figure 19). There has been no change in appearance of this area since the first inspection in 1993.
