(6) Document Title: 241-AY-102 Leak Detection Pit Drain Line Inspection Report		(7) USQ No.: R- <input checked="" type="checkbox"/> N/A	USQ Evaluator Sign/Date

Document Number: RPP-RPT-56464, Rev 0

Purpose of Document: Report on visual inspection of 241-AY-102 Leak Detection Pit Drain Line.

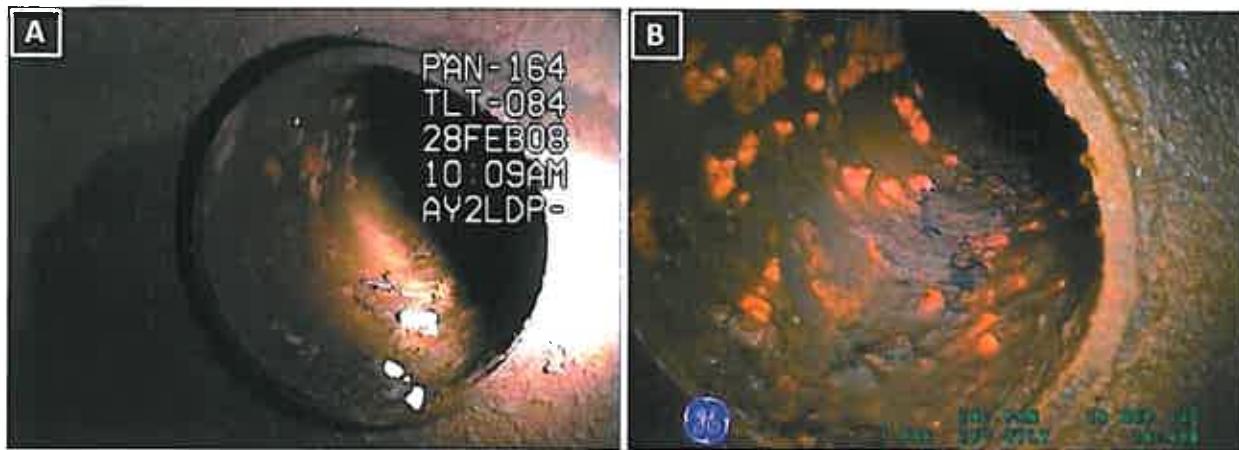
Figure 1-10 shows comparative photos of the 6-in. drain line entry into the riser from inspections done in 2008 and 2012.

Figure 1-10. Tank AY-102 Leak Detection Pit Drain Line Condition in 2008 (A) and 2012 (B)

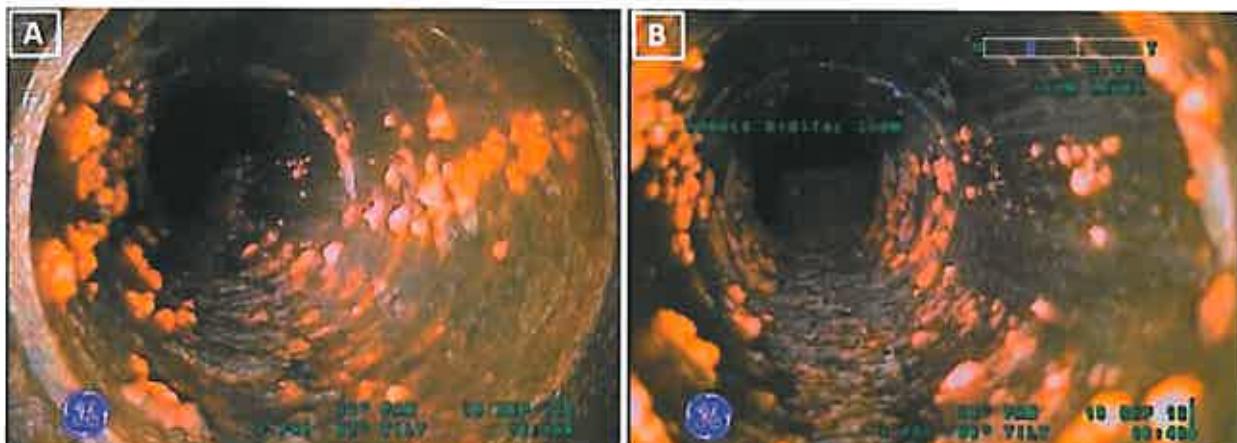
Figure 1-11 shows photos of the LDP drain line as far as access would allow during the 2012 inspection. Sediment and tubercles (formed by microbial organisms present in the LDP) are present in this section. Extensive photographs of all sections of the LDP riser and sump tank from the previous inspections are provided in RPP-RPT-55666.

Figure 1-11. Tank AY-102 Leak Detection Pit Drain Line Interior During 2012 Inspection

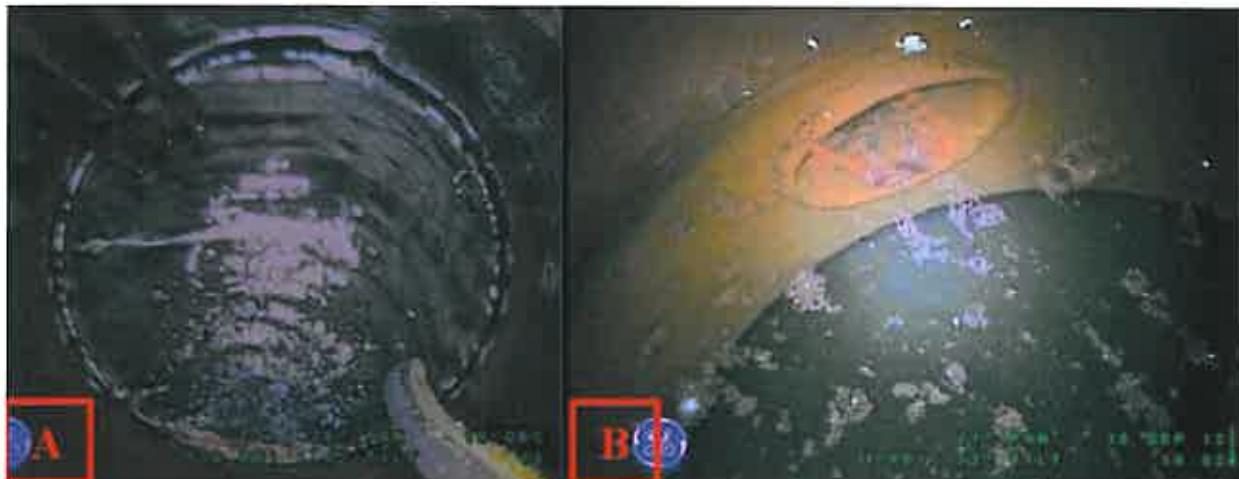
The high rate of bubbling exiting the drain line into the LDP riser is shown in Figure 1-13(A). The 6-in. drain line was barely submerged in the video. If the level rises slightly above this level (as it was in September 2012), there is no bubbling to be seen from the drain line.

Figure 1-13. Photos from Video Showing Bubbling from Drain Line on 12/19/2012 (A), Photos from Video Showing Drain Line Just Underwater and No Bubbling on 9/18/2012 (B)

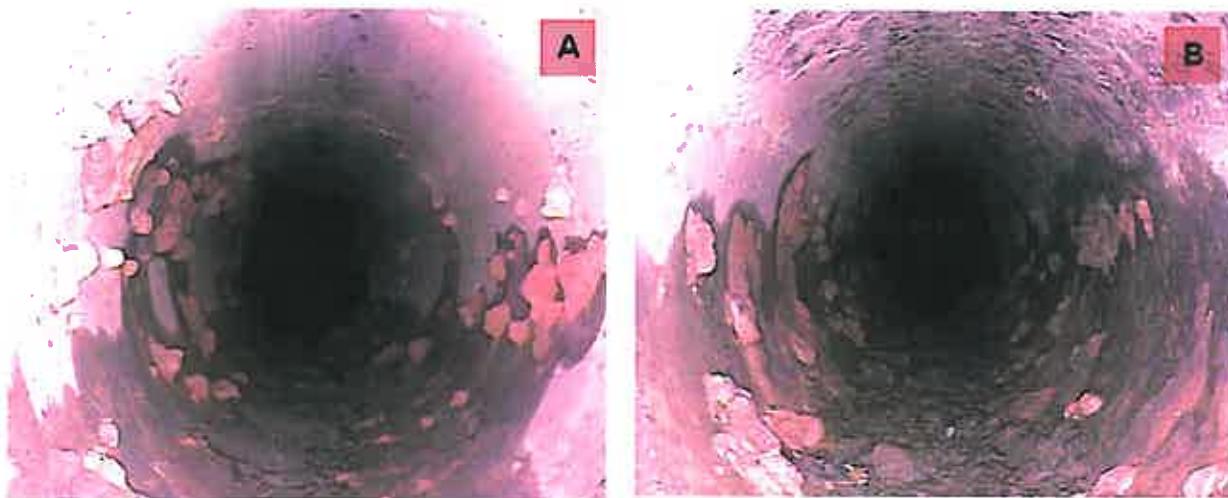
The top of the pipe was in good condition, as shown in Figure 3-3 and Figure 3-4. The amount of debris in the bottom of the pipe is similar to the 2012 inspection.

Figure 3-3. View of 6-in. Drain Line Prior to Crawler Leaving Deployment System

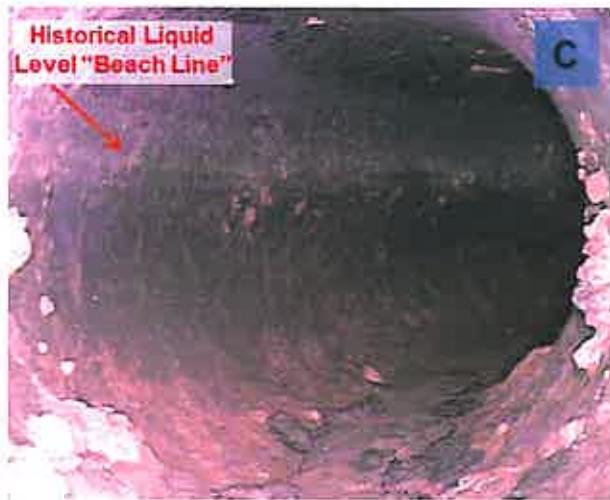
Section 2 is the first elbow of the piping expansion loop and the 4 ft of pipe between the first and second elbows. This section showed substantial wetness and corrosion debris on the bottom of the pipe. The crawler movement through this material was similar to driving through mud. A horizontal waterline consistent with the historical level in this system can be seen on the wall in Figure 3-5.

Figure 3-5. View of First Elbow Prior to Entering

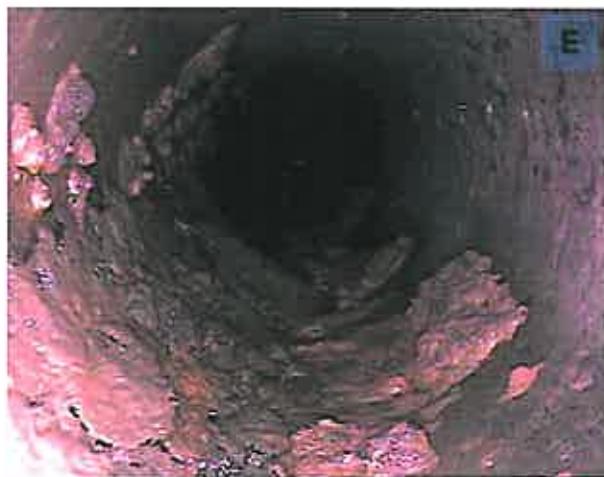
Figure 3-7 shows the straight section about halfway between the first and second elbow and also shows an increasing amount of sediment.

Figure 3-7. View of 6-in. Drain Line Part Way Between First and Second Elbow

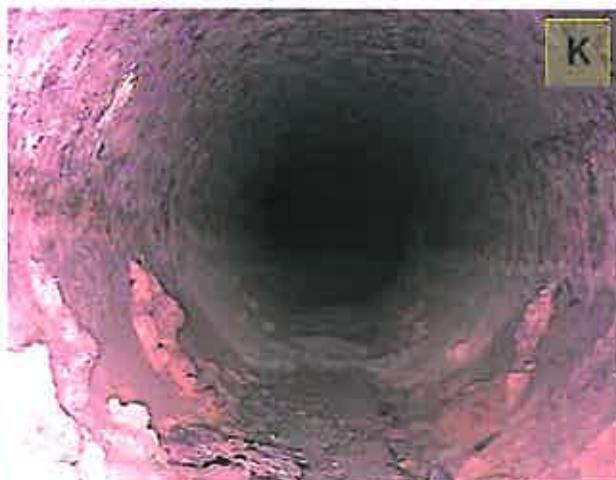
Section 4 is the third elbow of the piping expansion loop and the 4-ft long section between the third and fourth elbows. This section appears much drier than previous sections. Figure 3-11 shows considerable debris in the third elbow. There is a distinct color change from wet to dry in this section between the two elbows, as shown in Figure 3-12 and Figure 3-13. The corrosion debris on the bottom of the pipe, along with the waterline, is still evident. Traversing through this material was less challenging because crawler traction was better in the drier environment. The transition point (dark-to-light color at the bottom of the pipe) is the anticipated location of the liquid level prior to the pumping of the LDP on November 14, 2013.

Figure 3-13. View of Region Downstream of Third Elbow (a distinct color change, perhaps a transition to a completely dry region)

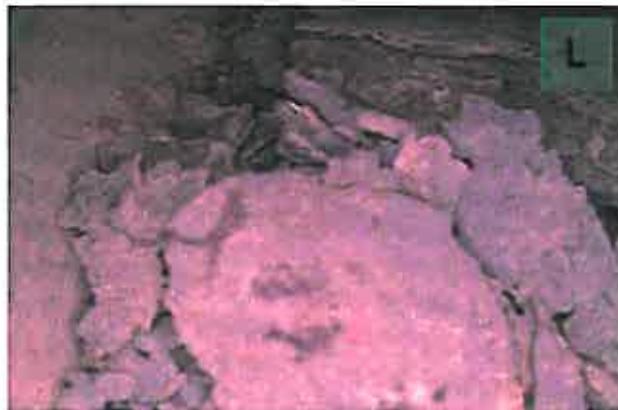
Figure 3-14. View of Debris on the Bottom of the Drain Line Just Prior to Entering Fourth Elbow (very dry)

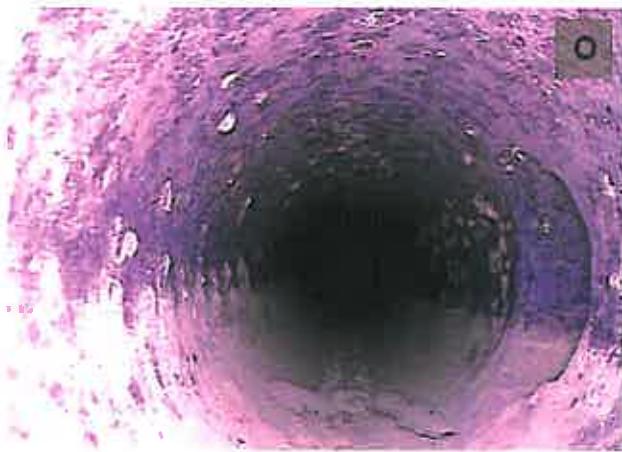
The legacy stain from the waterline can be seen on the bottom third of the tee (Figure 3-17). Camera operability at this section of the drain line was limited, so additional views looking up into the tee 4-in. drain line were not performed. However, since the views gathered of the 4-in. branch connection were dry, this observation supports the conclusion that no liquid has recently traversed through the 4-in. line and into the 6-in. drain line. These features are shown in Figure 3-17 through Figure 3-19. Some of the debris in Figure 3-18 appears to be from construction (e.g., wood fragments).

Figure 3-17. View of 4-in. Tee Entering the Side of the 6-in. Drain Line

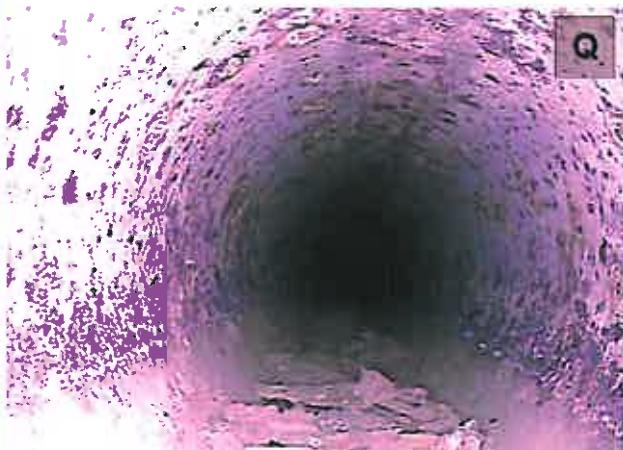
Figure 3-19. View of Debris on the
Bottom of the Drain Line
(about 2 ft from second tee)

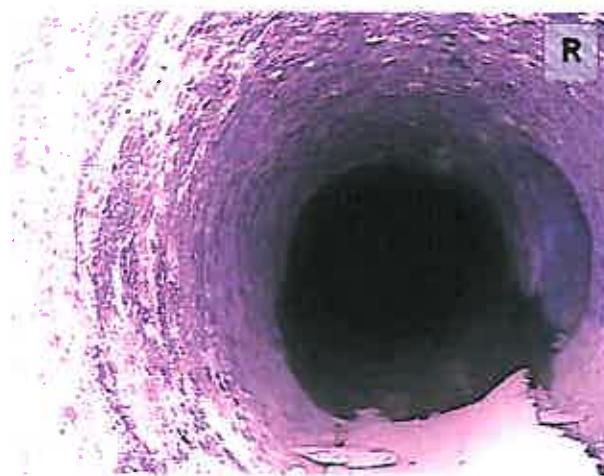
Section 7 begins at the second tee and extends about 6 feet toward the center drain. Moisture accumulation begins immediately after the second 4-in. tee, as seen in Figure 3-20. The moisture is seen to cover the entire inner surface of the drain line pipe as the crawler traverses further from the second tee. This region of the drain line was not in contact with liquid from the LDP sump during the previous pumping evolution.

Figure 3-20. View of Moisture Seen after Second 4-in. Tee

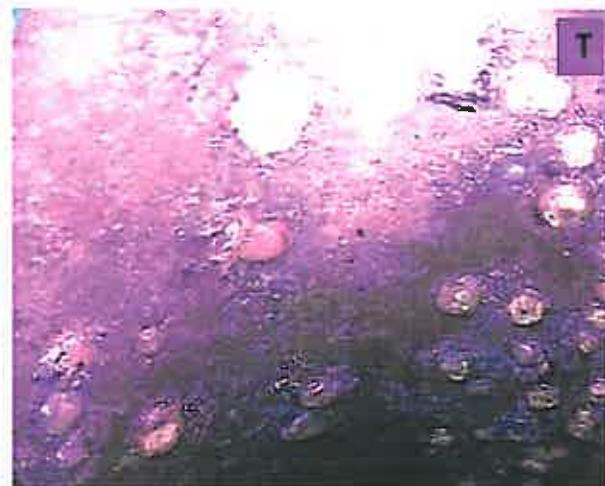
The 4-in. drain line from the second tee is dry and shows dry sediment in the bottom, similar to the first tee. This sediment may be blow sand or construction debris left in the system from construction. Debris and corrosion product were visible on the bottom of the 6-in. line (see Figure 3-21). As the crawler entered the moist region after the second tee, corrosion and tubercles were present again, indicating that this region has seen increased moisture over a long period of time. This corrosion formation and the condition of a section of the pipe sidewall can be seen in Figure 3-22.

Figure 3-22. View of Corrosion Along 6-in. Drain Line (in region where moisture was seen after second tee)

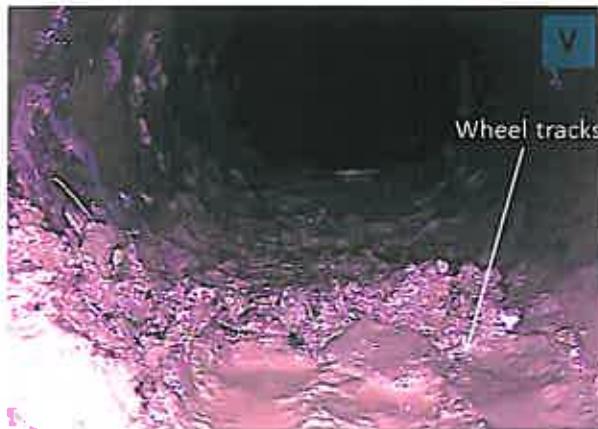
The crawler was reversed back and forth multiple times trying to make further progress. It is about 20 feet from the second tee to the center of the tank, and the crawler progressed about 13 feet beyond the second tee, stopping about 7 feet from the center of the tank. Figure 3-24 shows the wheel tracks left by the crawler's attempts to push through the mud in the drain line. These tracks delineate the extent of progress of the crawler into the drain line.

Figure 3-24. Partial View of the Saturated Debris on the Bottom of the Drain Line, Which Stopped Crawler Progress (approximately 7 ft from center of the tank)

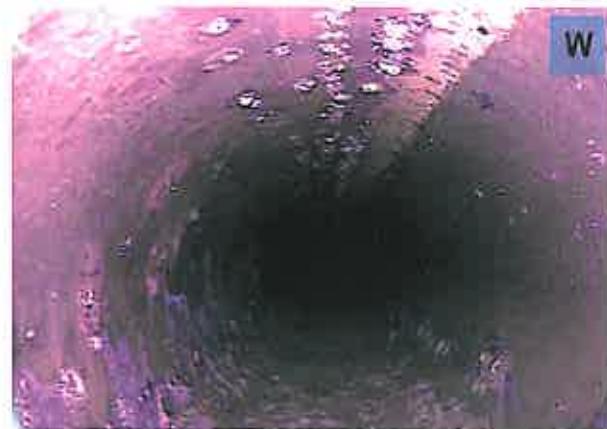
Figure 3-25. Last View Looking Down 6-in. Drain Line (approximately 7 ft from center of the tank)

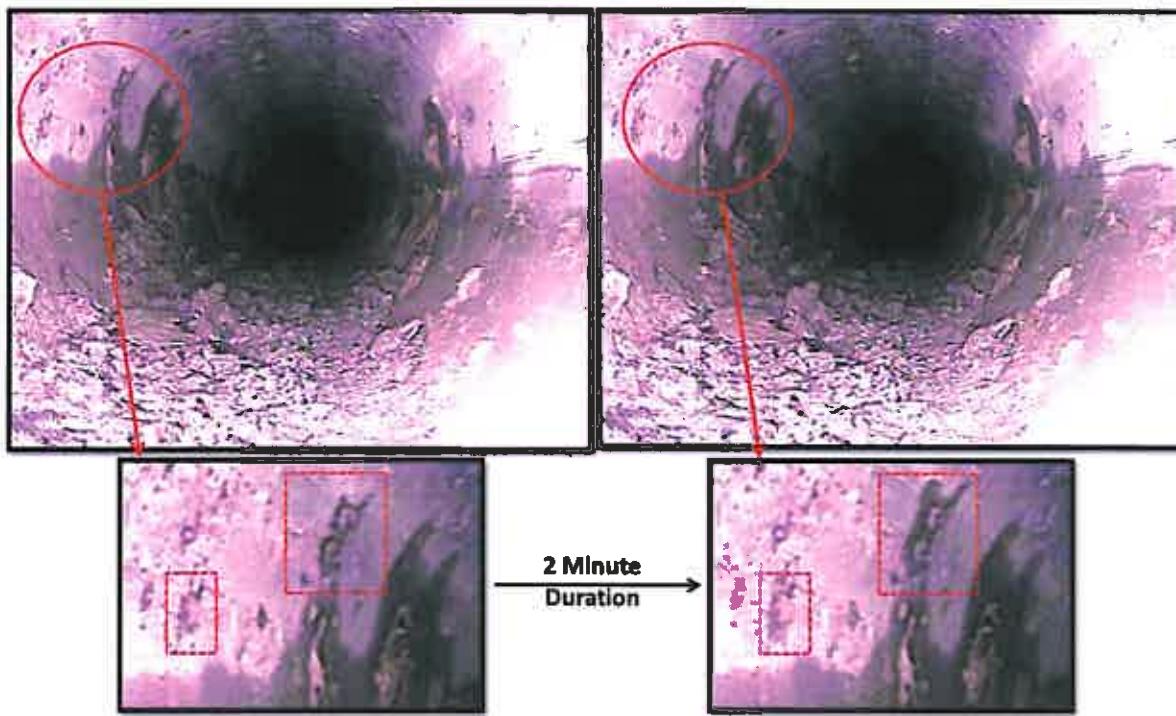
As seen in Figure 3-26, over a span of two minutes, the moisture had begun to rewet the pipe wall in a direction traveling towards the top of the pipe. Although this location is near a weld, the most probable explanation of this observation is that the tubercles themselves contain moisture and when disturbed and/or slowly over time, they release this moisture into the surrounding regions. This conclusion is supported by the view of the drain line prior to the crawler entering (see Figure 3-3), where the existing tubercles have isolated areas of moisture around them.

Figure 3-26. Water Movement from Wall Debris in the Drain Line

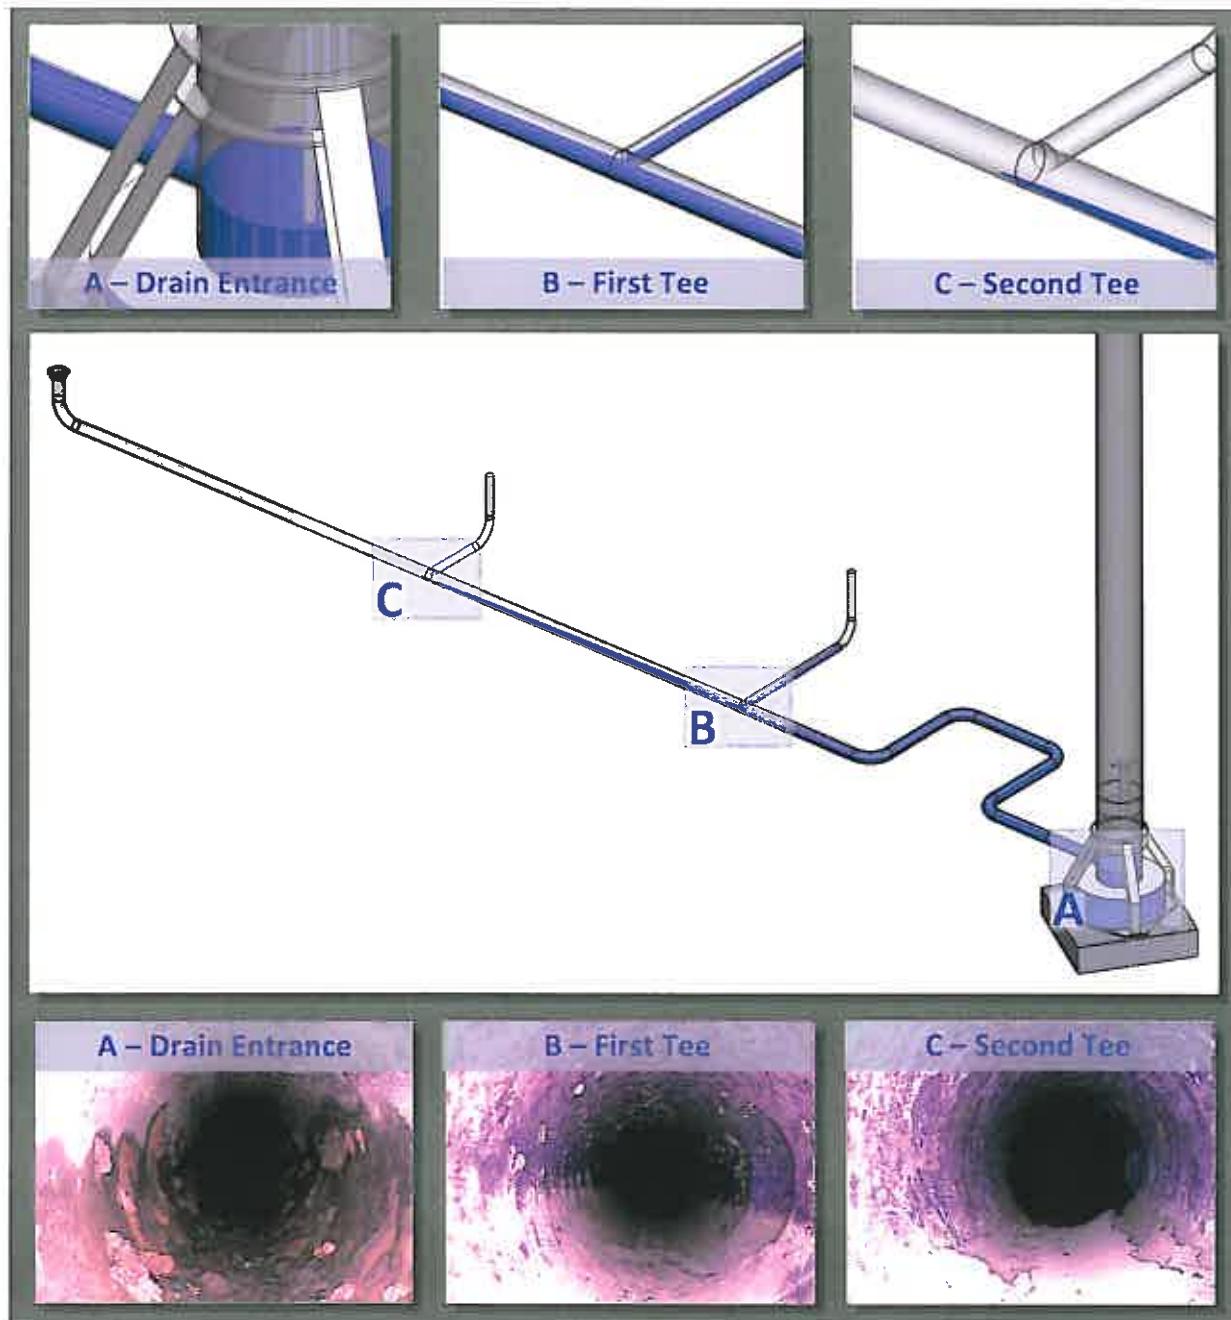
Farther up the drain line, at the first tee (Figure 3-28, Item B), the historical water level represents just under half of the pipe being filled with stagnant liquid for extended durations. The waterlines discovered during the visual inspection support this and show evidence of water filling part of the first branch of the drain line.

Figure 3-28. Stagnant Water High Water Mark Overview
