# **Survey of Transport Airplane Structural Repairs and Alterations: Survey & Teardown Final Results**

**2011 Aircraft Airworthiness & Sustainment Conference**

**April 20, 2011**

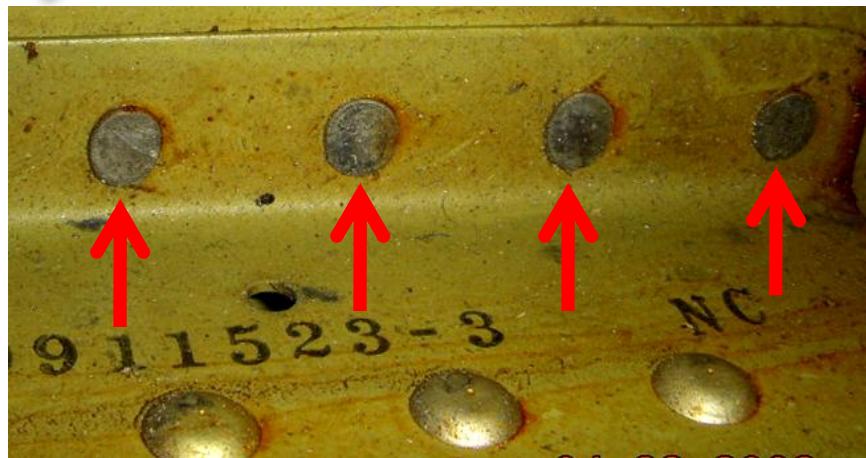
Fasteners installed in Chem-mil skin step

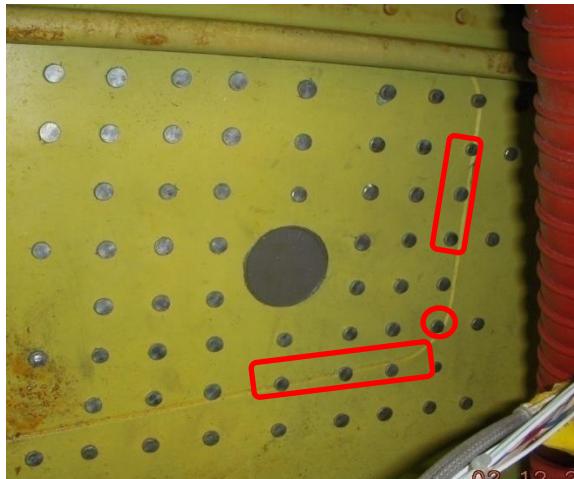
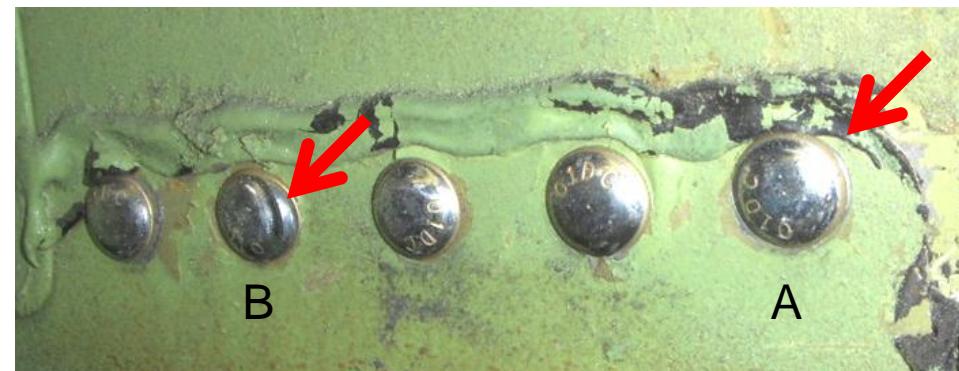
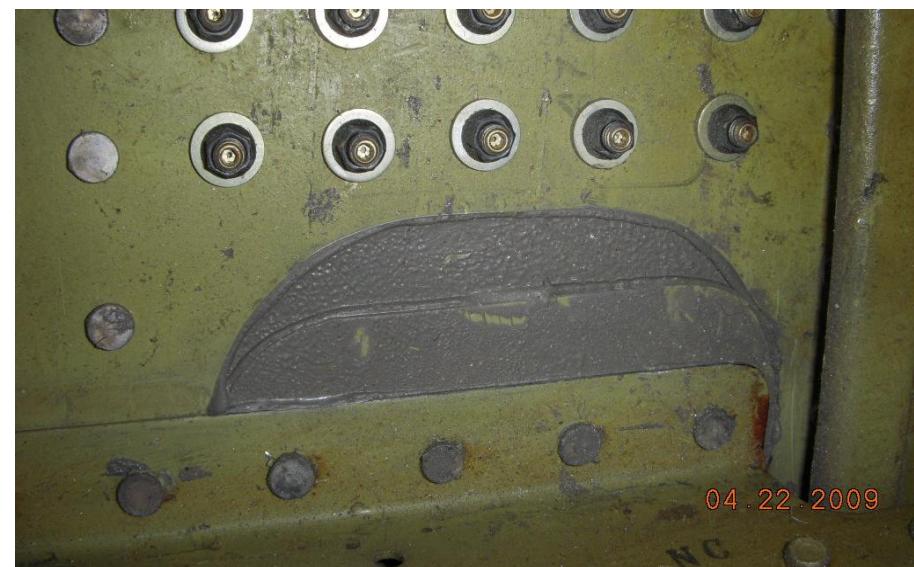
Missing filler and field fasteners required per repair drawing

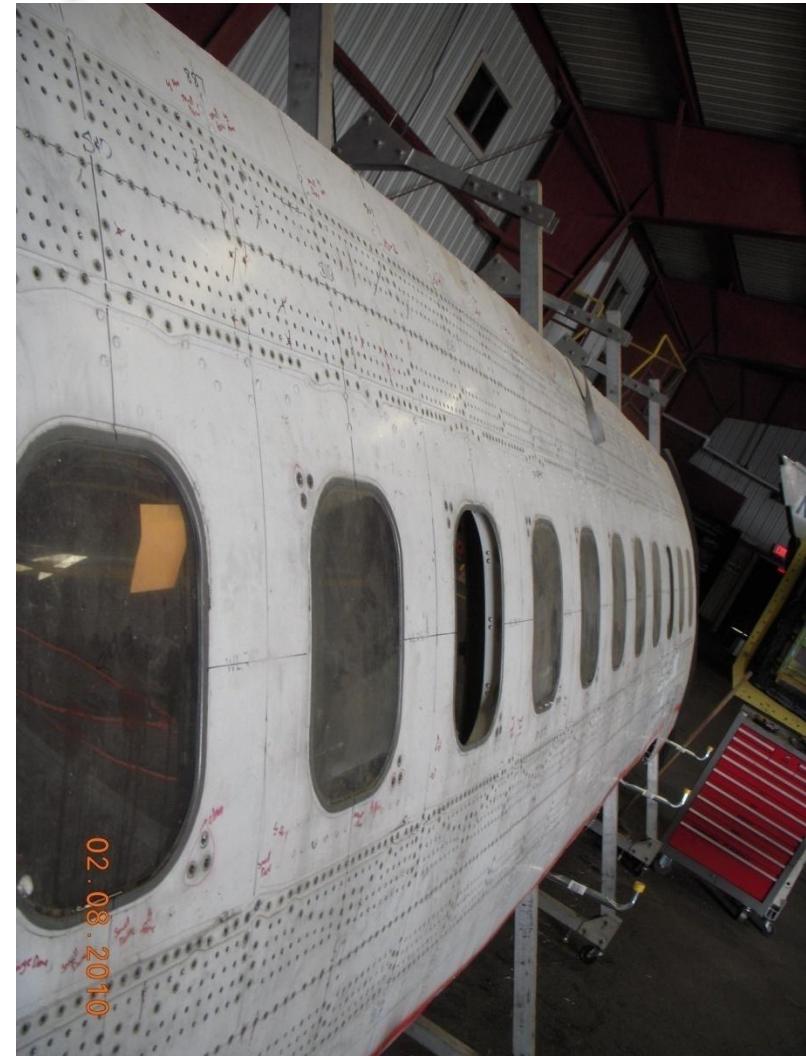
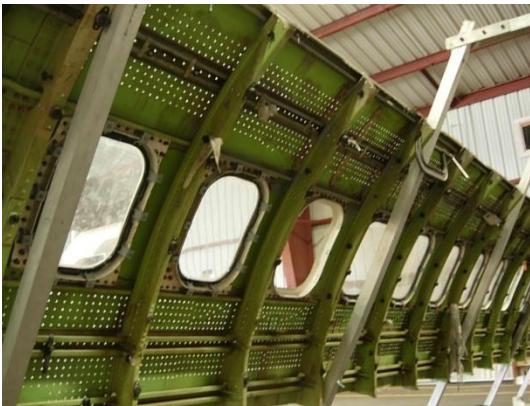
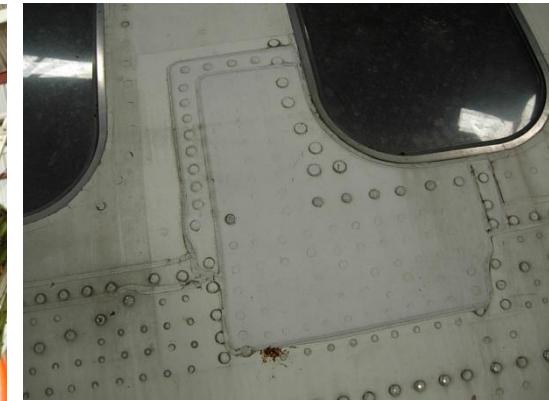
## B737-200 Fuselage Sections (2) Window Belt Replacement Lap Joint Modification Specimen 1&2

- Teardown and Inspection complete
- BS-727-907, S-10L-14L & S-10R-14R
- Modified structure has 35255 cycles since installation and 86436 total cycles at retirement

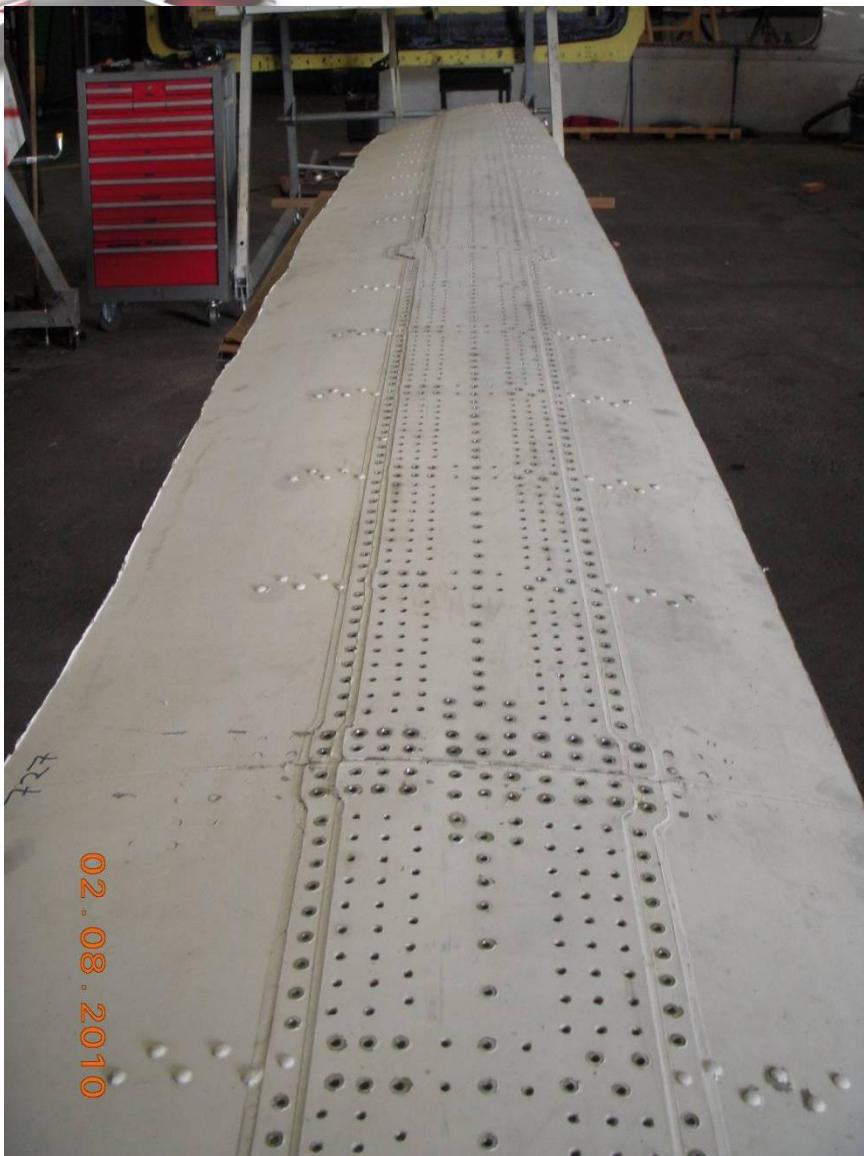
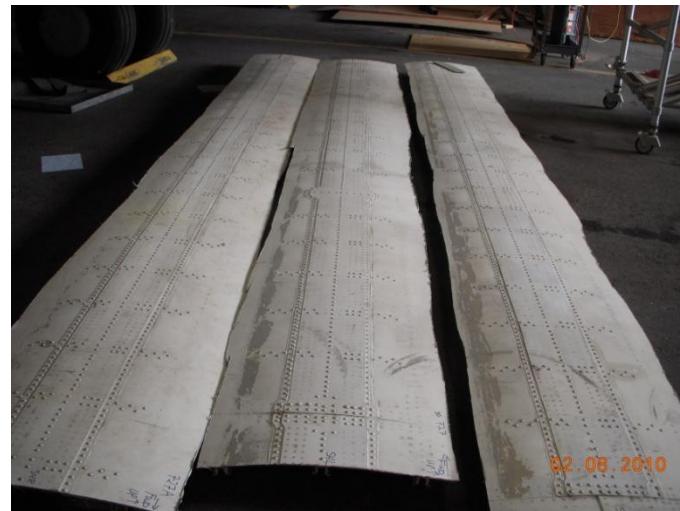
# B737-200 Fuselage Sections (4) Crown Skin Lap Joint Modification Specimens 3 & 4

- Teardown and Inspection complete
- Modified structure has 35255 cycles since installation and 86436 total cycles at retirement
- BS-540-907 S-4L & S-4R

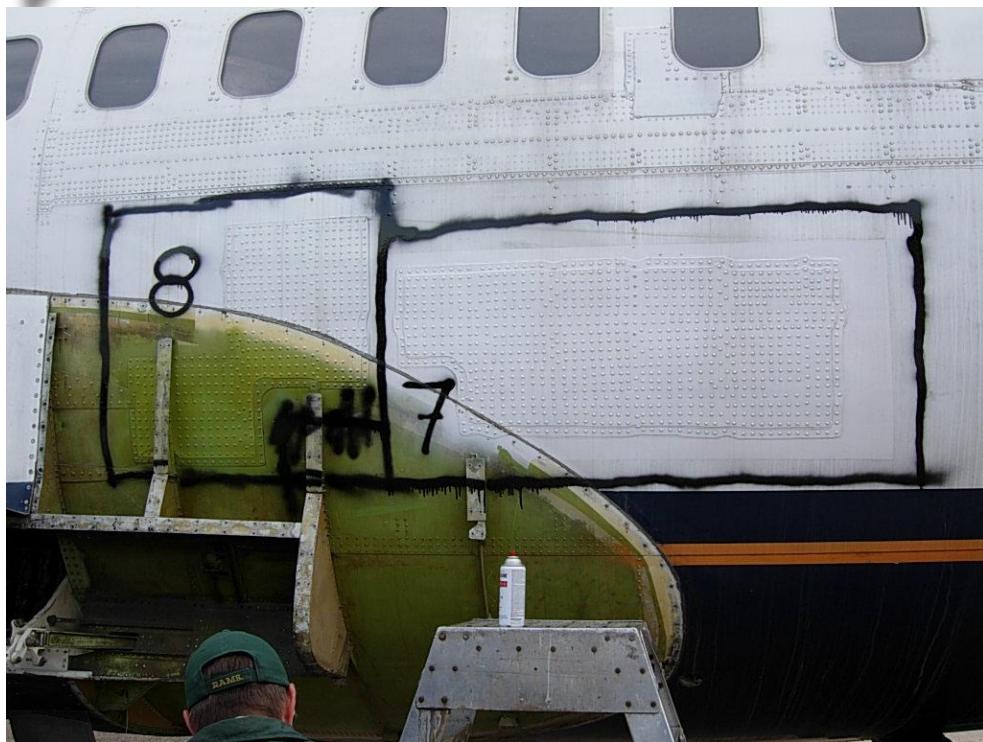
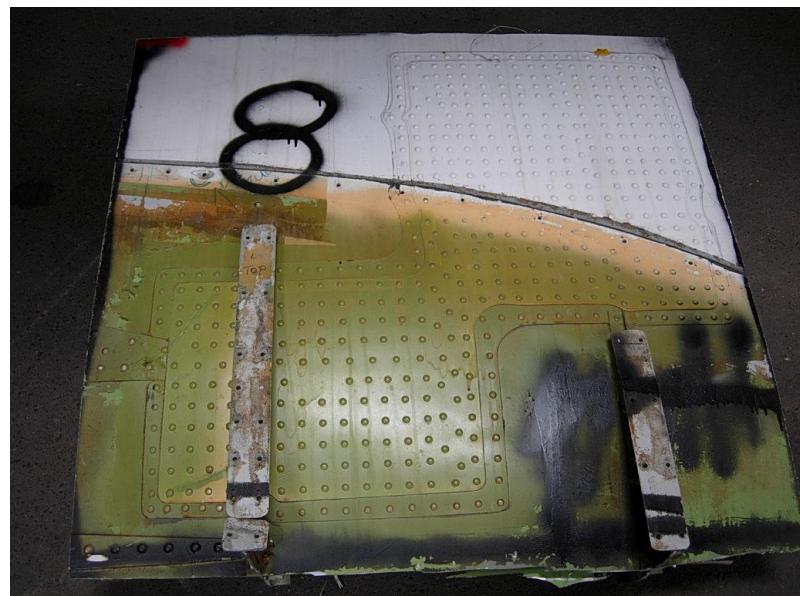
# B737-230 fuselage sections – Skin Repair Patch LR8

- Fuselage skin repairs at BS-747, S-14L-19L
- Repaired at 70109 cycles (est.)
- Airplane retired at 86436 total cycles
- 16327 Cycles (est.) on repaired structure
- Repair of skin crack at BS-727A+14 above S-17L.
- Repair incorporates 2 existing repairs which were removed.

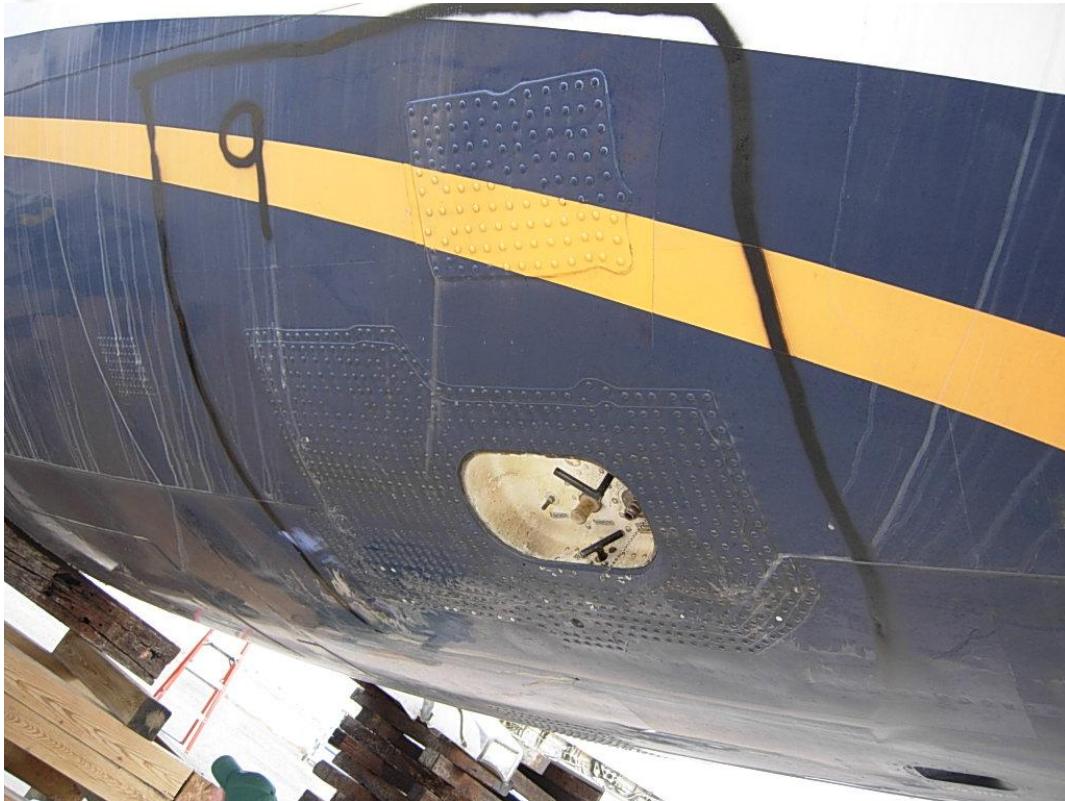
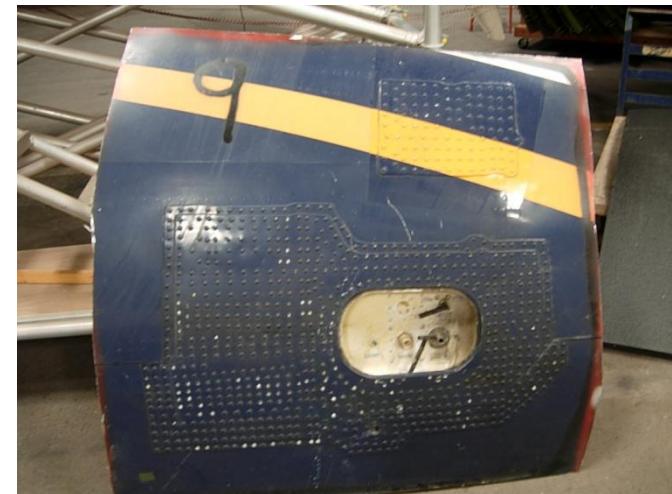
# B737-230 fuselage sections – Skin Repair Patch LR9

- Large fuselage skin repair at BS-967, S-25L forward side of water panel cutout
- Repaired at 53009 cycles (4/18/01)
- Airplane retired at 86436 total cycles
- 33427 Cycles on repaired structure
- Two adjacent repairs
- Older, small repair nearby at B- 942 S-24L (5/30/00) (estimated 48946 cycles at repair)

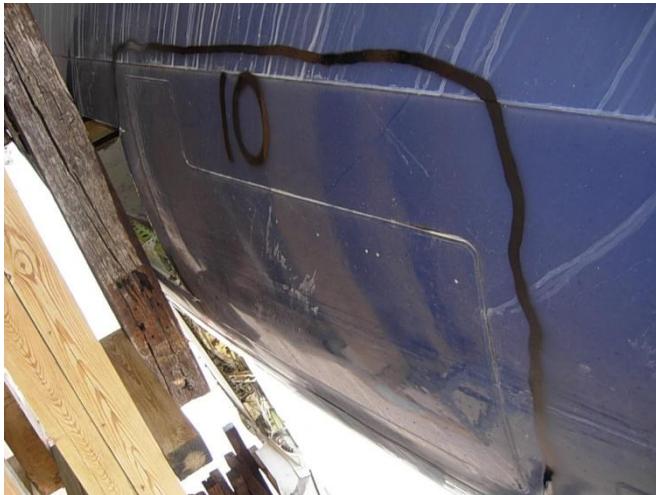
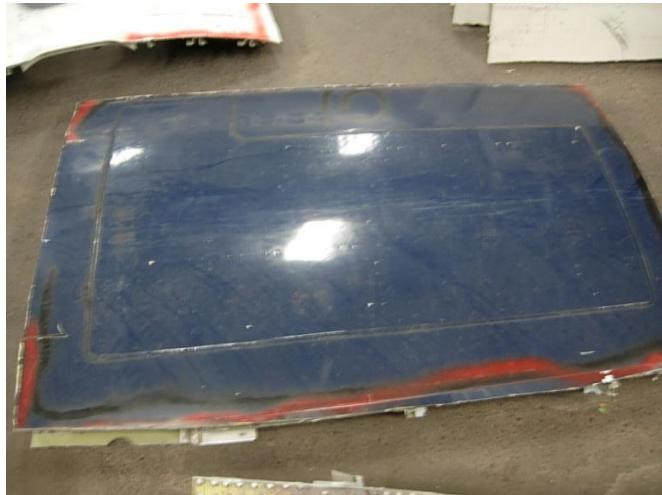
# B737-230 fuselage sections – Skin Repair Patch LR10

- Fuselage skin repairs at BS-807-867, S-26L-26R
- Repaired at 53447 cycles (est.)
- Airplane retired at 86436 total cycles
- 32989 Cycles on repaired structure (est.)
- Multiple co-located repairs
- Larger Repair possibly encompasses older small repair
