# LDRI Orbiter Inspection System

# Motivation

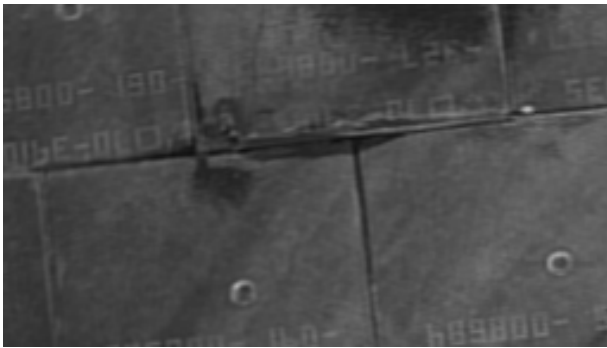
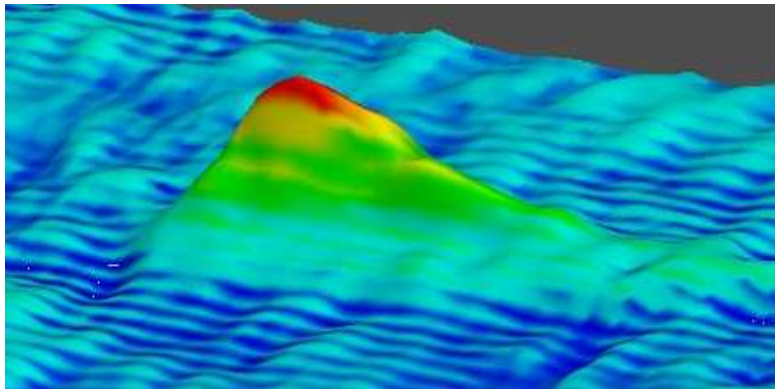
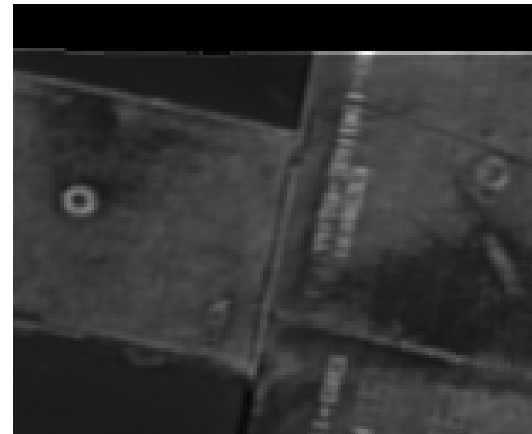
# STS-114

- Two pieces of gap filler loosened and were removed prior to re-entry

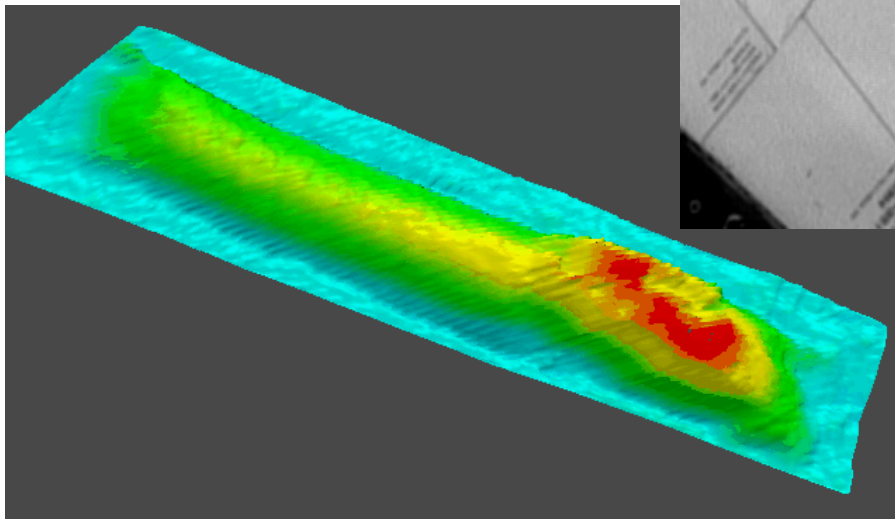
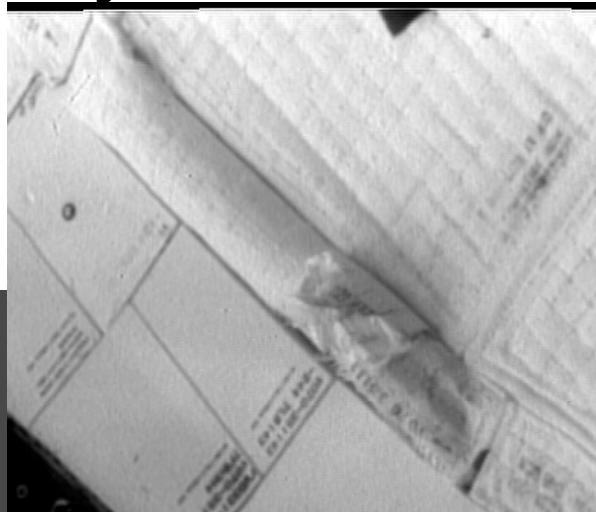
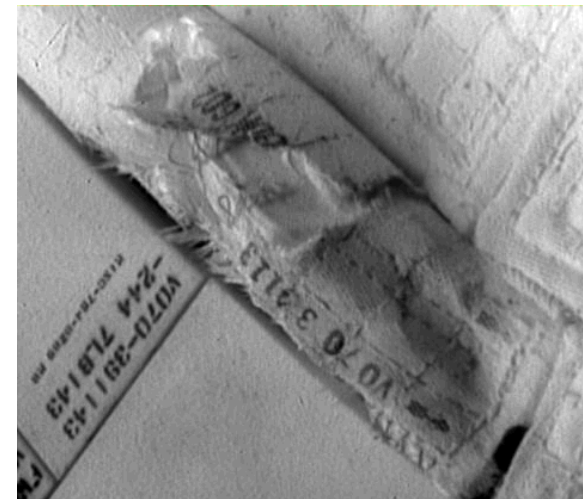
# STS-114

- TPS Blanket billowed out due to MMOD strike
- Cleared for re-entry as-is

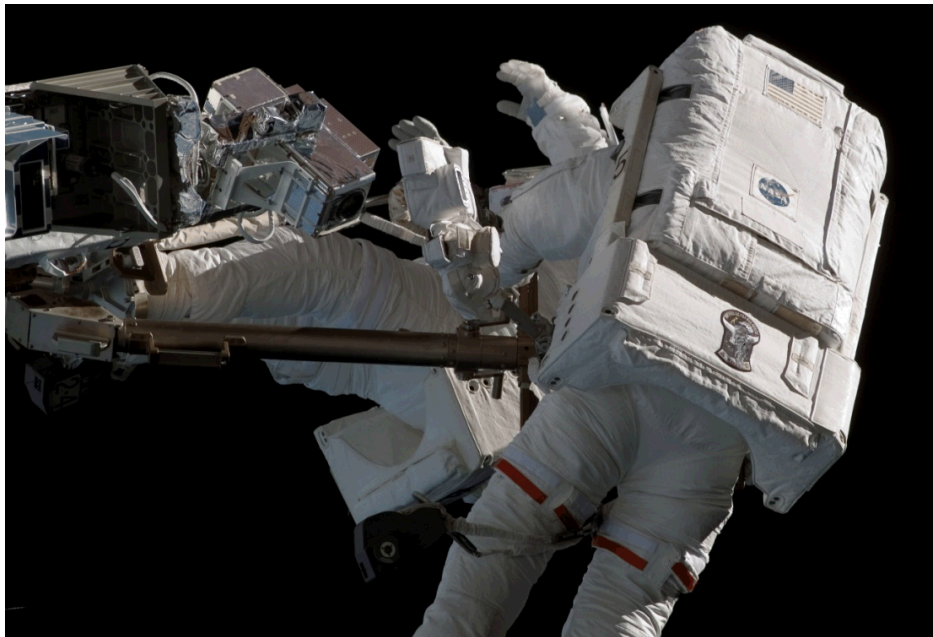
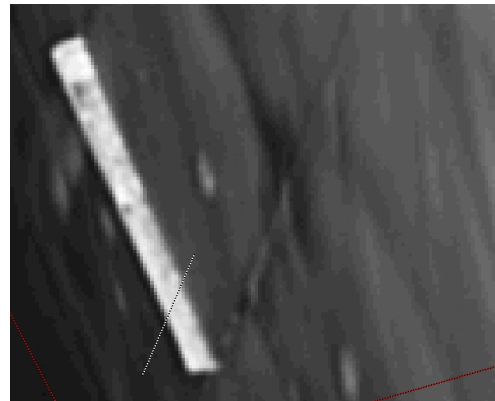
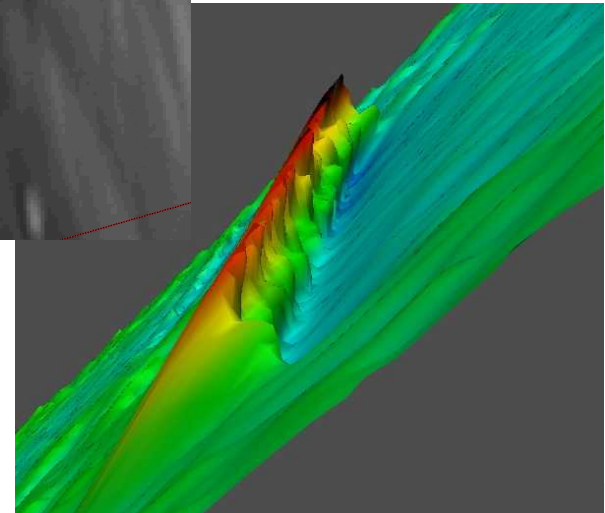
# STS-121

- Another protruding gap filler was identified. Cleared to re-enter as-is
- Astronauts tested the OBSS as a work platform

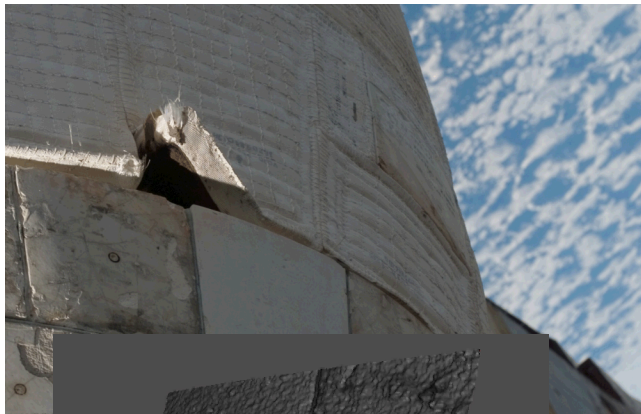
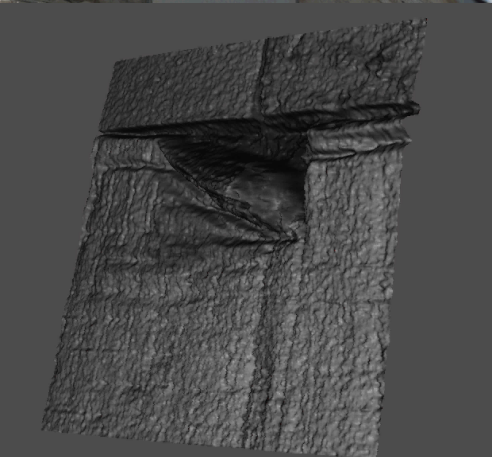
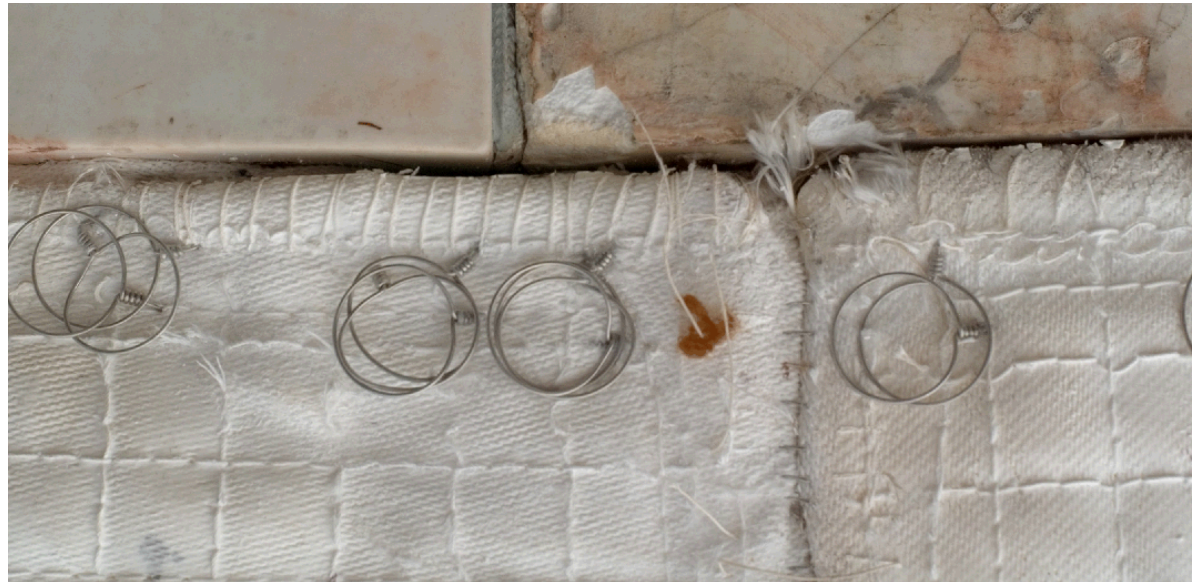
# STS-117

- OMS pod blanket partially detached during launch. Repaired during EVA with pins and surgical staples

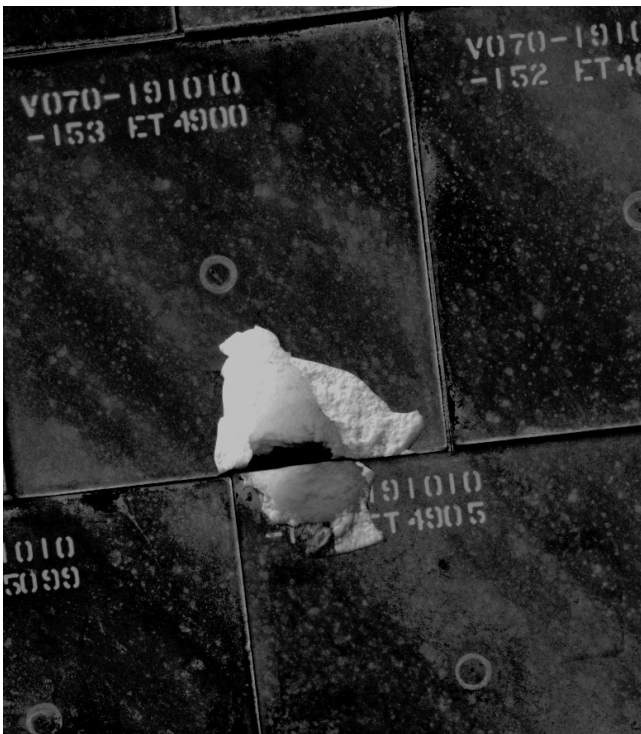
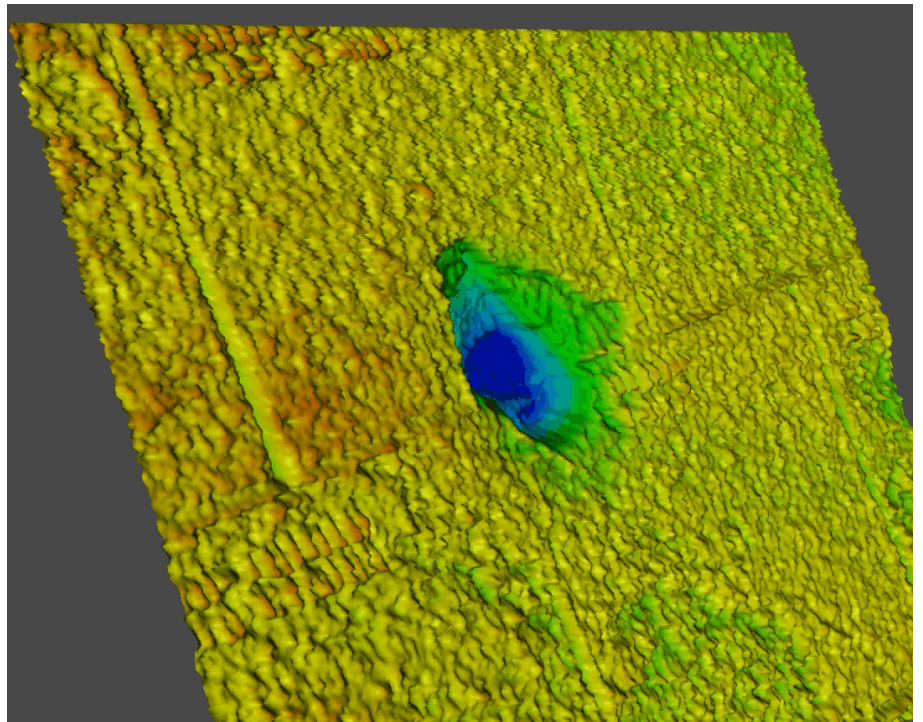
# STS-118

- Belly tile gouge identified and examined. Cleared to re-enter as-is
