CONF-950739-1
SAND094-3230C

FAILURE ANALYSIS OF A FIBERGLASS-REINFORCED PLASTIC PRESSURE VESSEL

S. J. Glass, E. K. Beauchamp, M. Carr, T. R. Guess, S. L. Monroe, R. J. Moore, A. Slavin, and N. R. Sorenson, Sandia National Laboratories, Albuquerque, NM 87185.

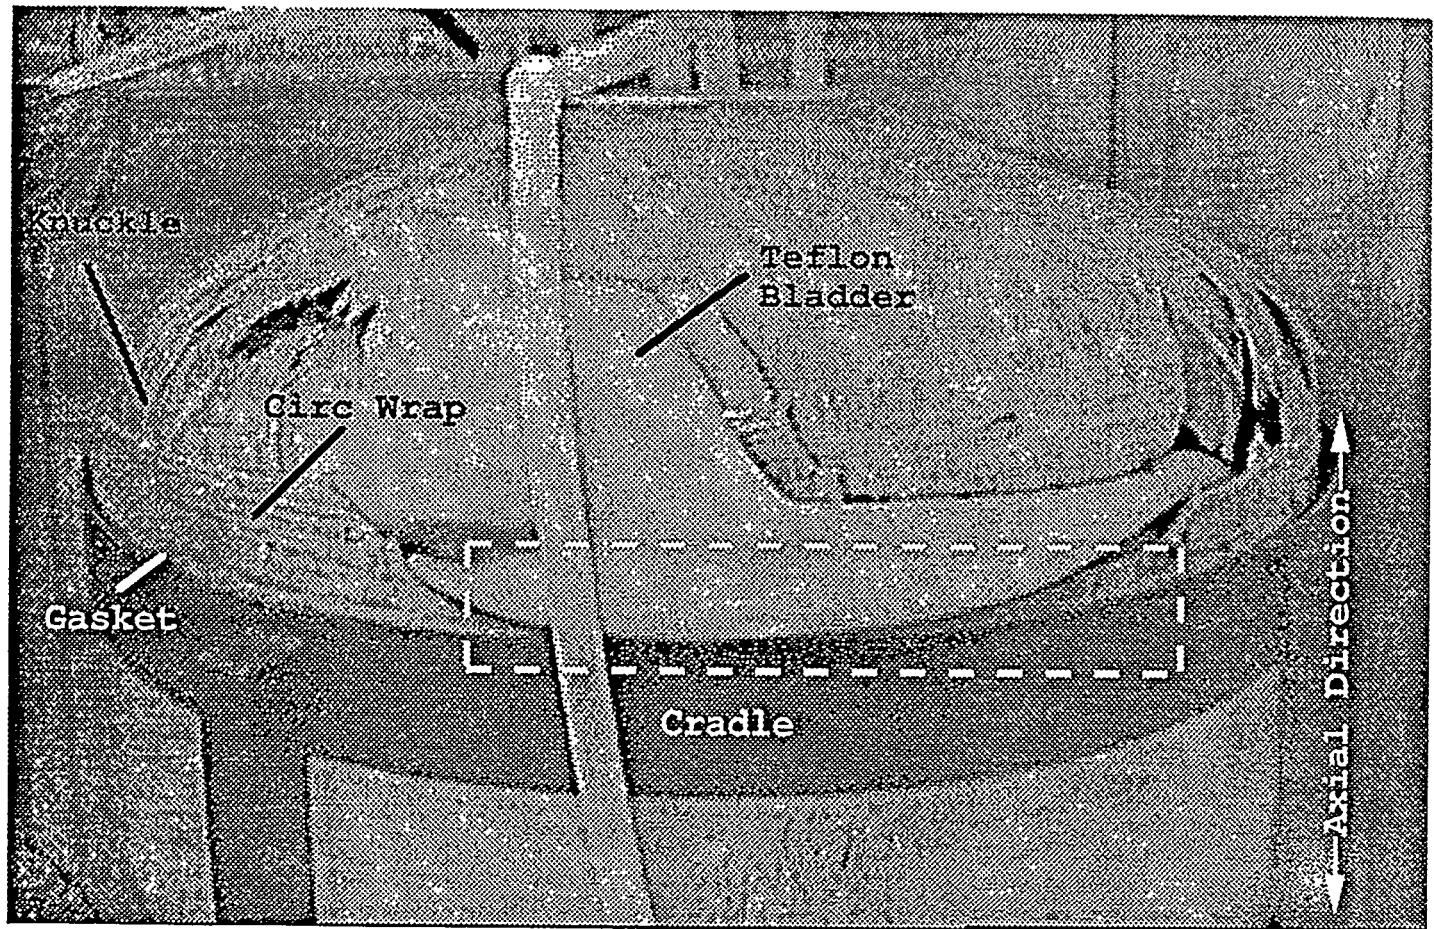
Macroscopic examination of the primary fracture surface revealed two areas (Fig. 2, Areas A and B) of planar circumferential (or hoop) fracture, normal to the longitudinal axis of the vessel, extending almost completely through the circ wrap and cross plies as shown in the schematic in Fig. 3A. If the vessel is exposed to sufficiently high axial tensile stresses, this type of planar hoop crack is expected in the circ wrap (a result of interfacial failure between the fibers and the epoxy matrix), but not in the cross plies. Fracture in the cross plies should exhibit extensive fiber pull-out producing a fracture surface that is not planar (Fig. 3B). The planar fracture surface of the cross ply region was the first evidence that the vessel had been compromised in some way that weakened the fibers.

Fig. 2. Following an in situ examination of the ruptured vessel, a three by twenty inch section (section in dashed lines in Fig. 1), containing the primary fractures, was cut from the vessel for detailed examination. Macroscopic examination of the primary fracture surfaces revealed two areas (Areas A and B) of planar circumferential (or hoop) fracture, normal to the longitudinal axis of the vessel, extending almost completely through the circ wrap and cross plies.

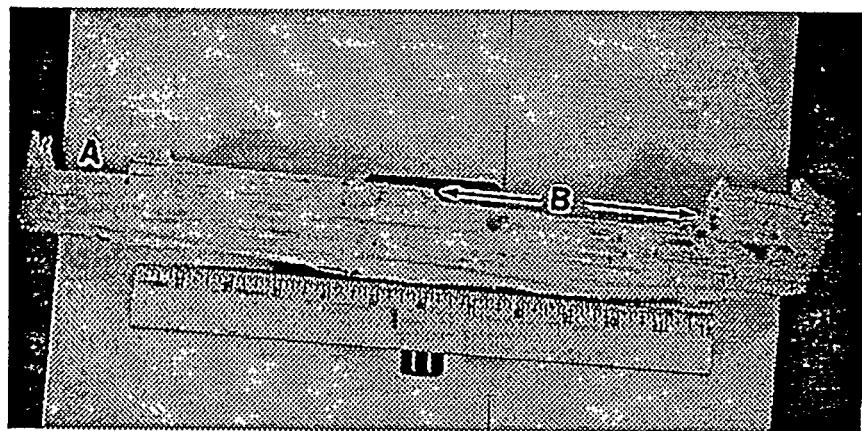
Fig. 3A. Schematic cross section of the planar fracture surface observed for the circ wrap and cross plies of Area A.

Fig. 3B. Schematic cross section of the expected fracture surface topography for the circ wrap and cross plies.

Normal fracture profile. Planar fracture profile observed in Areas A and B.

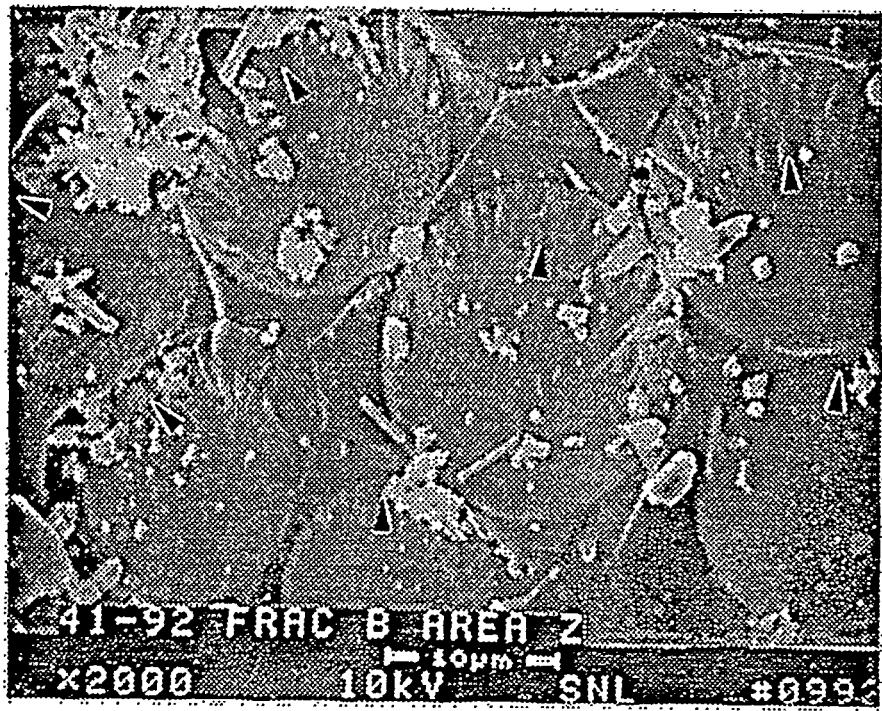
SEM examination of the fracture surface of the flexure bar with the pre-existing crack was performed. The pre-existing crack contained planar fracture both in the circ wrap and in some of the cross plies immediately adjacent to the circ wrap. The remainder of the cross plies, which failed during flexure testing, exhibited fiber pull-out (Fig. 6A) and the fibers in this region failed at high stresses. EDS verified the presence of Ca and Al as major constituents of the E-glass fibers (Fig. 6B). This EDS information can be contrasted with the EDS spectrum from material from the planar region of fracture (Fig. 7A). Fibers in this region failed at low stresses (~689 MPa)). EDS of these fibers (Fig. 7B) indicated Ca and Al depletion.

Fig. 7A. SEM micrograph of a fractured fiber from a region of fracture exhibiting planar fracture (Fig. 5B, Area 1).

Fig. 7B. EDS of fiber from planar fracture region indicated depletion of Ca and Al relative to the EDS spectrum in Fig. 6B.

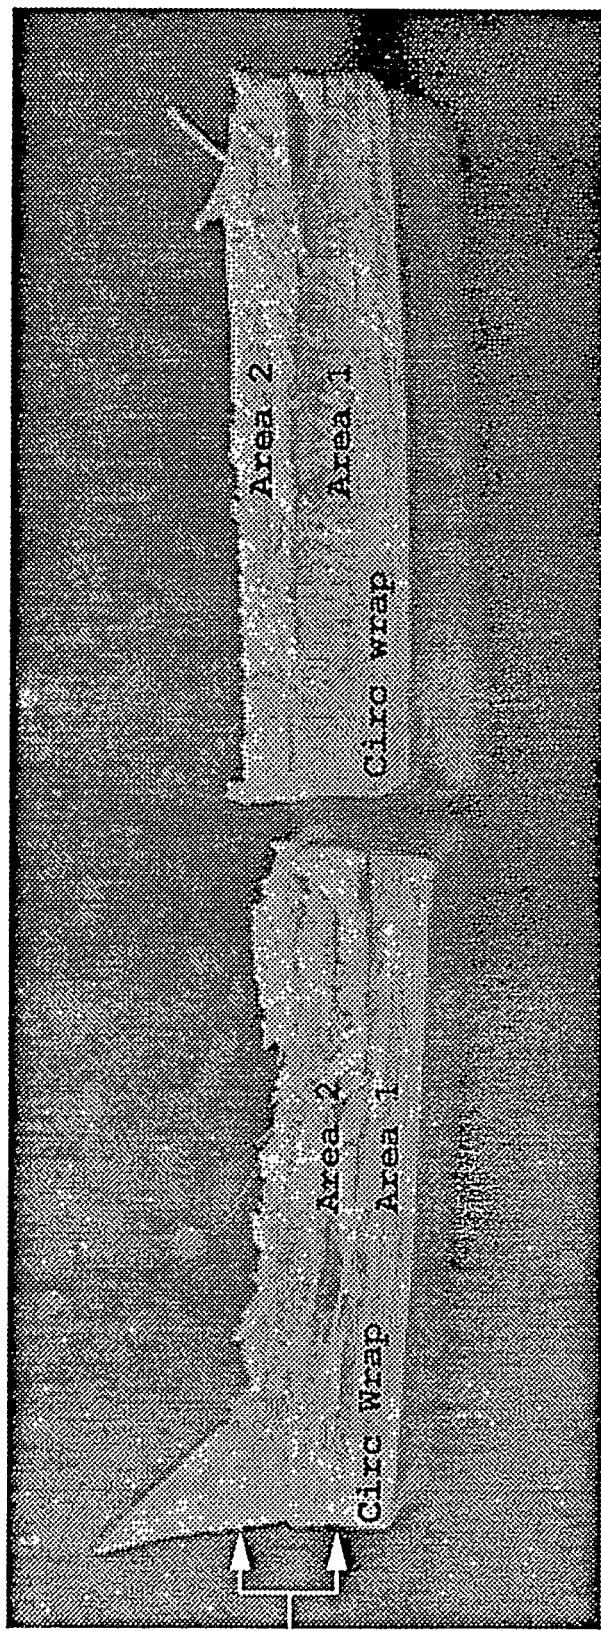
Fig. 5

Figure 5 shows the fracture surfaces of a flexure specimen which did not contain a pre-existing crack (A) and the specimen described above that did (B). The direction of crack propagation is from the bottom of the figure proceeding towards the top. Figure 5A shows no planar fracture in the cross ply regions (Area 2). Figure 5B shows the two types of macroscopic fracture features in the cross plies, i.e., the pre-existing crack exhibits planar fracture (Fig. 5B, Area 1), whereas the fracture surface produced during testing exhibits the expected fiber pull-out (Fig. 5B, Area 2).

Fig. 5A. The fracture surface of a flexure specimen which did not contain a pre-existing crack. There is no planar fracture in the cross ply regions (Area 2).

Fig. 5B. The fracture surface of a flexure specimen which contained a pre-existing crack in the circ wrap. The direction of crack propagation is from the bottom of the figure to the top. The photo shows the two types of macroscopic fracture features in the cross plies, i.e., the pre-existing crack exhibits planar fracture (Area 1), whereas the fracture surface produced during testing exhibits the expected fiber pull-out (Area 2).

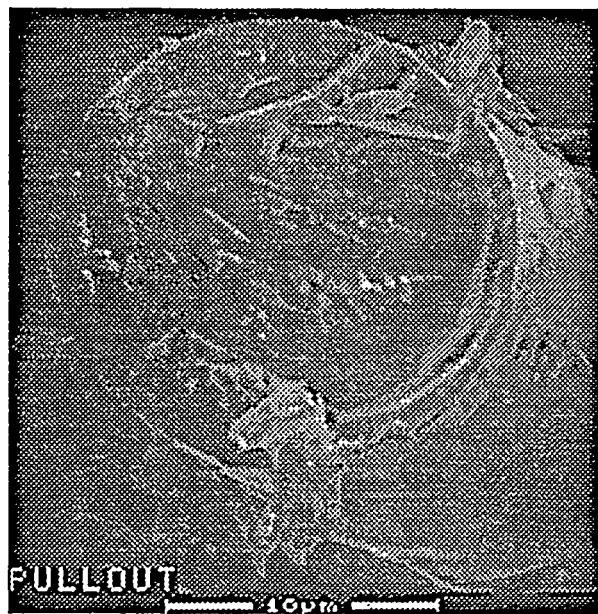
Fig. 6

Fig. 6A. SEM micrograph of a fractured fiber from a region of fracture exhibiting extensive fiber pull-out.

Fig. 6B. EDS verified the presence of Ca and Al as major constituents of E-glass fibers in the region of Fig. 6A.

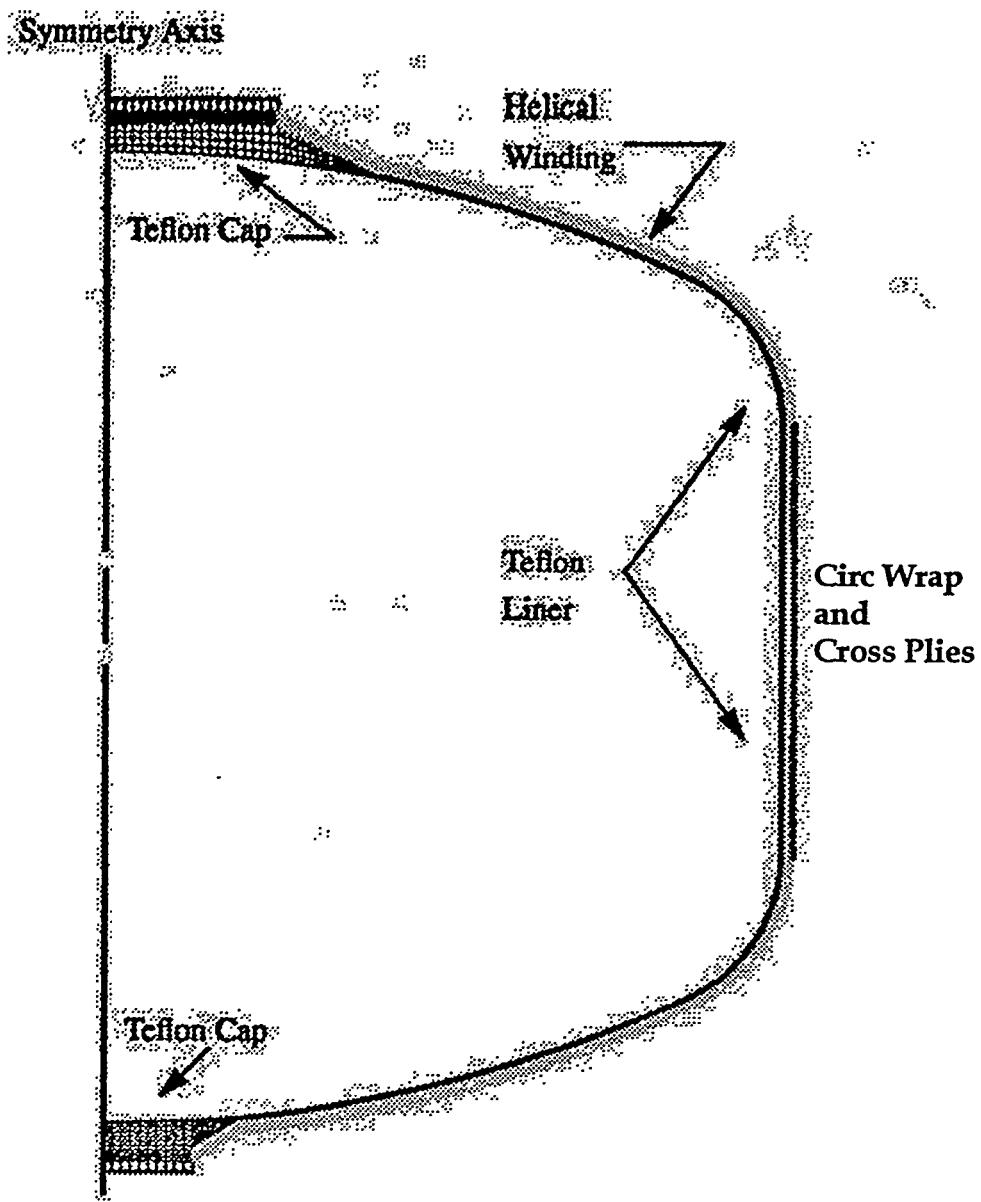
Figure 1. Finite Element Model Geometry and Mesh

Fig. 9 Finite element model geometry and mesh of the FRP vessel and teflon liner.
