# **Final Report for the Erosion-corrosion Analysis of Tank 241-AW-02E Feed Pump Pit Jumpers B-2 and 1-4 Removed from Service in 2013**

**J. S. Page**

Washington River Protection Solutions LLC

March 2014

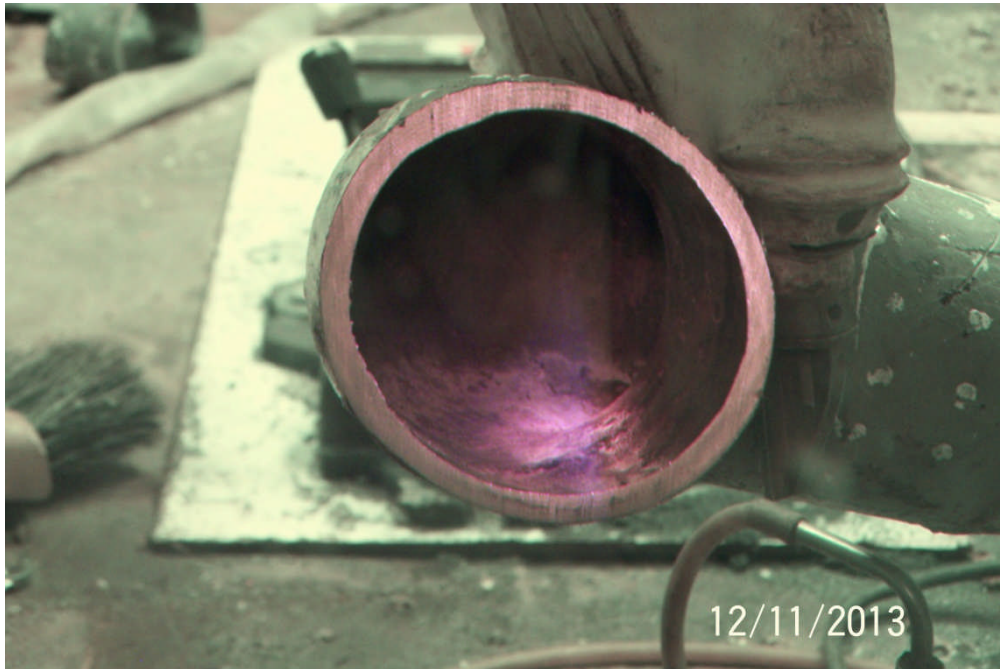
The cutting of coupons from the jumper also allowed some of the inner walls to be viewed through the hot cell window. Looking inside the jumper pipes revealed some residue and possible corrosion products. The following figures show many of the details observed through the hot cell window, and Appendix B contains additional pictures taken of the jumper pieces in the hot cell. Figure 2-9 shows the inside of the first elbow on jumper B – 2. A flashlight was shone through the hot cell window which better showed the interior but also gave a reddish hue to the surfaces. A thin, light, opaque layer was observed having some variation in the thickness. The SEM analysis of the coupon cut from the jumper in this area provided more details on the composition and thickness of this layer, Section 2.4.

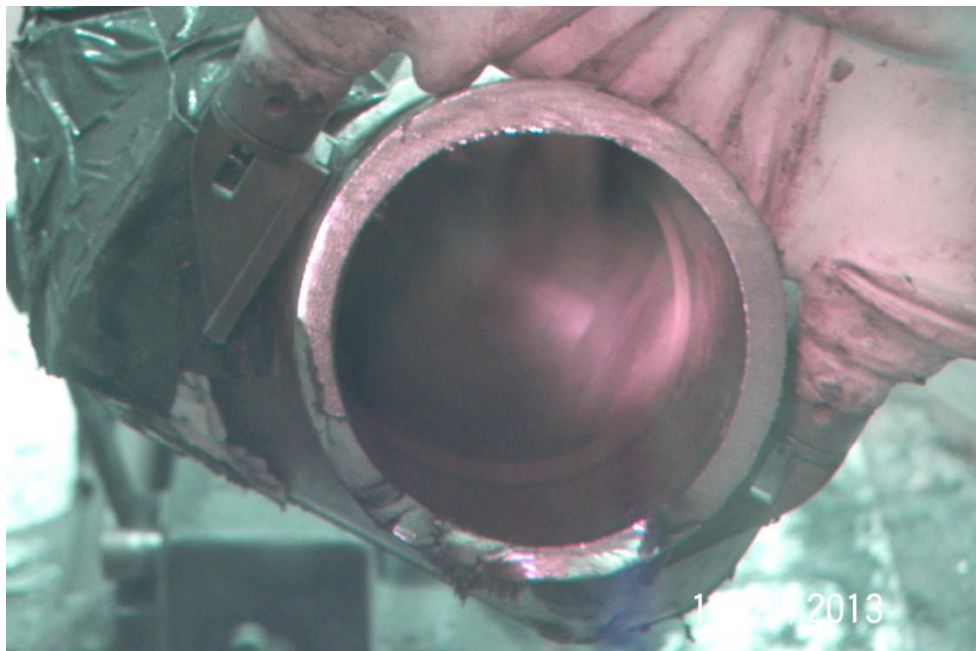
Connector B of jumper B – 2 was also held up to the hot cell window for visual inspection of the inside surface of the stainless steel connector. Figure 2-10 shows that the inner surface is considerably clean, shiny, and free of residue and corrosion. This corresponds well with the UT results which showed no thinning of the wall thickness on the connector.

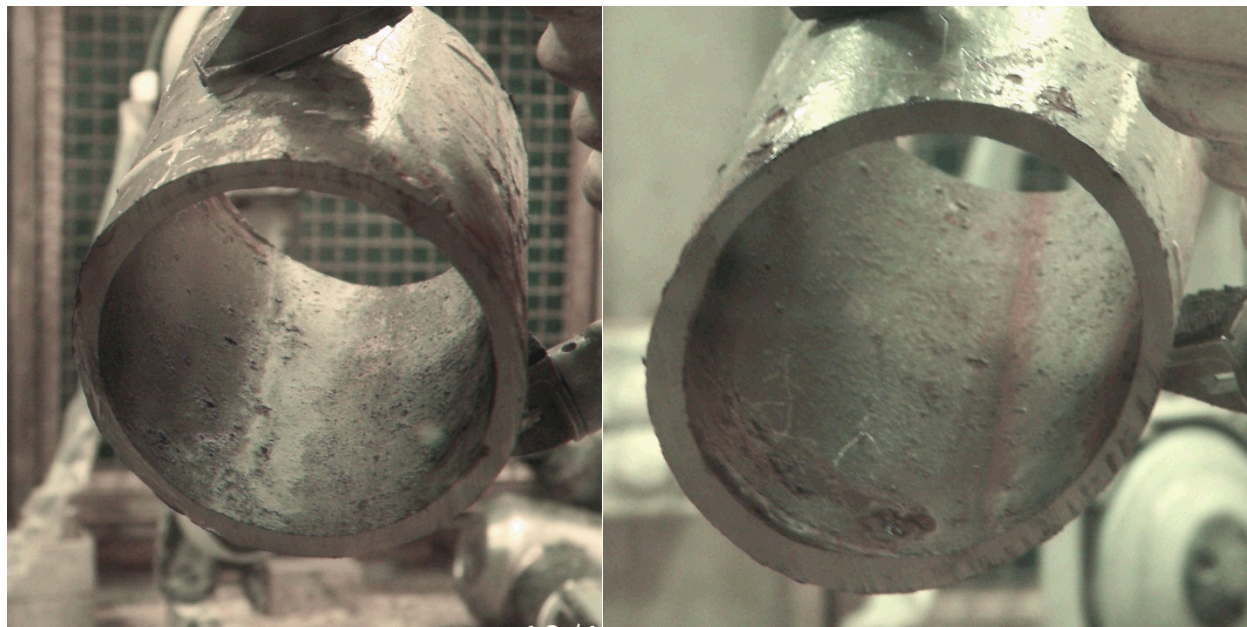
A section of the straight pipe was also examined at the hot cell window before a coupon was cut from it. Figure 2-11 shows the pipe from two different angles displaying a majority of the inner surface. The surface has an area of a thin white residue on one side and a few patches of blistering, indicating spots of possible corrosion. The wall exposed from the cross-sectioning of the pipe appears to have a uniform thickness supporting the UT work which showed only small variations in the pipe wall thickness measurements.

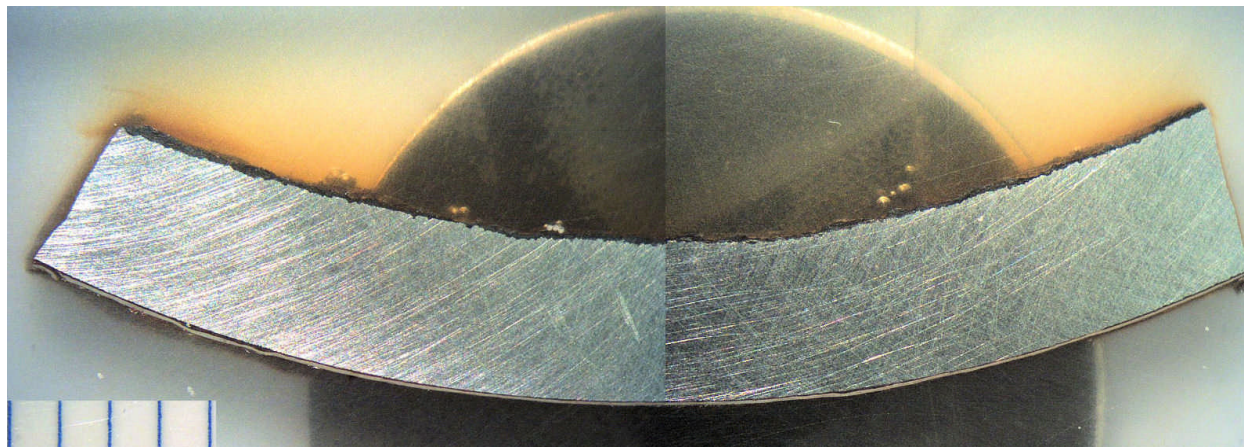
Visual inspection of the cross-section in Figure 2-14 shows that the pipe wall is intact with no areas of excessive wall thinning due to erosion-corrosion. The presence of a corrosion layer and the rougher surface texture of the interior surface indicate that some slight wall thinning has occurred. The inner surface of the pipe contains small pits along the cross-section and a thin layer of corrosion and/or tank waste. The pits and corrosion/residue layer can also be seen in Figure 2-15, which is a series of microphotographs taken at a higher magnification across the coupon. The scale bars are in increments of 1/16 of an inch.

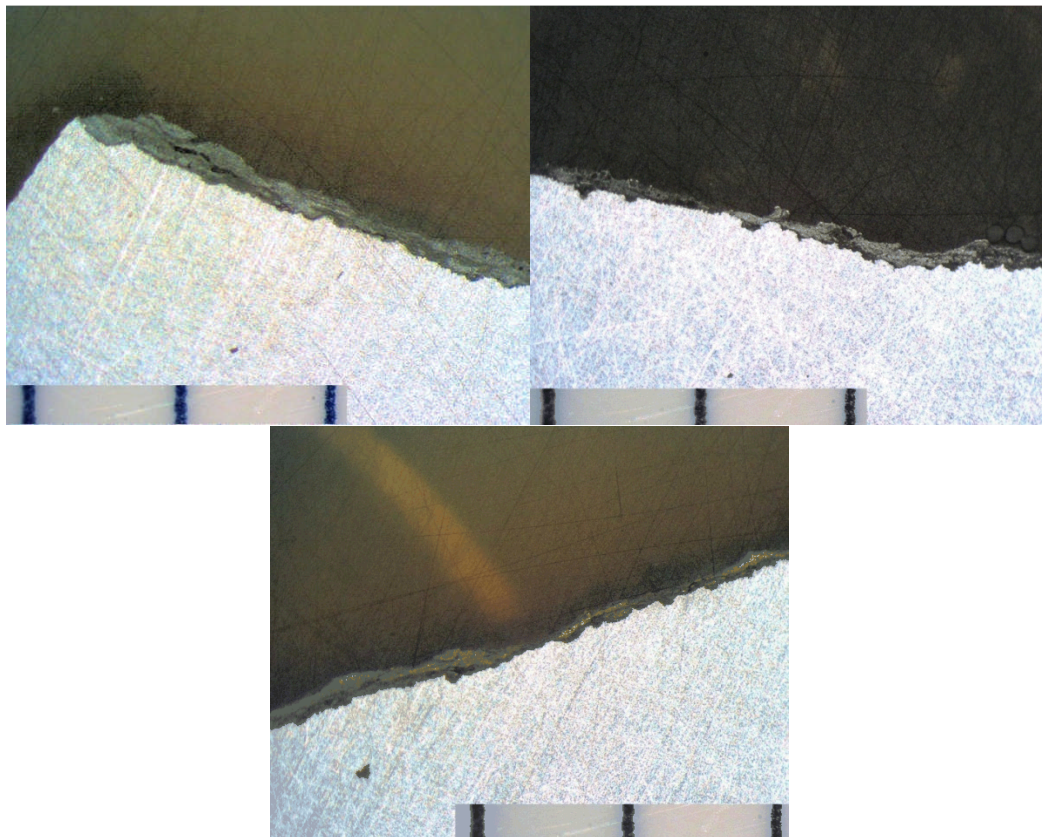
The increased magnification in the images in Figure 2-15 shows that the pits are small and continuous with a continuous layer of corrosion/residue product on the surface of the pipe.

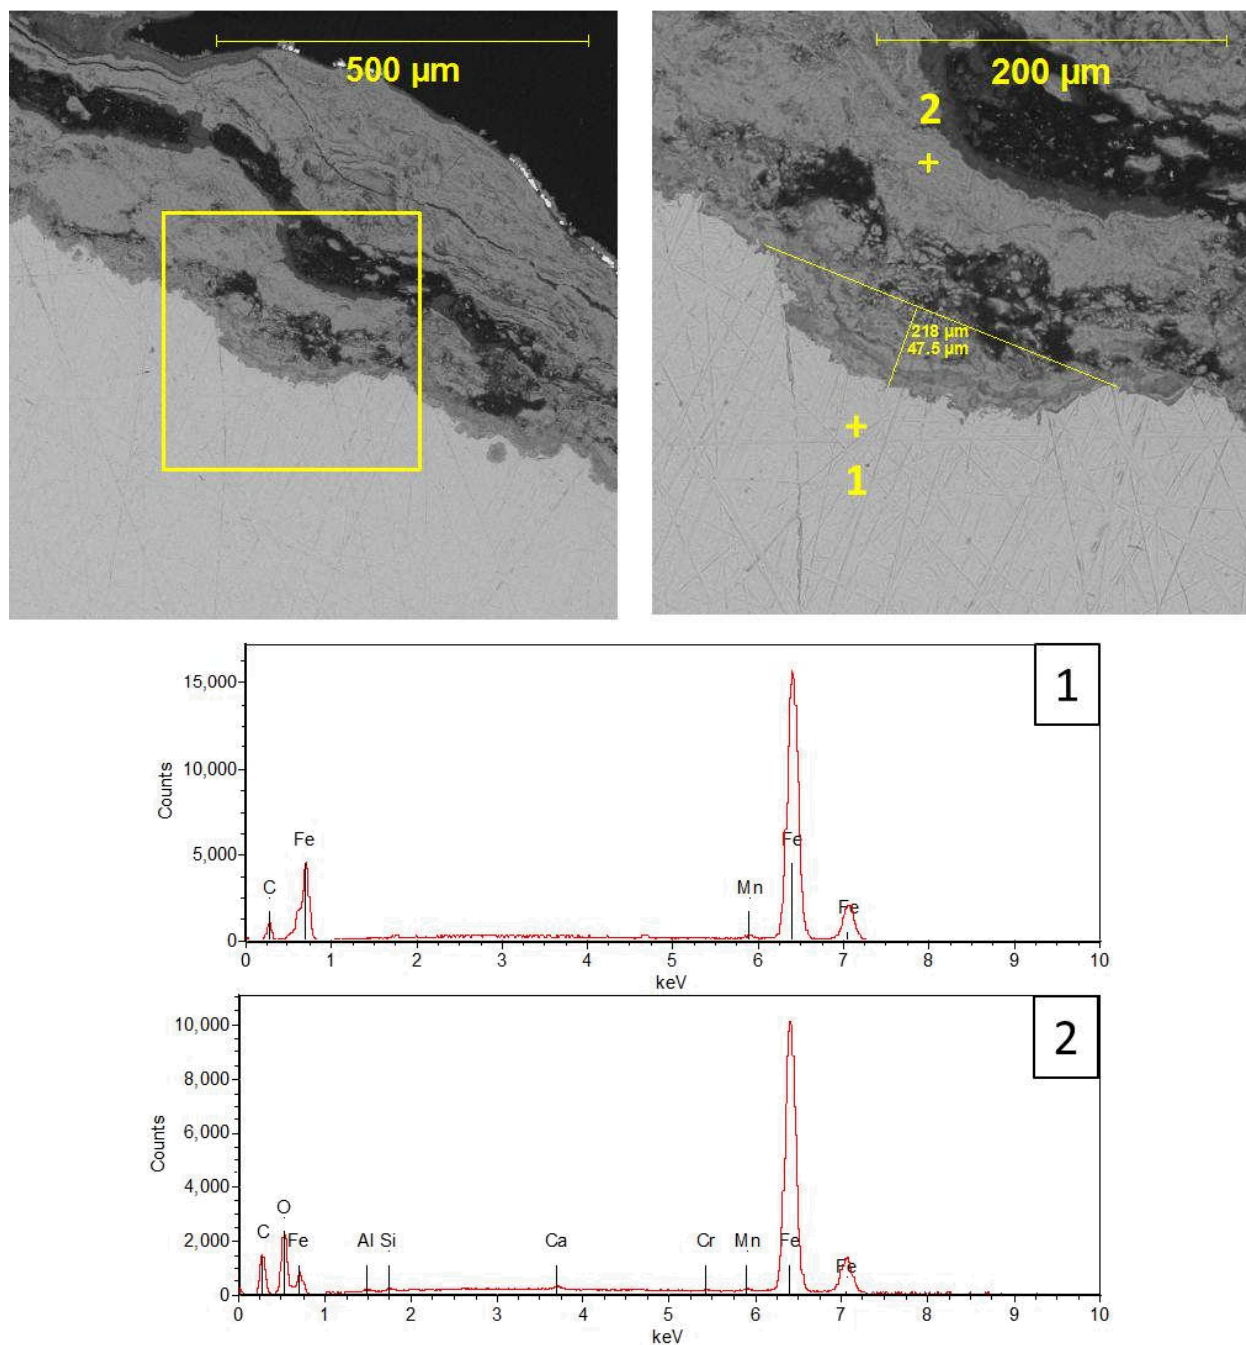
Another pit detected on the inner pipe surface of coupon #1 is shown in Figure 2-18. The pit is 10.2 mils wide and 4.6 mils deep with iron oxide/hydroxide in the pit and along the surface. Several smaller pits can also be seen near this pit in the left image with various morphologies ranging from undercutting to subsurface. A layer of tank waste residue was also detected on top of the corrosion layer. The EDS spectrum in Figure 2-18 was acquired at the yellow cross and shows the layer to be a calcium phosphate (similar to hydroxylapatite) with trace amounts of

sodium, magnesium, aluminum, and silicon. This tank waste layer was observed across the pipe cross-section, and it maintained a consistent elemental composition suggesting a single phase.

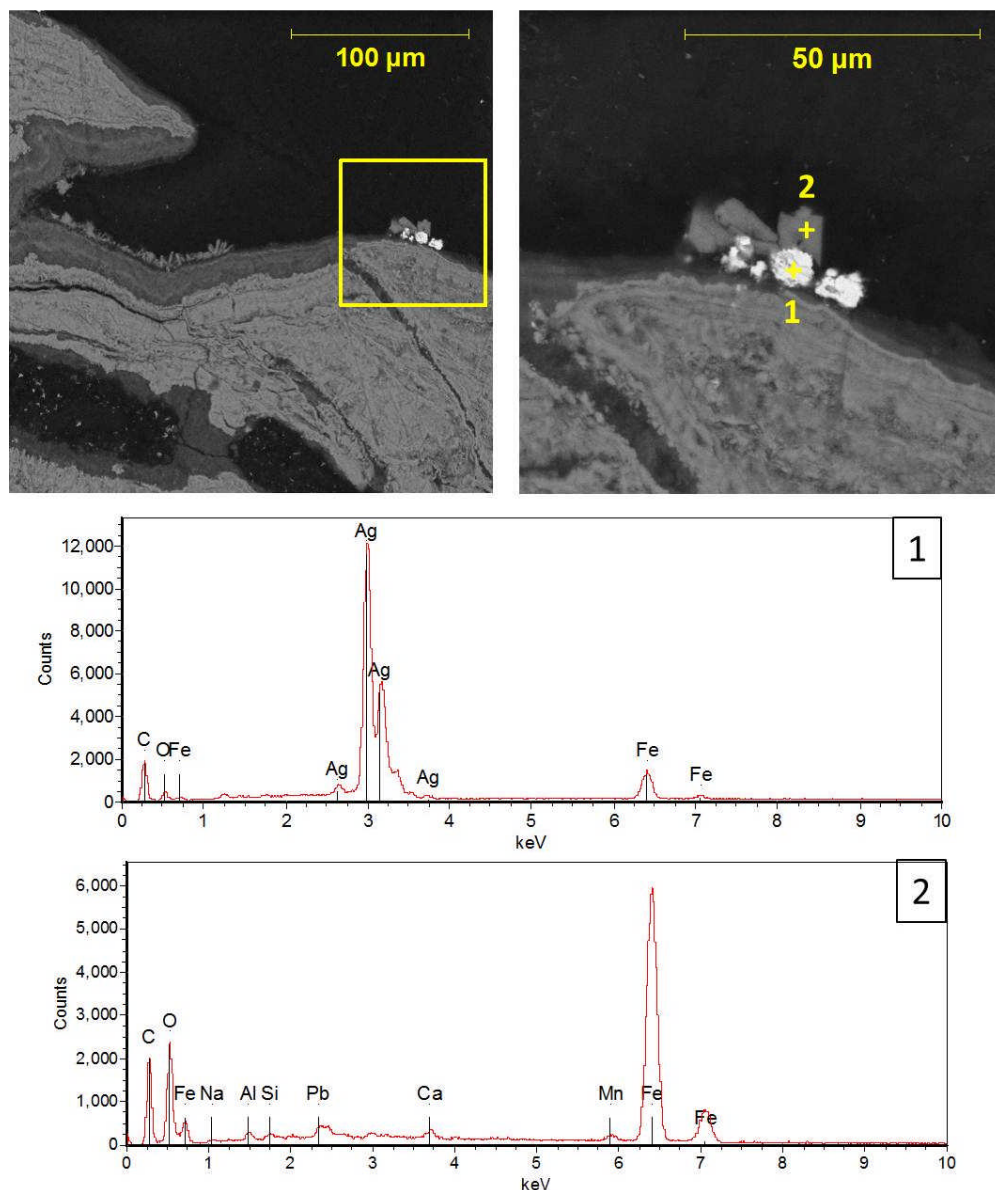
**Figure 2-19. Scanning Electron Microscopy Images and Energy Dispersive Spectrometry Spectra of Particles on the Corrosion Layer.**

Small nodules and crystals were detected along the surface of the corrosion and tank waste layers. Figure 2-19 shows one set of these features. The images were acquired in backscatter electron image (BEI) mode which produces a brightness that corresponds to elemental mass. In other words, heavier mass elements reflect the impinging electrons better, producing a brighter spot in the image. The bright nodules in the right image are rich in silver as detected in the corresponding EDS. The darker particles attached to the nodules are a crystalline iron oxide/hydroxide. Silver has been detected in the past using SEM on corroded metals exposed to tank waste (RPP-RPT-56410, *Report on the Examination of Tank 241-AY-102 Removable*

*Corrosion Probe Extracted in September 2013 from the Multi-Probe Corrosion Monitoring System).* A possible mechanism is the electrochemical deposition of silver as silver ions are reduced at the metal surface due to the corrosion electrochemical circuit.

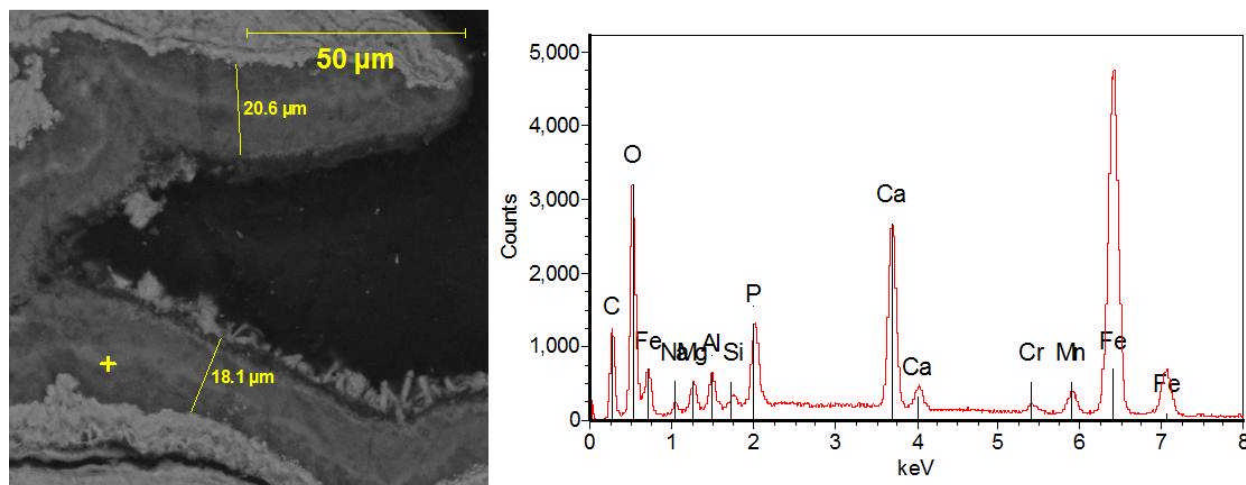
**Figure 2-20. Scanning Electron Microscopy Image and Energy Dispersive Spectrometry Spectrum of a Tank Waste Layer on the Corrosion Layer of Coupon #1 of Jumper B - 2.**

Figure 2-20 shows an SEM image of the tank waste layer on a section of corrosion which has partially lifted from the corrosion layer. The tank waste layer, ~0.8 mils (20 µm) thick, has penetrated this area and coated the corrosion indicating that the tank waste was deposited after the corrosion had formed and separated. The EDS spectrum from the marked location again shows the tank waste to be primarily calcium phosphate with trace sodium, magnesium, aluminum, and silicon.

Calcium phosphate is a relatively rare species in tank waste. However, it has been observed, typically in sludge due to the low solubility. It may have formed on the pipe surfaces when calcium-rich process water was used to flush residual supernatant, rich in phosphate.

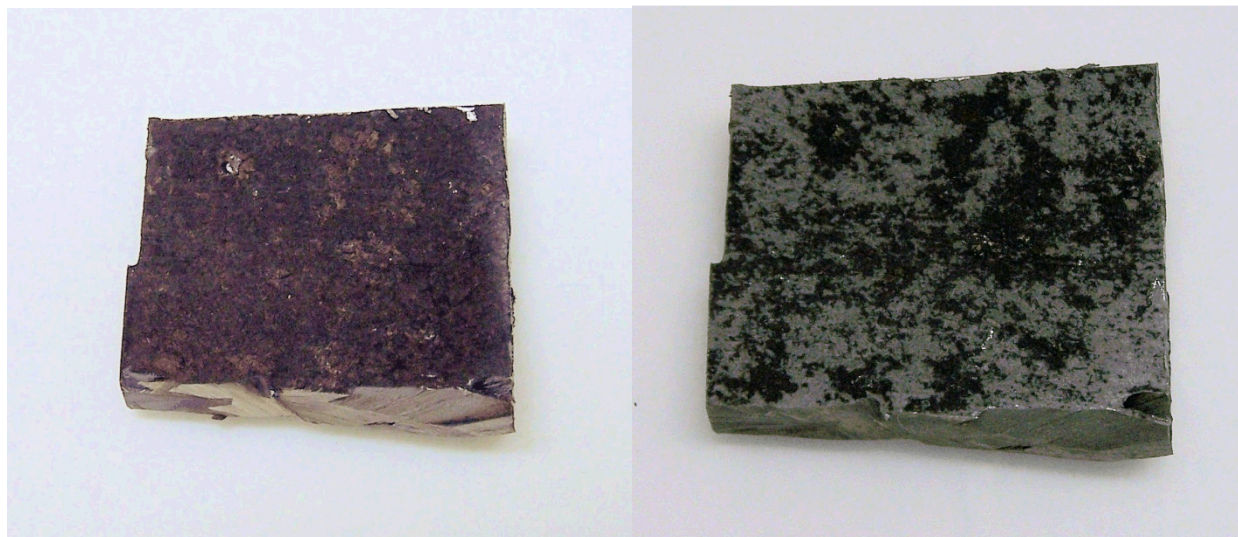
**Figure 2-21. Photos of Coupon #2 from Jumper B – 2 Before (Left) and After (Right) the Ammonium Citrate Treatment Corrosion Removal Process.**

Photos of coupon #2 from jumper B – 2 were taken before and after the citrate treatment and are shown in Figure 2-21. The photo on the left was taken before the corrosion removal process, and a dark-brown, rough coating of corrosion and tank waste product is seen across the entire surface. The photo on the right was taken after the citrate treatment, and the surface is free of the brown layer. Much of the pipe surface is bare metal with black areas (possibly a thin oxide layer). Overall, the total mass loss due to removal of the corrosion and tank waste layers was only 0.4%, which indicates that there was only a minimal amount of corrosion and tank waste on the surface.

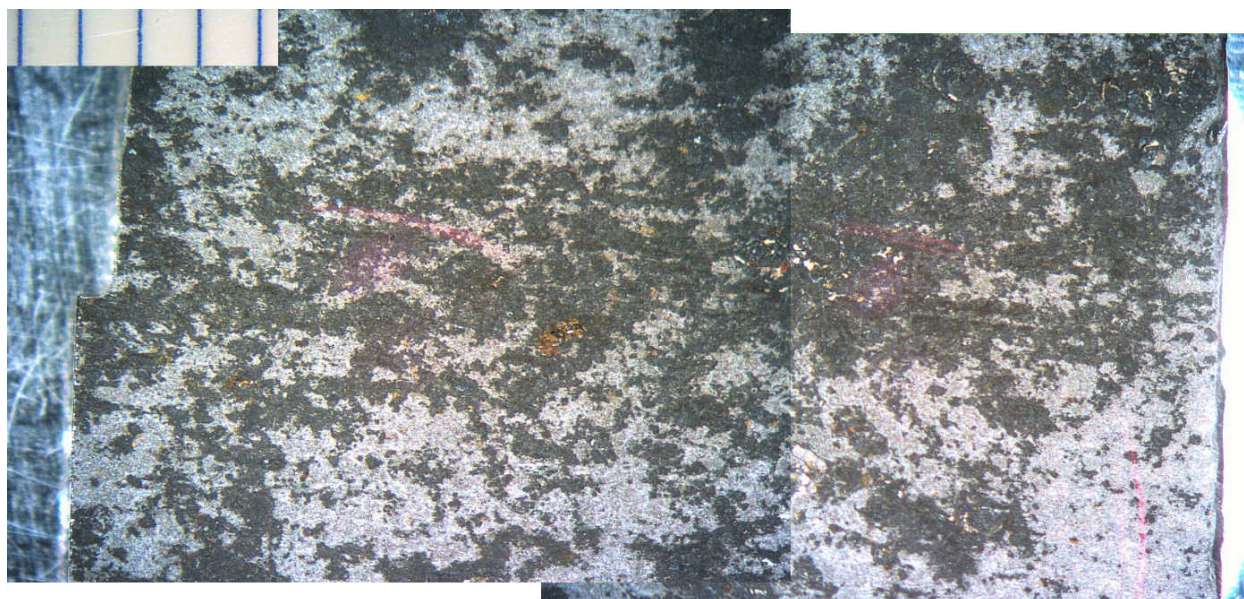
**Figure 2-22. Photomicrograph of Coupon #2 After the Corrosion Layer was Removed.**

The cleaned coupon was then imaged on the optical microscope to look for features which might indicate corrosion or erosion. Figure 2-22 is the resulting mosaic of two combined images since the size of the coupon did not allow for a complete view at the lowest magnification. The scale bar in the upper left is in increments of 1/16 of an inch.

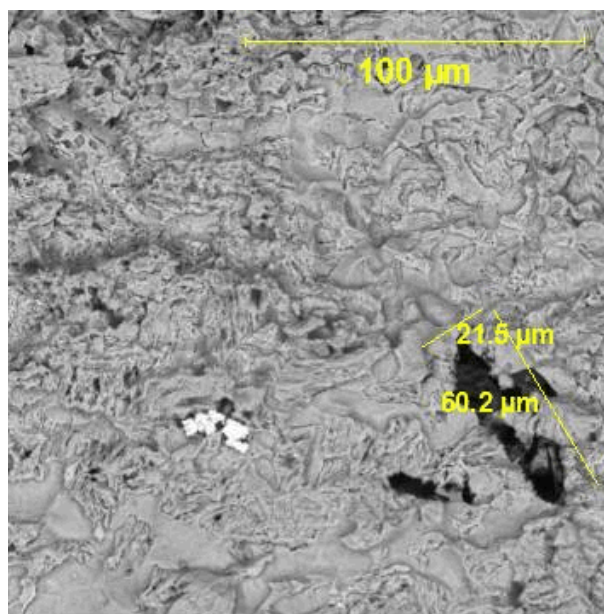
**Figure 2-26. Scanning Electron Image of a Pit on Coupon #2 of Jumper B – 2.**

Some pitting was also observed on coupon #2 from jumper B – 2. Figure 2-26 shows a small pit measuring 2.3 mils (60.2 μm) by 0.8 mils (21.5 μm). The bright particles to the left of the pit are silver particles, seen routinely near other pits and corrosion on both jumper sections and in previous corrosion analyses using passive corrosion coupons (RPP-RPT-56410); this is probably from the electrochemical corrosion circuit reducing ionic silver from the surrounding solution.

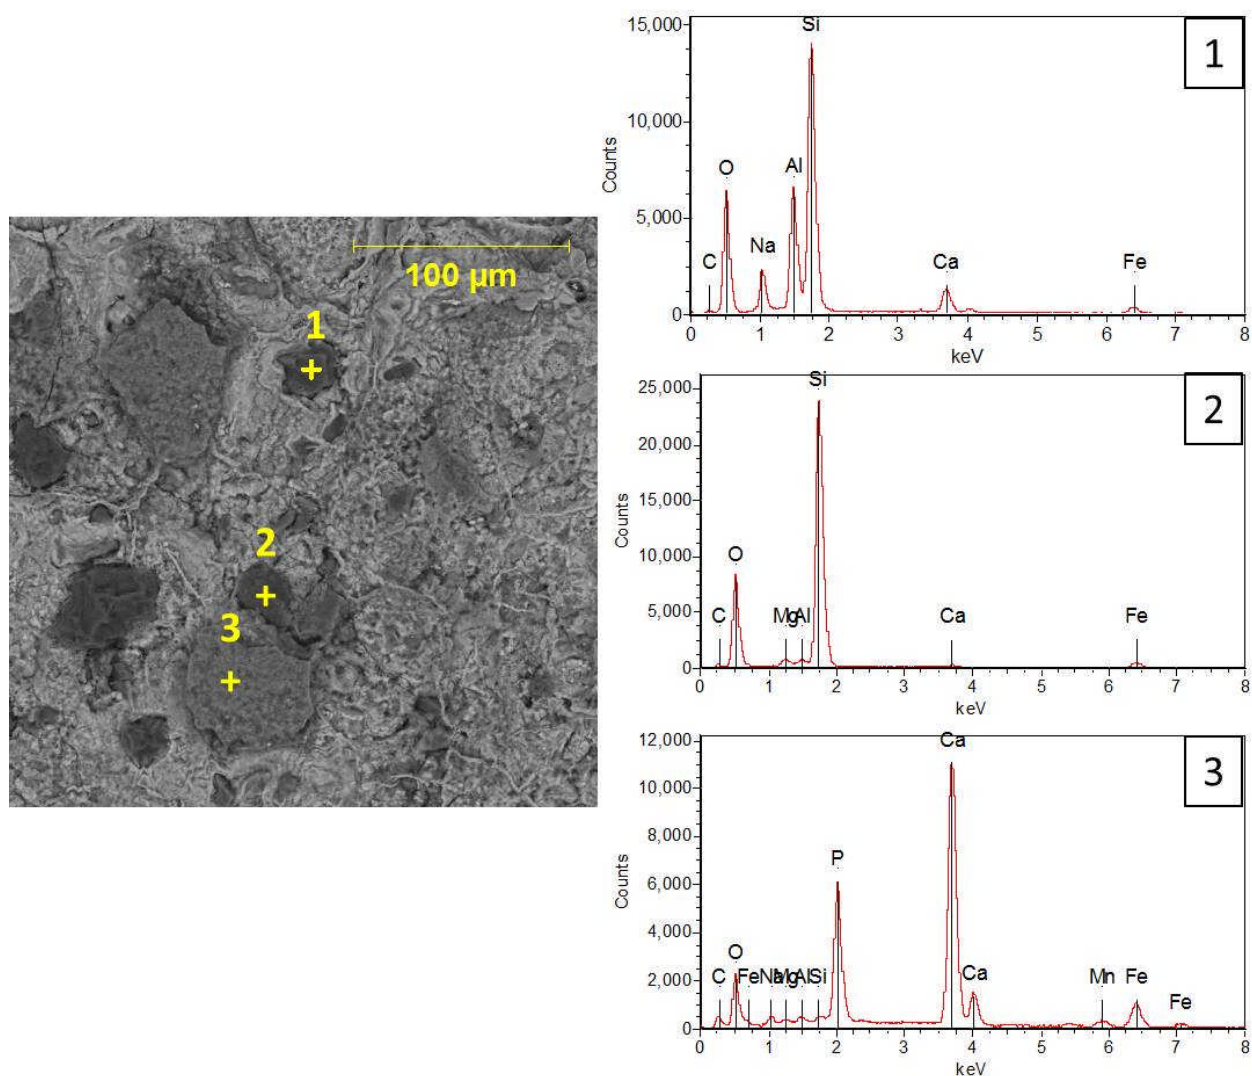
**Figure 2-27. Scanning Electron Microscopy Image and Energy Dispersive Spectrometry Spectra of Different Particles Embedded In and On the Corrosion Layer.**

Occasionally, other particles were detected embedded in the corrosion layer that remained on the surface after the citrate treatment. Figure 2-27 shows a sodium aluminosilicate (possibly cancrinite) at spot #1, a silicate (quartz) at spot #2, and the calcium phosphate layer at spot #3. In addition, aluminum oxide particles were also detected (images not shown).

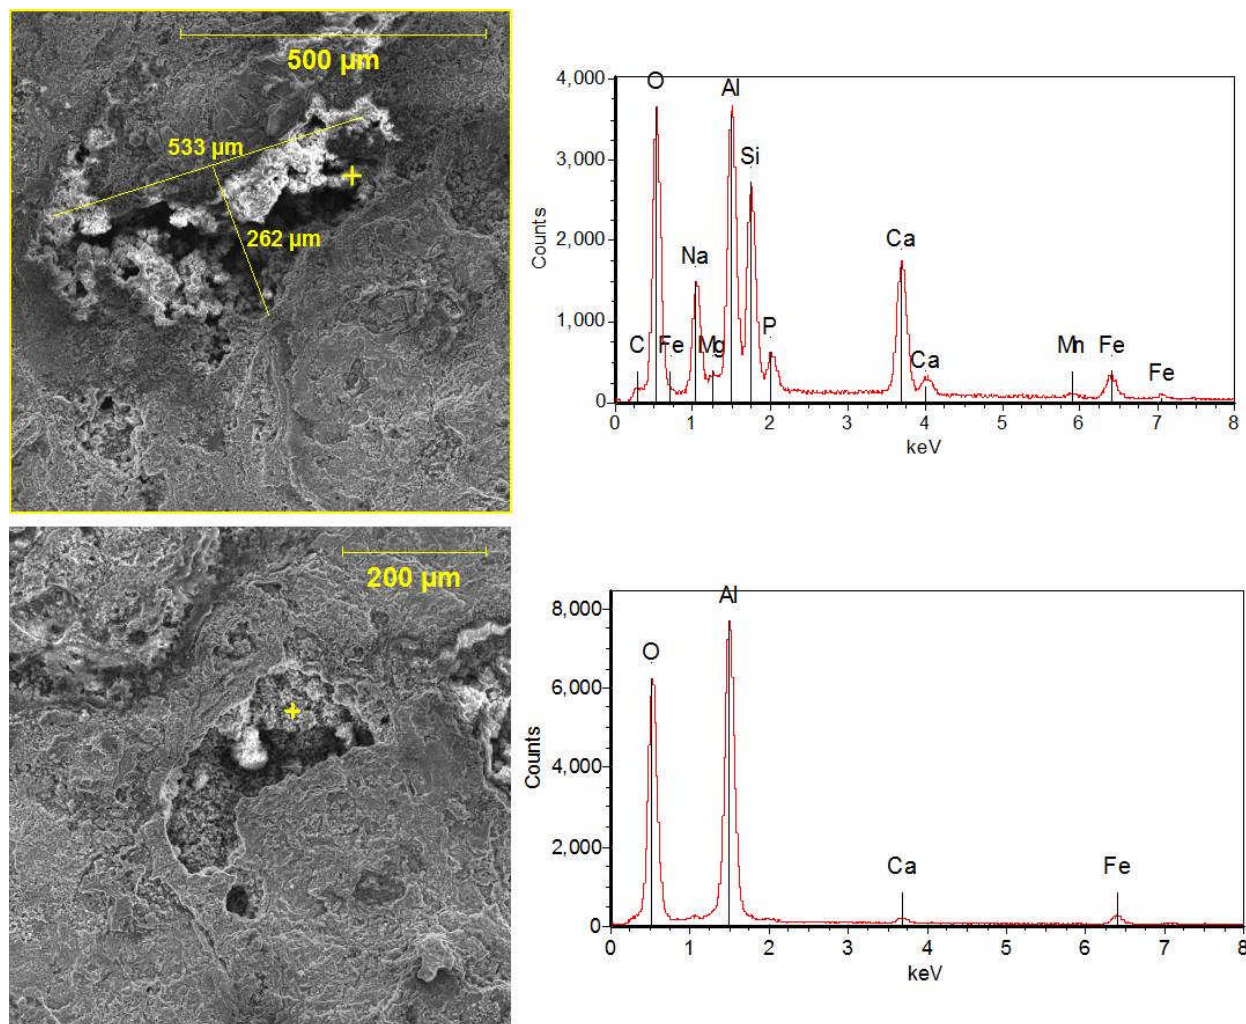
Figure 2-33 displays two pits that were characterized using SEI mode of the SEM providing morphology and the perspective of depth of these features. The pit in the upper image measured 20.8 mils (533  $\mu\text{m}$ ) by 10.2 mils (262  $\mu\text{m}$ ) and has a mixture of tank waste particles inside the pit comprised of both sodium aluminosilicate and calcium phosphate. The pit in the lower image measured at about 12 mils (300  $\mu\text{m}$ ) across contained aluminum oxide (possibly gibbsite) particles.

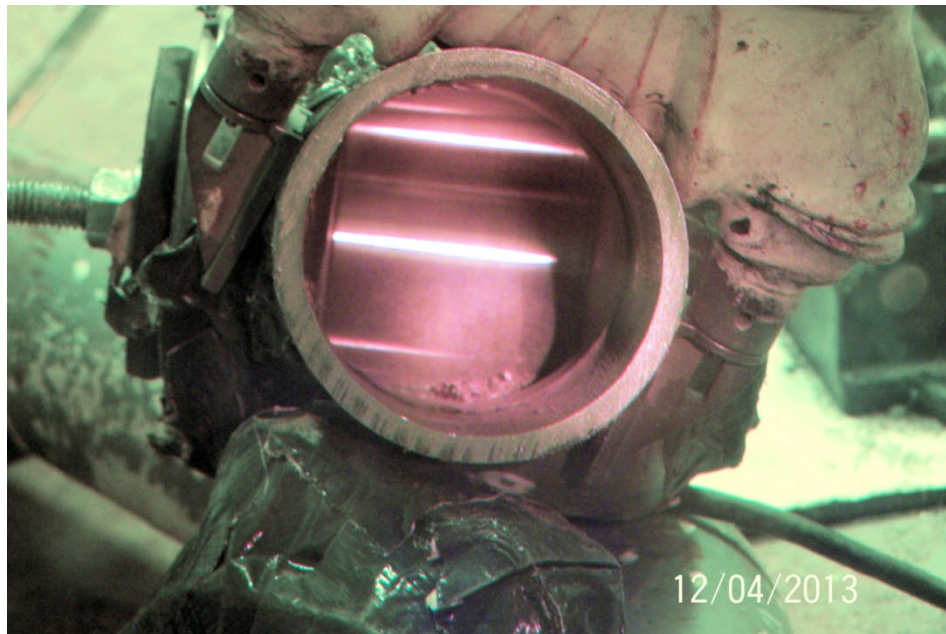
Connector 1 (connected to the pump discharge nozzle) was also held up to the hot cell window to inspect the inner wall of the stainless steel connector, Figure 3-8. The surface of the inner wall of the connector appeared free of any corrosion and tank waste residue and reflected the light from a flashlight (bright line in the photo). A pile of material can be seen on the bottom surface of the connector and is likely a result of the cutting process.

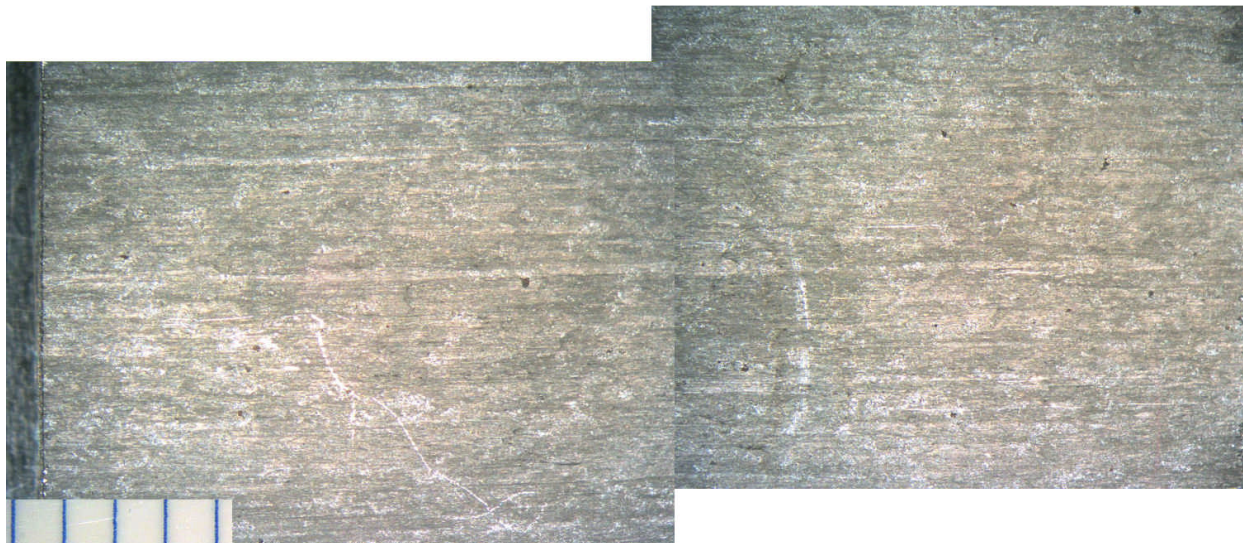
**Figure 3-16. Photomicrographs of Coupon #1 of Jumper 1 – 4 After the Corrosion Layer was Removed.**

The cleaned coupon was then imaged on the optical microscope to look for features which might indicate corrosion or erosion. Figure 3-16 is the resulting mosaic of two combined images since the size of the coupon did not allow for a complete view at the lowest magnification. The scale bar in the lower left is in 1/16-inch increments.

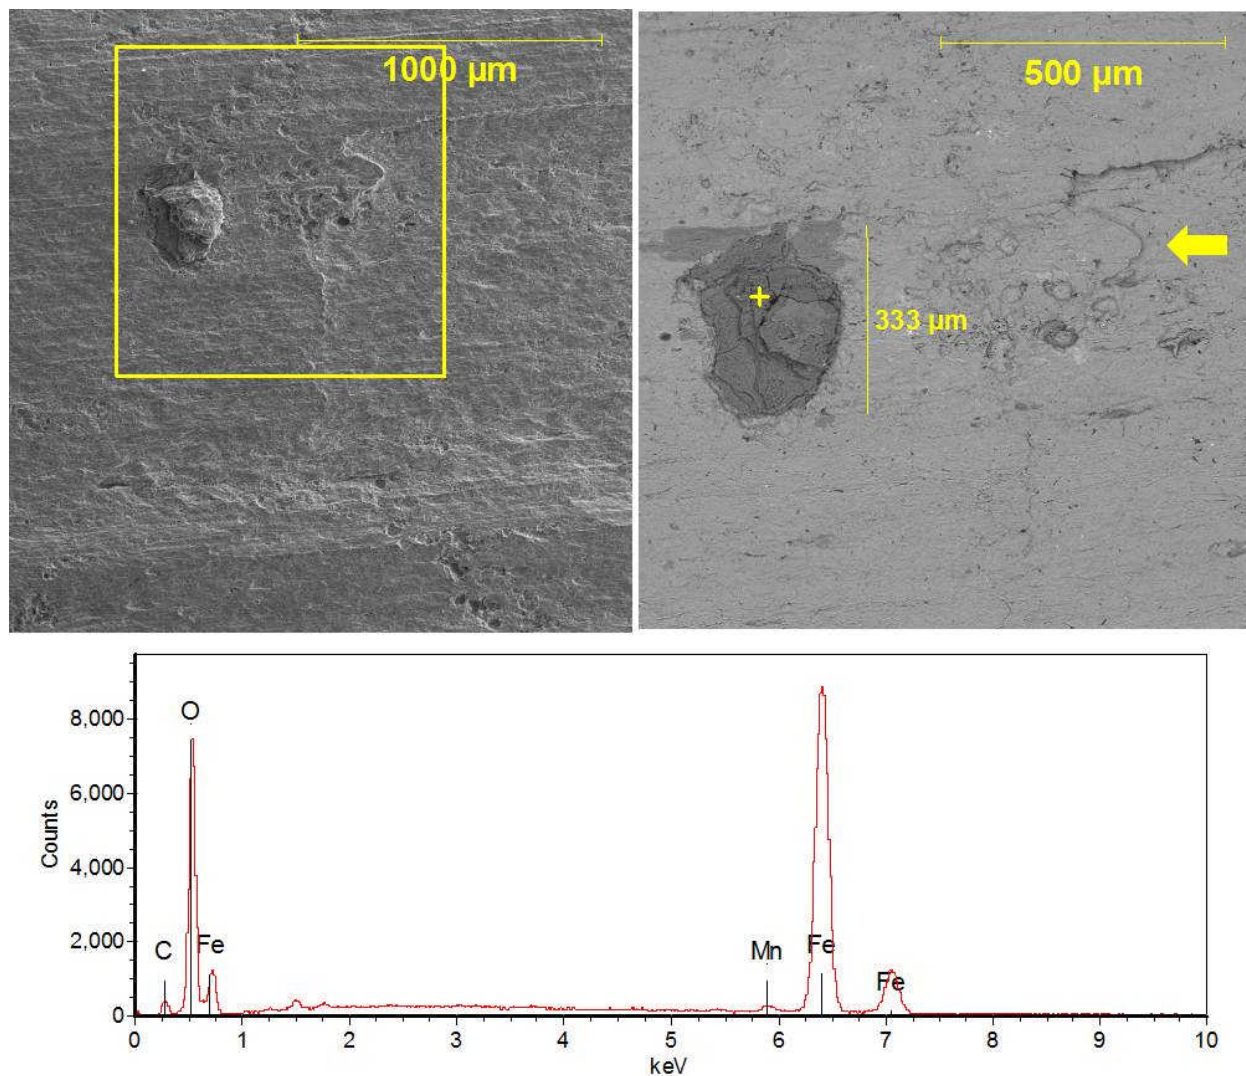
Figure 3-19 contains SEM images from another location on the coupon and shows two main features. The first feature is a spot of corrosion product which rests on a pit approximately 13.0 mils (333  $\mu\text{m}$ ) in diameter, and the second feature is a structure on the surface which corresponds to the striations seen in the optical images of this coupon (yellow arrow). This structure, along with the striations, appears to be an artifact from the pipe manufacturing process.

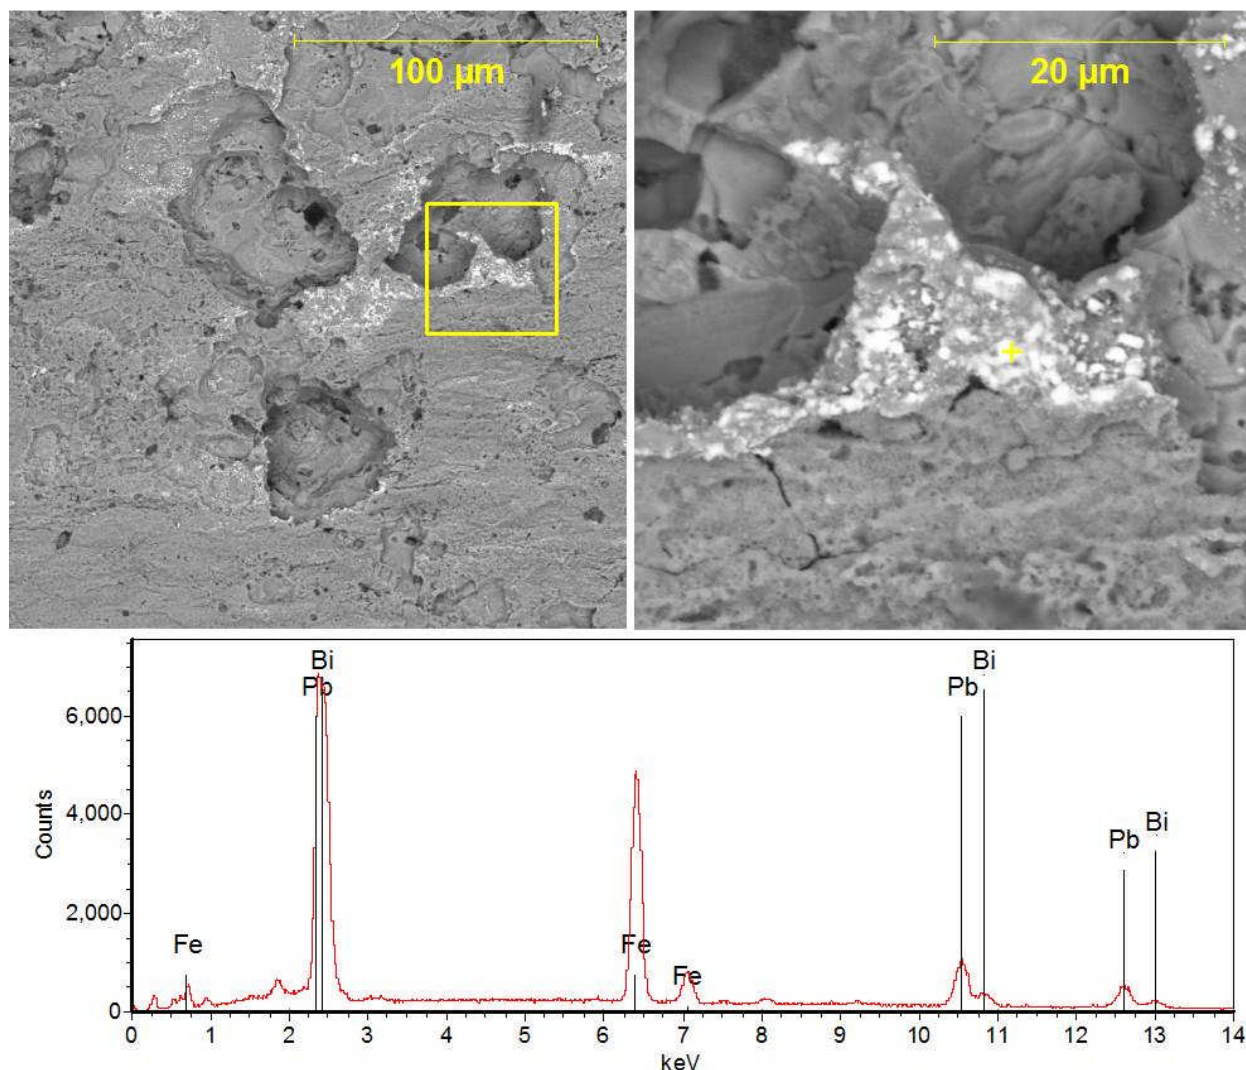
Similar to the silver deposits on the coupons from jumper B – 2, coupon #1 from jumper 1 – 4 also showed the deposition of heavy metals near pits on the pipe surface. Figure 3-20 shows particles of a lead-bismuth phase which were deposited near some pits and were likely from the reduction of the ion from the liquid flowing in the pipe.

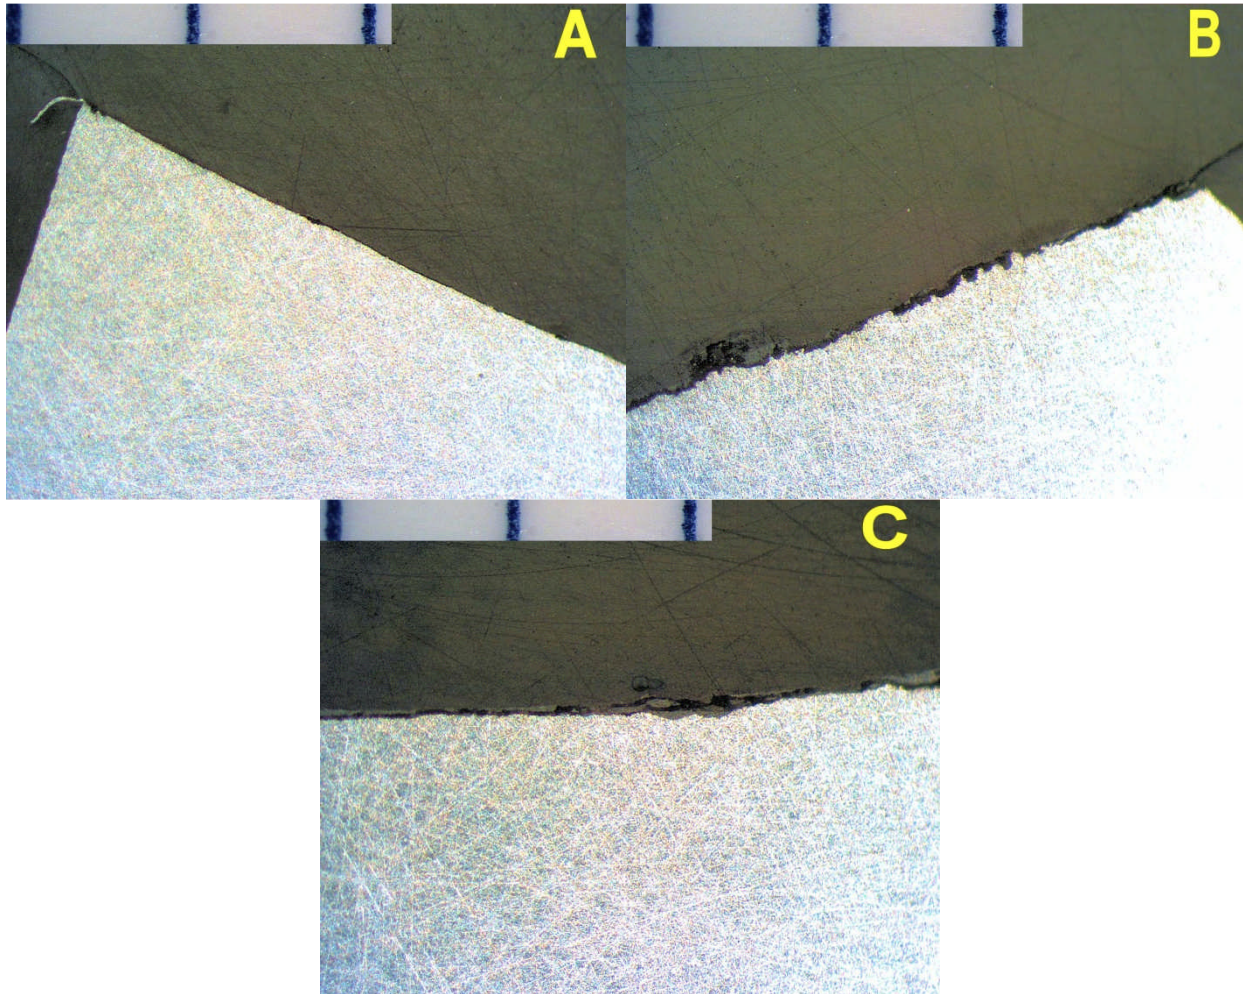
Visual inspection of the cross-section in Figure 3-21 shows that the pipe wall is intact with no areas of wall thinning due to erosion-corrosion. The right side of the image shows that the inner surface of the pipe here contains small pits along the cross-section and a thin layer of corrosion and/or tank waste. In contrast, the left side of the image appears less corroded at this magnification, indicating a non-uniform corrosion of the pipe.

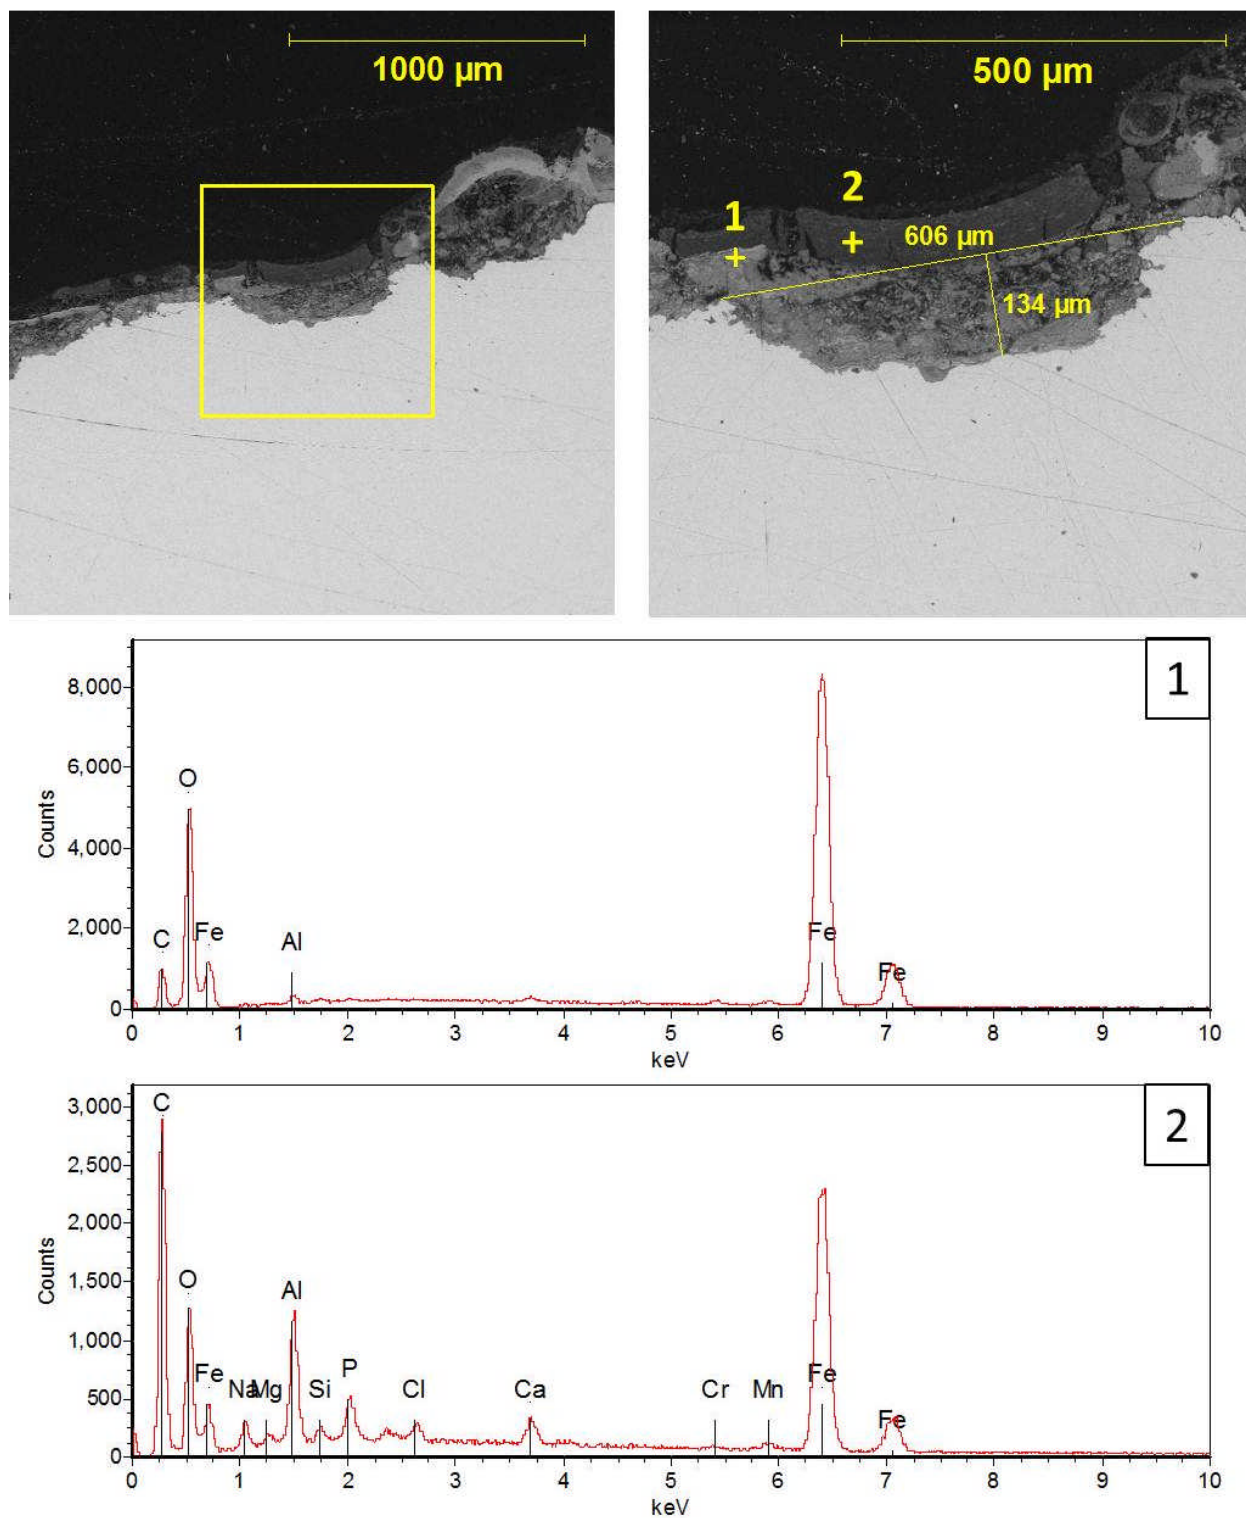
Figure 3-24 contains SEM images from a pit on the right side of the coupon cross-section that measured 23.6 mils (606  $\mu\text{m}$ ) across and 5.2 mils (134  $\mu\text{m}$ ) deep. The pit, along with the entire surface in this area, is coated with a layer of iron oxide as indicated in EDS spectrum 1. There is an additional layer on top of this corrosion layer, and it is comprised mainly of iron, aluminum, oxygen, and carbon (EDS spot #2). This tank waste layer appears to be an iron oxide, aluminum oxide, and either an oxalate or carbonate mix.

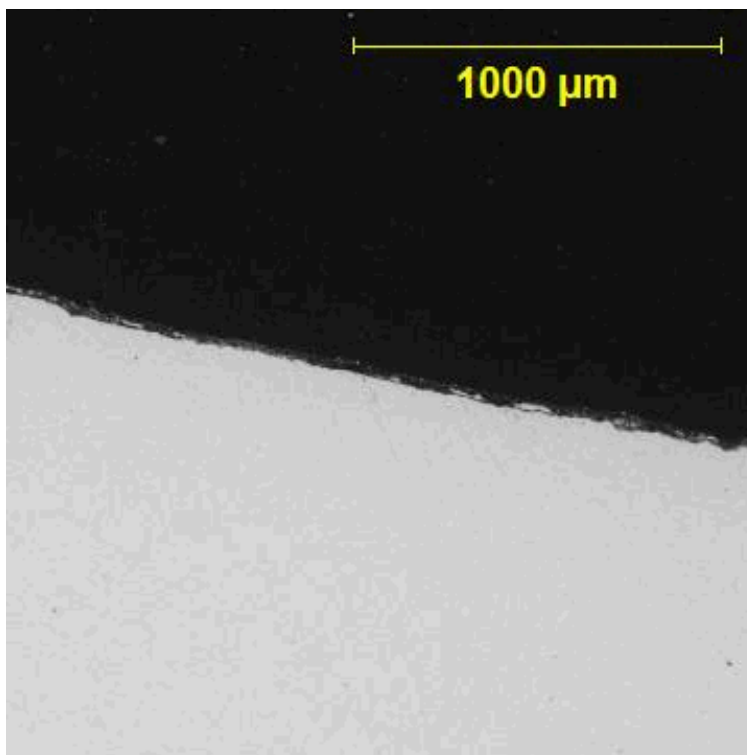
In contrast to Figure 3-24, Figure 3-25 is an SEM image from the left side of the cross-section acquired at the same magnification as the left image in Figure 3-24. The absence of the general corrosion and pitting is apparent on the left side of this coupon. This suggests a varying environment of corrosion on the inside of this pipe. One section was probably exposed to the liquid for an extended period of time and supports the observations of the cross-sectioned elbow in Section 3.3.1.
