# **Final Report for the Erosion-corrosion Analysis of Tank 241-AW-02E Feed Pump Pit Jumpers B-2 and 1-4 Removed from Service in 2013**

**J. S. Page**

Washington River Protection Solutions LLC

March 2014

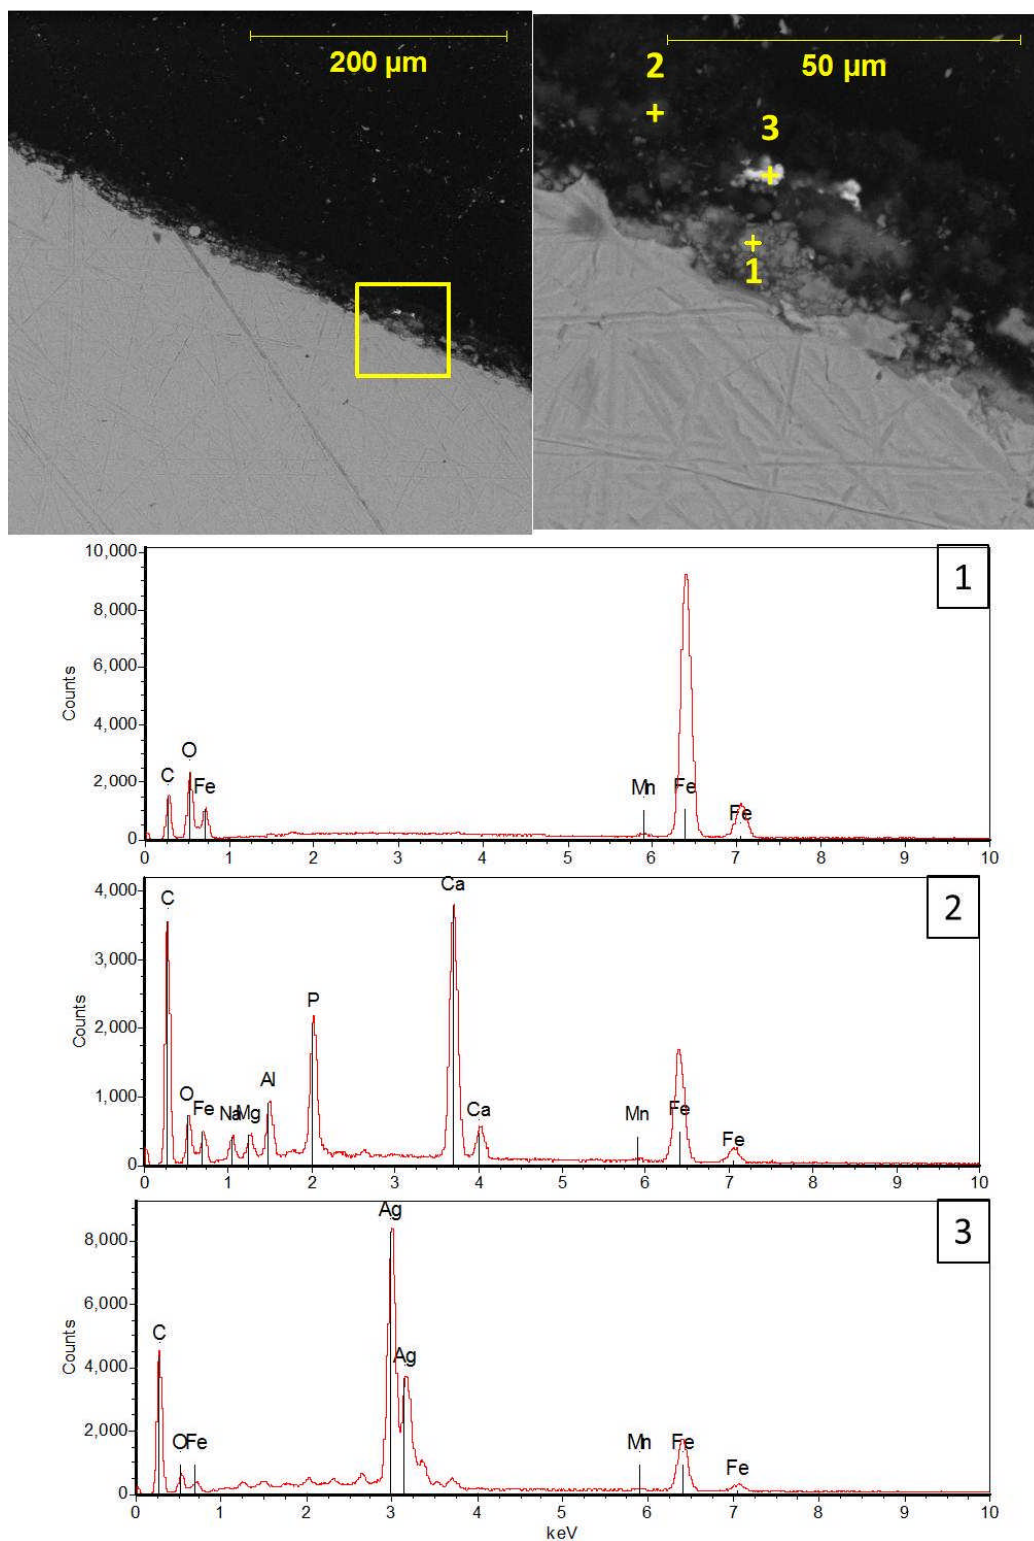
Figure 3-26 shows another location on the left side of the cross-sectioned coupon #2 of jumper 1 – 4. The right image is a magnified view of the location of the area in the yellow box in the left image. Three different locations were analyzed by EDS as indicated by the numbered yellow crosses and corresponding spectra. EDS spot #1 confirms that the thin layer immediately on the pipe wall is iron oxide/hydroxide (corrosion product). EDS spot #2 shows that a tank waste product consisting mainly of a calcium phosphate is also present at this location. Small particles of silver metal (EDS spot #3) are also dispersed on this section of the coupon.

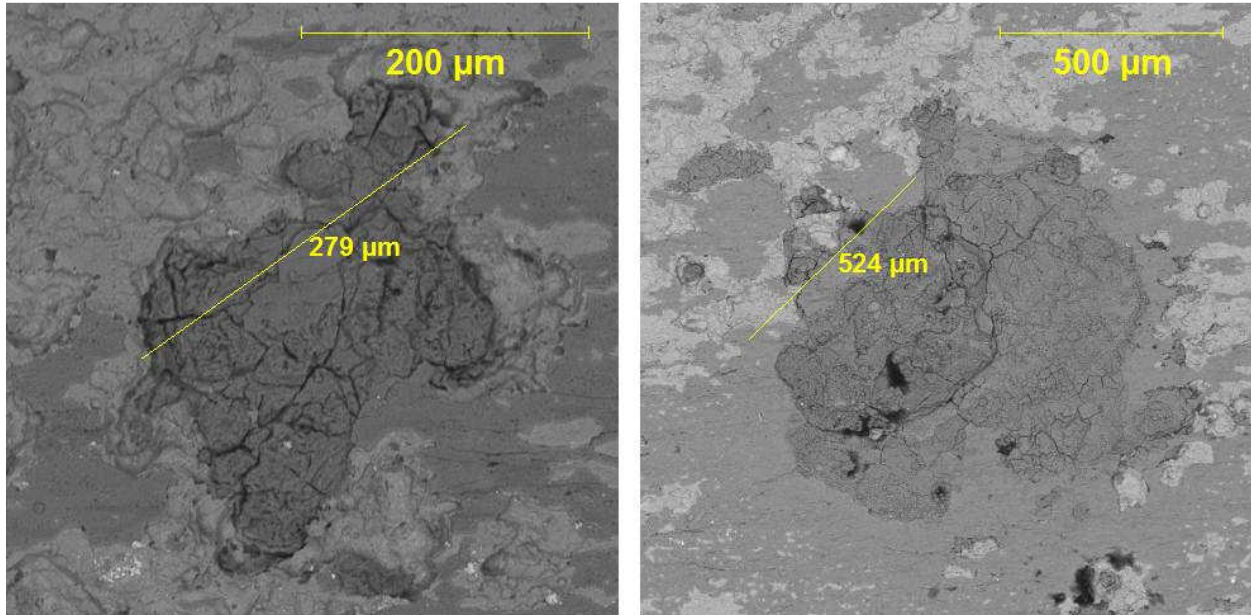
Figure 3-31 shows SEM images of two separate pits detected on the surface of coupon #3 of jumper of 1 – 4. Both pits are filled with corrosion product. The pit on the left was measured at 10.9 mils (279  $\mu\text{m}$ ) across, and the pit on the right was measured at 20.4 mils (524  $\mu\text{m}$ ) across.

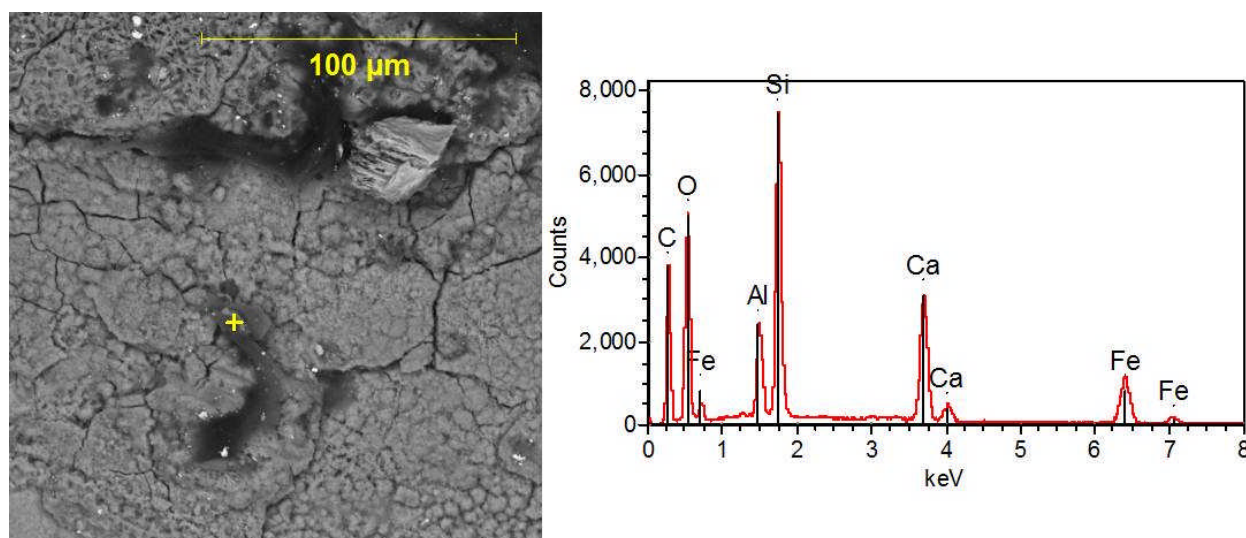
**Figure 3-33. Scanning Electron Microscopy Image and Energy Dispersive Spectrometry Spectrum of a Calcium Aluminum Silicate Tank Waste Material on Coupon #3 of Jumper 1 – 4.**

Tank waste material, which remained after the ammonium citrate treatment, was detected in a few locations lodged on areas of corrosion. The material varied from high carbon content which is probably organic material (Figure 3-32) to a calcium aluminum silicate (Figure 3-33).
