Double-Shell Tank AY-102 Radioactive Waste Leak Investigation

14178 - Session 116, Storage and Retrieval of HLW

D. J. Washenfelder
Washington River Protection Solutions

Date Published
March 2014

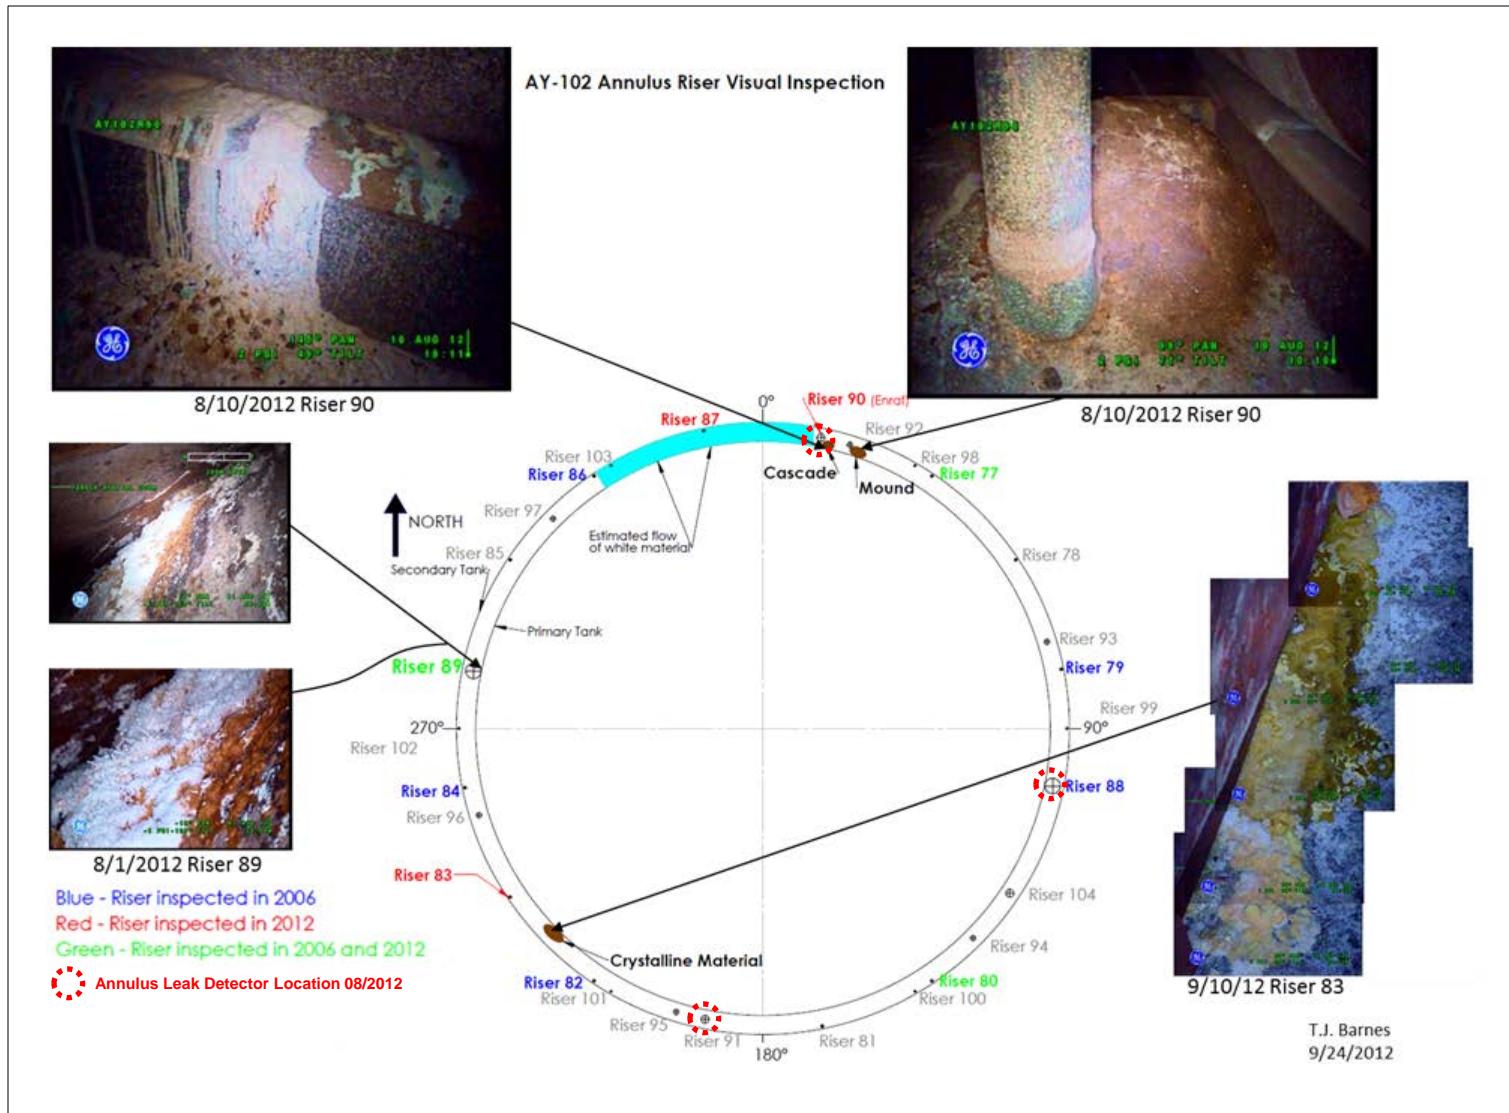
Tank AY-102 Annulus Video Inspection: Sites with Floor Material

- Annulus Floor Material near Riser 83, September 26, 2012:
 - 45 mR/hr dose rate
 - Principal Chemical Constituents: NaNO_3 , Na_2CO_3 , NaNO_2 , KNO_3 ¹
 - Principal Radionuclide Constituents: Sr-90; Cs-137
 - Conclusion: Tank Waste
- Annulus Floor Material near Riser 90, October 10 & 15, 2012:
 - “Brown Mound”: Feldspar and quartz – “Hanford Soil”
 - “Cascade”: Tank Waste

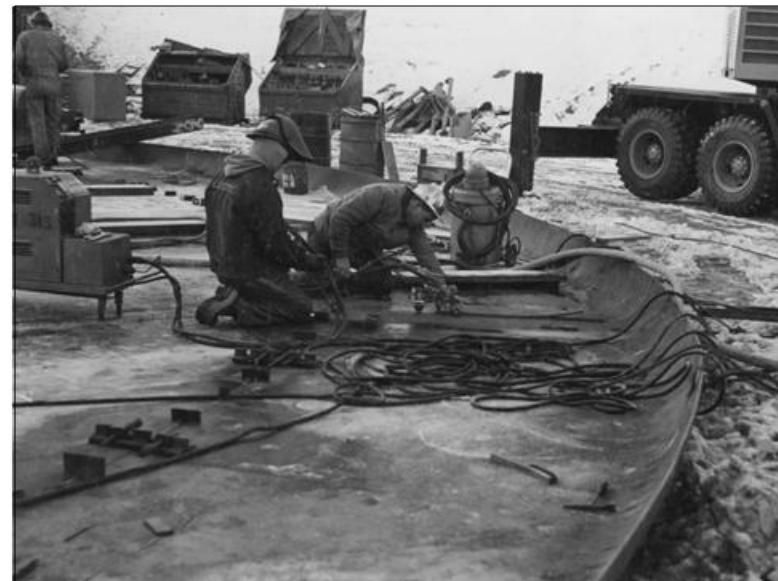
**Welding Tank AY-102 Secondary Tank Bottom
(8051-1-Photo)**

- Secondary Liner Warpage

- Use of thin $\frac{1}{4}$ -inch plates complicated by work in extreme cold (-20°F to -10°F) caused liner warpage. As plates were preheated and welded, convex bulges and wrinkles appeared.
- Flame heating and water fast quench partially eliminated wrinkles. But when plates were heated by the sun new wrinkles appeared.
- February, 1969 survey found 22 liner locations exceeding allowable 2-inch convexity. Root-to-crown slopes up to 1-inch per foot were present, exceeding allowable 3/8-inch per foot.
- These were eventually accepted for placement of the insulating refractory.

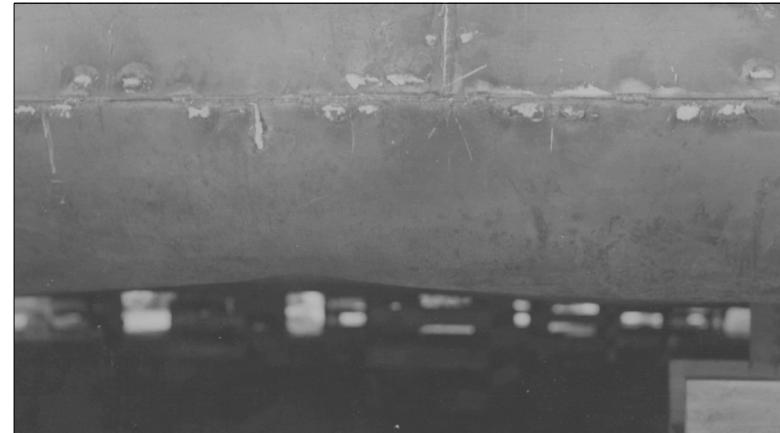
Example of Warped Secondary Tank Bottom Knuckle (8074-Photo)

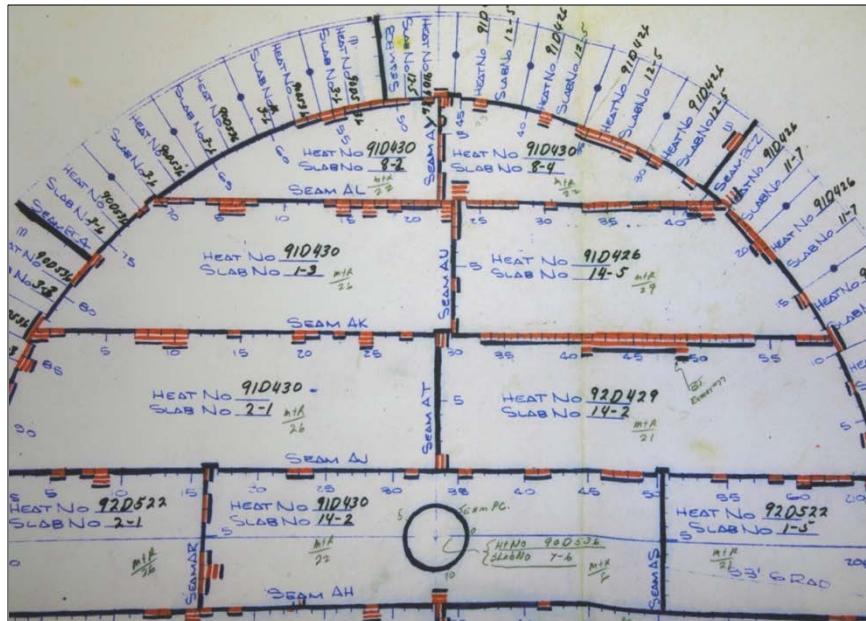
- Primary Tank Bottom Weld Rejection Rate
 - Weld quality was a continuing concern. The floor plate weld rejection rate was ~ 36%. Many welds were repaired several times before passing radiographic examination.

Primary Tank Bottom Plate Weld Map for northern section of tank showing rejected welds in red, and accepted welds in blue. The weld map shows instances of welds being repaired several times before passing inspection.

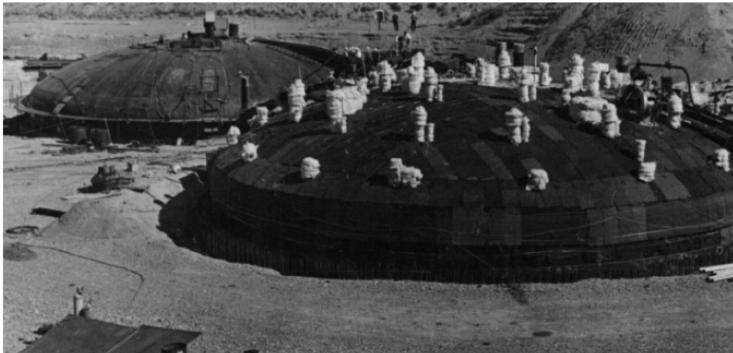
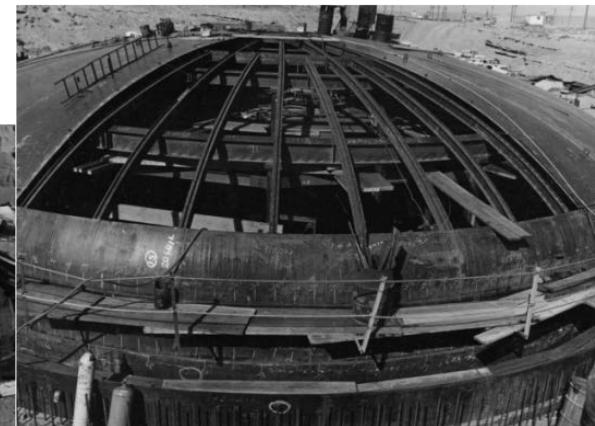
- Rainwater saturated the insulating refractory pad in the weeks before the primary tank was scheduled for post-weld stress-relief.
- During stress relief, the tank bottom temperature could not be raised above 210°F for two days, while steam escaped from the water-soaked refractory.
- The tank temperature eventually reached the required annealing temperature and was held at temperature for the required time.

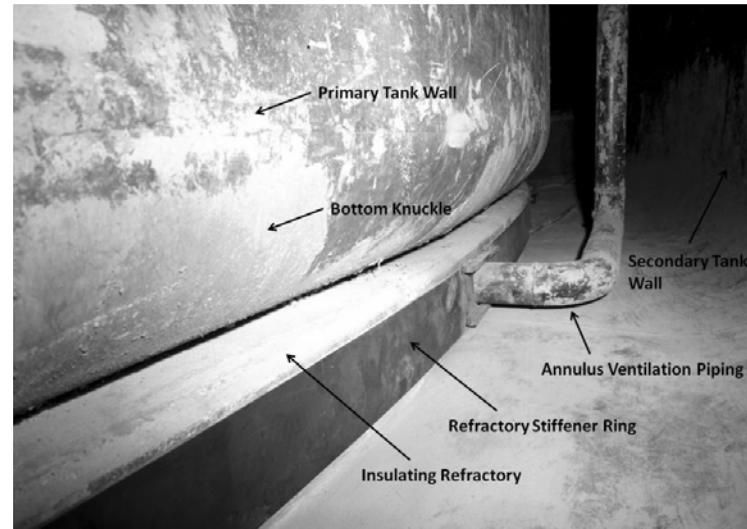
- Insulating refractory damage from stress-relief and hydrostatic test of primary tank
 - Full depth cracks $\frac{1}{4}$ -inch wide extending several feet under primary tank
 - Spongy top surface; affected depth increased as outer lip approached
 - Air passages blocked with spalled refractory
 - Thought to result from skin friction as primary tank expanded and contracted across surface of refractory concrete pad during stress-relief, and “oil-canning” of the tank on the outside perimeter of the pad

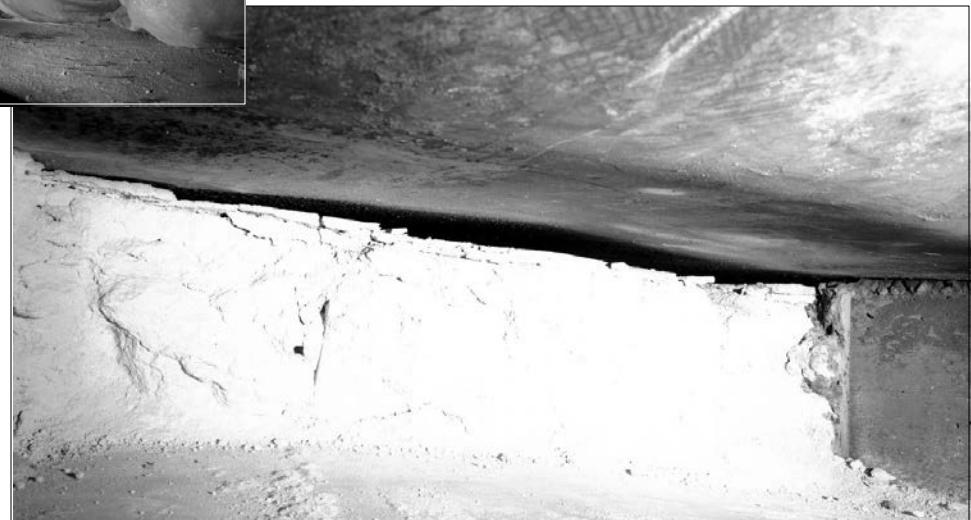
Tank AY-101 Primary Tank Gap over Insulating Refractory (52788-8-Photo). Gaps in Tank AY-102 were reported to be larger.

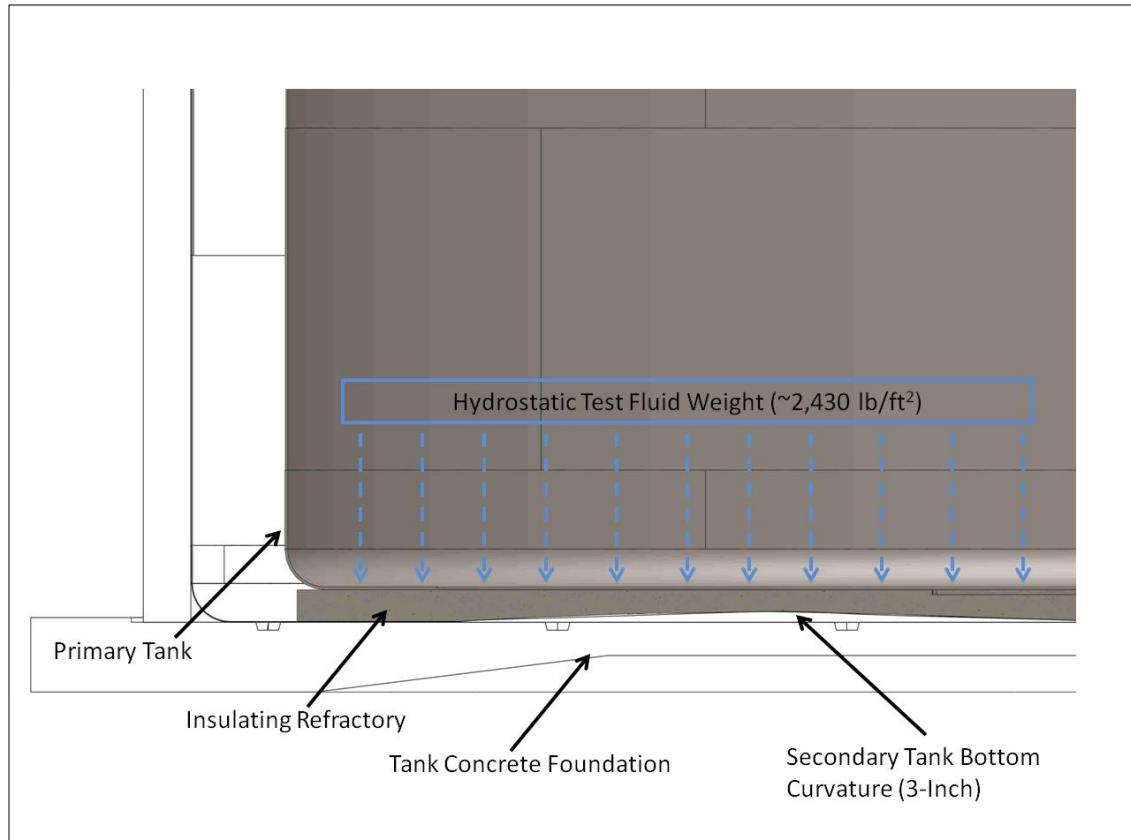
Tank Configuration with 3-Inch Secondary Tank Convex Bottom Curvature during Hydrostatic Test.

- Corrosion at high waste temperatures in a tank whose waste containment margins had been reduced by construction difficulties.
 - During 1977 – 1979 and 1983 – 1984 waste with insufficient NaNO_2 corrosion inhibitor probably came into contact with tank bottom. The corrosion situation was exacerbated by introduction of high-temperature tank C-106 sludge during 1998-1999.
 - Secondary floor liner bulges and primary tank post-stress relief condition created untenable performance demands for insulating refractory and primary tank bottom.
