DOE/NV--1517

Post-Closure Inspection Report for  
the Tonopah Test Range, Nevada

For Calendar Year 2013

**U.S. Department of Energy  
National Nuclear Security Administration  
Nevada Field Office  
Las Vegas, Nevada**

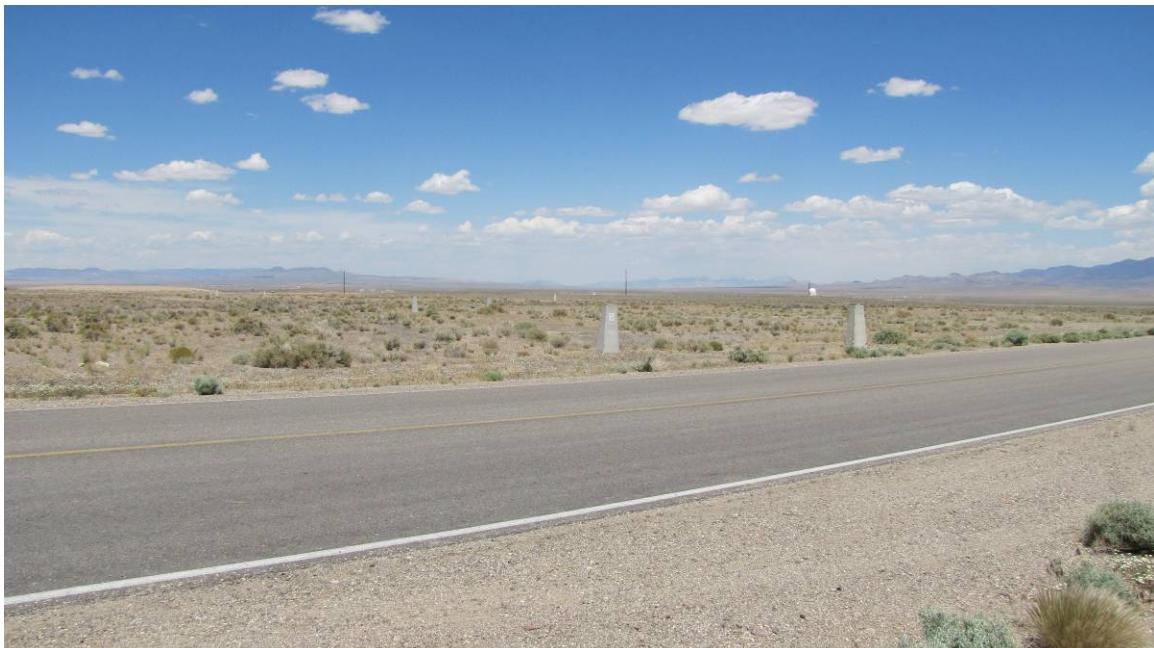
Photograph 4: CAU 424, Landfill Cell A3-2, Looking North, 05/14/2013

Landfill Cell A3-2 (CAS 03-08-002-A302): Minor settling was observed that did not require repair. No other issues or concerns were identified, and maintenance and repairs were not required. Inspections should continue as scheduled.

6. Waste Unit Cover (Landfill A3-2):  a. Is there evidence of settling or cracking?  b. Is there evidence of erosion (wind or water)?  c. Is there evidence of human or large animal intrusion onto the site?  d. Are animal burrows present?  e. Is there trash or debris within the use restricted area?  f. Are there any other issues not specifically described in this checklist?	YES	X	MINOR SETTLING NEAR NORTH END, NO REPAIR, MONITOR NEXT YEAR.

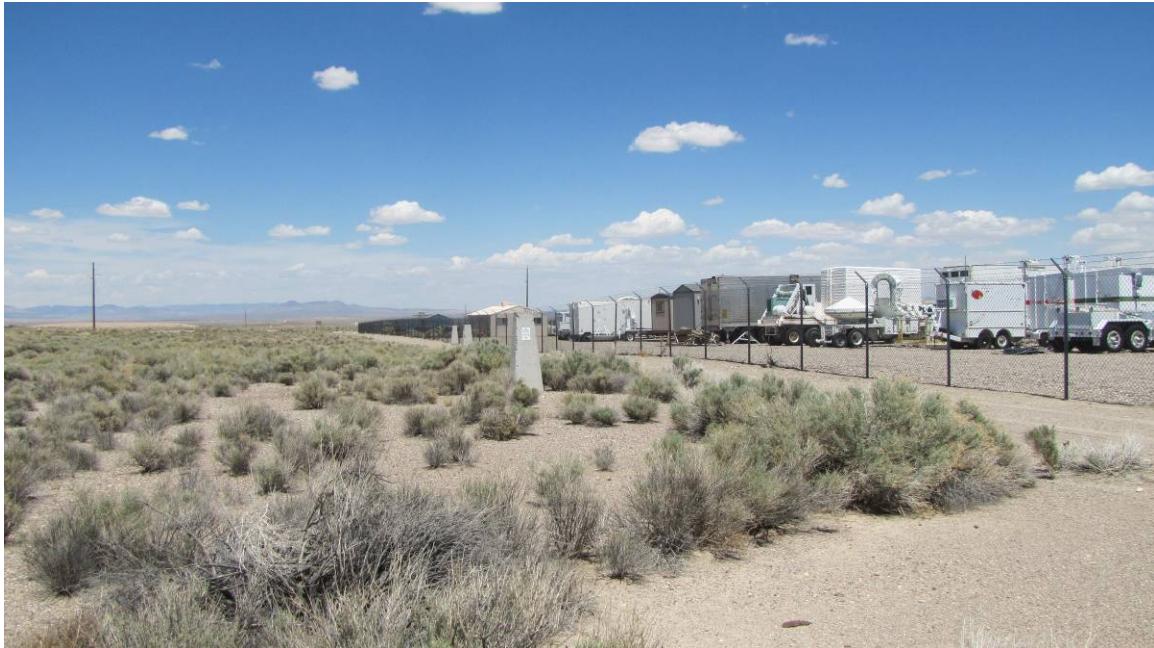
Photograph 5: CAU 424, Landfill Cell A3-3, Looking North, 05/14/2013

Landfill Cell A3-3 (CAS 03-08-002-A303): Erosion on the road that traverses the site was observed, and metal debris was visibly protruding up through the surface of the landfill. The road that goes over the landfill was permanently closed. The protruding metal debris was cut at the surface, and loose debris was picked up. Removed debris was disposed of in the TTR sanitary landfill. A 1-foot cover was constructed over the road and compacted by wheel rolling. Repairs were completed on July 16, 2013. Additional lava rock was required in high-traffic areas to mark the locations of the surface grade monuments. Additional lava rock was placed on the surface grade monuments on July 16, 2013. No other issues or concerns were identified, and additional maintenance and repairs were not required. Inspections should continue as scheduled.

9. Waste Unit Cover (Landfill A3-3, western two cells):  a. Is there evidence of settling or cracking?  b. Is there evidence of erosion (wind or water)?  c. Is there evidence of human or large animal intrusion onto the site?  d. Are animal burrows present?  e. Is there trash or debris within the use restricted area?  f. Are there any other issues not specifically described in this checklist?	YES	X	MINOR EROSION DUE TO TRAFFIC, VISIBLE ON SURFACE

Erosion repairs were completed at Landfill Cell A3-3 on July 16, 2013. Subsidence was repaired at Landfill Cell A3-4 on July 16, 2013. Additional lava rock was placed in high-traffic areas to mark the locations of the surface grade monuments at Landfill Cell A3-3 and Landfill Cell A3-8 on July 16, 2013. Additional maintenance or repairs were not required. Inspections should continue as scheduled.

3. Field Conclusions/Recommendations:
ADD' L LAVA ROCK SHOULD BE ADDED AT A3-3 AND A3-8.
REPAIR SUBSIDENCE AT A3-4.
REMOVE SOME DEBRIS AND RE-COVER AT A3-3

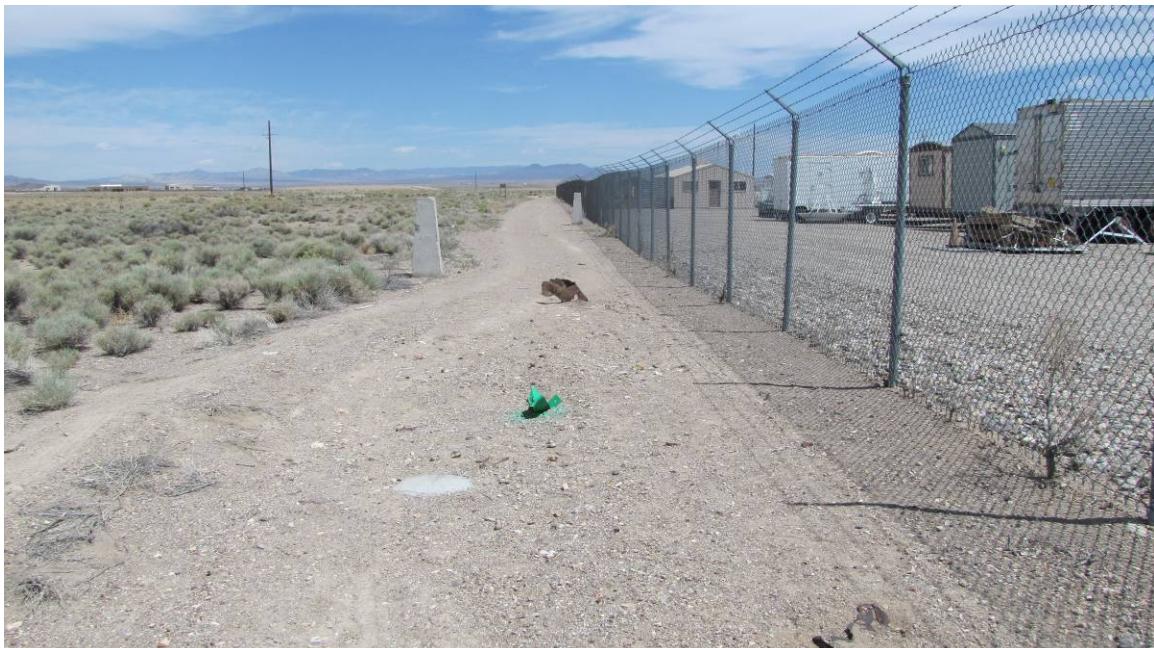
Photograph 6: CAU 424, Landfill Cell A3-3, Debris Looking North, 06/11/2013

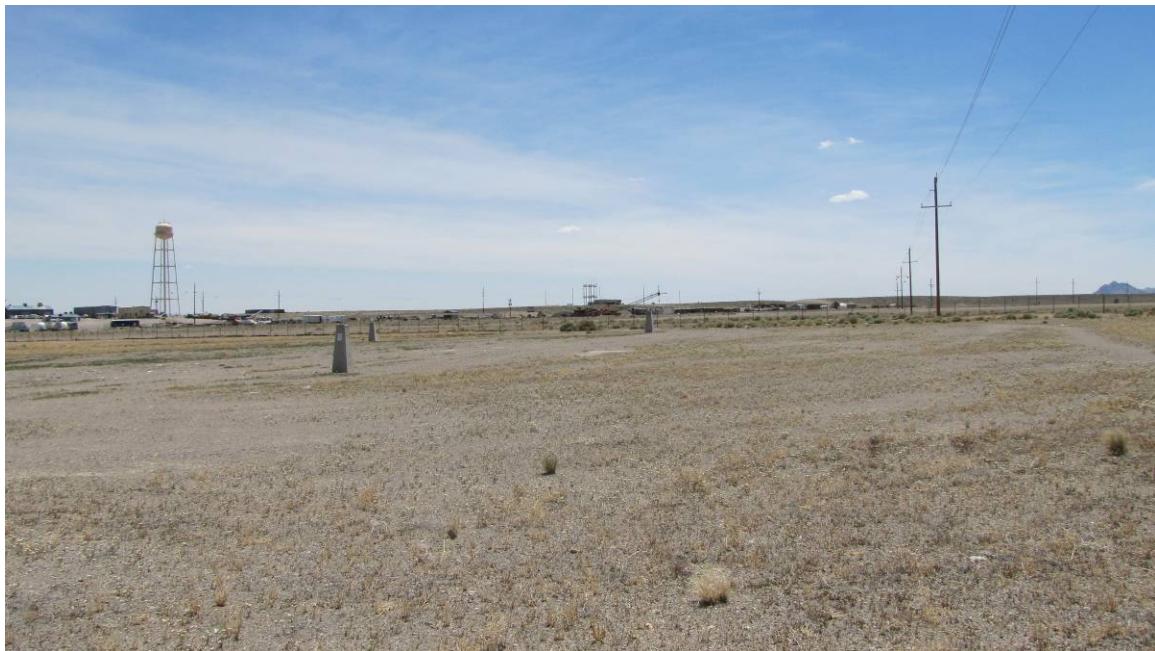
Photograph 7: CAU 424, Landfill Cell A3-4, Looking North, 05/14/2013

Landfill Cell A3-4 (CAS 03-08-002-A304): An area of subsidence was observed on the cover. The subsidence was repaired on July 16, 2013. No other issues or concerns were identified, and additional maintenance and repairs were not required. Inspections should continue as scheduled.

d. How many down or loose signs need to be re-hung?		O	
15. Waste Unit Cover (Landfill A3-4):	YES	NO	EXPLANATION (required if shaded box is checked)
a. Is there evidence of settling or cracking?	X		~10' x 10' AREA OF SUBSIDENCE NEAR N. SIDE,

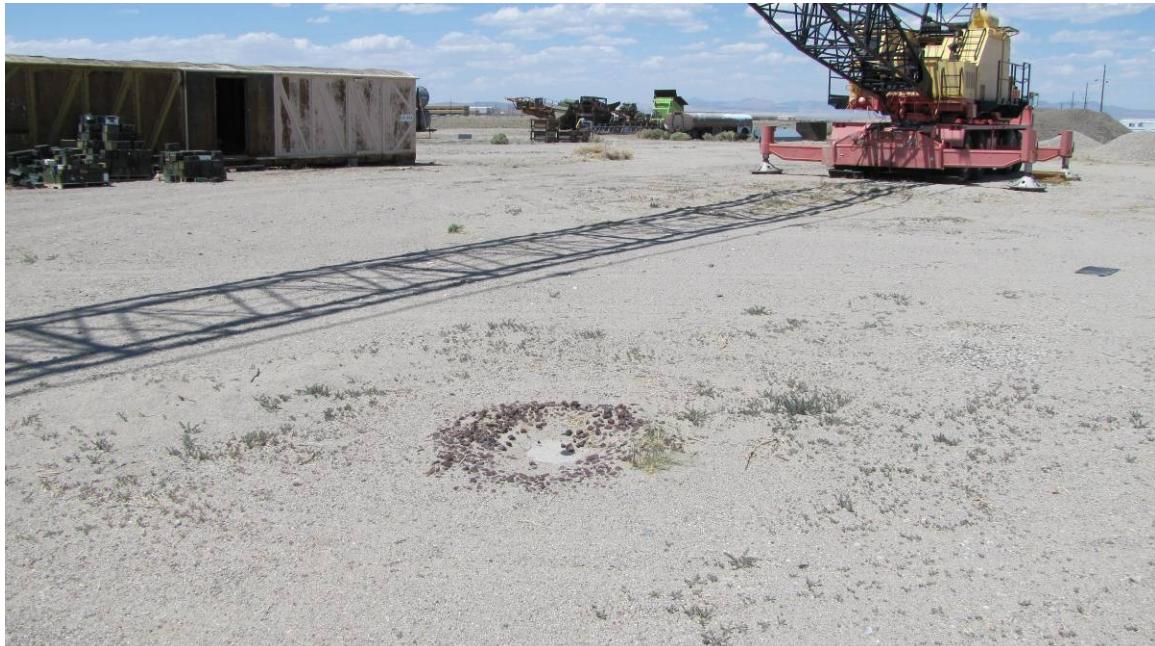
Photograph 10: CAU 424, Landfill Cell A3-8, Looking West, 05/14/2013

Landfill Cell A3-8 (CAS 03-08-002-A308): Additional lava rock was required in high-traffic areas to mark the locations of the surface grade monuments. Additional lava rock was placed on the surface grade monuments on July 16, 2013. No other issues or concerns were identified, and additional maintenance and repairs were not required. Inspections should continue as scheduled.

a. Are all four (4) surface markers in good condition and is lava rock sufficient to locate them?		<input checked="" type="checkbox"/>	LAVA ROCK IS SUFFICIENT TO LOCATE, BUT ADD'L ROCK SHOULD BE ADDED TO ENHANCE VISIBILITY

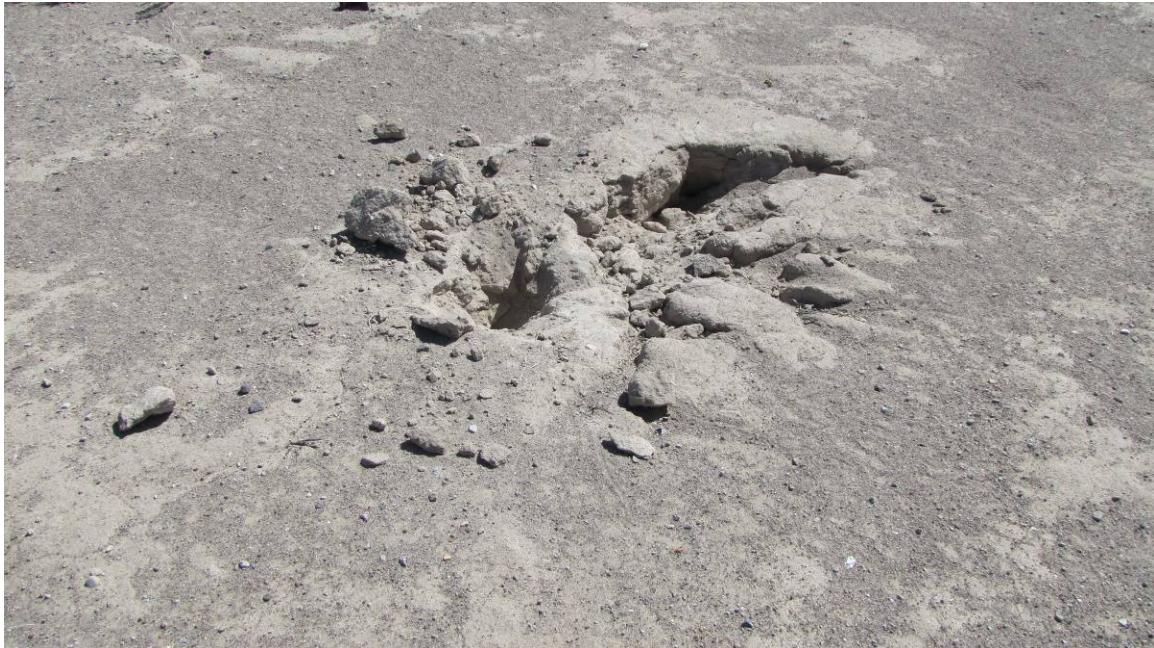
Photograph 11: CAU 453, Subsidence, 05/14/2013

Two areas of subsidence and animal burrows identified during the inspection were repaired on July 16, 2013. Inspections should continue as scheduled.
