Hanford Single-Shell Tank Leak Causes and Locations - 241-T Farm

C.L. Girardot, D.G. Harlow

Key Words: leak location, leak cause, tank, integrity assessment, T Farm, T-106, T-111, leak assessment

Abstract: This document identifies 241-T Tank Farm (T Farm) leak causes and locations for the 100 series leaking tanks (241-T-106 and 241-T-111) identified in RPP-RPT-55084, Rev. 0, Hanford 241-T Farm Leak Inventory Assessment Report. This document satisfies the T Farm portion of the target (T04) in the Hanford Federal Facility Agreement and Consent Order milestone M-045-91F.

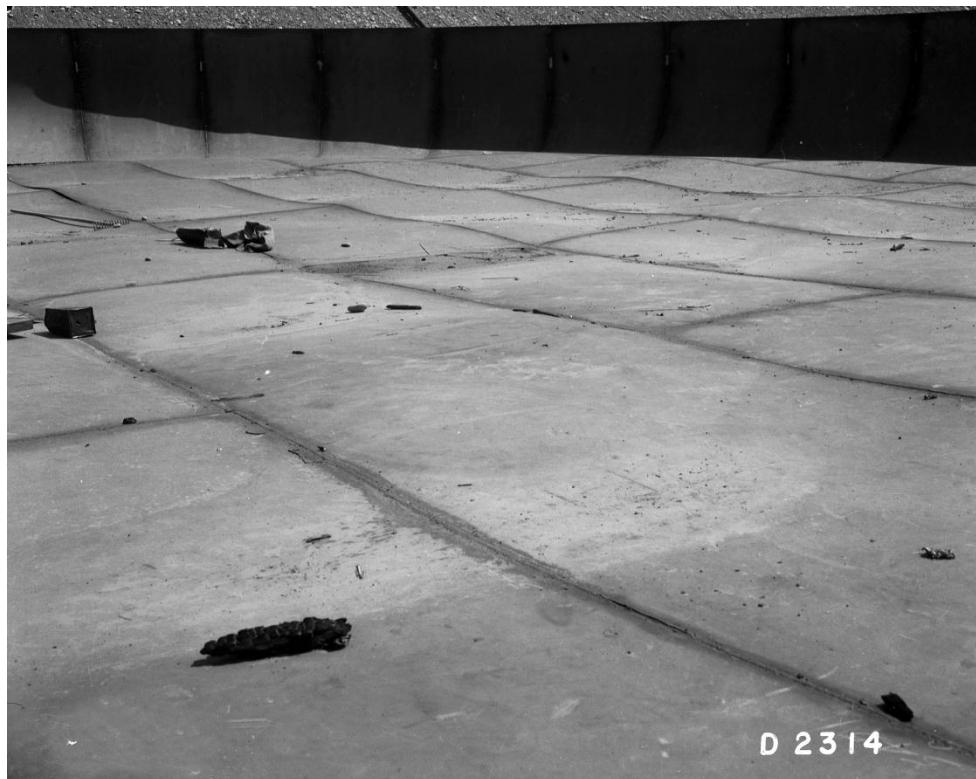
The T Farm tanks experienced a reported buckling of the bottom liners during construction of the tanks and all of the T Farm tank bottom liners required replacement (HW-7-103, *Hanford Engineering Works Monthly Report April 1944*, page 14).

“The extensive buckling of 75’ liner bottoms at Bldg. 241-T received considerable attention, and it was decided that all twelve of the bottoms would require replacement. The subcontractor is proceeding with this work.”

**Figure 3-3. T Farm Tank Buckled Liner April 15, 1944
(Specific Tank Not Identified)**

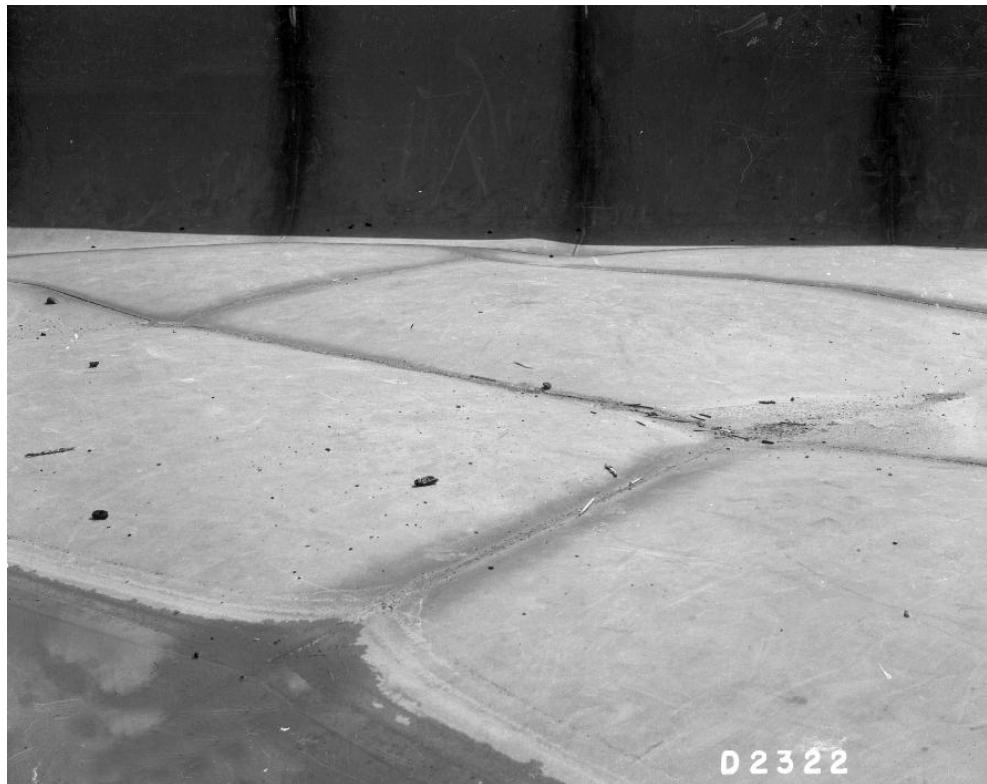
Figure 3-4. Tank T-111 Tank Buckled Liner April 15, 1944

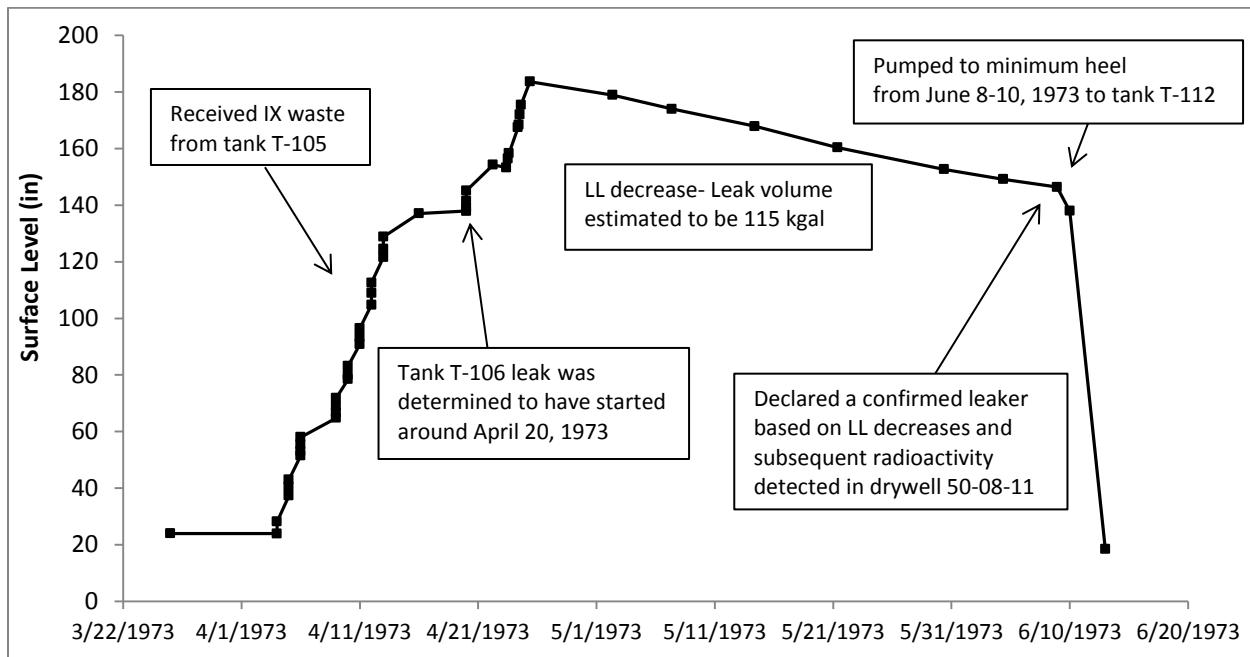
The tank T-106 leak was determined to have started on or around April 20, 1973 (AEC Report 1973). The tank was declared a confirmed leaker June 8, 1973 based on liquid level decreases and subsequent radioactivity detected in drywell 50-08-11. A plot of the tank T-106 liquid level from March 26, 1973 through June 13, 1973 (see Figure 4-4) shows the transfer of ion exchange (IX) waste from tank T-107 to tank T-105 and cascaded to T-106 and subsequent liquid level decrease from a leak. The total leak volume of waste from the tank, 115 kgal, occurred during the transfer of waste into tank T-106 through pumping the waste to tank T-112 starting June 8, 1973.

Figure 4-4. Tank T-106 Liquid Level March 26, 1973 through June 10, 1973

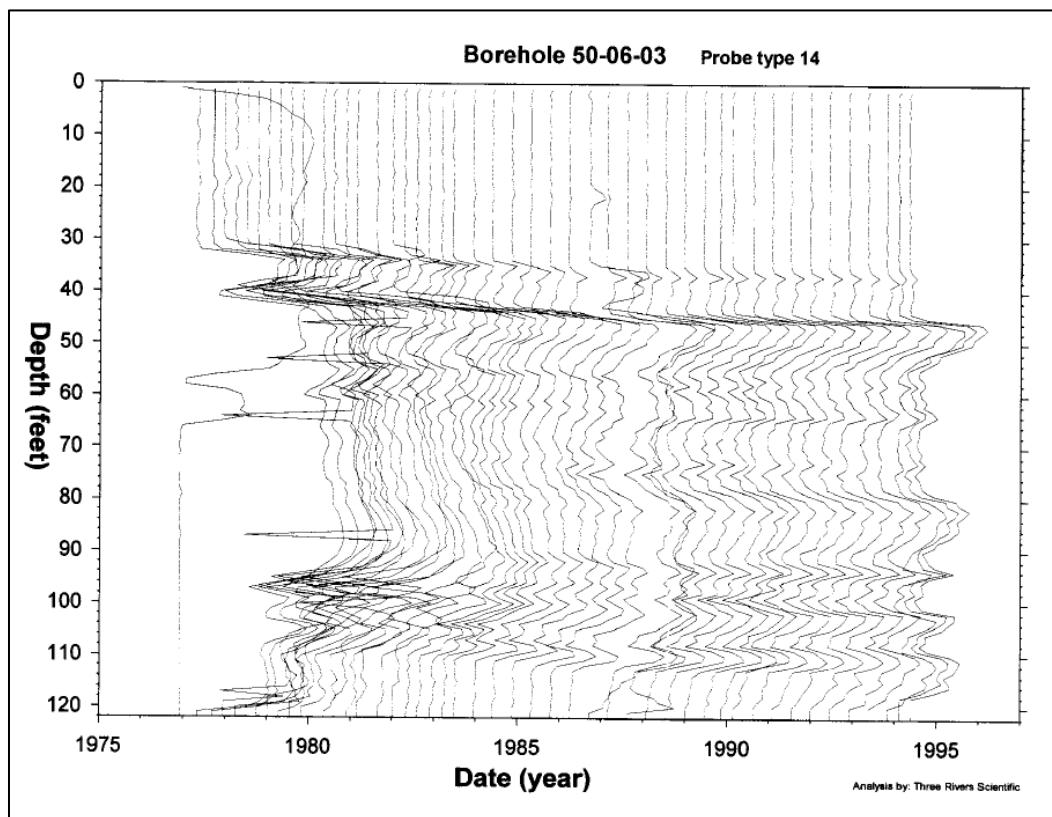
Drywell 50-06-03 is located approximately 3.1-ft from the tank T-106 footing. Drywell 50-06-03 was drilled in June 1973 with the first recoverable reading on June 27, 1973 with two peaks, 350K cpm at ~46-ft BGS and 500K cpm at ~82-ft BGS (see Appendix A1). The next reading on July 24, 1973 reported two peaks, 337K cpm at 43-ft BGS and 257K cpm at 77-ft BGS, both peaks at a higher BGS level. Radioactivity continued to be detected through August 1987 at about the 82 to 92-ft BGS level. The peaks were reported at the higher BGS level (~45-ft BGS) later from 1984 to 1987.

Figure 4-7. Tank T-106 Drywell 50-06-03 (RPP-6088)

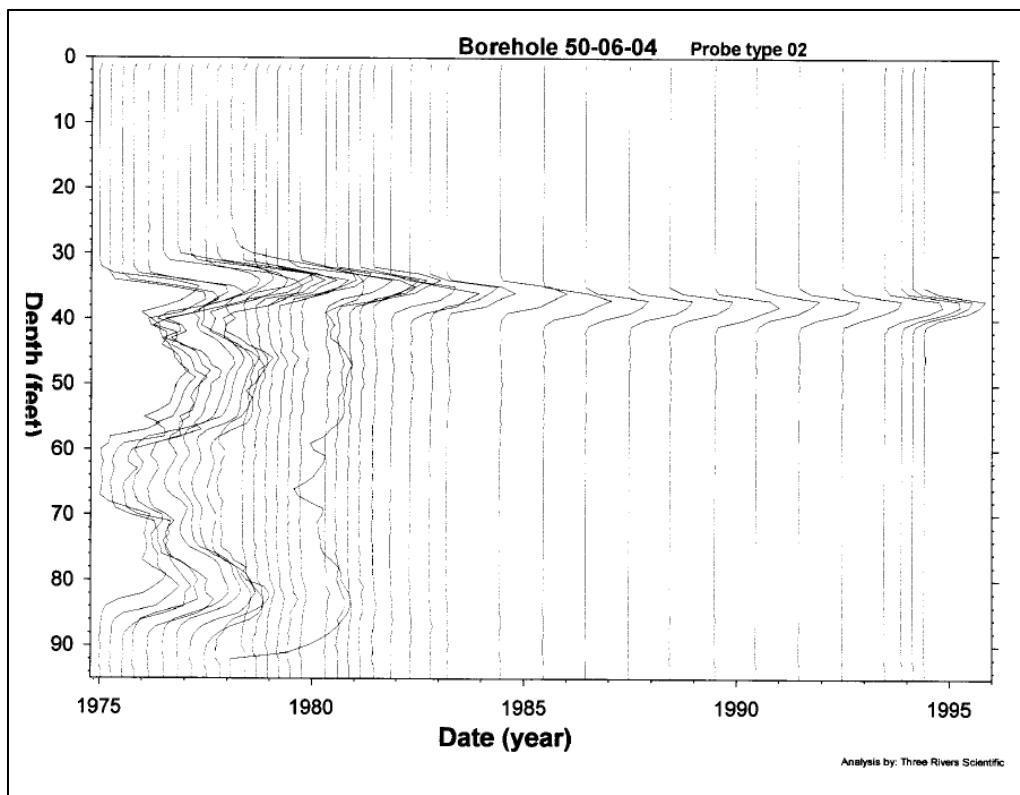
Drywell 50-06-04 is located approximately 2.2-ft from the tank T-106 footing. Drywell 50-06-04 was drilled in July 1973 with the first recoverable readings reported on July 24, 1973 with two peaks, 387K cpm at 33-ft BGS and 290K cpm at 45-ft BGS (see Appendix A1). Radioactivity levels gradually declined through June 1987 but the peak continued to be reported at the higher BGS depth (33-37-ft BGS).

Figure 4-8. Tank T-106 Drywell 50-06-04 (RPP-6088)

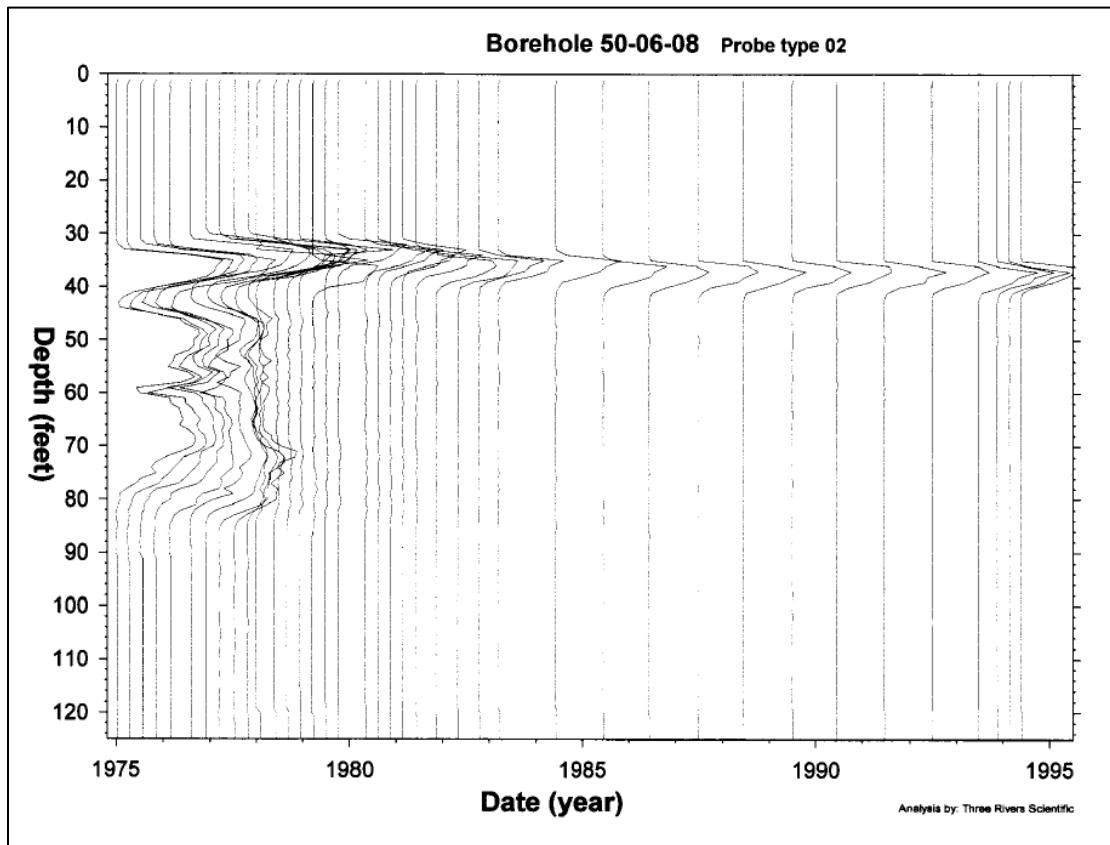
Drywell 50-06-08 is located approximately 4.8-ft from the tank T-106 footing. Drywell 50-06-08 was drilled in July 1973 with the first recoverable reading on July 11, 1973 with two peak reported, 450K cpm from 32 to 39-ft BGS and 350K cpm at ~49-ft BGS (see Appendix A1). The next recoverable reading on July 24, 1973 reported only one peak at 34-ft BGS. Readings gradually declined to 22.9K cpm by June 1987 at this BGS level.

Figure 4-13. Tank T-106 Drywell 50-06-08 (RPP-6008)

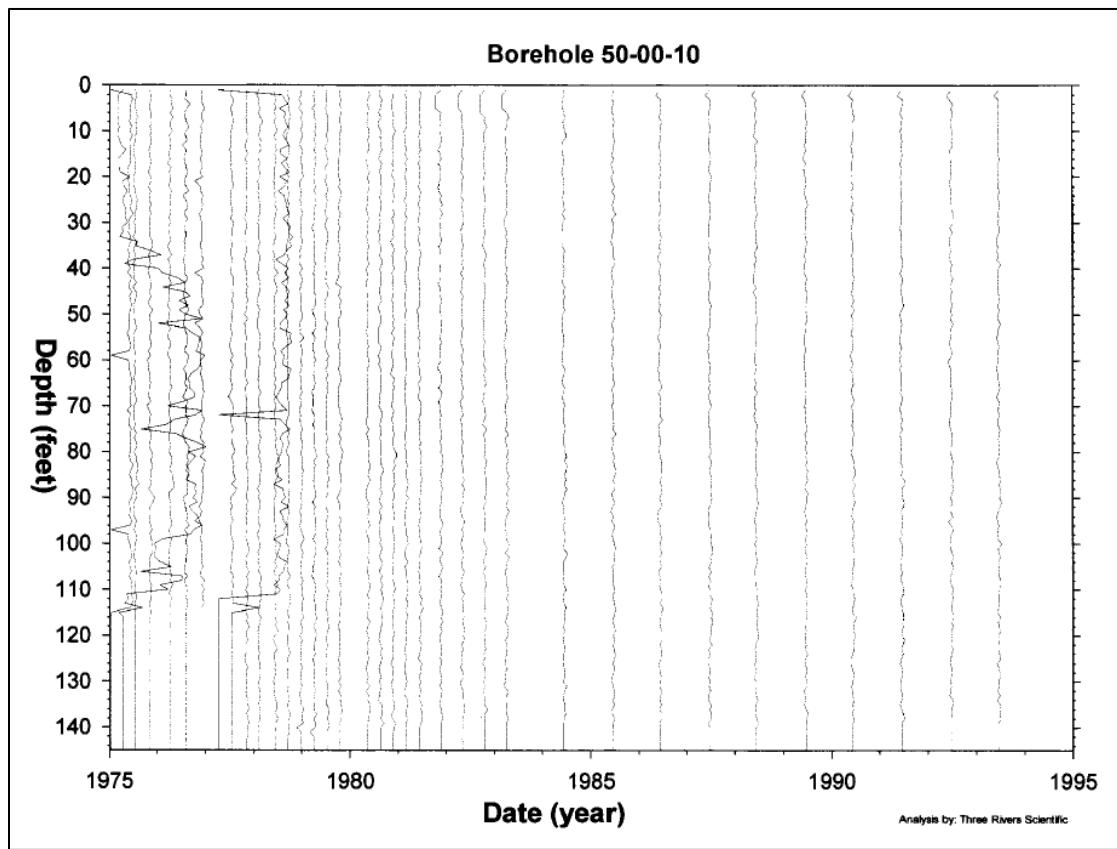
Drywell 50-00-10 is located approximately 39-ft from the tank T-106 footing. Drywell 50-00-10 was drilled in 1944 with the first recoverable reading in 1973 reported as less than values (see Figure A1-1). No other drywell data were recovered except for Figure 4-15 which shows the depths of radioactivity from 1975 to 1995 (RPP-6088).

Figure 4-15. Tank T-106 Drywell 50-00-10 (RPP-6088)

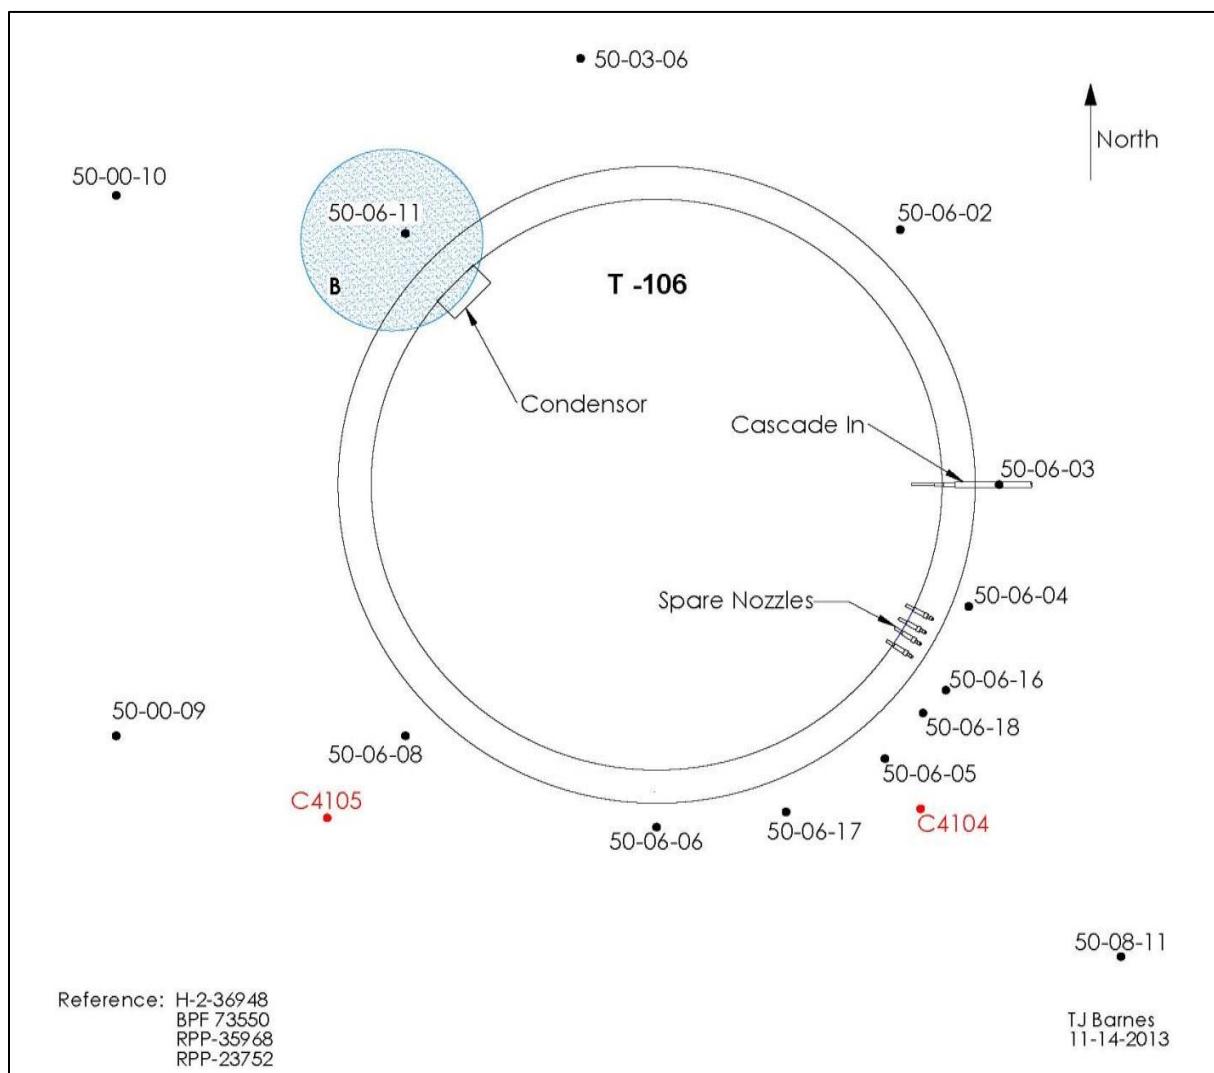
Figure 4-20. Tank T-106 Possible Leak Location (July 1973)
Tank inner ring is steel liner; outer ring is outer edge of tank footing

The tank T-106 was determined to have started on or around April 20, 1973 (see Section 4.4.1). Only two drywells (50-08-11 and 50-00-10) were located near the tank when the tank was first suspected of leaking. Additional drywells were installed near tank T-106 beginning in June 1973.

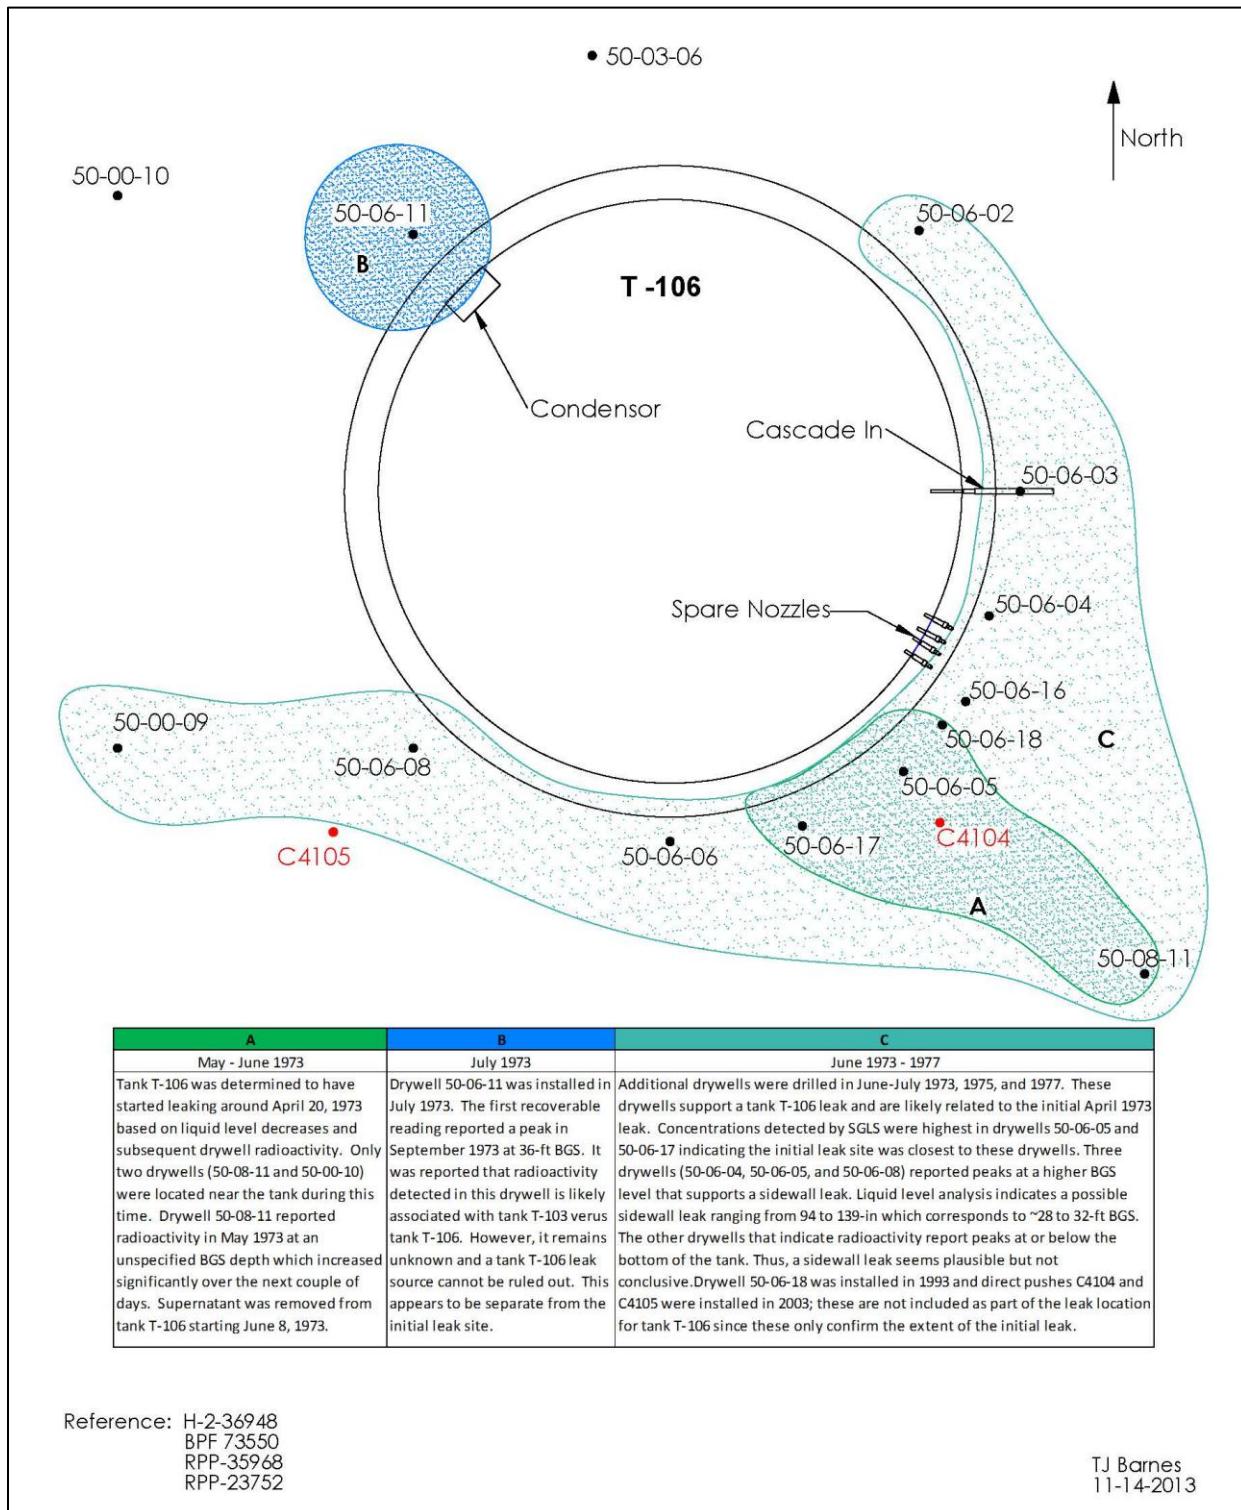
Figure 4-22. Tank T-106 Possible Radial Leak Locations
 Tank inner ring is steel liner, outer ring is outer edge of tank footing

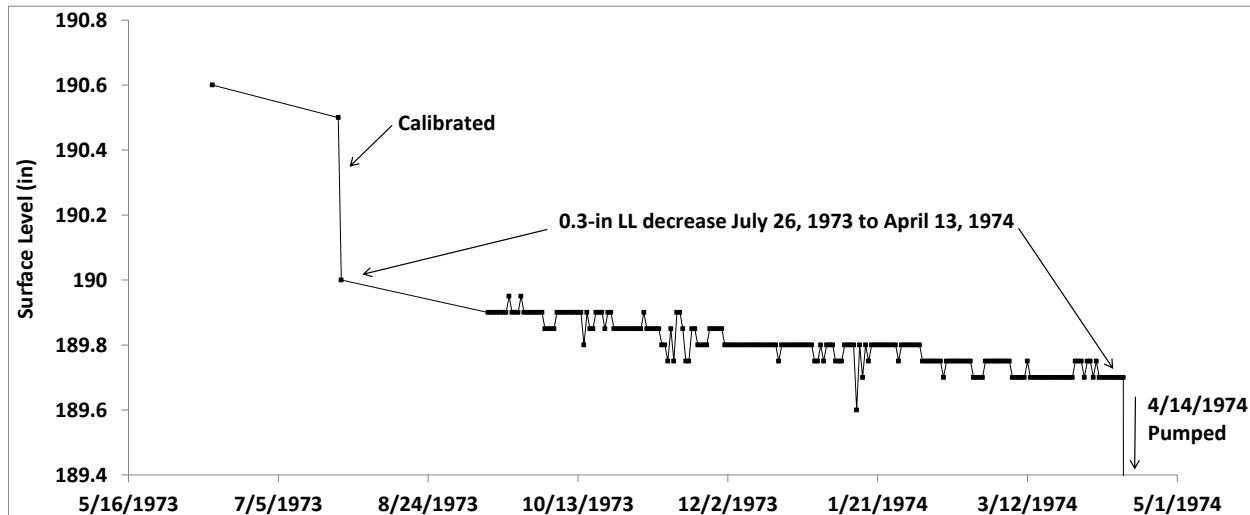
Tank T-111 was first suspected of leaking due to a 0.3-in liquid level decrease (~700 gal) in April 1974. The liquid level decrease was reported to have occurred starting July 26, 1973 (190-in) to April 13, 1974 (189.7-in), a period of nine months (see Figure 5-4). Supernatant was removed from tank T-111 to tank S-110 starting April 14, 1974. The leak volume was estimated to be less than 1,000 gal (HNF-EP-0182, *Waste Tank Summary Report for Month Ending February 28, 2013*).

Figure 5-4. Tank T-111 Liquid Level June 13, 1973 to April 14, 1974

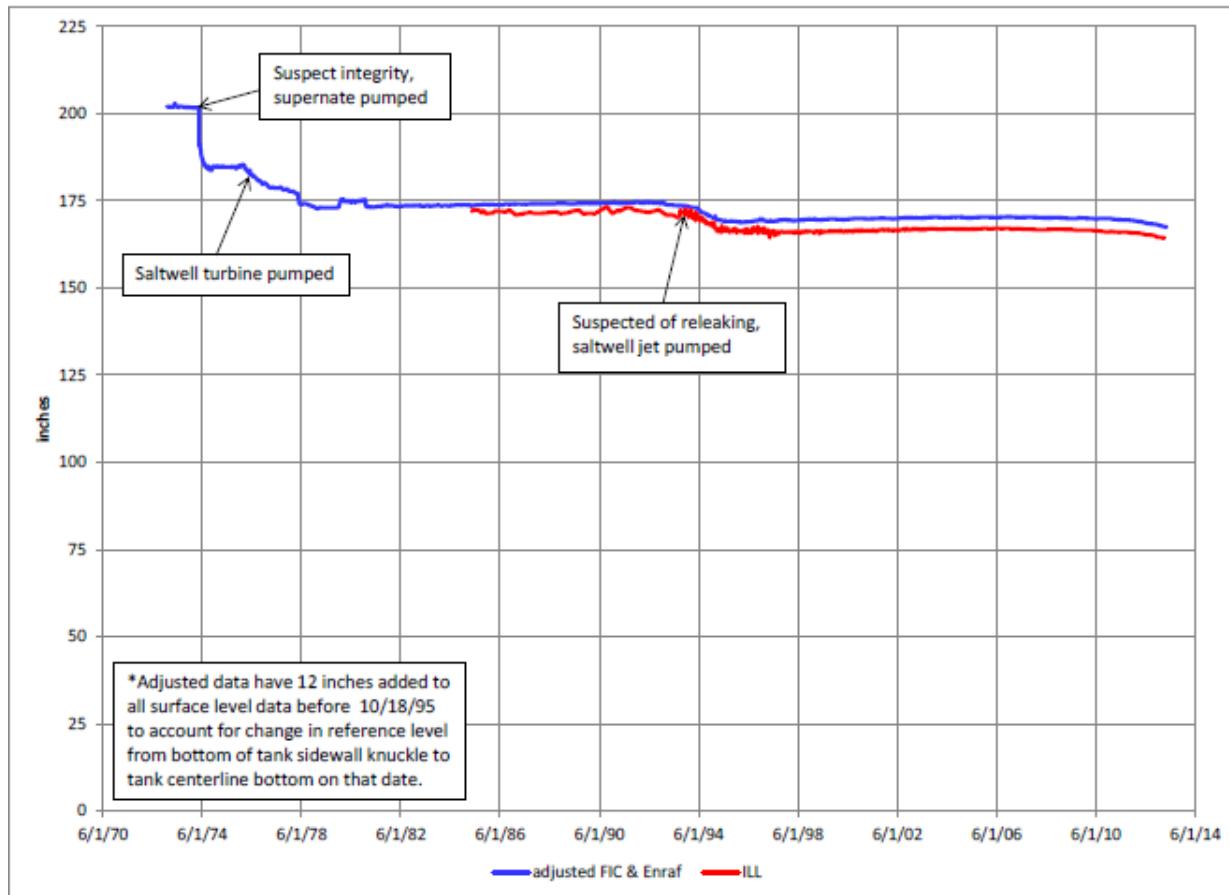
From 1978 to 1993, tank T-111 had an apparent water intrusion of over 1.5-in as shown in Figure 5-5 (RPP-RPT-54964, Rev. 1). However, in 1993 the liquid level began to decrease and the tank was suspected of leaking again. A jet pump was installed and additional liquid was removed to the extent practical in 1994 and 1995. From 1995 to 2006, the tank liquid level increased 1-in before the liquid level began to drop again. Since 2006, the liquid level has been decreasing with the decrease rate accelerating with time. The volume of tank T-111 liquid leaked from 1995 to January 2014 is calculated at ~2,600 gal (RPP-RPT-54964, Rev. 2) after analysis of possible contributing factors including gas accumulation.

Figure 5-5. Tank T-111 Interstitial Liquid Level and Adjusted* Surface Level Data (RPP-RPT-54964, Rev. 1)

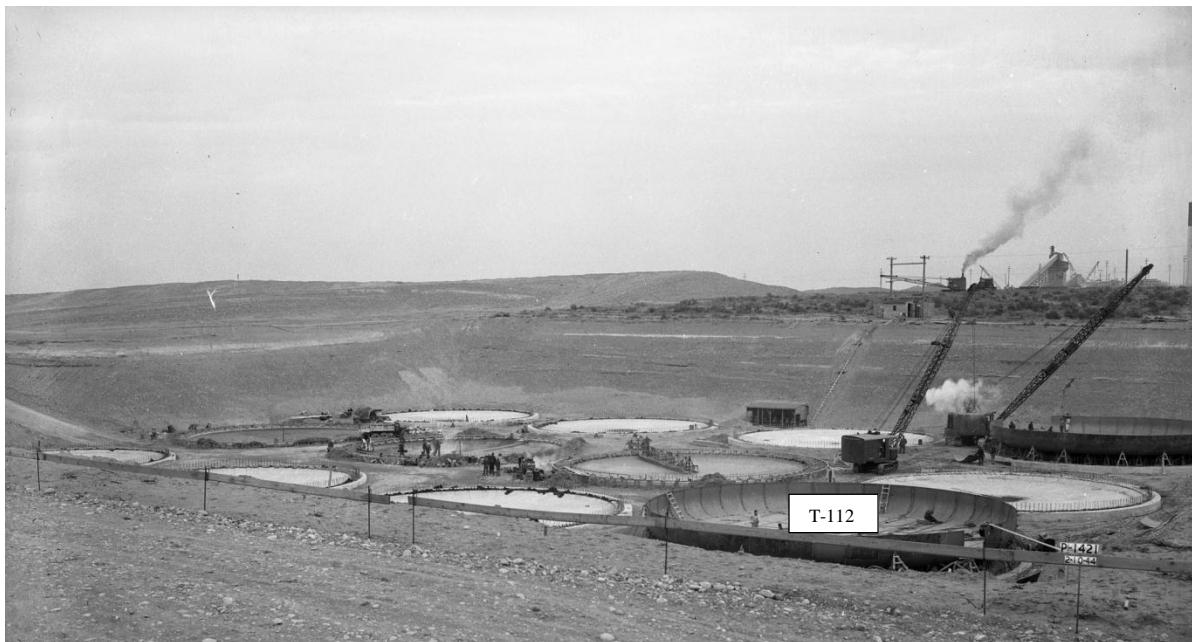
**Figure B-1. T Farm Initial Tank Liner Construction
February 10, 1944 (P-1421)**

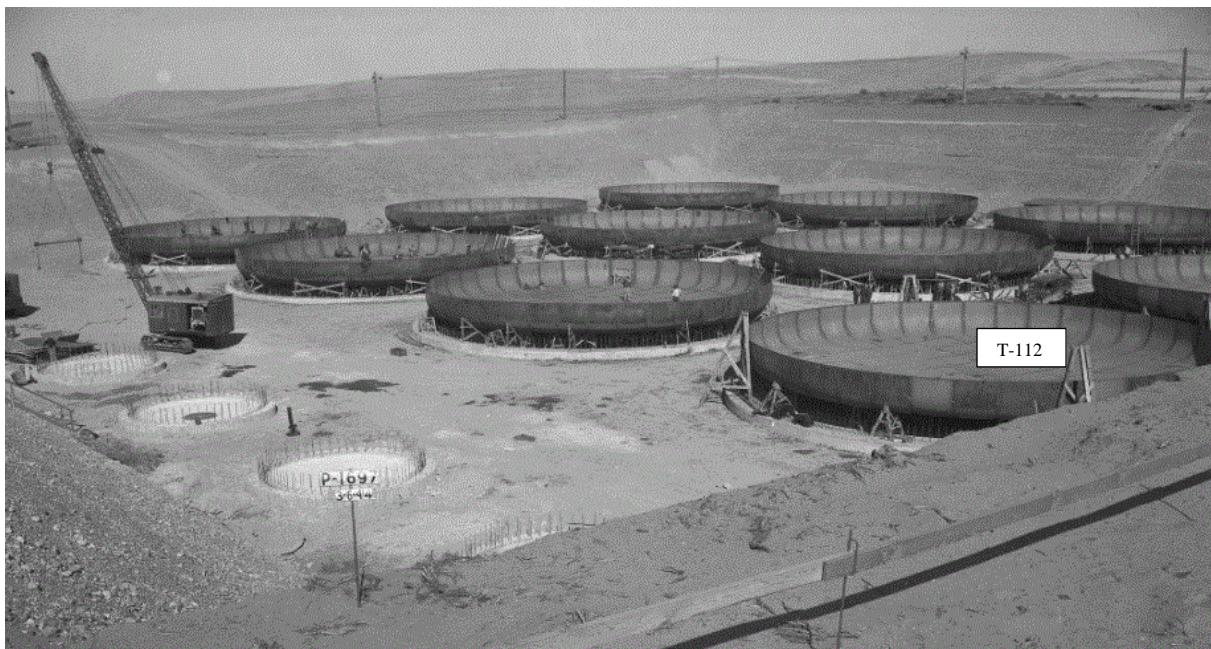
**Figure B-2. All T Farm 100 Series Tank Bottom Liner and Knuckles Fabricated
March 6, 1944 (P-1697)**

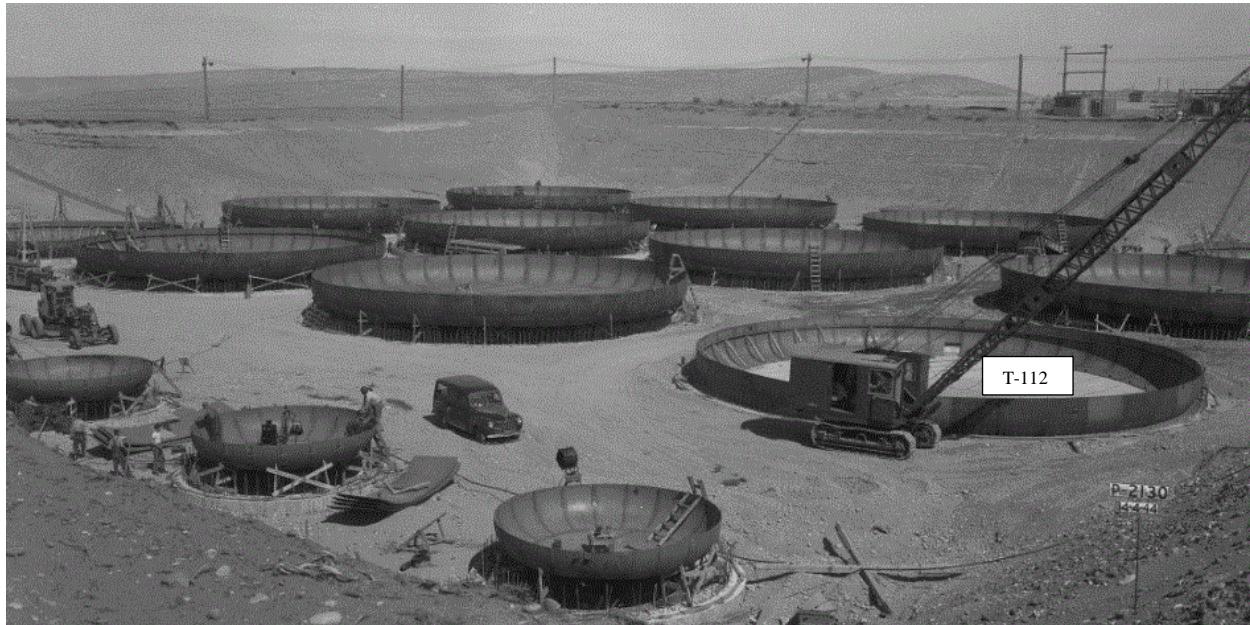
Figure B-3. Start of Bottom Liner Replacement - Tank T-112
Tank Lowered and Bottom Liner Removed, Knuckle in Place
April 4, 1944 (P-2130)

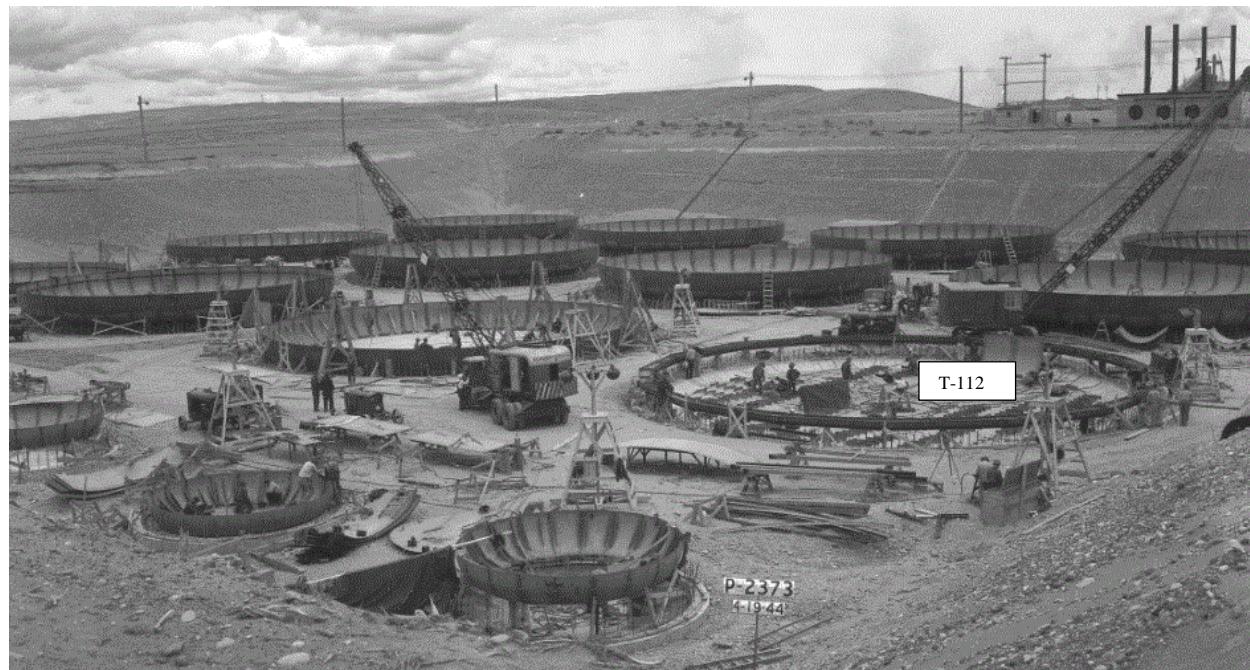
Figure B-4. Tank T-112. Started Welding Replacement Bottom Liner, Two Knuckle Plates Positioned. Tank T-109 Lowered and Bottom Liner Removed, Knuckle to be Removed?
April 19, 1944 (P-2373)

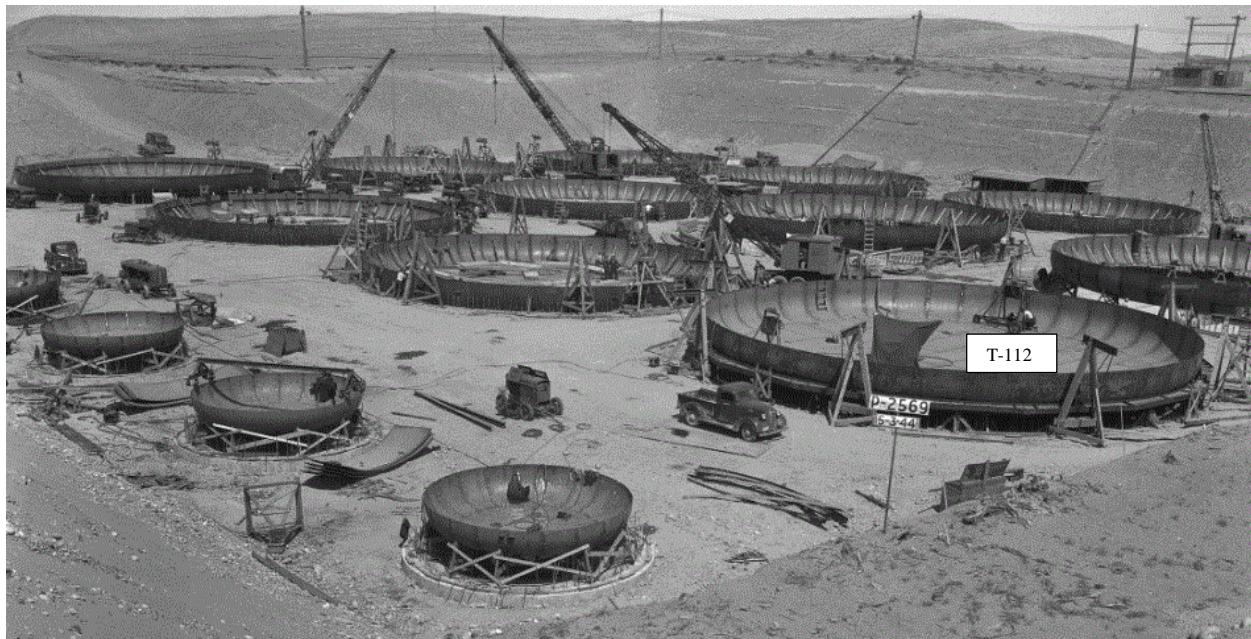
**Figure B-5. Tank T-112 Bottom Liner and Knuckle Replaced
Several Tanks Lowered with Bottom Liners Removed, Knuckles in Place
May 3, 1944 (P-2569)**

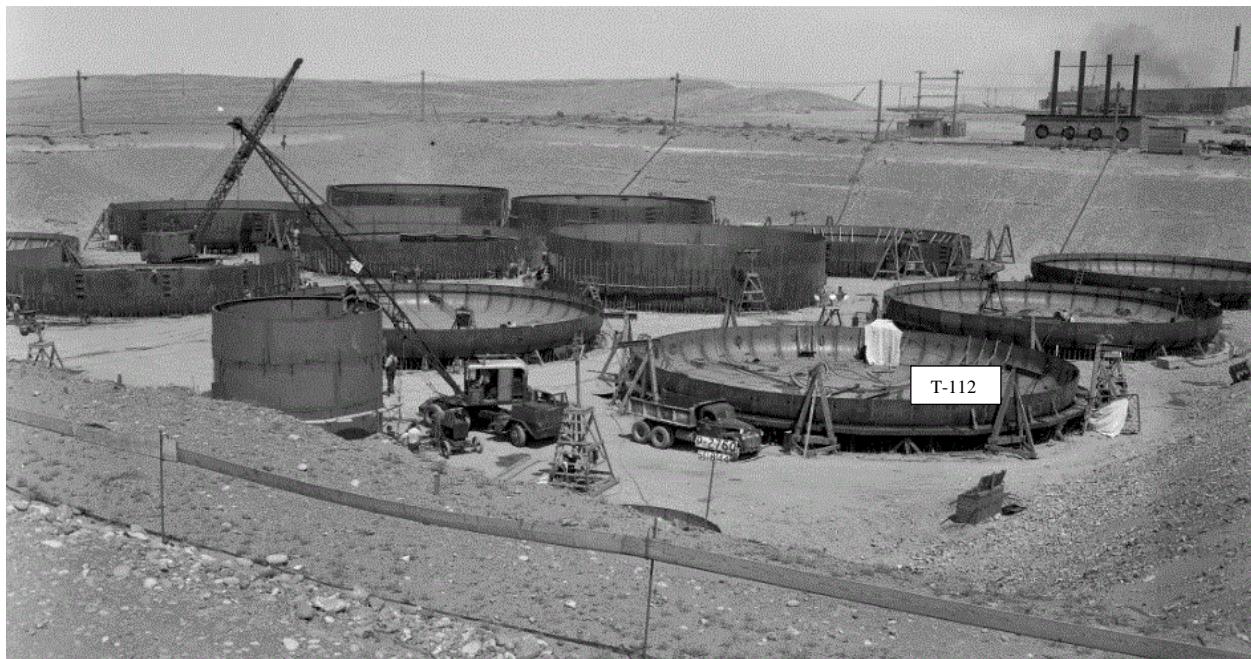
**Figure B-6. T Farm Bottom Liner Repairs in Place
Eight Tanks with at Least One Tier of Sidewalls in Place
May 18, 1944 (P-2760)**

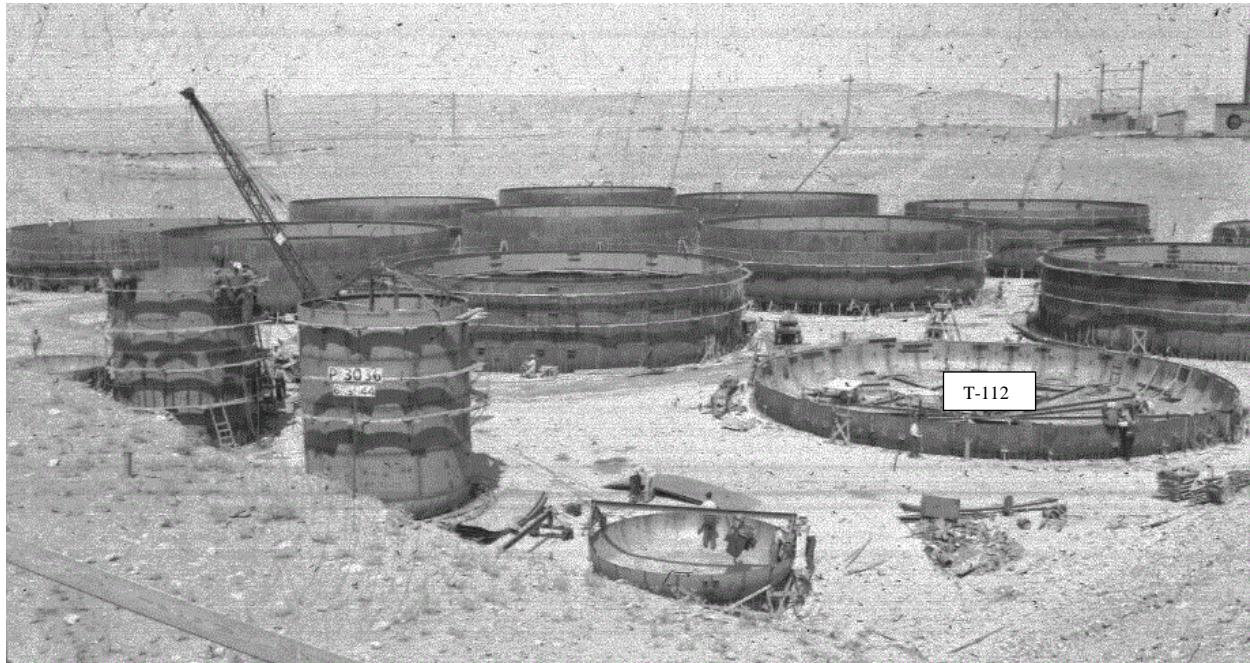
**Figure B-7. T Farm Bottom Liner Repairs Complete
Eleven Tanks with Most Sidewalls in Place
June 5, 1944 (P-3036)**

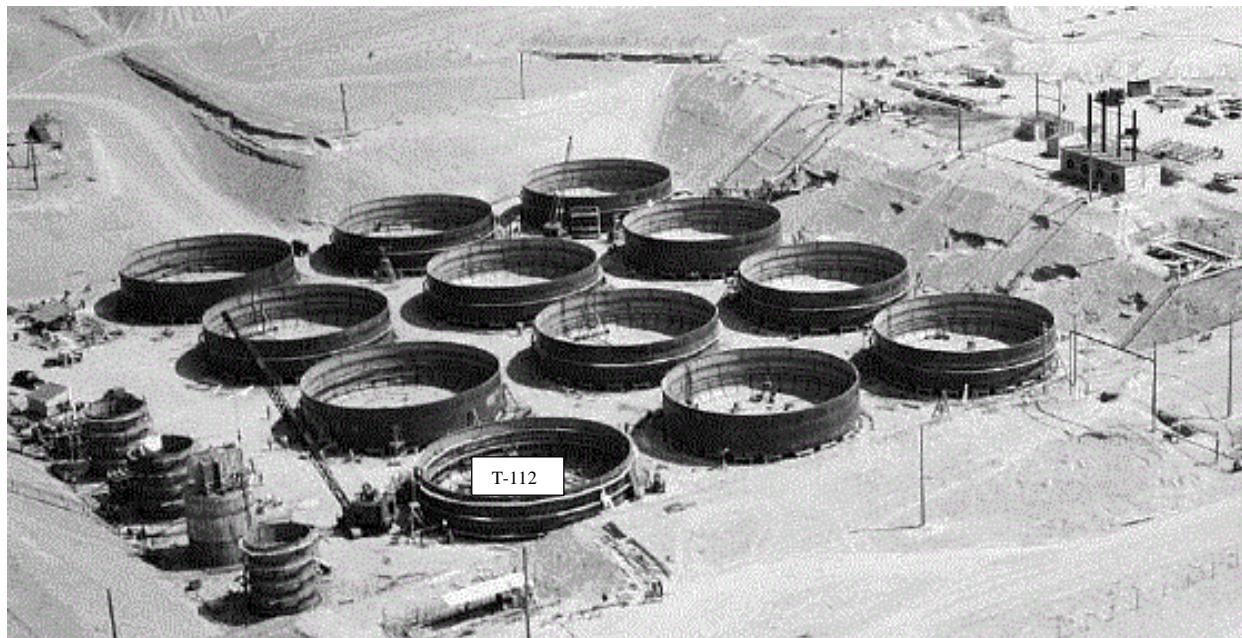
**Figure B-8. T Farm Tank Bottom Liner Replacement/Repair Complete
June 22, 1944 (P-3495)**

Tank T-112 identified for reference. Tank T-112 sidewalls being installed but tank was lowered before June 5, 1944, indicating bottom liner replacement was complete before that date. Other tanks appear to be lowered onto concrete pads indicating no further work on replacement bottom liners.
