U.S. DEPARTMENT OF  
**ENERGY**

# 2013 Annual Site Inspection and Monitoring Report for Uranium Mill Tailings Radiation Control Act Title I Disposal Sites

March 2014

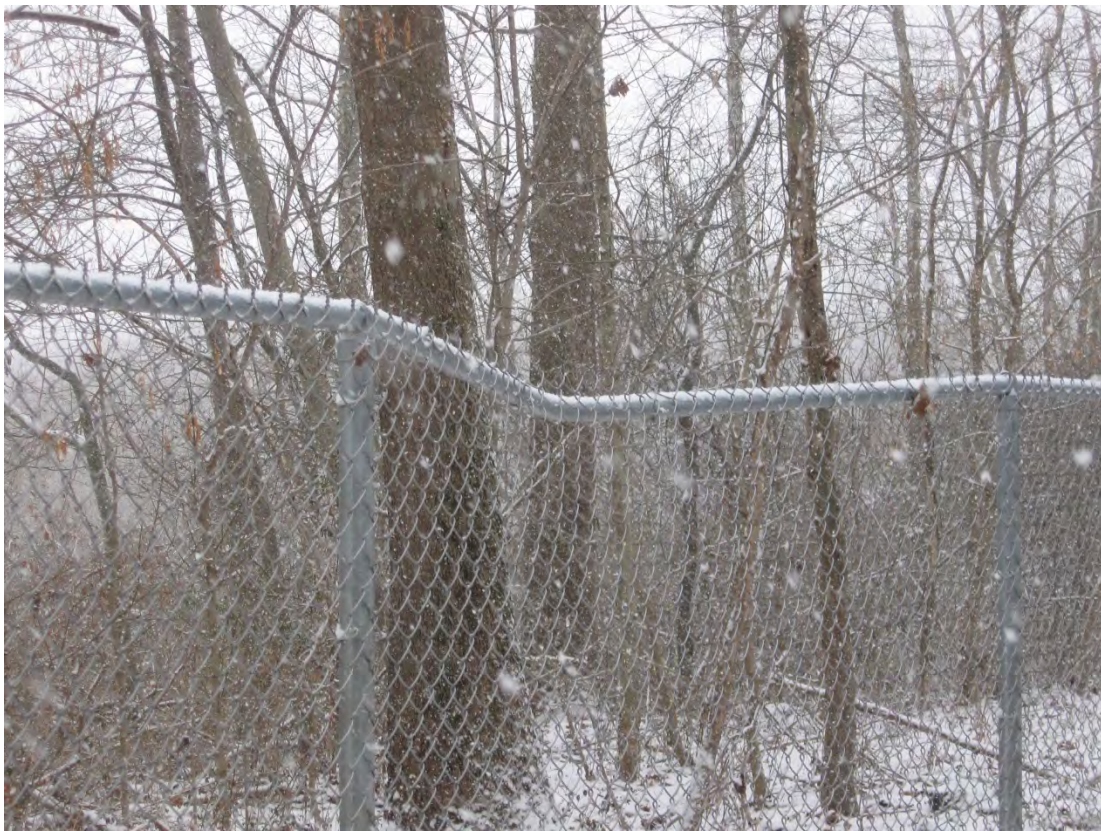
The chain link perimeter fence that encircles the site was replaced in 2007. The fence had minor damage at several locations along the south fence line due to fallen trees (PL-2 thru PL-6).

| Photo Location Number | Azimuth | Photograph Description |
|---|---|---|
| 4 | NA | Damaged fence east of perimeter sign P12. |

*BUR 12/2013. PL-4. Damaged fence east of perimeter sign P12.*

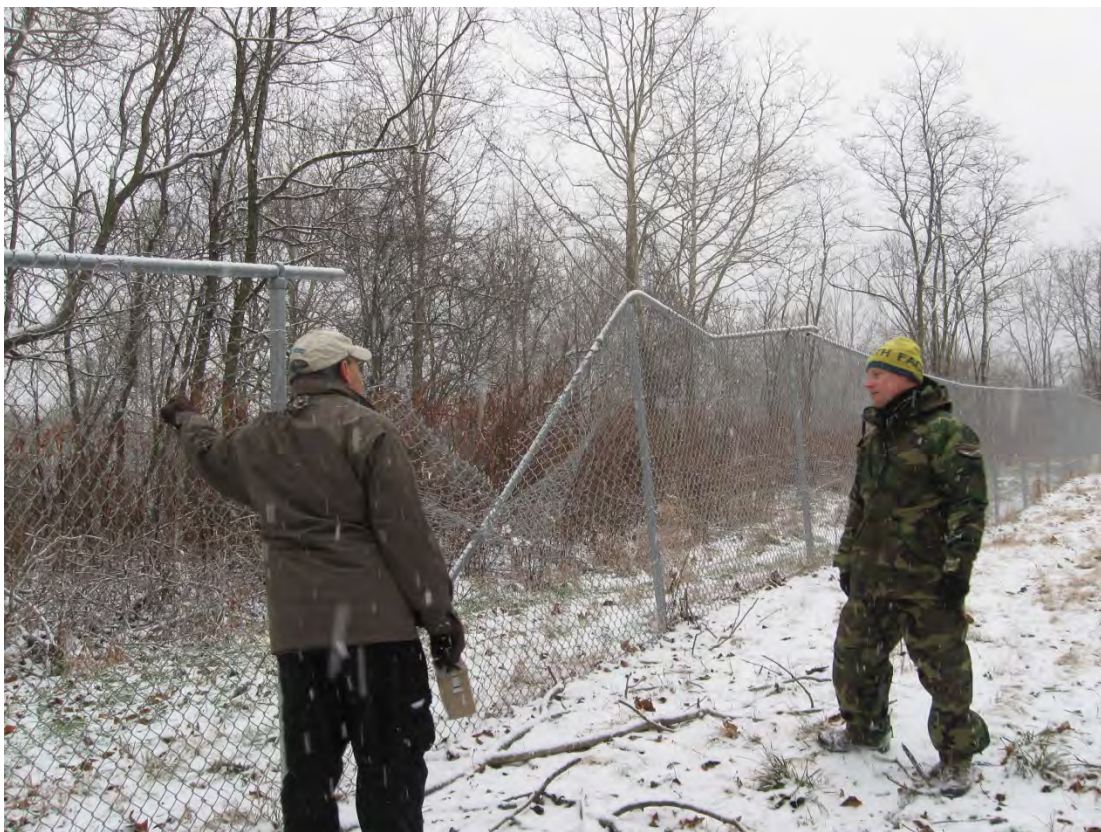
| Photo Location Number | Azimuth | Photograph Description |
|---|---|---|
| 5 | NA | Damaged fence east of perimeter sign P11. |

*BUR 12/2013. PL-5. Damaged fence east of perimeter sign P11.*

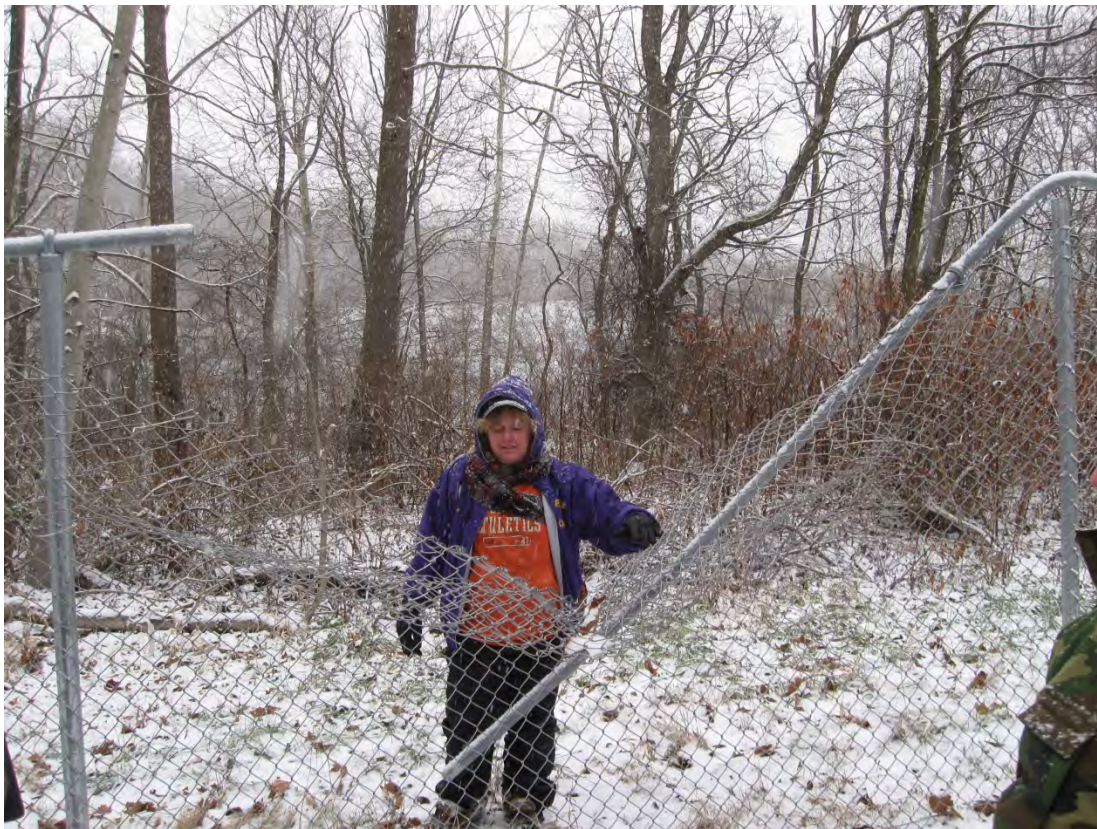
*BUR 12/2013. PL-6. Damaged fence east of perimeter sign P11.*

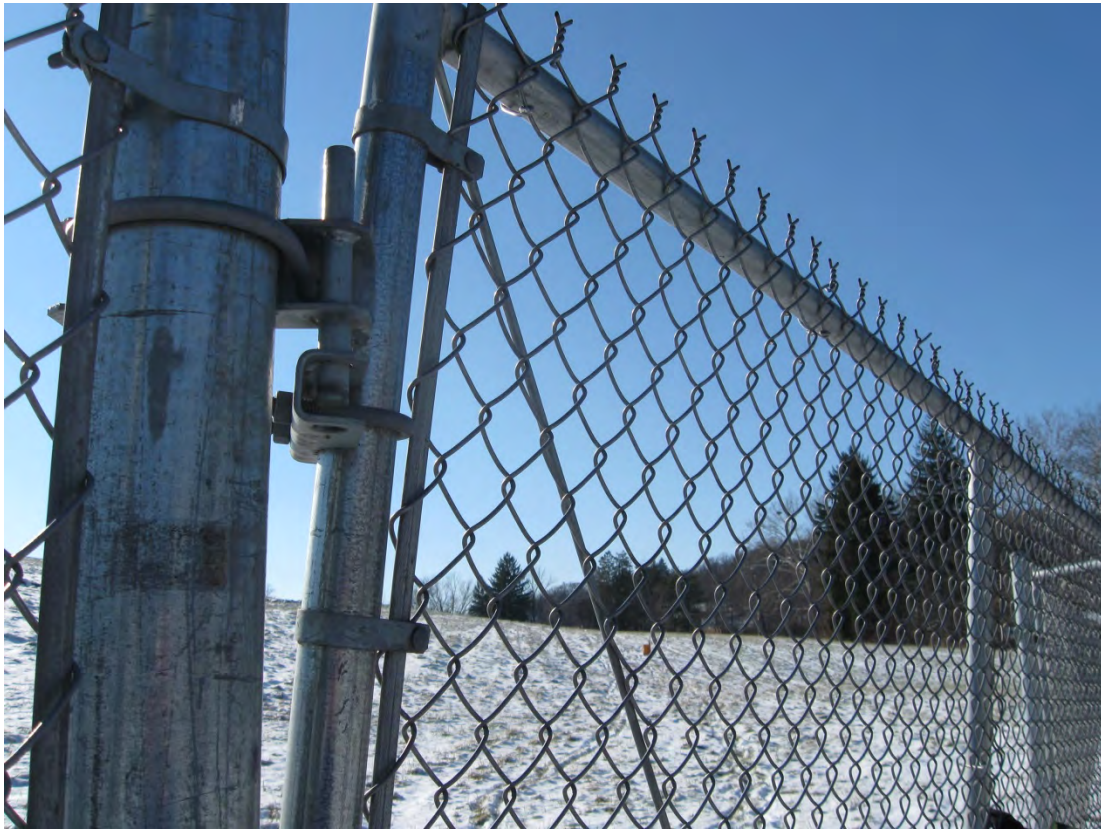
*CAN 10/2013. PL-1. Damage to vehicle gate near perimeter sign P8.*

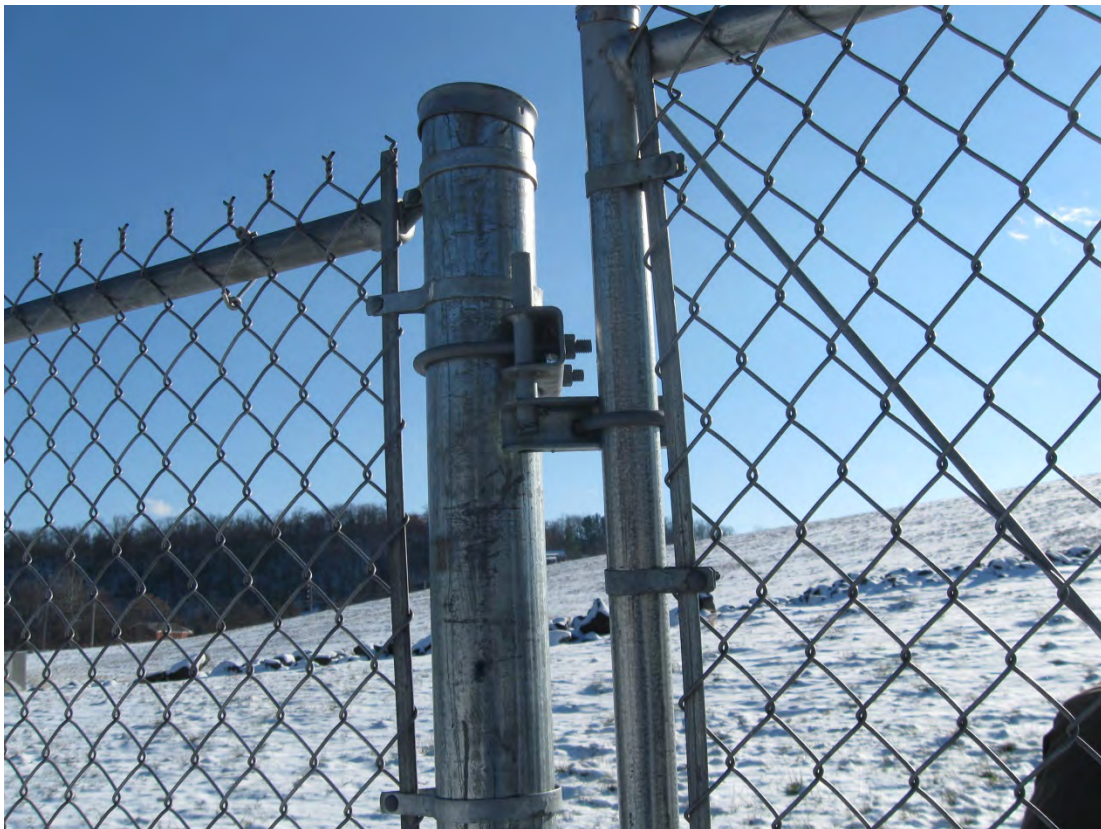
*CAN 10/2013. PL-2. Damage to vehicle gate near perimeter sign P8.*

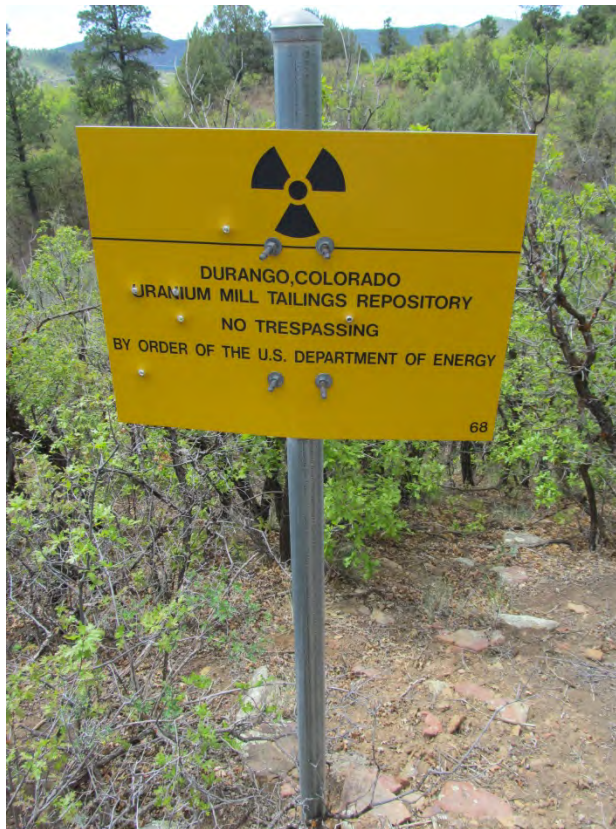
*DUD 5/2013. PL-3. Perimeter sign P68, showing bullet hole damage.*

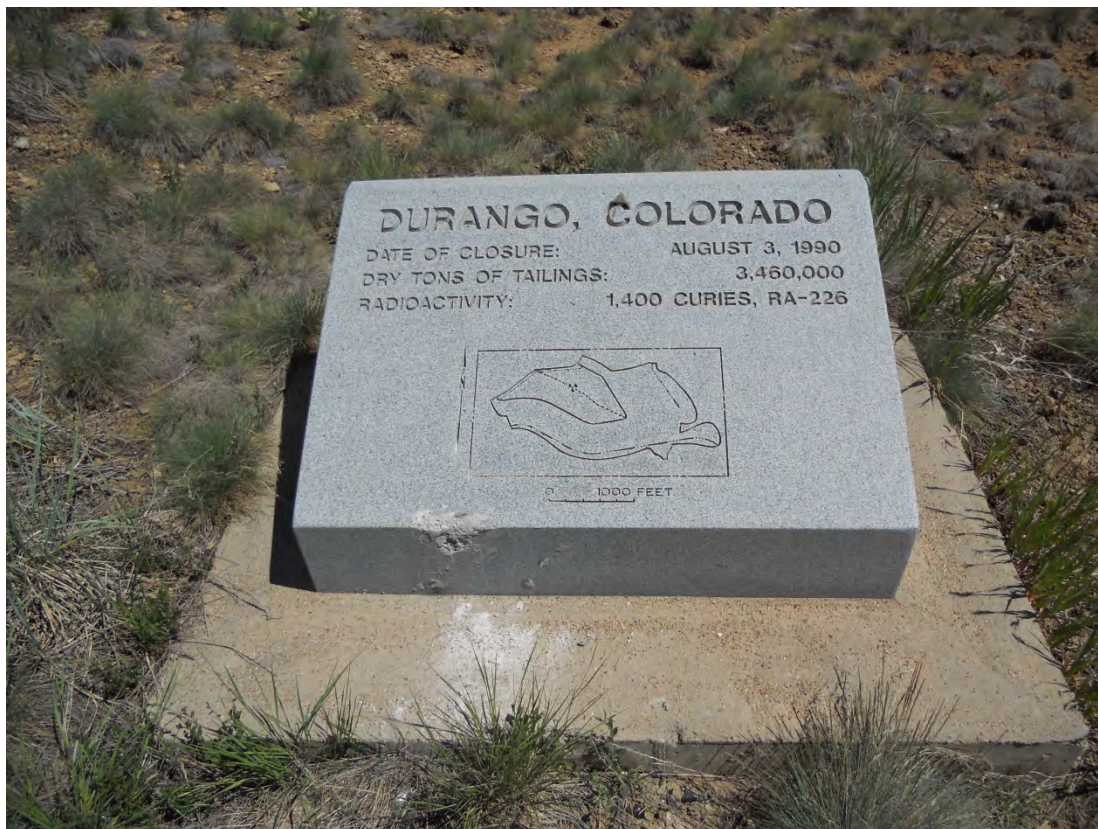
*DUD 5/2013. PL-4. Site marker SMK-1, showing damage.*

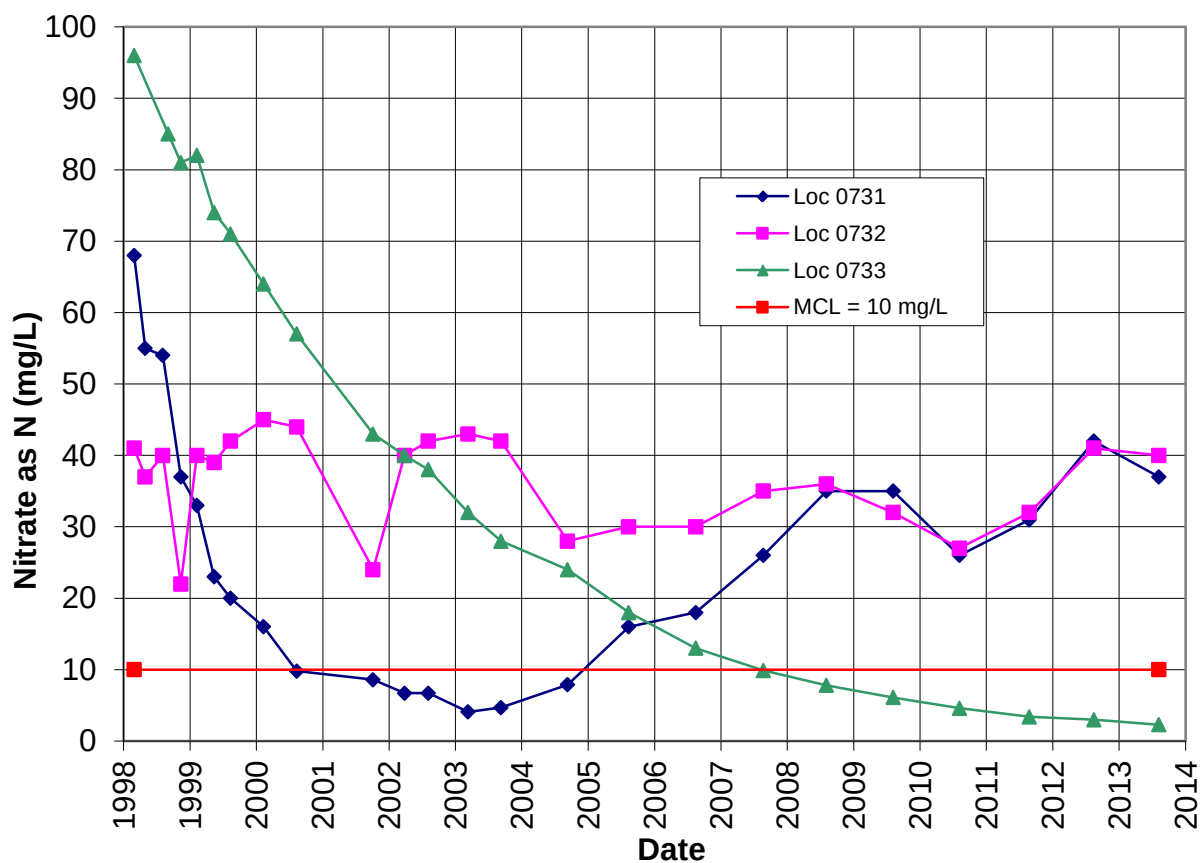
Figure 6-3. Time-Concentration Plots of Nitrate (as Nitrogen) in Groundwater at the Grand Junction Disposal Site

Nitrate (as nitrogen) concentrations in groundwater continued to exceed the MCL of 10 mg/L in the paleochannel monitoring wells (0731 and 0732) through 2013 (Figure 6-3). Concentrations in well 0731, following an initial steep downward trend, remained below the MCL from 2000 through 2004. In 2005 and continuing through 2013, concentrations steadily increased and remain above the MCL. Concentrations in well 0732, though varied, have consistently remained above the MCL since 1998. Concentrations in well 0733 continued a significant downward trend, dropped below the MCL in 2007, and reached a low of 2.3 mg/L in 2013. Historically, the highest concentration of nitrate (96 mg/L) occurred in 1998 from disposal cell well 0733. In 2013, the concentration of nitrate decreased, and the nitrate levels in both paleochannel monitoring wells are very similar: 37 mg/L in well 0731 and 40 mg/L in well 0732.

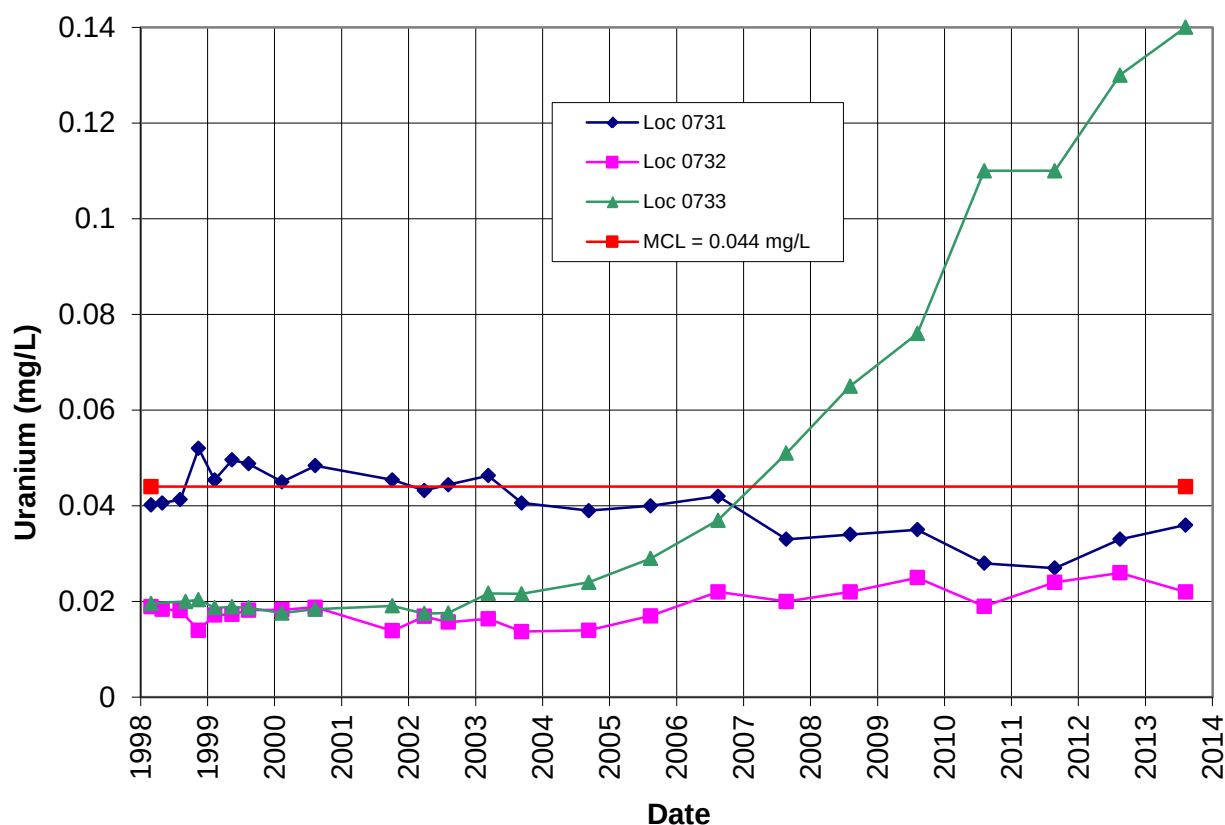
Figure 6-5. Time-Concentration Plots of Uranium in Groundwater at the Grand Junction Disposal Site

Uranium concentrations in groundwater were below the MCL of 0.044 mg/L in paleochannel monitoring wells 0731 and 0732, and were above the MCL in well 0733 (Figure 6-5). Concentrations in well 0731, after an initial increase above the MCL, have been below the MCL since 2003. Concentrations in well 0732 have been below the MCL since 1998 and have remained relatively consistent. Concentrations in well 0733 remained relatively consistent through 2003, at which time an upward trend began, which leveled off at 0.11 mg/L for the 2010 and 2011 sampling events and increased slightly to 0.14 mg/L in 2013.

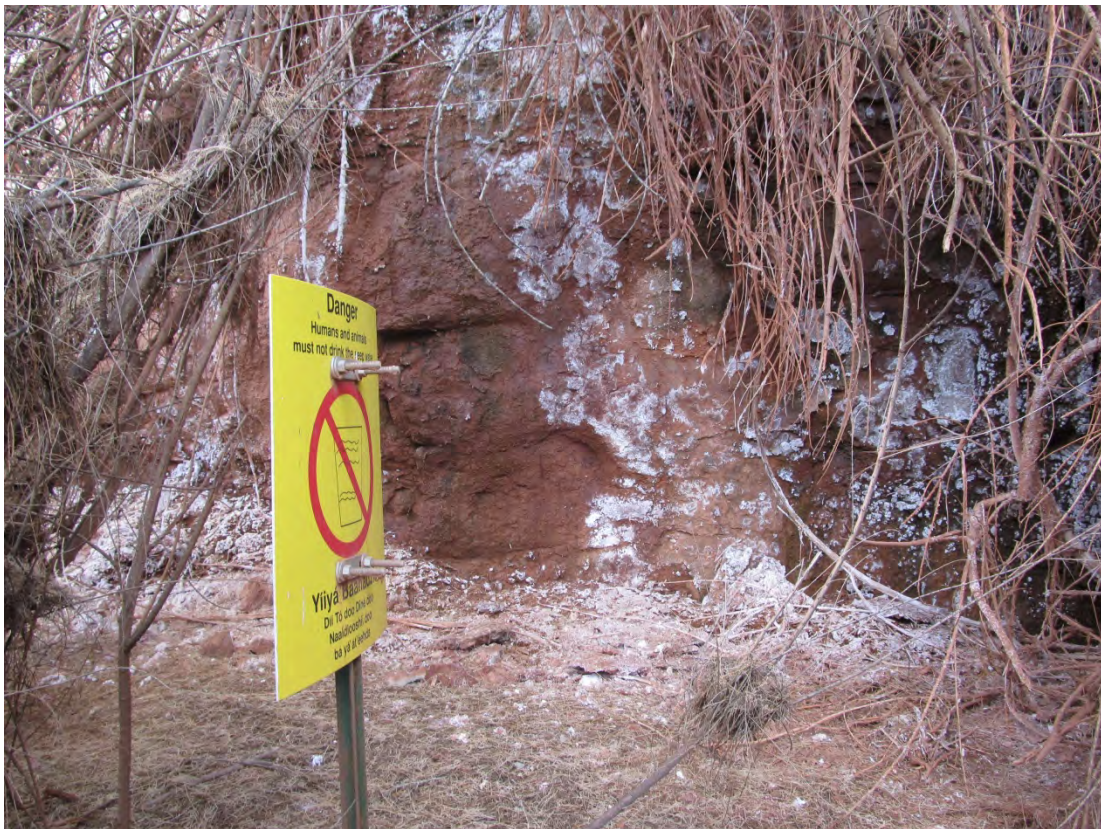
*HAT 4/2013. PL-10. Seep 248 dripping conditions; no standing water.*

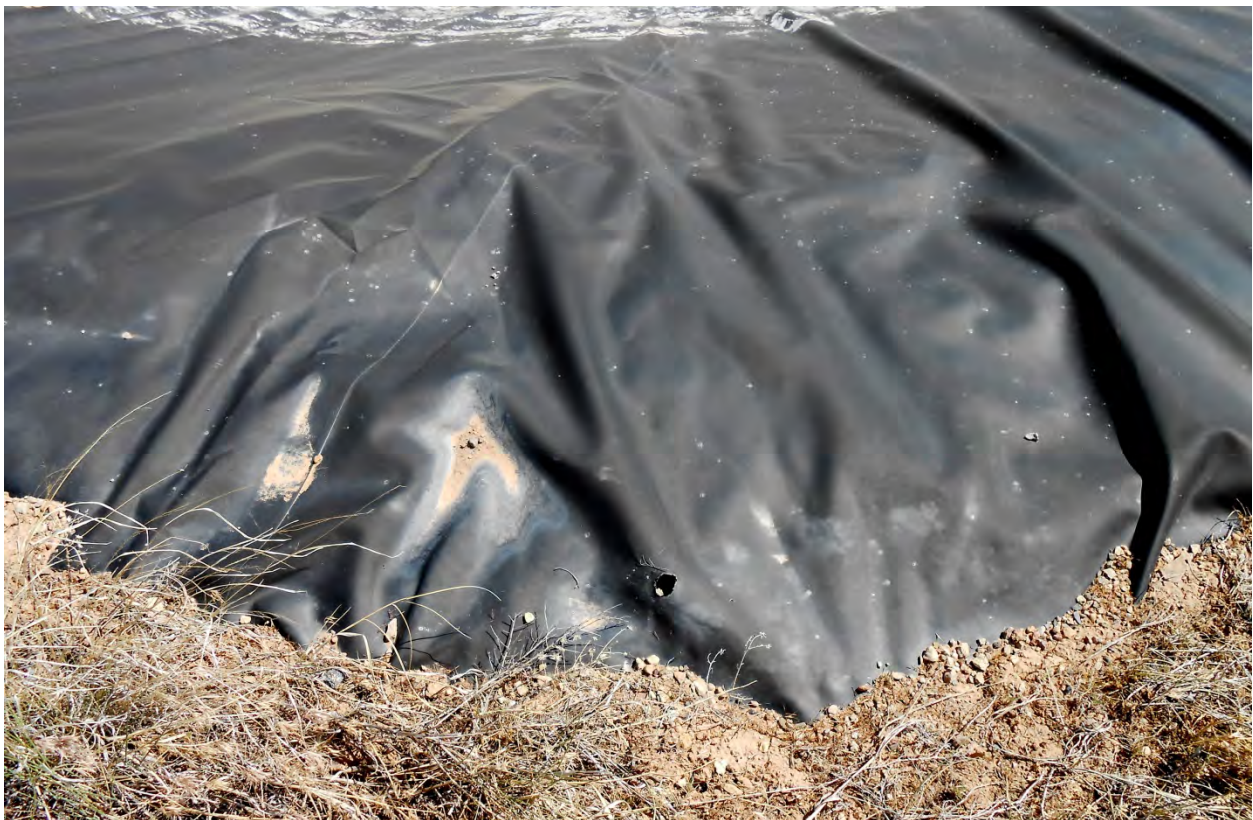
*RFL 6/2013. PL-7. Small hole in evaporation pond liner.*

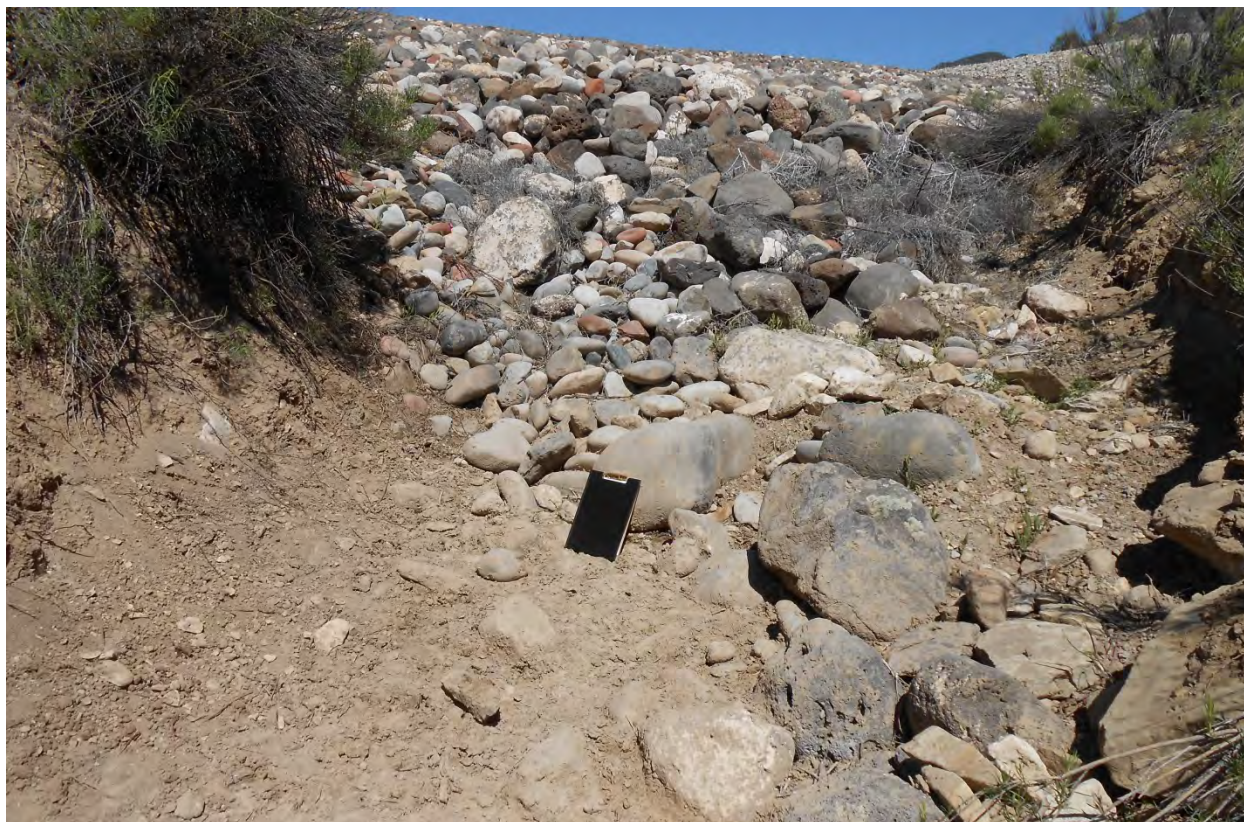
*RFL 6/2013. PL-8. Evidence of cattle at toe ditch runoff point.*

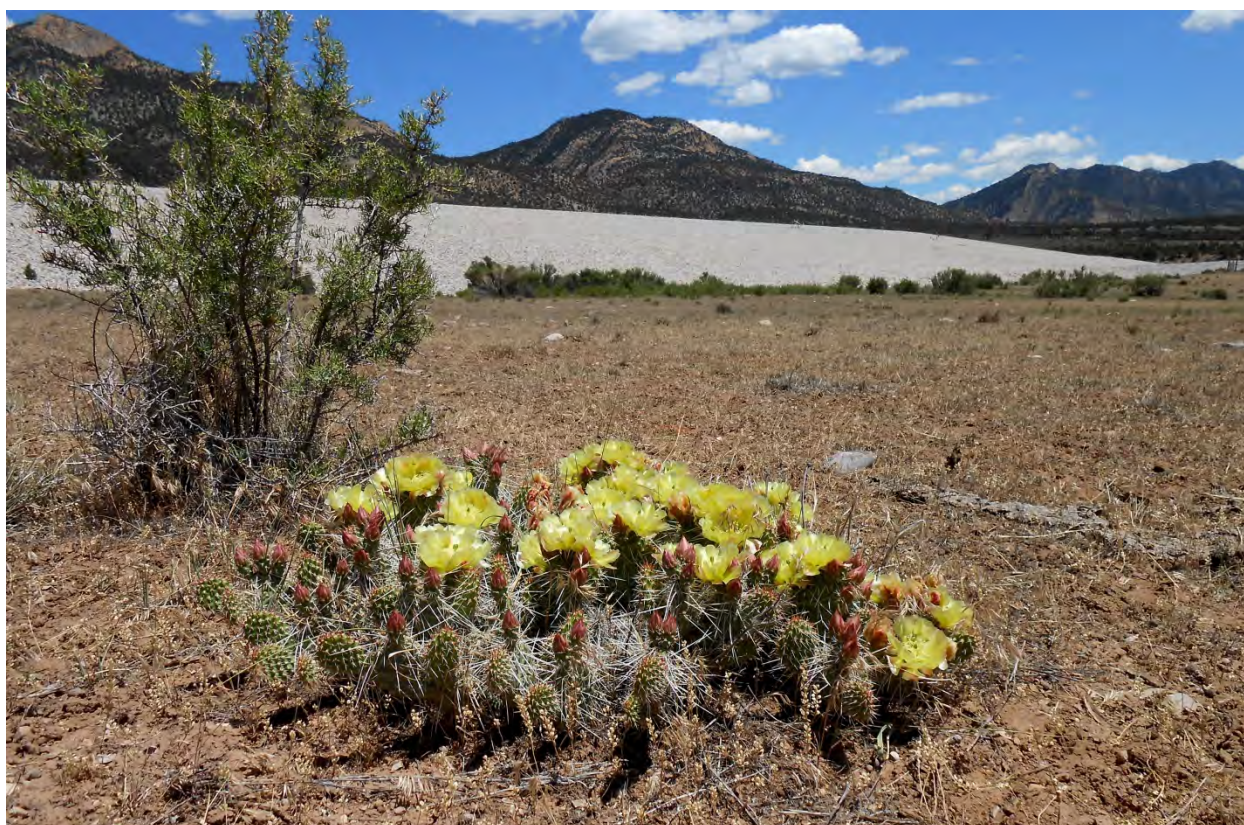
*RFL 6/2013. PL-9. Prickly pear cactus with cell in background; other vegetation grazed heavily.*

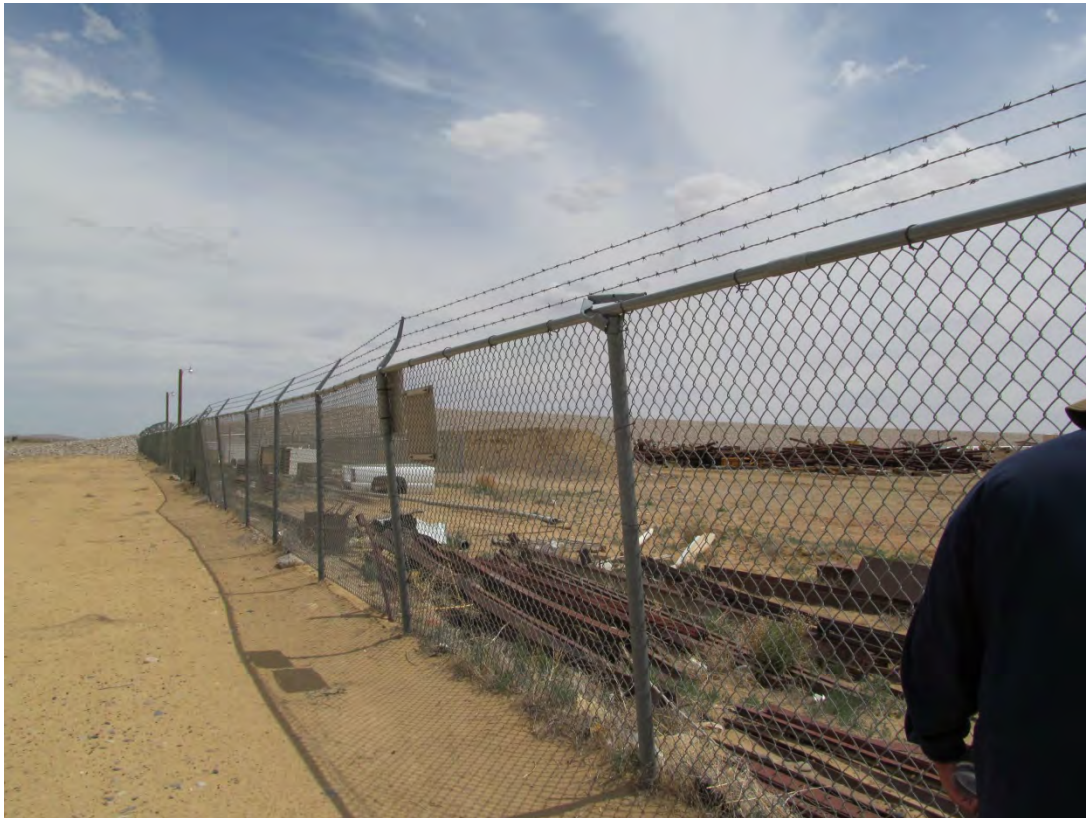
*SHP 5/2013. PL-2. Damaged fence line near perimeter sign P15.*

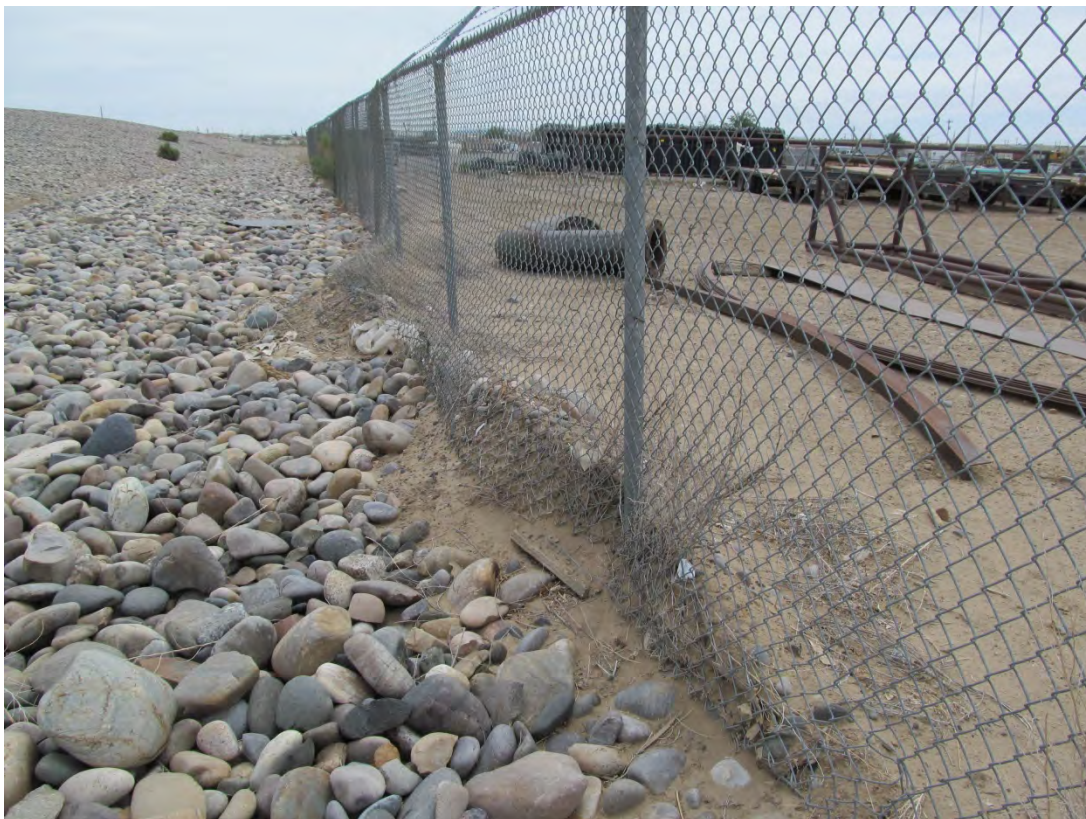
*SHP 5/2013. PL-3. Dirt pushed under fence between P11 and P12.*

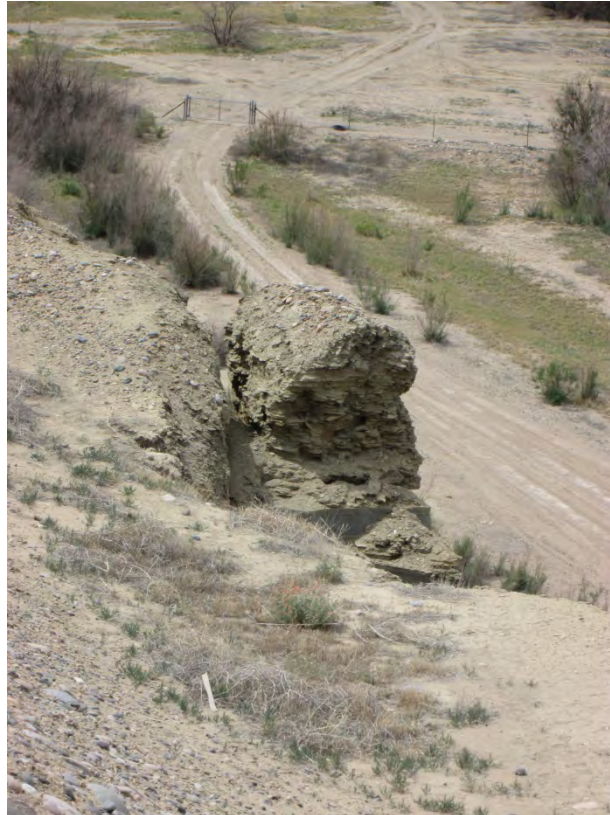
*SHP 5/2013. PL-15. Terrace escarpment pedestaling; piping was also observed.*

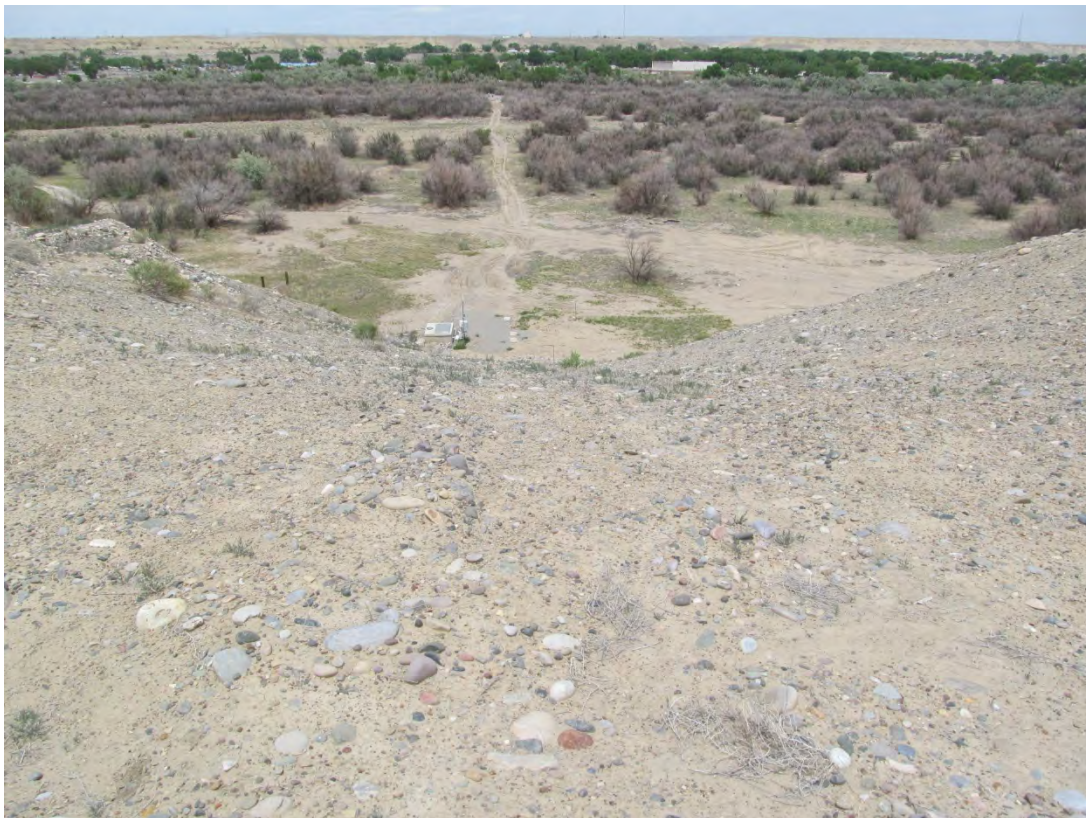
*SHP 5/2013. PL-16. View down repaired section of escarpment; no new erosion.*

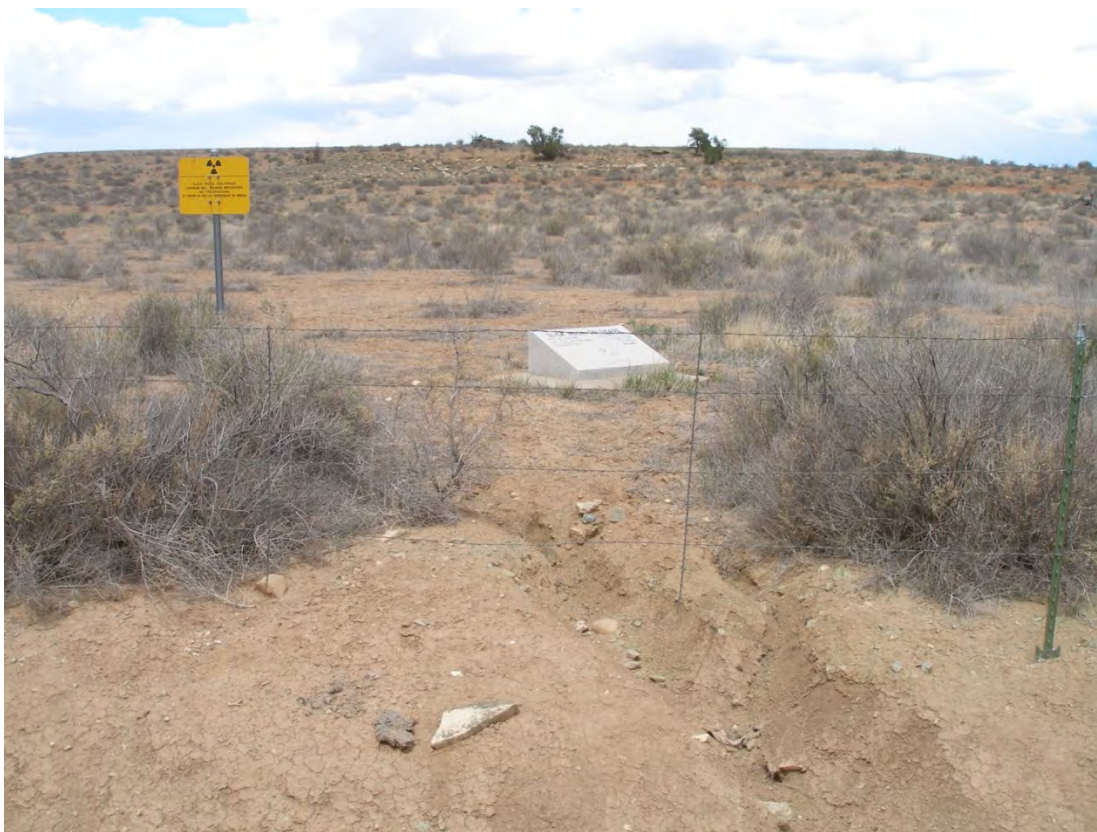
*SRK 5/2013. PL-1. Site marker near entrance gate, erosion*

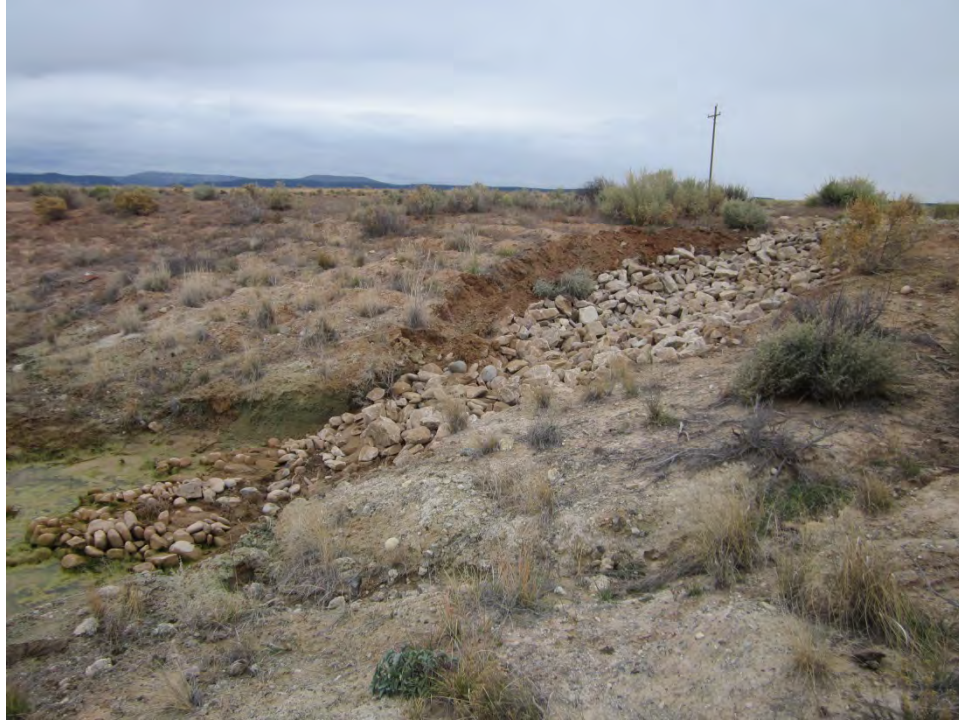
*SRK 11/2013 PL-6 Retention pond channel after November repair work.*

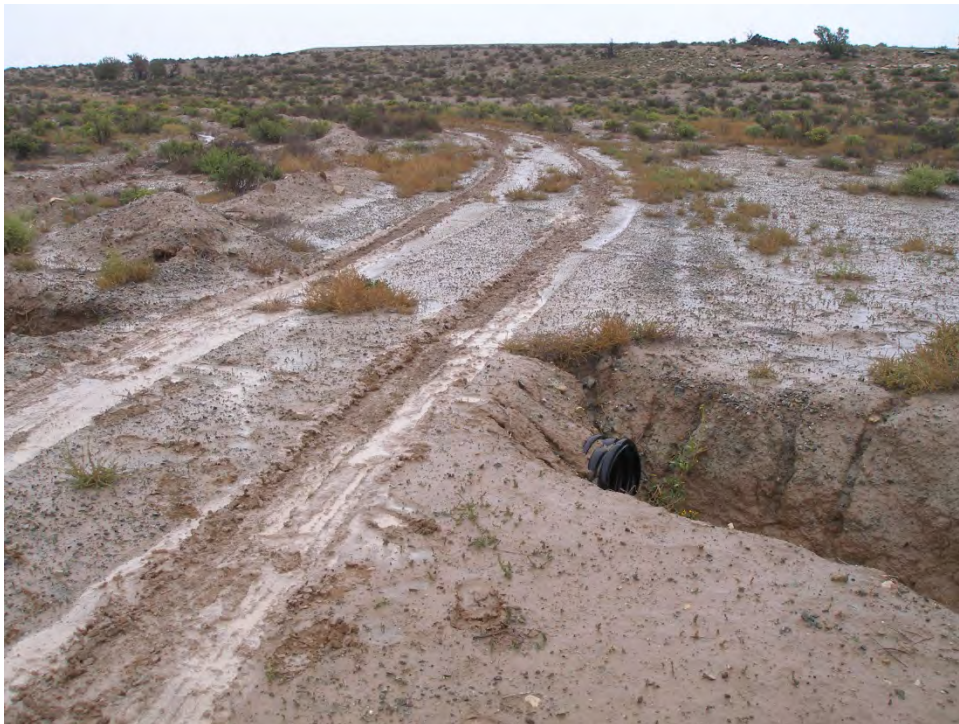
*SRK 11/2013 PL-7 Culvert before replacement*

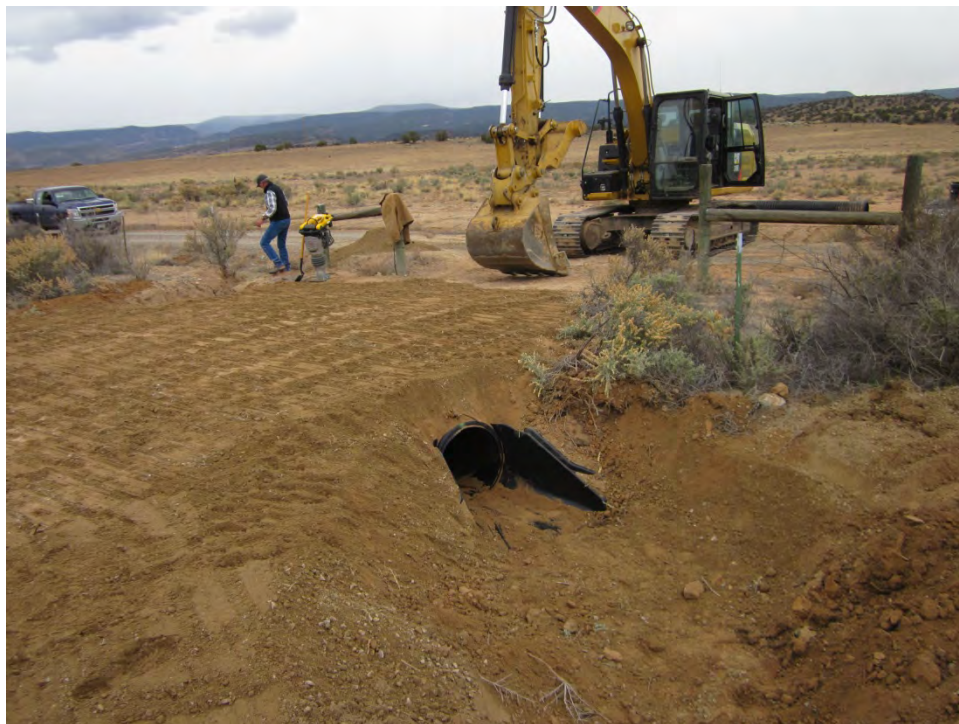
*RK 11/2013 PL-8 Culvert after November repairs*
