Final Report
Engineered Geothermal System
Demonstration Project
Northern California Power Agency,
The Geysers, CA
2008-2009

AltaRock Energy, Inc.
Seattle, WA

December 31, 2010
Revised: June 24, 2013

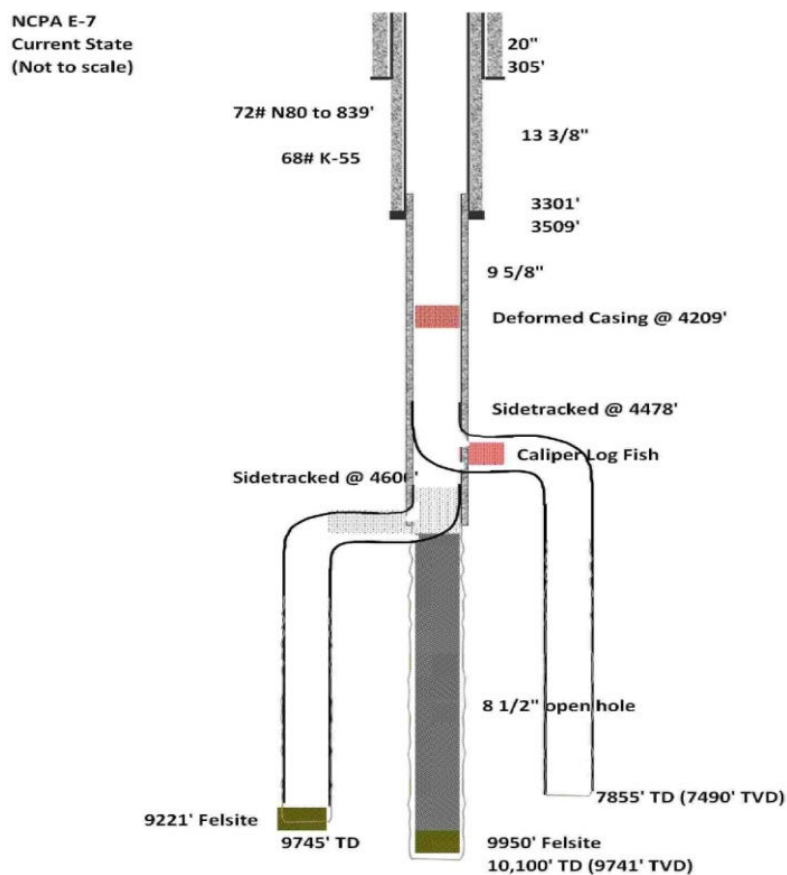
Well E-7 was drilled on the lower E-pad of the NCPA lease in 1988, and completed with three legs (Figure 2). The first two legs (OH and RD1) penetrated the felsite reservoir target strata at depths of 9440 feet and 9950 feet below ground surface (bgs). These legs were plugged with cement and a third leg (RD2) was drilled to a depth of 7855 feet bgs through a window cut in the casing liner at about 4500 feet. None of the legs were productive, likely due to the location of the well in the extreme southeastern extent of the Geysers reservoir, and the well was idled. In fact, no wells on the lower E-pad were used for production or injection until March 2008.

Figure 1. Existing well E-7 conditions prior to well workover.

the depth of the stuck fish to examine the 13 ³/₈ inch casing and 9 ⁵/₈ inch liner showed a damaged collar at 4207 feet. The 20 year old well was deemed suitable, and injection started in May 2008.

If the serpentinite that serves as the cap to the steam reservoir in the Geysers is exposed to fresh water, it can become very weak and even flow, making drilling through this formation very difficult. Most of the wells drilled through the serpentinite cap in the Geysers were drilled in the 1980's, before widespread water injection began in 2003 (in the case of the southeast Geysers). Well bore stability problems were recently reported in several wells in the Bottle Rock area, and largely attributed to hydration of the formation by injected water. The problematic lithology at Bottle Rock is argillite, which is similar to, but somewhat more forgiving, than the serpentinite. The extent to which the serpentinite may have been hydrated and weakened by E-pad injection prior to AltaRock's efforts to re-drill E-7 is difficult to ascertain. In 2008, prior to injection, the E-7 casing appeared to be in good condition except for the damaged collar at 4207 feet.

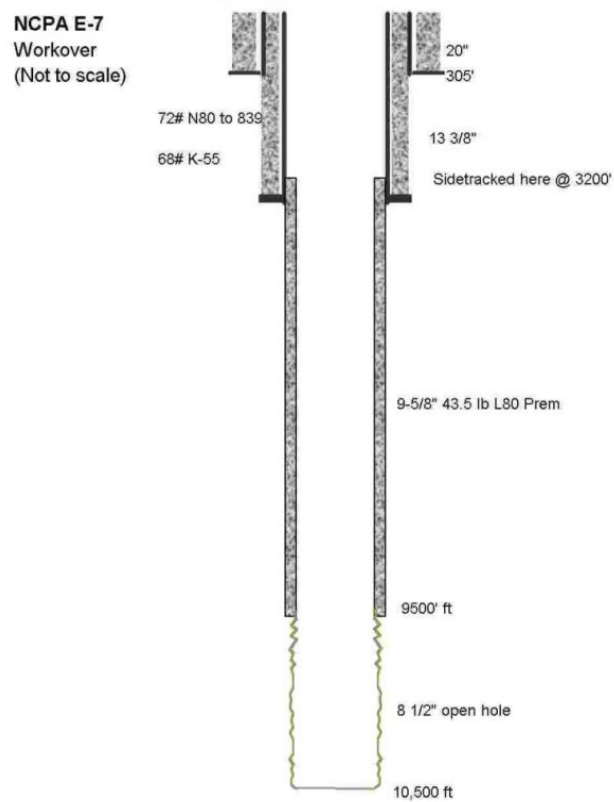
A well workover plan was presented in the application to the DOE in response to the FOA (Figure 2). The plan was to deepen well E-7 2000 feet into the felsite unit by re-drilling the well from 3200 feet bgs to 10,500 feet bgs and then creating an EGS in the felsite intrusive. A 9 ⁵/₈ inch casing was to be set to 9,500 feet bgs (casing shoe depth), below which would be a 1000 foot interval of 8.5 inch open hole (Figure 2). The 1000 ft cased interval in upper felsite (8500-9500 feet bgs) was to be a buffer between the overlying commercial steam reservoir and the EGS zone. This buffer was required by the field operator NCPA to separate the "normal" Geysers steam reservoir from the planned EGS reservoir.

Figure 2. Idealized schematic of original well workover plan from proposal (sidetracks not shown)..

The lack of success in deepening the E-7 well may be related the previous use the well as an injector. Water injected at the shoe of the casing 4600 feet bgs (Figure 2) would only have to migrate about 140 feet horizontally to hydrate serpentine at the shallowest depth of the first re-drill (E-7 RD3). The RD4 and RD4A re-drill boreholes were further away at about 800 horizontal feet. Hydration of the serpentine may also have occurred due to annular flow outside the casing. This would result in serpentine instability just outside the two windows that AltaRock cut in the casing to initiate each re-drill. The E-7 RD3 window did eventually become unstable and tight which could have been due to serpentine hydration during weeks of drilling rather than pre-existing conditions. No tightness was reported at the depth of the window of E-7 RD4. Water injection could have resulted in hydration and destabilization of the serpentine and contributed to the drilling problems encountered in attempts to deepen E-7.

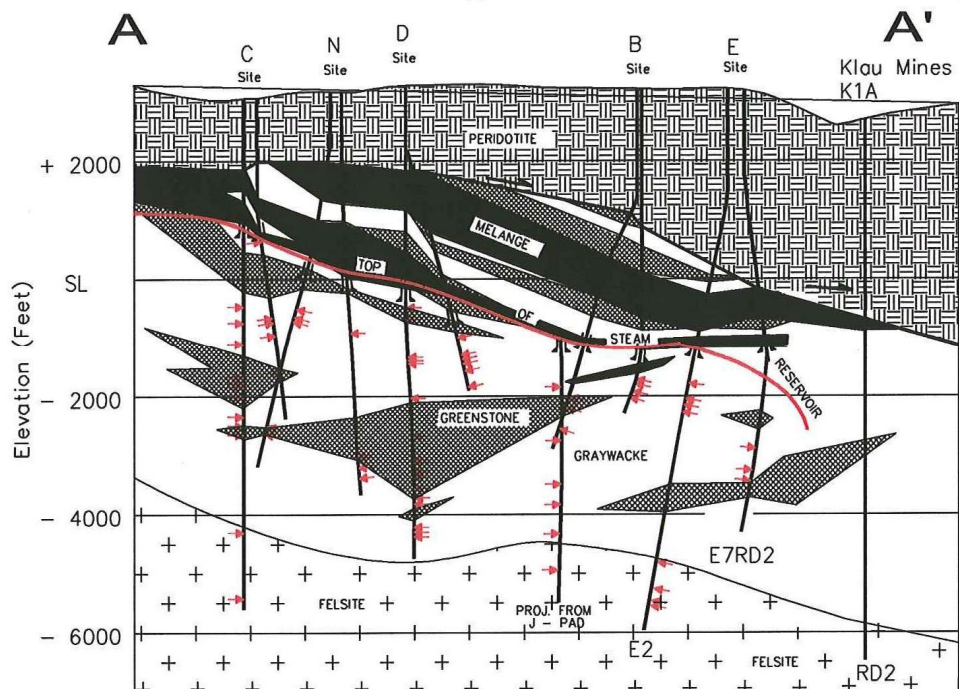
Figure 3. Lithologic Section at possible windows in casing.

The well plan included a window depth at 3200 ft bgs (Figure 3) to accommodate the new 13 ³/₈ inch casing, which had to be sidetracked from the well bore within the existing 13 ³/₈ inch casing (Figure 1). The plan was to set a cement plug in the existing casing, place a whipstock in the well and mill a 12 ¹/₄ inch hole, and extend 9 ⁵/₈ inch casing up to about 9,500 ft bgs. This varies considerably from typical well completions in the Geysers in that well sidetracks are typically started in the more competent bedrock encountered below the serpentine caprock, as previous sidetracks have been completed in well E-7. Deviating the well bore through the serpentine would prove much more problematic than AltaRock was led to believe.

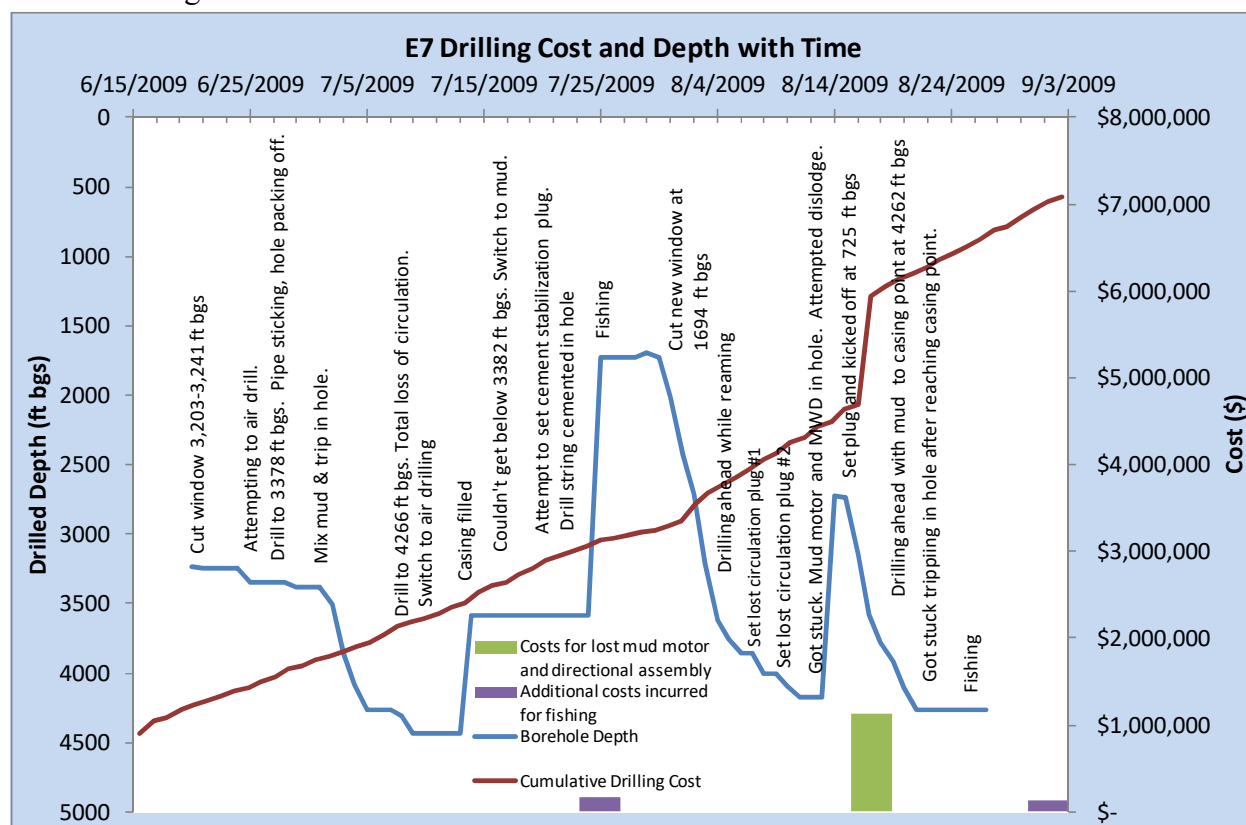
drilling history is summarized below and in Figure 4 and detailed in Appendix A. All the depths described are given in feet bgs.

Figure 4. Drilling progress and cumulative project costs over time. The bar graphs at the bottom of the graph illustrate the material and tool costs associated with fishing work and loss of drilling equipment; standby and labor costs are not included. The graph is annotated to show the timing of significant events.
