ABSTRACT

Properties Measured on Core from the U-15n Source Hole Location

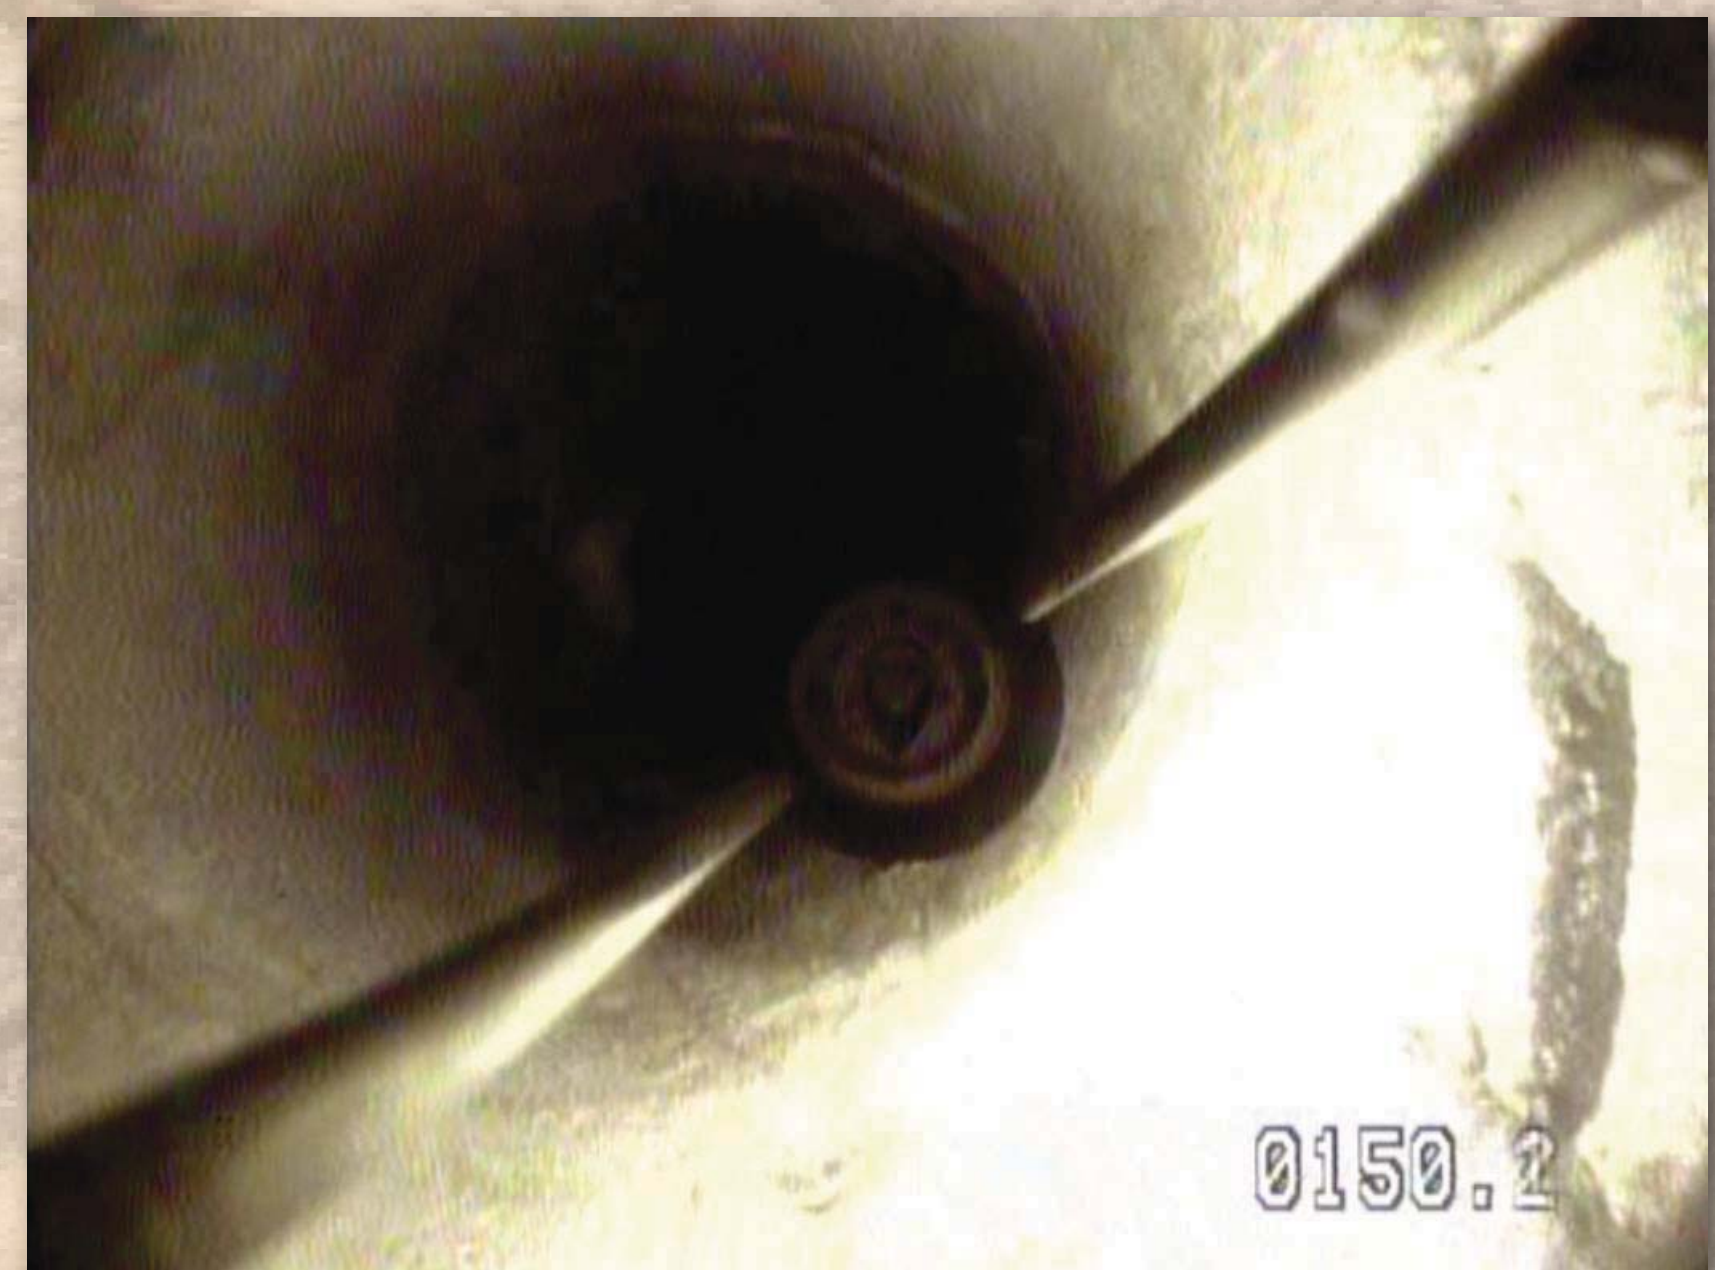
View of 0.91-m-diameter source hole prior to SPE-N-2, showing SPE-N-2 shot point location at a depth of 45.7 m. Note smooth borehole walls.

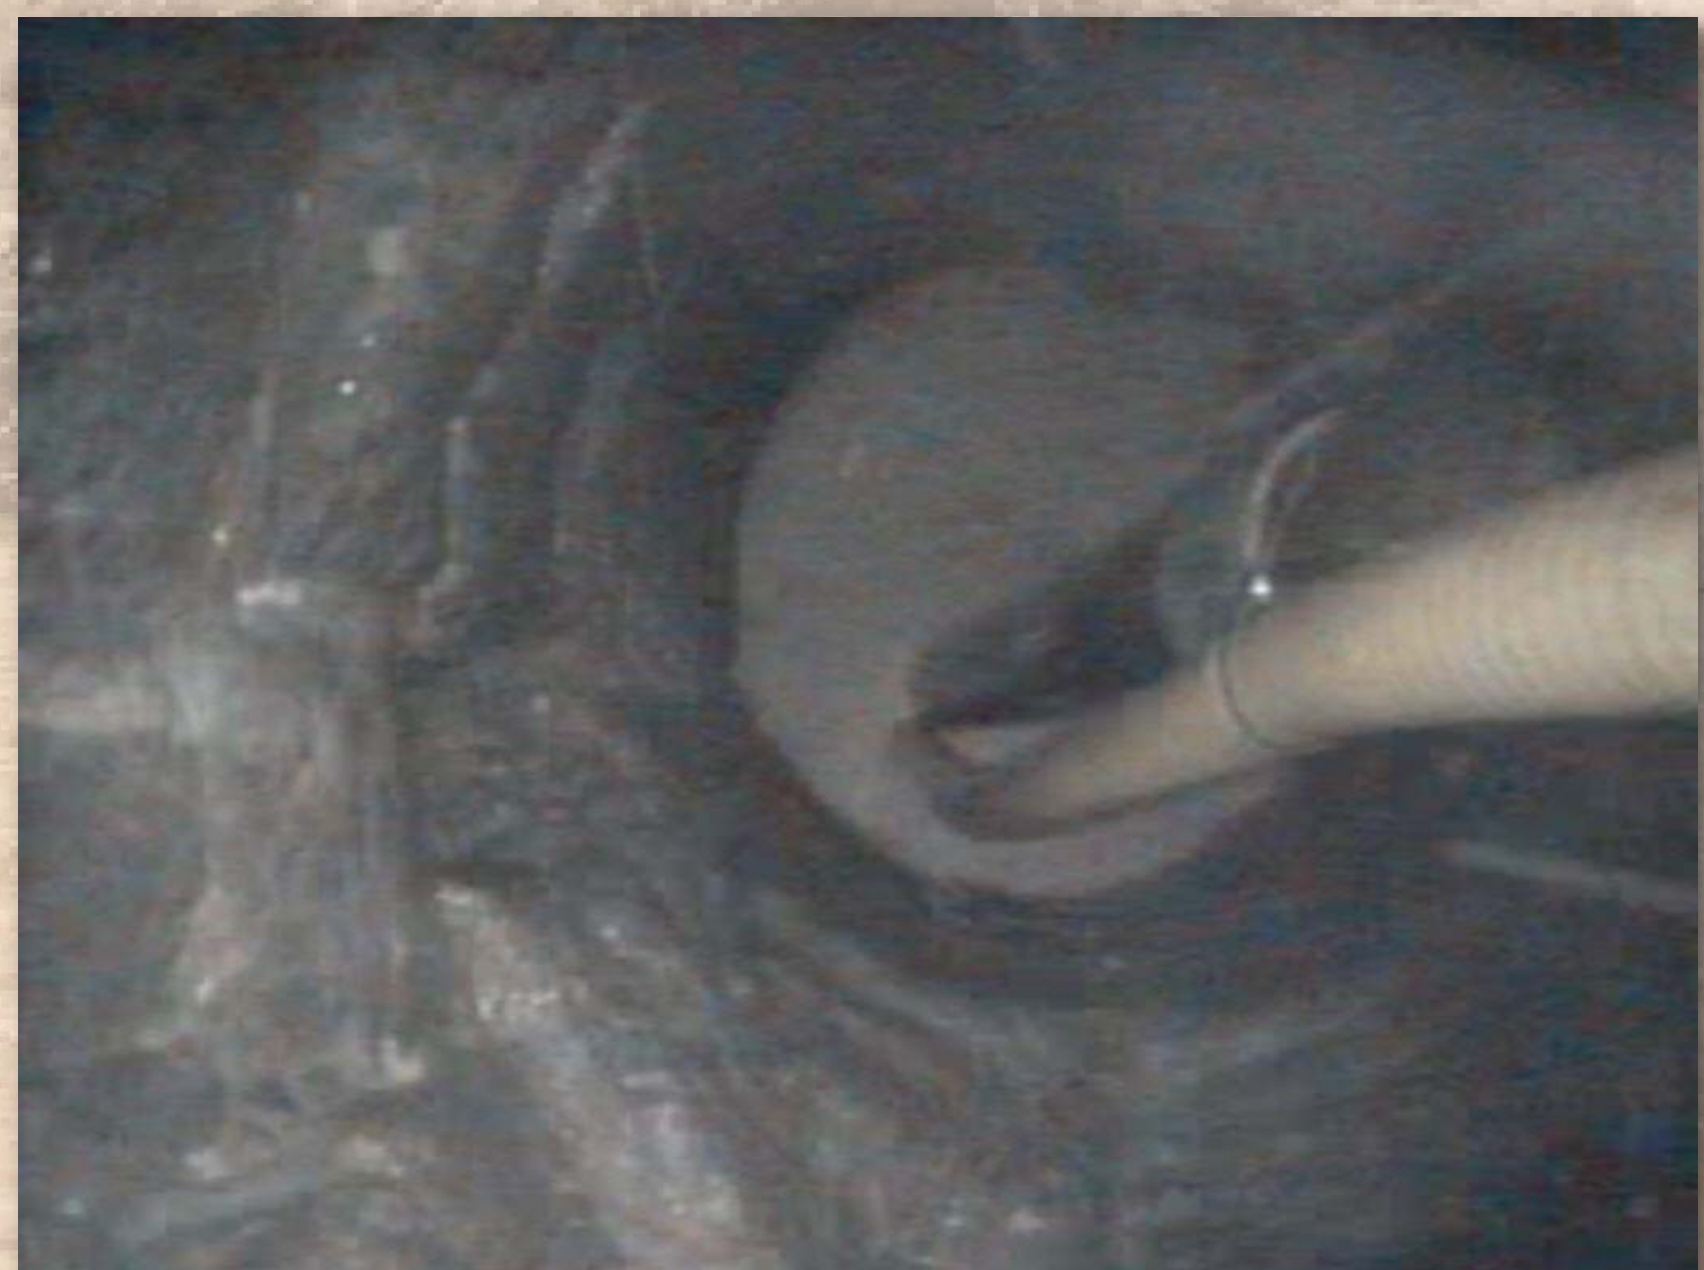
View of SPE-N source hole showing shot point location after the SPE-N-2 shot. Note slight enlargement of hole, blackened borehole walls, and stemming material resting on ledges within borehole walls.

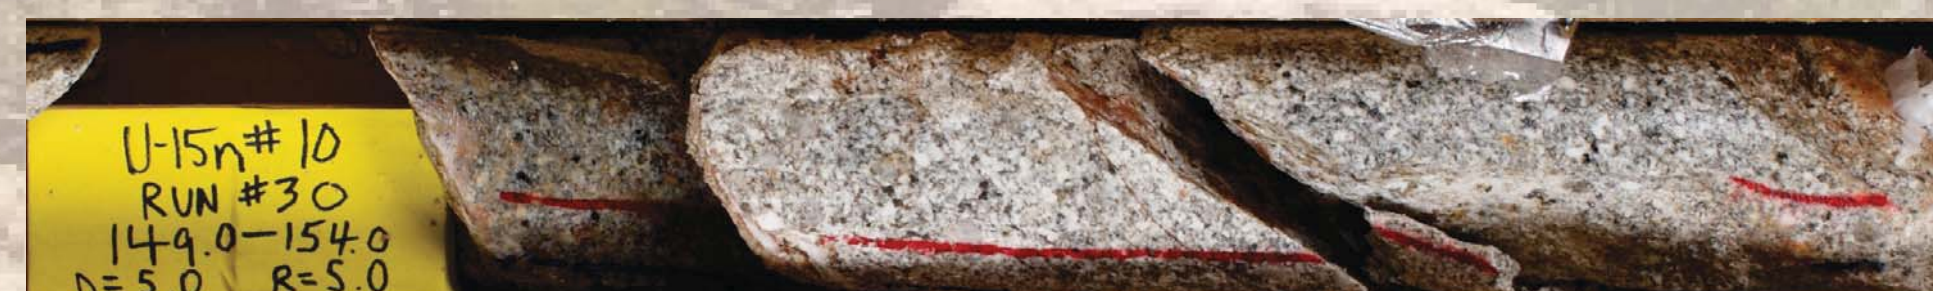
Photo of core recovered from angle-hole U-15n#10 near drilled depth of 149 ft. Note altered appearance of granite and coated fracture surfaces, indicating a natural fault. SPE-N-2 source is approximately 7.6 m to the right. Yellow block is approximately 8 cm long.

- Significant natural fault zone characterized by an interval of highly altered rock, including breccia, gouge, and slickesided surface
- Logged between the drilled depths of 149.0 to 155.0 ft

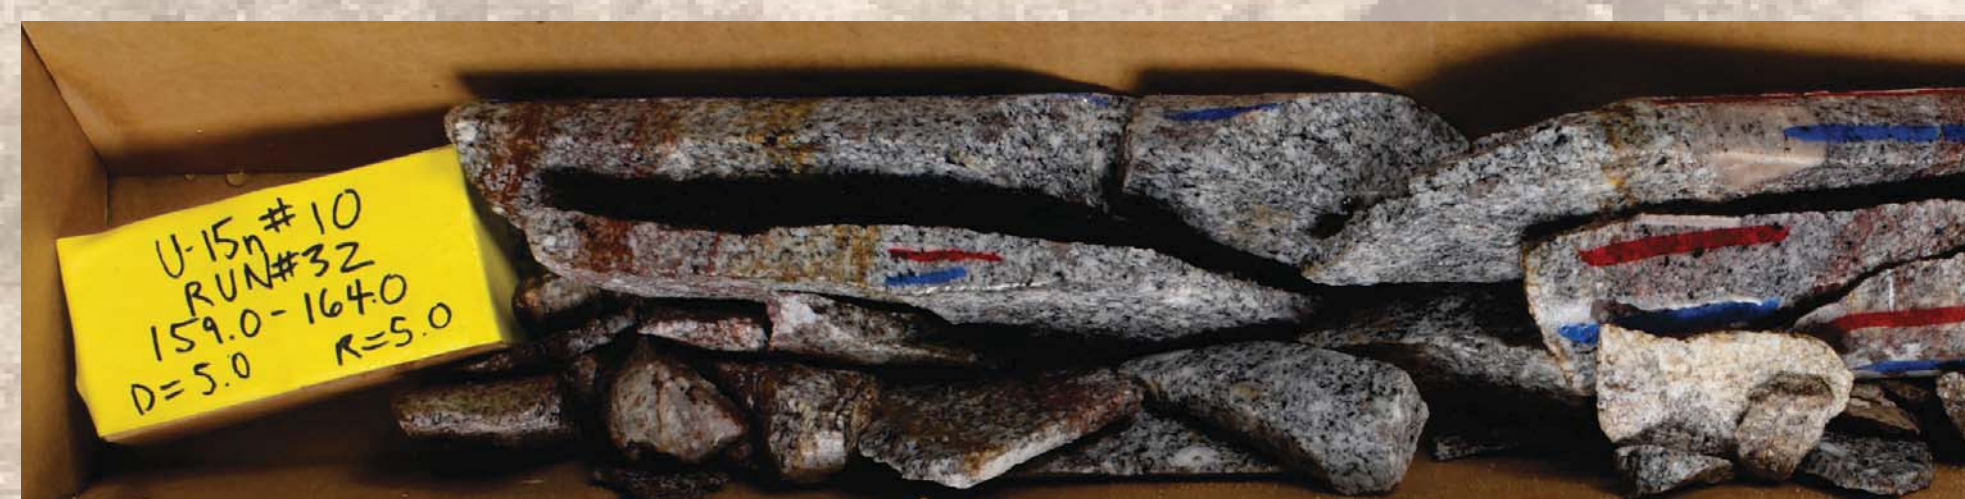
Photo of core recovered from angle-hole U-15n#10 near drilled depth of 159 ft. Fresh-looking fractures closest to yellow block are interpreted to be explosion-induced. SPE-N-2 source is approximately 4.5 m to the right. Yellow block is approximately 8 cm long.

- Interpreted to have been caused by the SPE-N-2 explosion
- Distinctive in both the recovered core and in the televiewer logs
- Appear fresh, with no associated secondary staining or alteration
- Have rougher fracture surfaces and more irregular shapes than the clearly natural fractures observed in the hole
- Tend to terminate against the natural fractures
- Most fractures observed in the borehole televiewer logs have orientations different than those in the established fracture sets, which suggests that the explosion-induced fractures formed in a stress field that is different than that associated with the majority of natural fractures
- Observed only below the drilled depth of 141 ft (approximately 10 m from the shot point), and are most prevalent 3.3 to 5.4 m from the shot point

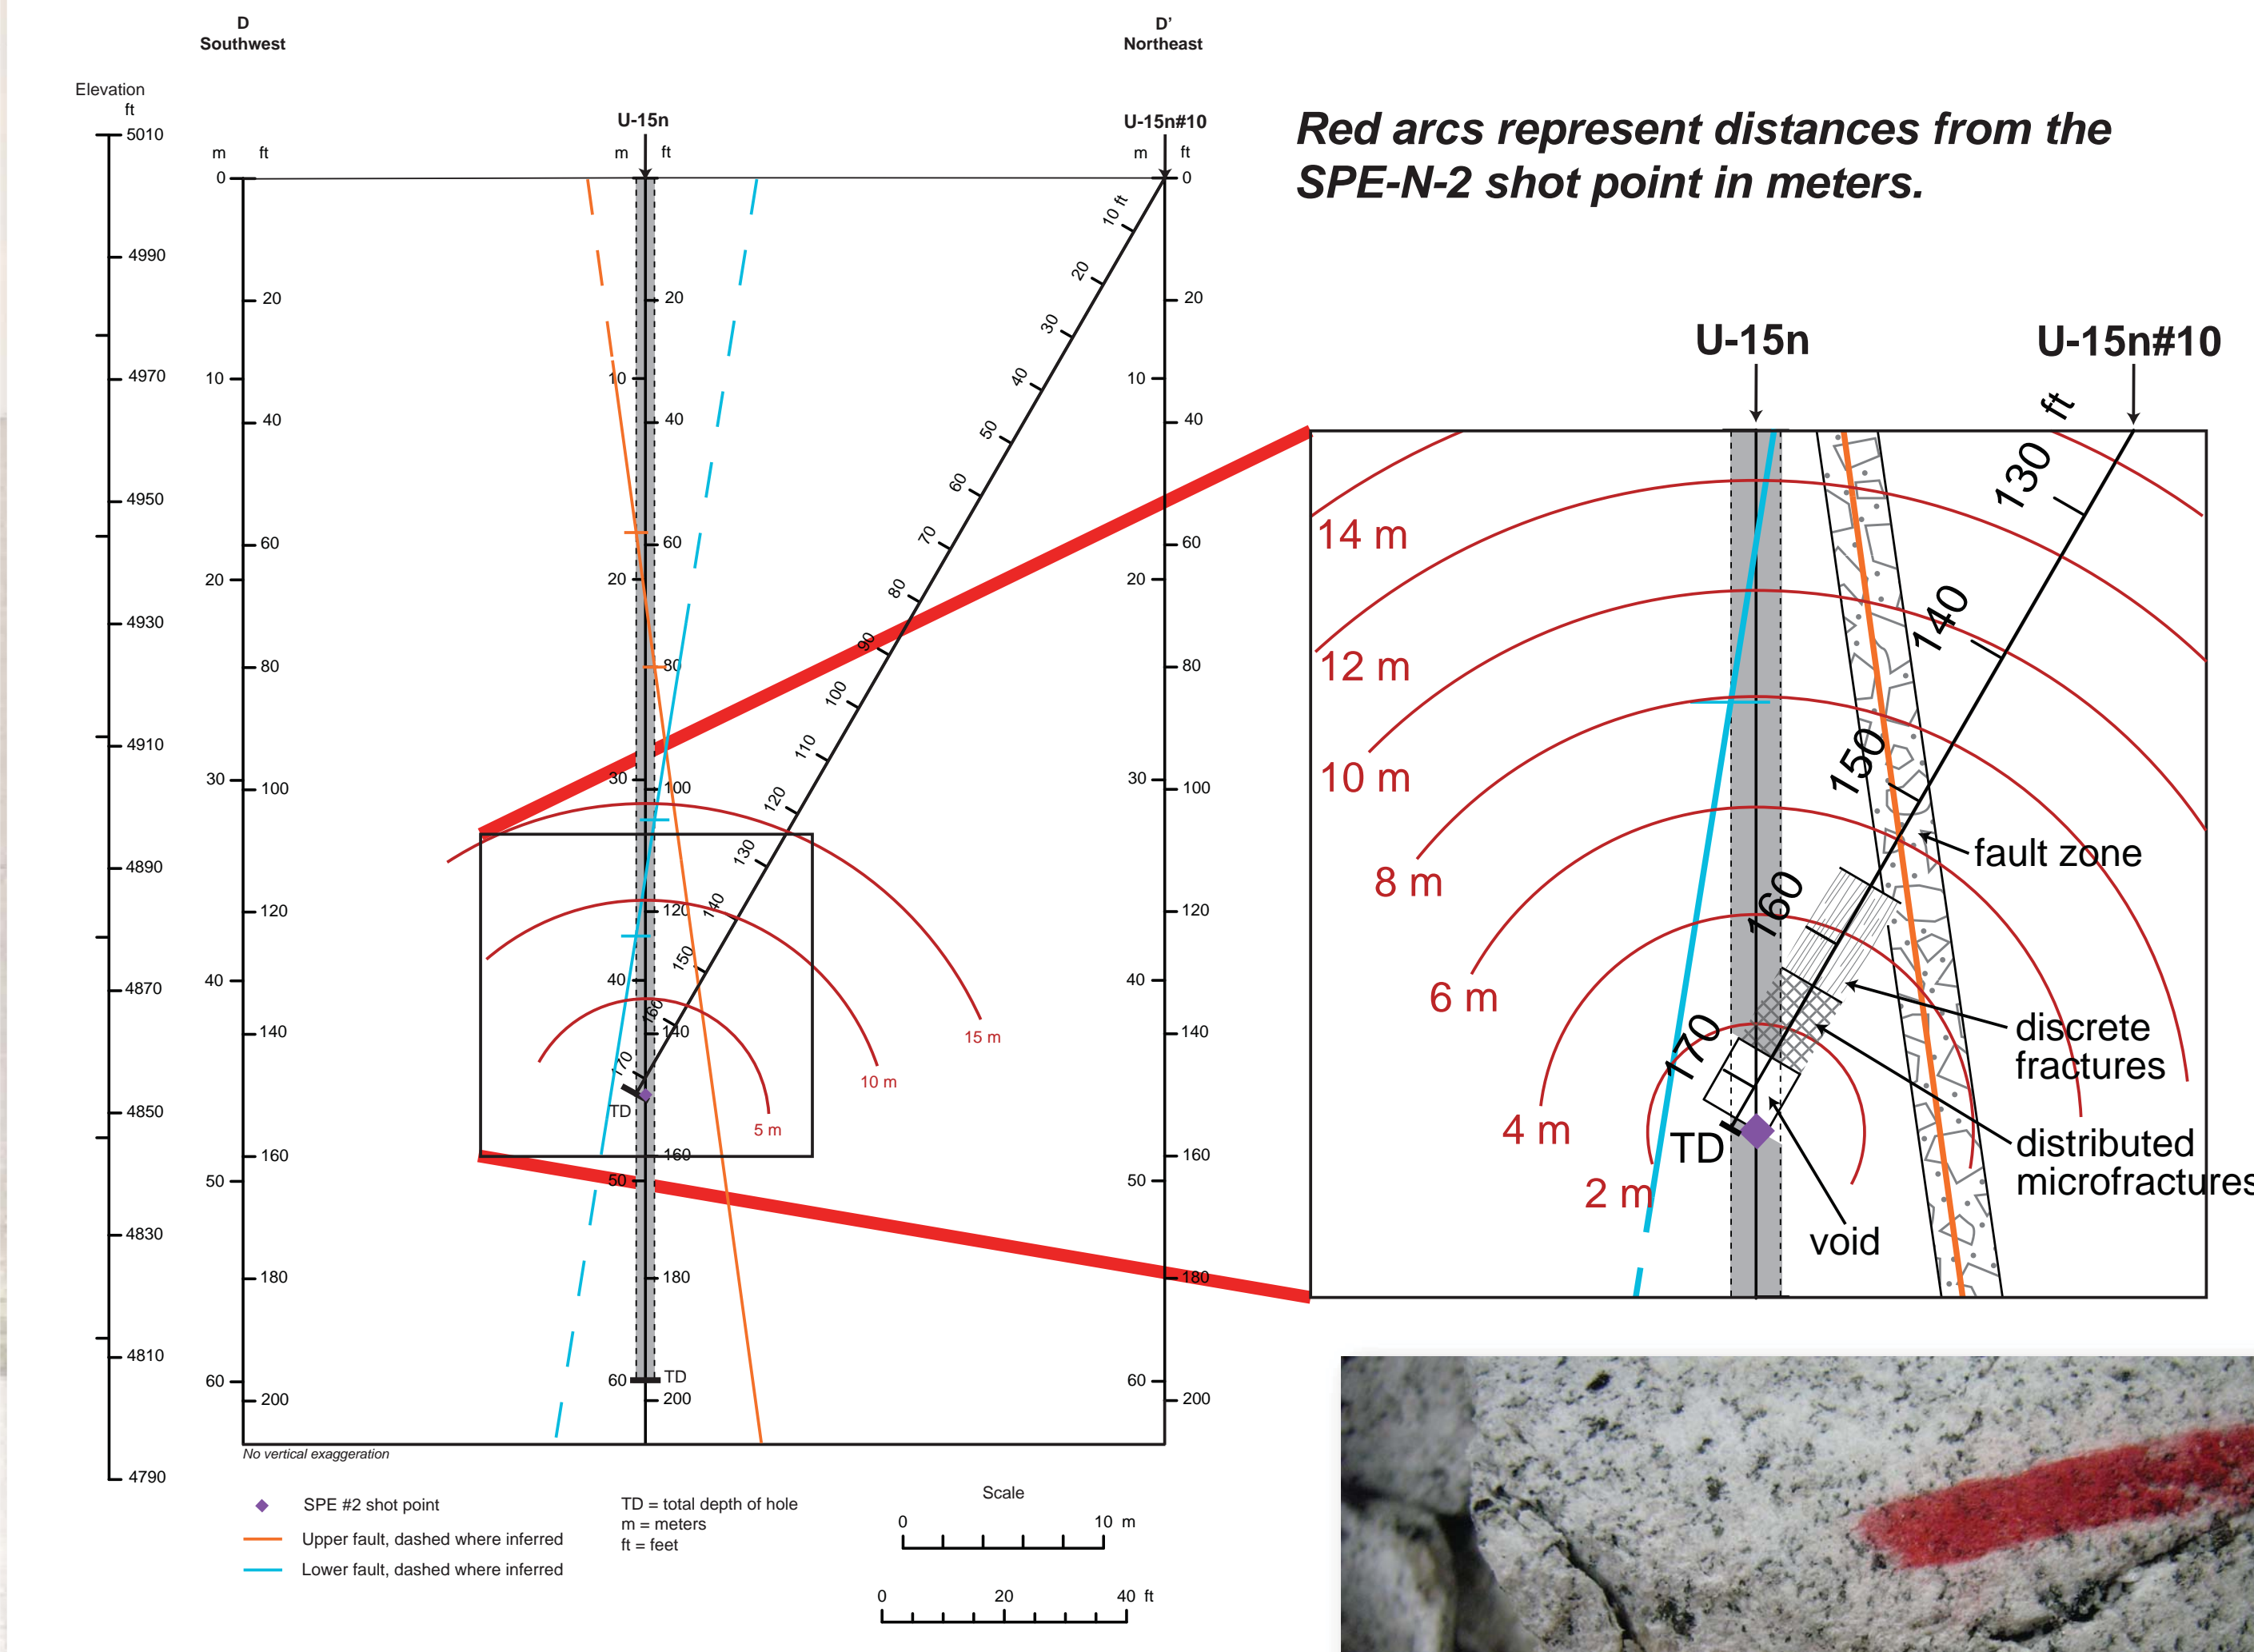
Section view of the SPE site showing the relative positions of the U-15n source hole, SPE-N-2 shot point, and path of angle core hole U-15n#10. Note locations of two natural faults encountered in the source hole, with projected extents shown by orange and blue lines.

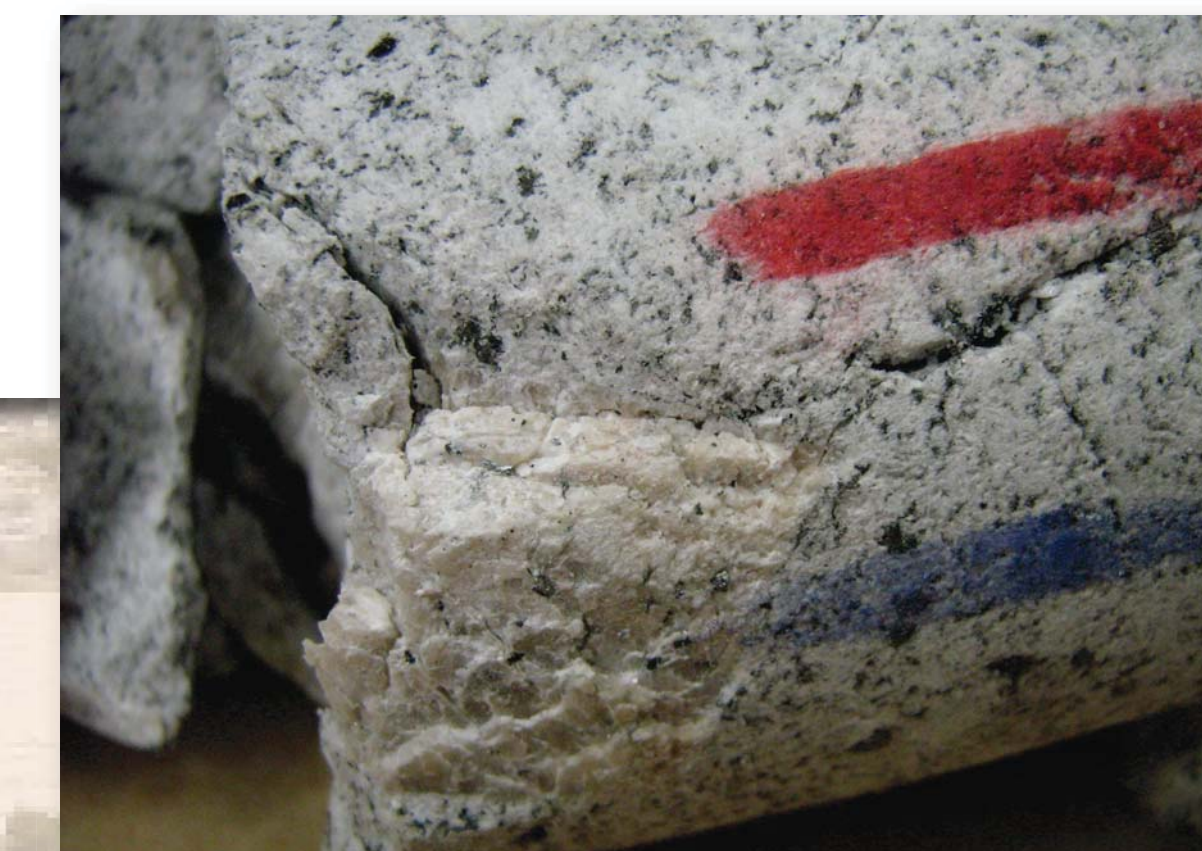
Fractured feldspar crystal retrieved from drilled depth of 168 ft in hole U-15n#10, approximately 1.8 m from the SPE-N-2 shot point. Red line is approximately 2.5 cm long.

- Many pieces of the recovered core have a white, chalky, damaged look
- Naturally occurring feldspar crystals are highly fractured
- Observed from the depth of 163 ft to the end of the recovered core at the depth of 168.4 ft, approximately 1.6 to 3.3 m from the shot point. SNL and Los Alamos National Laboratory studies currently in progress may provide more definitive data for this region

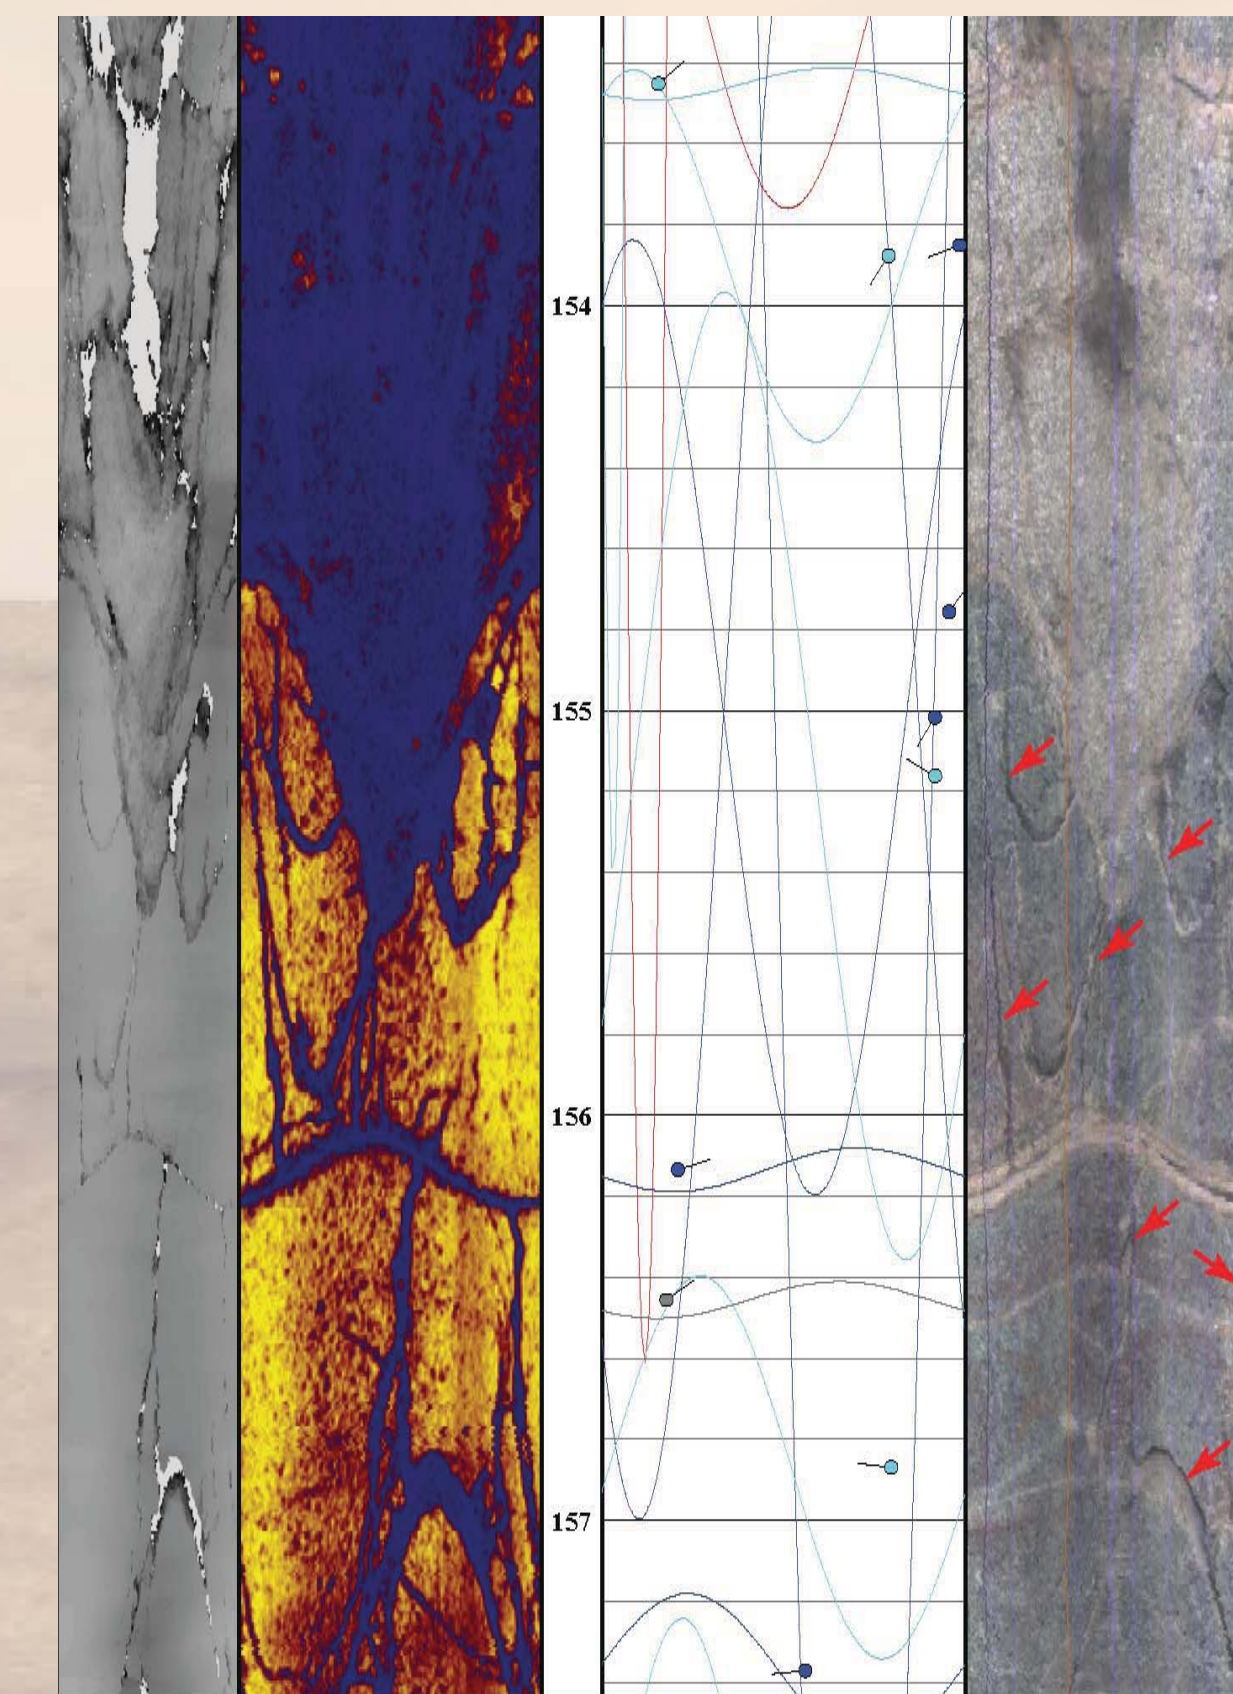
A portion of the U-15n#10 borehole image log showing explosion-induced fractures (red arrows)

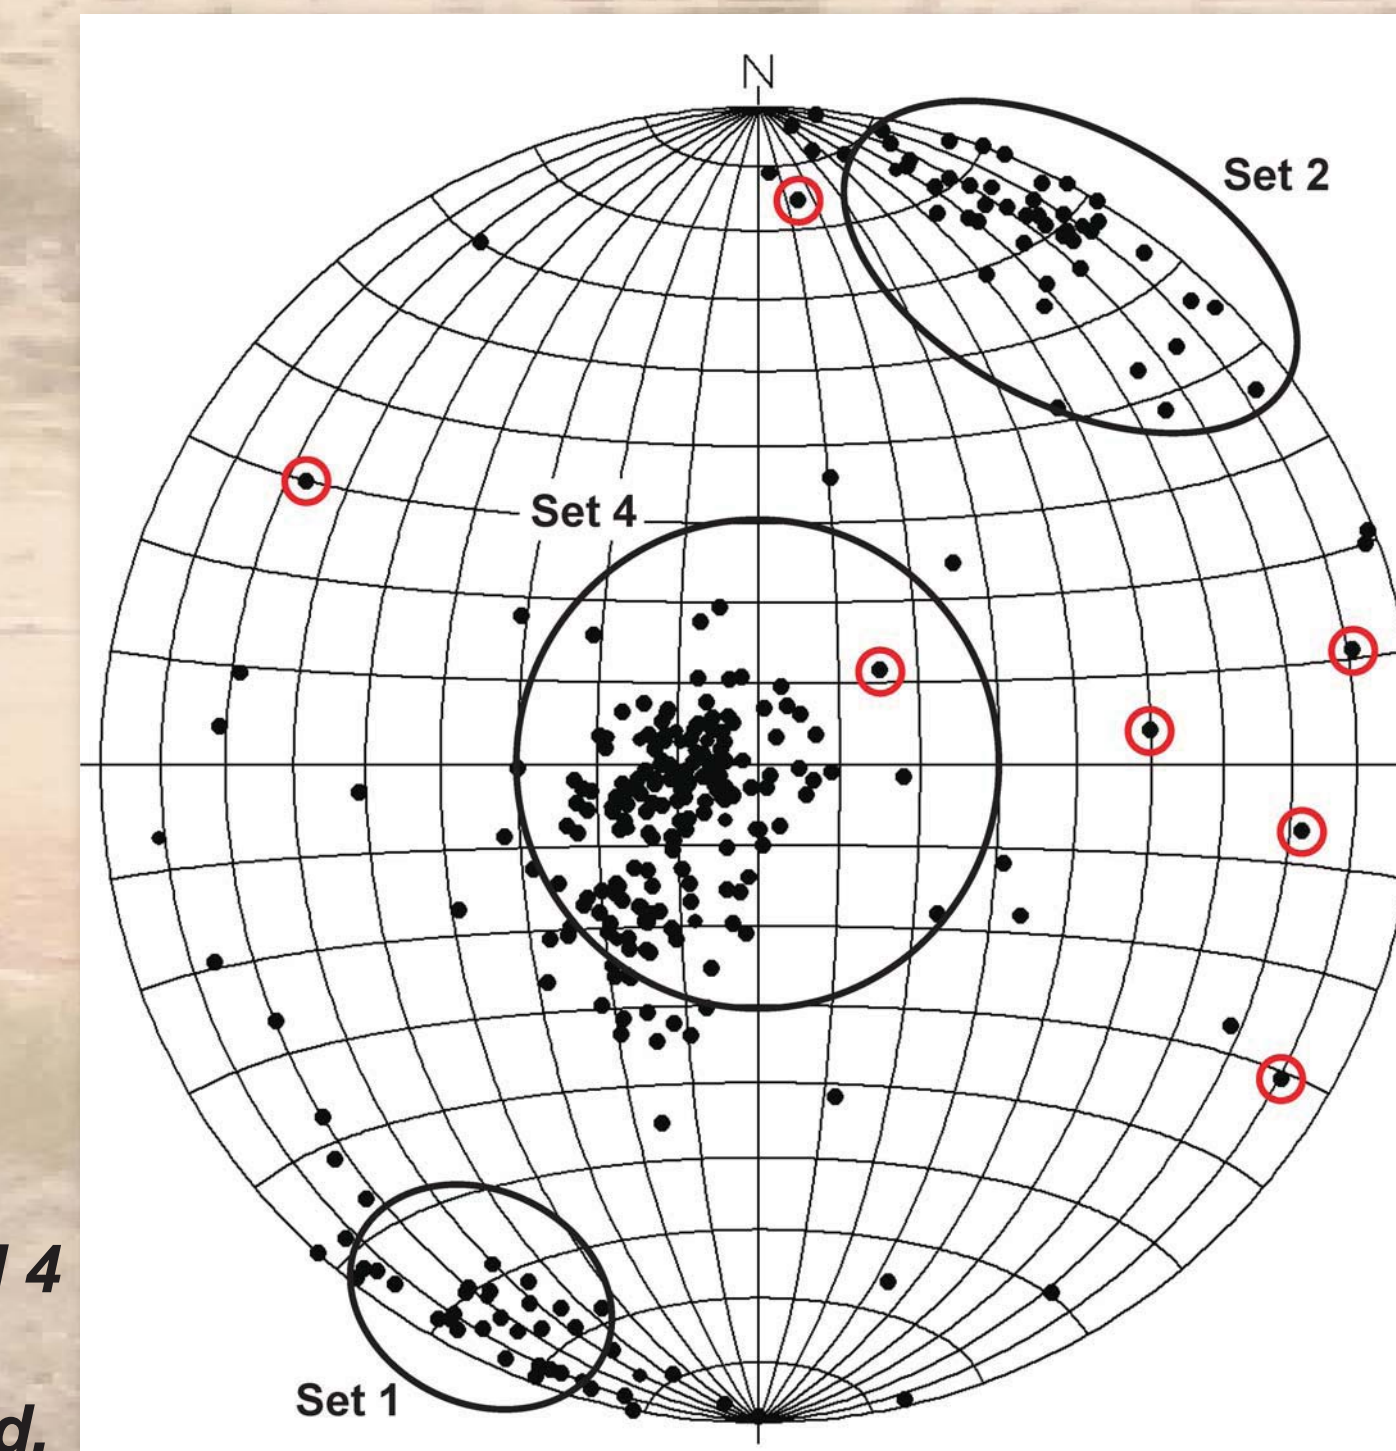
Fractures are plotted on a lower-hemisphere Schmidt net. Natural fractures grouped as Sets 1, 2, and 4 are circled in black. Explosion-induced fractures are circled in red.

Stereonet diagram of all fractures identified in the U-15n#10 televiewer logs, showing the orientations of explosion-induced fractures
