Failure Mechanisms in High Voltage Mylar Capacitors

Jaemi L. Herzberger¹ and Danelle M. Tanner

Special Use Hi-Rel Capacitors Department, 1732
 Sandia National Laboratories, Albuquerque, NM 87185
jlherzb@sandia.gov

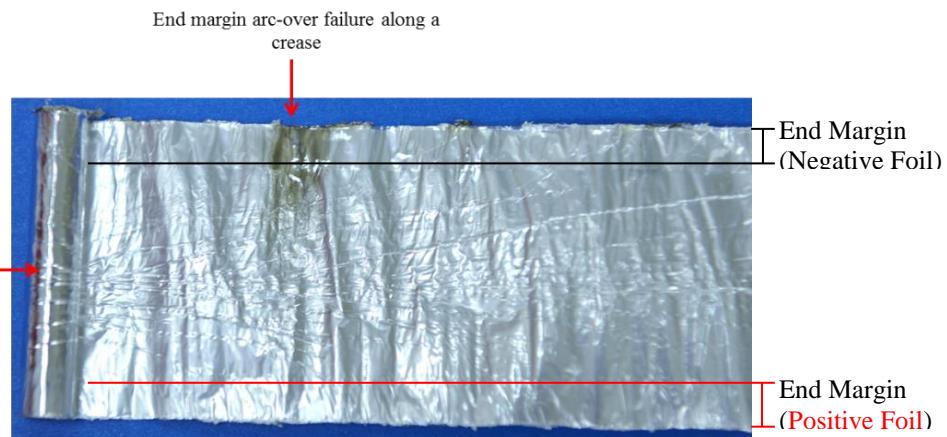
Significant creasing was observed to occur in both of the electrode foils in every capacitor from Build A. This creasing had two different signatures. The first form of creasing observed appeared to have been introduced during the manufacturer's winding process. These creases were more substantial nearest the mandrel, where the windings were initially fed by hand into the winding machine. It is possible that improper tensioning during the winding process, indicative of insufficient process control, caused the occurrence of this creasing. *Figure 3* is an example of windings that appear to have bunched near the center of the mandrel, resulting in significant creasing that radiated and affected many layers. Edge margin arc-over failure occurred in this location along a crease.

Figure 3. Creasing in the foil that led to edge margin arc-over

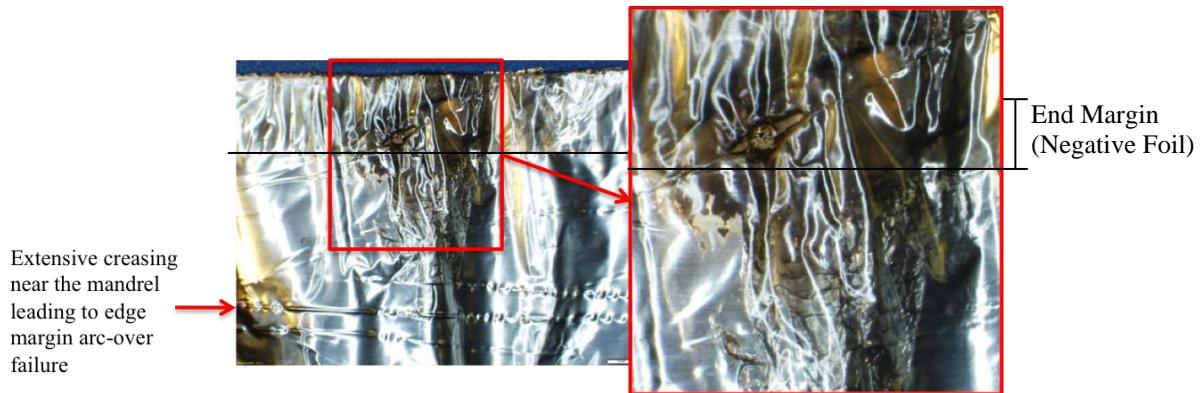
Figure 4 is a closer image of edge margin arc-over that occurred along one of the creases in the foil near the mandrel. Notice the physical evidence of arc-over, indicated by the carbon tracks extending to the edge of the foil and vaporized foil.

Figure 4. Crease-induced arc-over failure

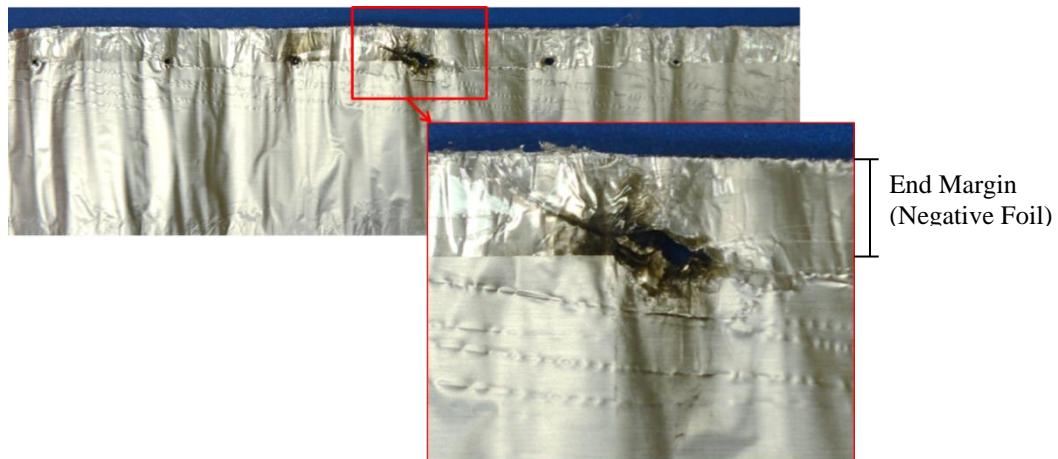
Figure 5 is an image of a dielectric punch-through failure that occurred along one of the creases formed during the winding process.

Figure 5. Crease-induced punch-through failure

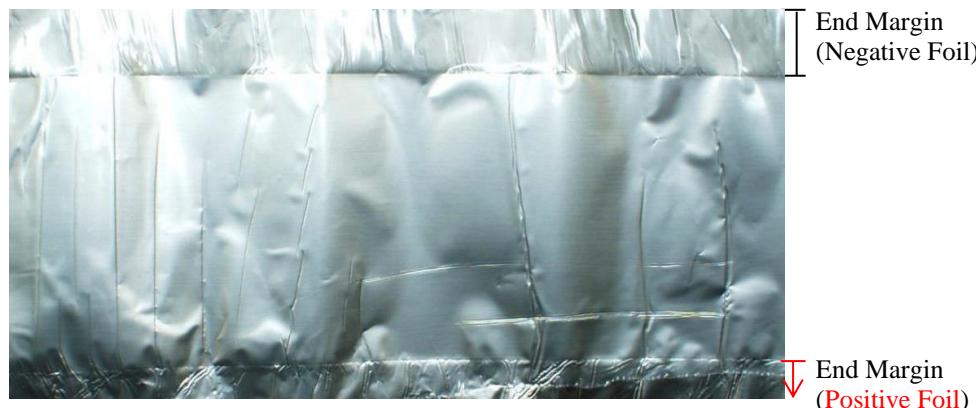
Figure 6 is another example of the type of creasing that can occur due to improper tensioning during winding. Rather than creasing along the length of the windings (horizontally) as shown above, these creases run parallel to the short side of the stack (vertically).

Figure 6. Creasing due to insufficient process control (improper tensioning)

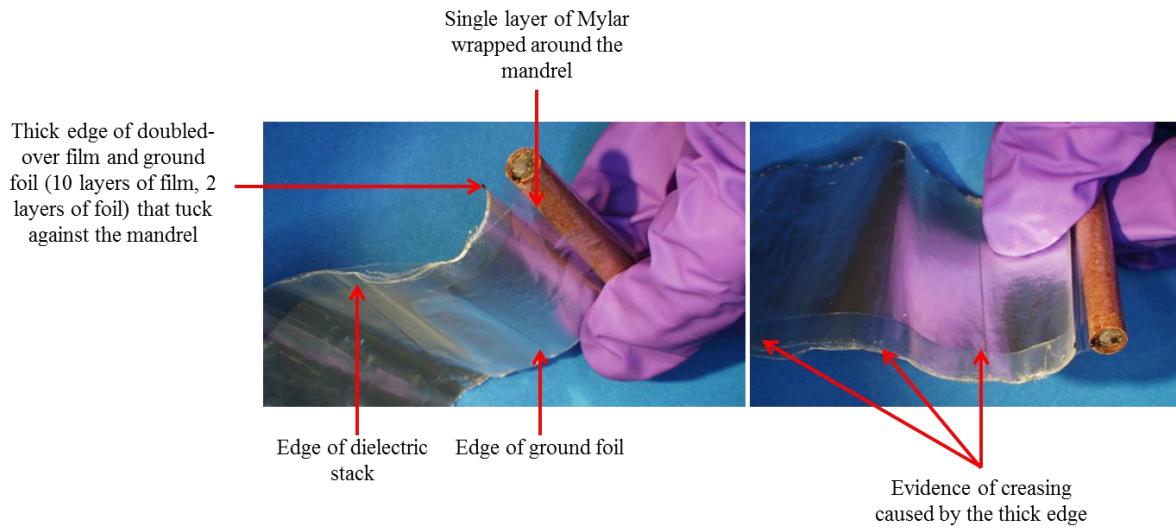
The first winding style consisted of a single layer of Mylar film that wrapped once around the bare mandrel, while the remaining five layers of Mylar and a single layer of Al foil were folded-over and tucked against the mandrel, creating a thick buried edge. Although each capacitor wrapped in this fashion had an average of 6.5 inactive wraps, the thick buried edge (a total of ten film layers and two foil layers) created a crease that affected as many as thirty windings. In this winding style, the inactive wraps contained a single foil, varying randomly between high voltage and ground. *Figure 7* shows the construction of the first winding style and the signature crease that is formed by a thick buried edge.

Figure 7. Construction of the first winding style

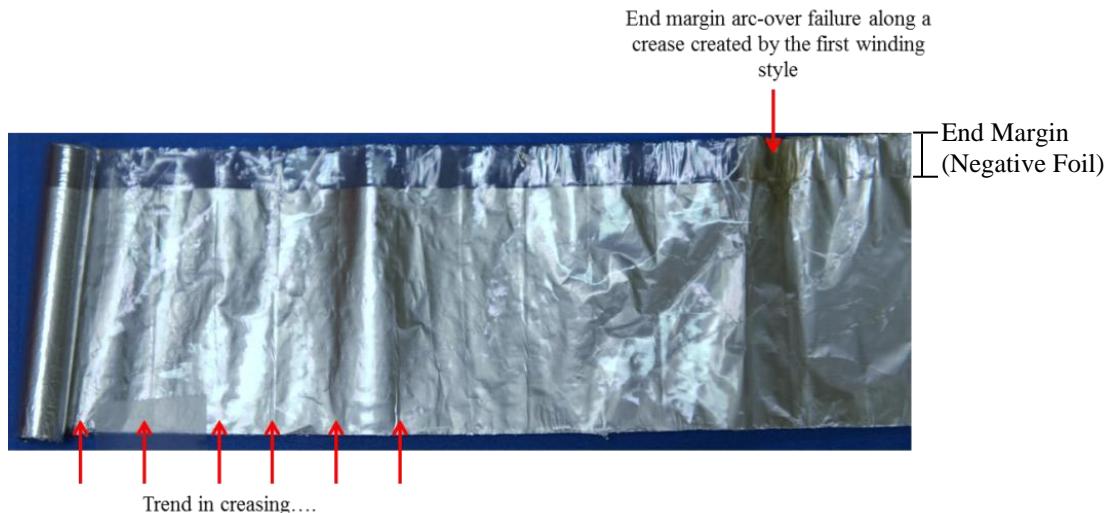
It was found that the crease created by the thick buried edge led to edge margin arc-over in several cases. *Figure 8* shows the pattern of creasing in the initial single-foil inactive area windings created by the thick buried edge. Notice that edge margin arc-over occurred along the crease at the onset of the active area.

Figure 8. Creasing from thick buried edge created by the first winding style

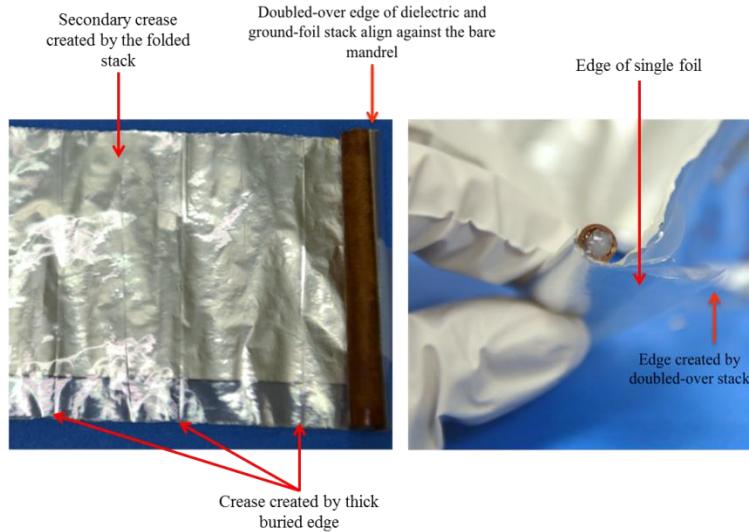
The second winding style construction consisted of doubling over the dielectric and foil stack and aligning it directly against the bare mandrel. Similar to the first winding style, this doubled stack created twelve layers of film and two layers of foil that resulted in a thick buried edge. However, a second buried edge was created beneath the inactive-wraps by the remaining portion of the film/foil stack that folded over. The second foil was introduced after an average of 6.5 single-foil inactive wraps. *Figure 9* shows the construction of the second winding style. Several instances of edge margin arc-over were discovered to occur along the creases created by both the primary and secondary thick buried edges.

Figure 9. Second winding style

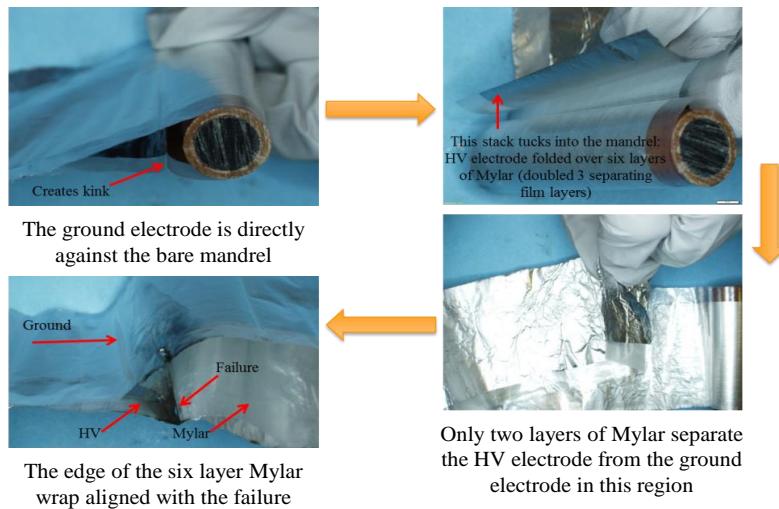
The third winding style construction consisted of the dielectric stack and a single foil wrapping around the mandrel in a “sling” fashion (*Figure 10*). This design configuration did not include any inactive wraps. Instead, the second foil was introduced directly into the folded crease against the mandrel. Therefore, in this active region, only two layers of Mylar dielectric separated the high voltage electrode from the ground electrode. Also, a thick buried edge was created against the mandrel, and in the location where the doubled stack (six layers of film and two layers of foil) ended. Every STB tested capacitor in this design failed due to edge margin arc-over that occurred along one of the thick buried edges.

Figure 10. Third winding style

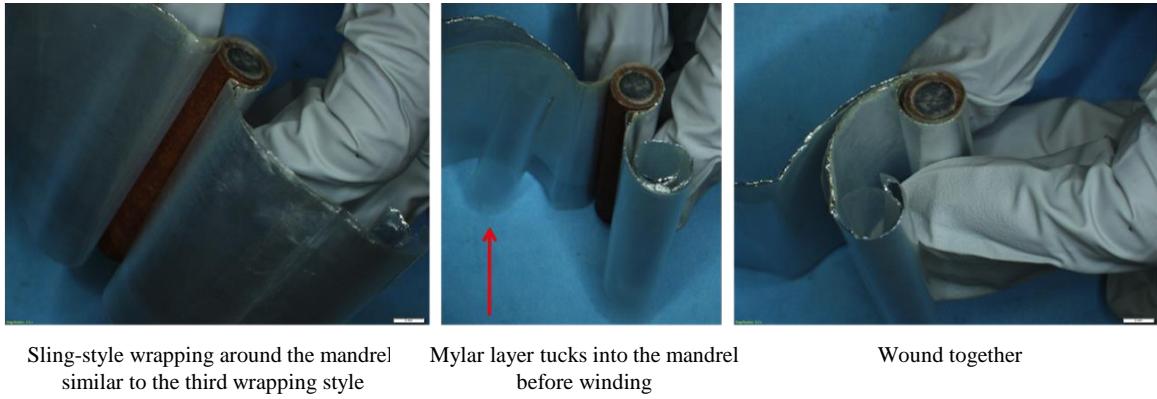
In a later lot that used the third winding style, eight inactive wraps were included. Again in this configuration, the dielectric stack and a single foil were positioned around the mandrel, creating a sling. The mandrel and stack were then wound together and the second foil was introduced after eight windings. A slight crease was created in the windings due to the sharp fold against the mandrel, however, no arc-over or punch-through failures correlated with this crease. The addition of the inactive wraps to the third winding style increased the STB failure voltage by approximately 1 kV. Also, the number of dielectric punch-through failures increased, and the number of edge margin arc-over failures were minimized. The failures that occurred in the newer design were randomly located throughout the windings. This is an improvement from the older lot, where the majority of failures were due to arc-over that occurred along the thick buried edges. *Figure 11* shows the construction of the redesigned third winding style.

Figure 11. Redesigned third winding style

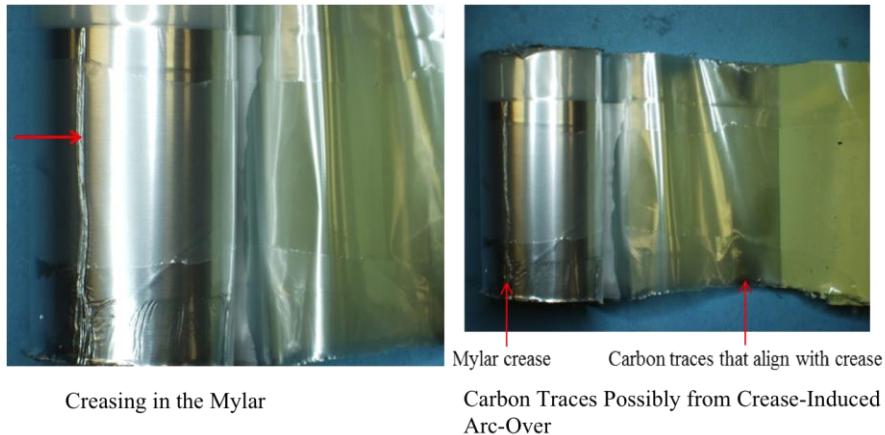
In some capacitors, creasing of the Mylar was detected. This creasing was correlated with failures due to edge margin arc-over (*Figure 12*).

Figure 12. Creasing in the Mylar that led to arc-over

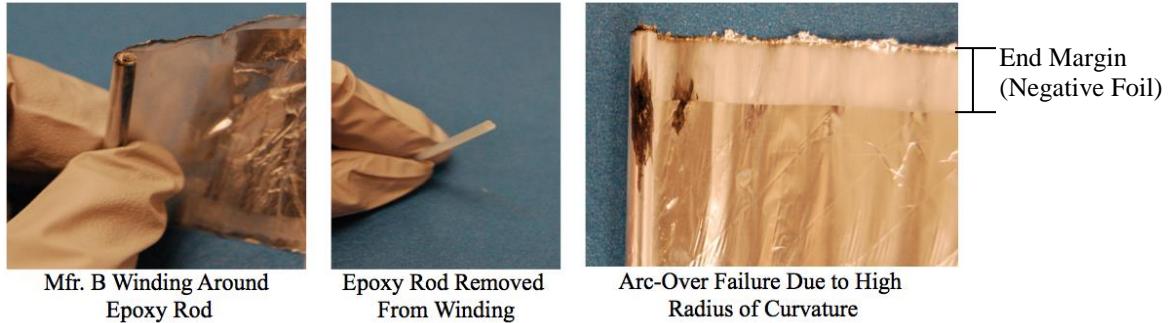
All STB tested capacitors from Build B failed due to edge margin arc-over and dielectric punch-through that occurred close to the mandrel. This development build used a split mandrel during the winding process, which was then removed and replaced with a 2.5 mm (0.1 in) diameter epoxy rod. The small diameter mandrel in these capacitors created a high curvature that increased the electric field strength in that location. Additionally, although no obvious issues were observed with the winding in this build, the failures could be correlating with the beginning of the winding. As a result, the average STB failure voltage was low, sometimes close to the rated voltage. *Figure*

13 shows this epoxy rod, as well as the windings around it and edge margin arc-over failure due to the increased electric field strength.

Figure 13. Epoxy mandrel rod used in Build B and the associated high curvature arc-over failure

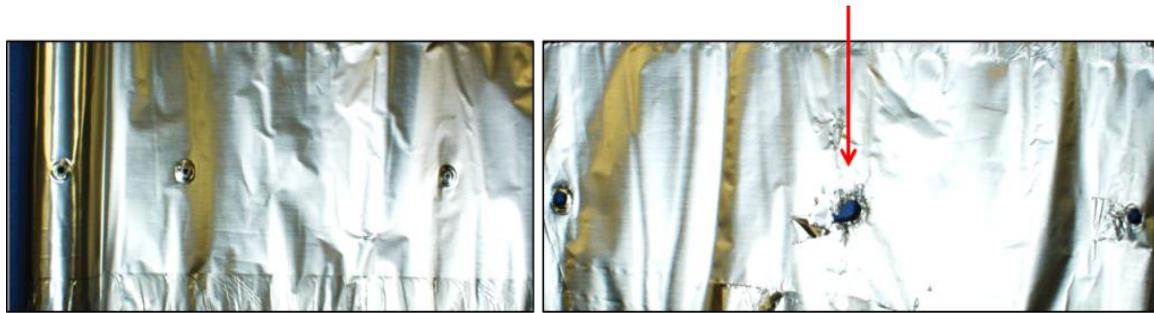
Figure 14 shows an example of dielectric punch-through that occurred near the mandrel due to the high curvature.

Origin of punch-through failure, HV foil view

Figure 14. Dielectric punch-through failure induced by the high curvature

The capacitors from Build A were wound around a 0.5 in diameter mandrel. This helped to mitigate risks associated with increased electric field strengths due to the higher curvature.
