Wedge Assembly Failure Analysis

Kevin Jameson

April 23, 2014

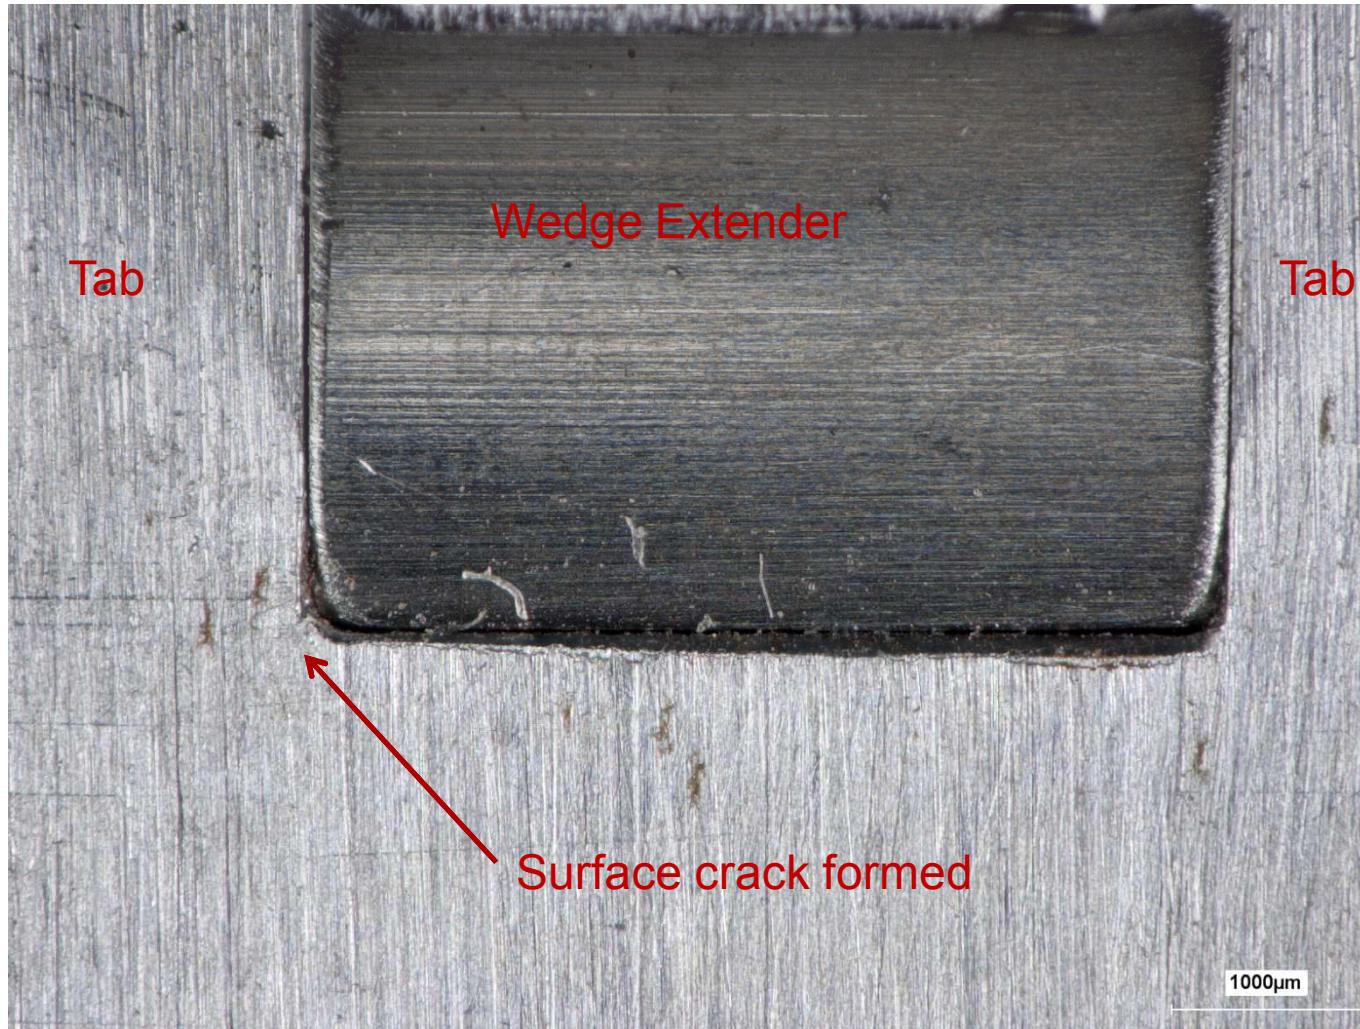
Surface Cracks forming

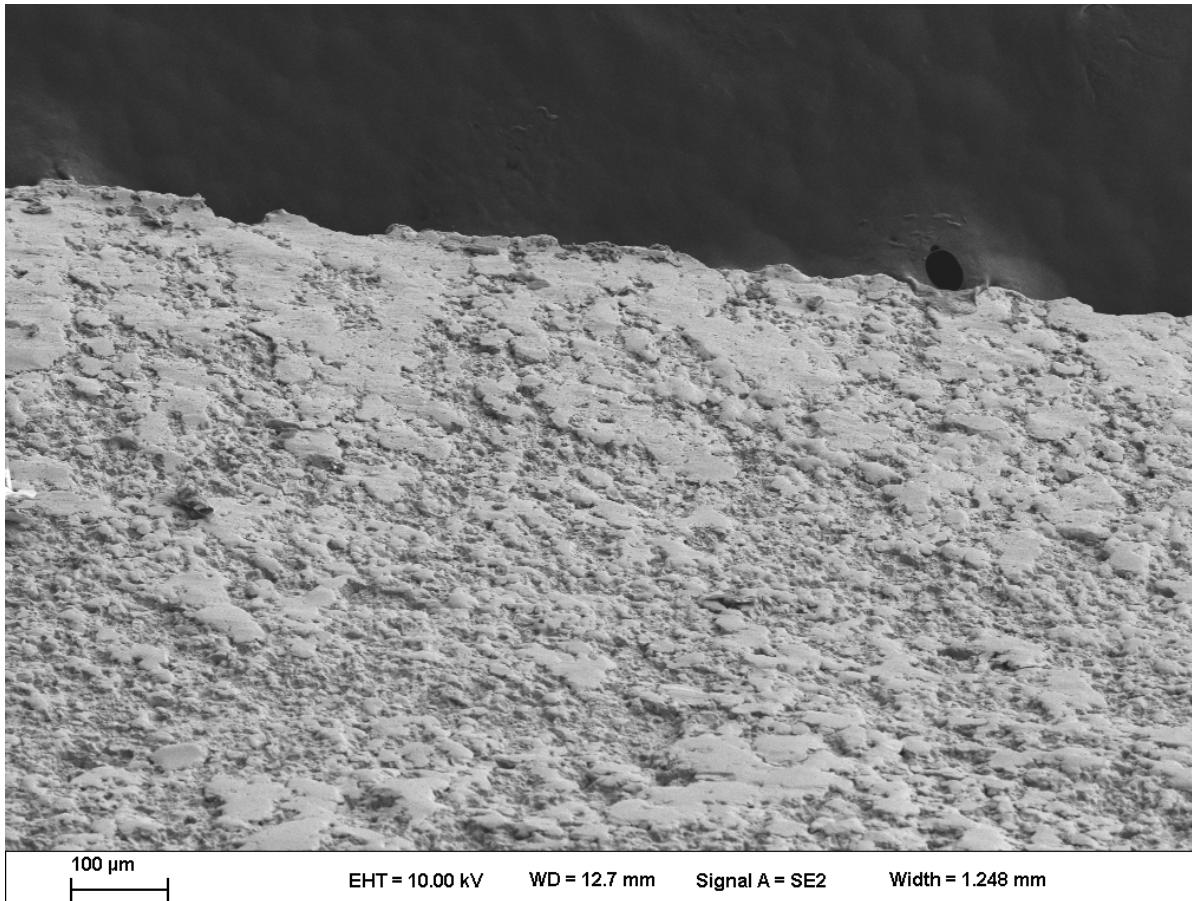
Fracture Face Damaged

- Fracture occurred early in service life
- Fracture surface severely hammered

- Remove stress risers on the inside corners
- Relax tolerances on the press fit of the wedge extender into the wedge
- Change design, allow the wedge extender to have the tabs
- Address the water infiltration
- Address the HE and the Temper Embrittlement

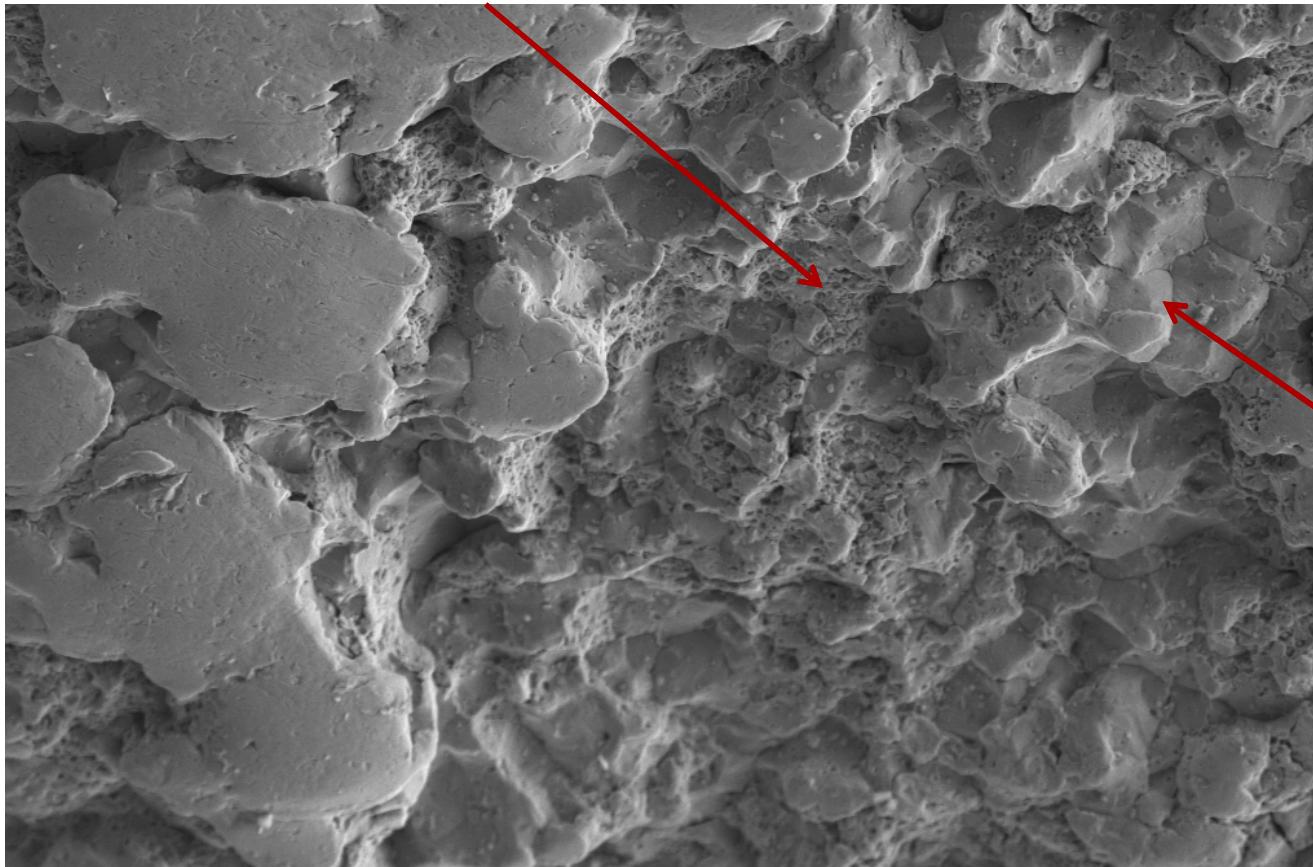
Ductile fracture

Brittle fracture

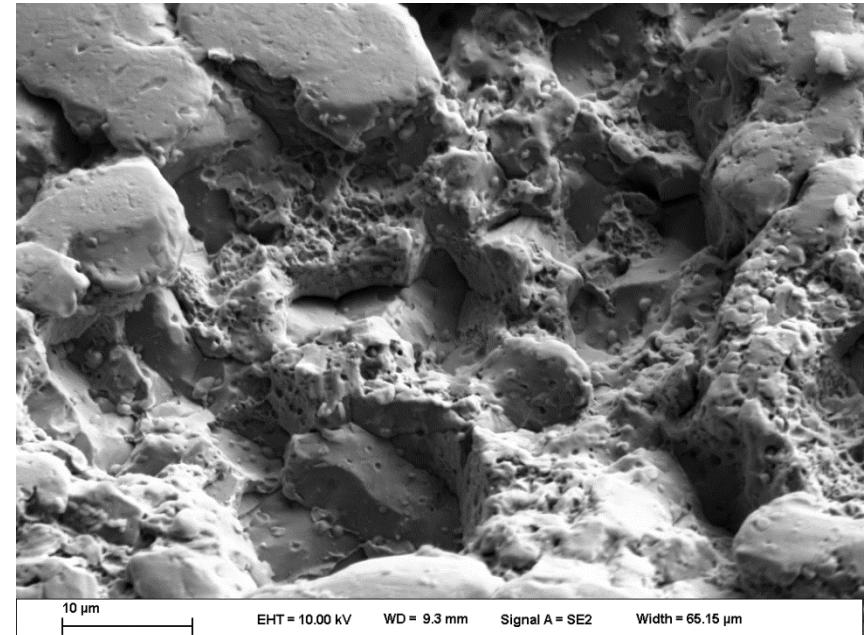
- Mixed-Mode Failure
- Hydrogen Embrittlement
- Temper Embrittlement
