# DOCUMENT RELEASE FORM

# Hanford Single-Shell Tank Leak Causes and Locations - 241-TX Farm

**Abstract:** This document identifies 241-TX Tank Farm (TX Farm) leak causes and locations for the 100 series leaking tanks (241-TX-107 and 241-TX-114) identified in RPP-RPT-50870, Rev. 0, Hanford 241-TX Farm Leak Inventory Assessment Report. This document satisfies the TX Farm portion of the target (T04) in the Hanford Federal Facility Agreement and Consent Order milestone M-045-91F.

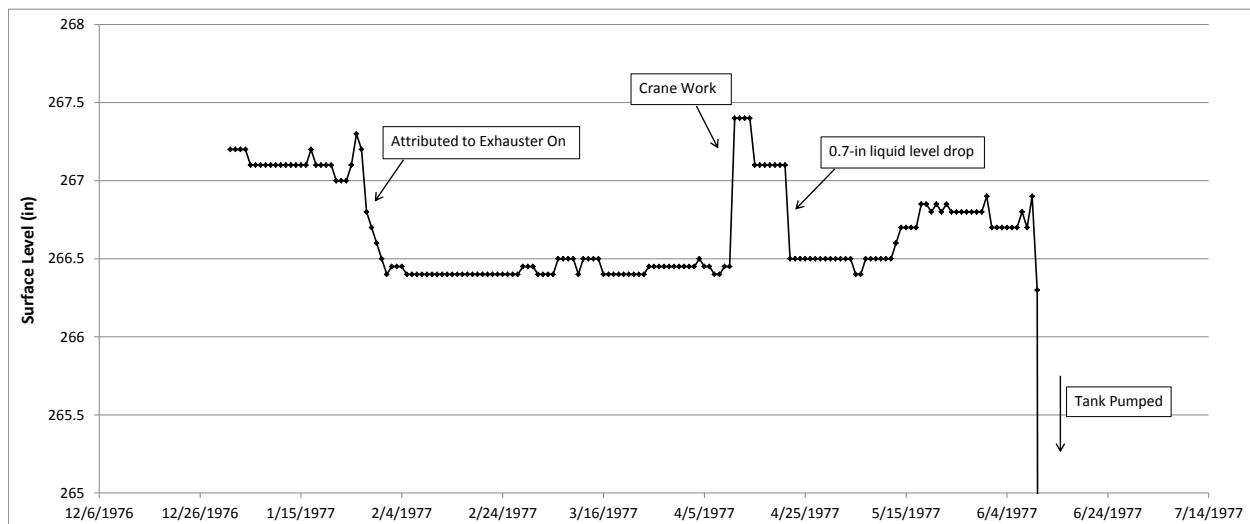
**Figure 4-4. Tank TX-107 Liquid Level January 1977 through June 1977**

On July 6, 1977 (after most of the tank contents had been removed), it was reported that the liquid level dropped 0.5-in due to an inadvertent submersible pump startup (OR 77-115, *Liquid Level Decrease, Tank 107-TX July 6, 1977*).

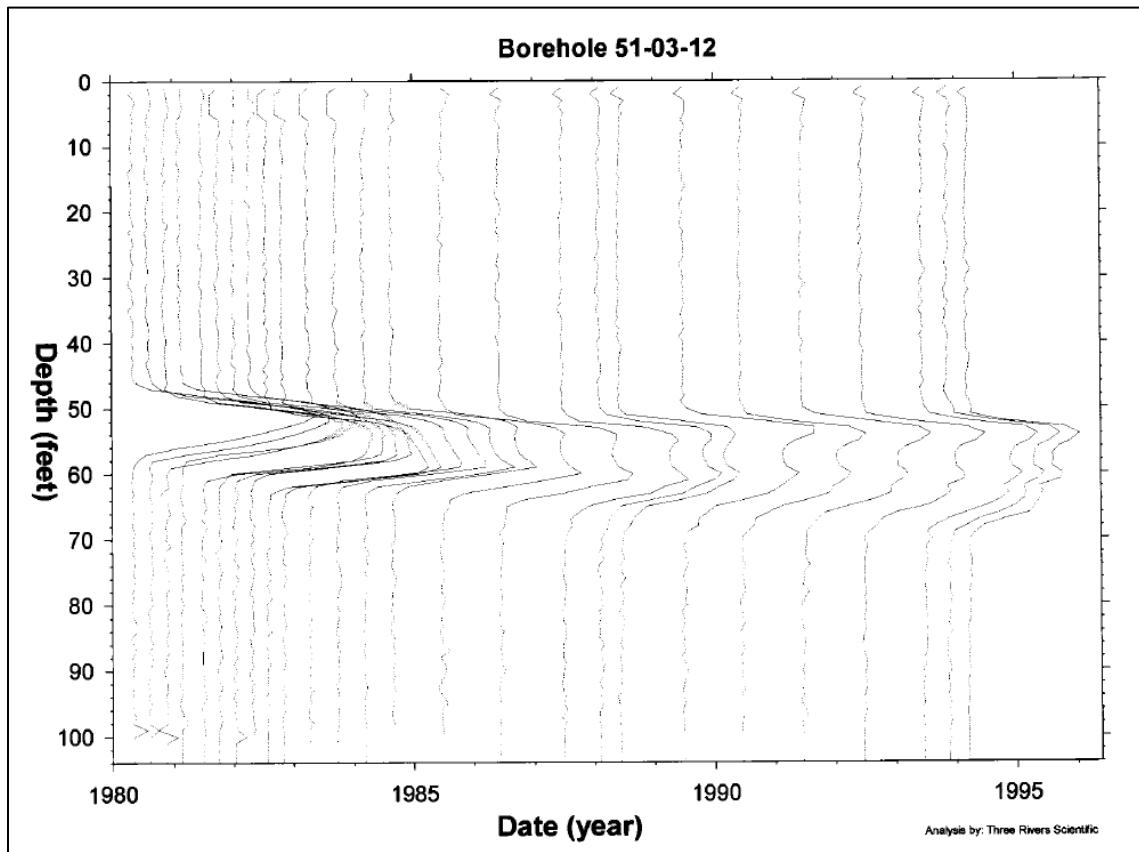
**Figure 4-14. Tank TX-107 Drywell 51-03-12 (RPP-6353)**

Drywell 51-03-12 is located approximately 12-ft from the tank TX-107 footing. Drywell 51-03-12 was drilled in November 1971 with the first recoverable reading on July 6, 1973 reported as less than values. Readings continued to be reported as less than values through May 1976. Beginning on October 21, 1976 a peak of 3.1K cpm was reported at 53-ft BGS (see Appendix A1).

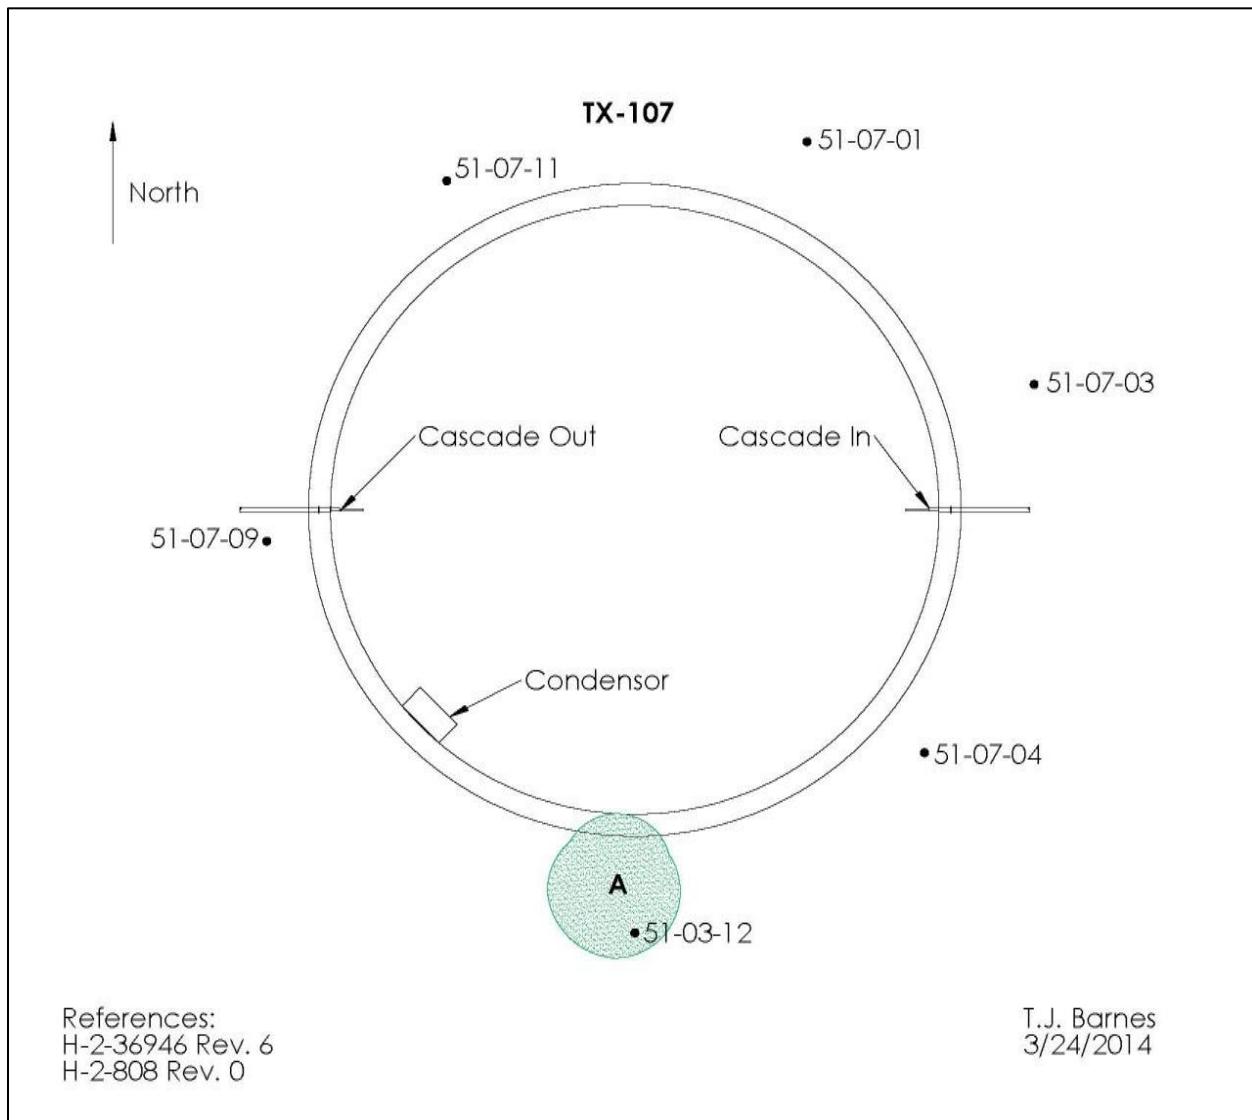
**Figure 4-15. Tank TX-107 Possible Leak Location (October 1976 to April 1977)**

Tank TX-107 was first suspected of leaking based on radioactivity reported in drywell 51-03-12, initially detected in October 1976 which increased to above the minimum criterion in April 1977. Tank TX-107 was later confirmed as the source in June 1977 after subsequent drywells were drilled (see Section 4.5.1.13).

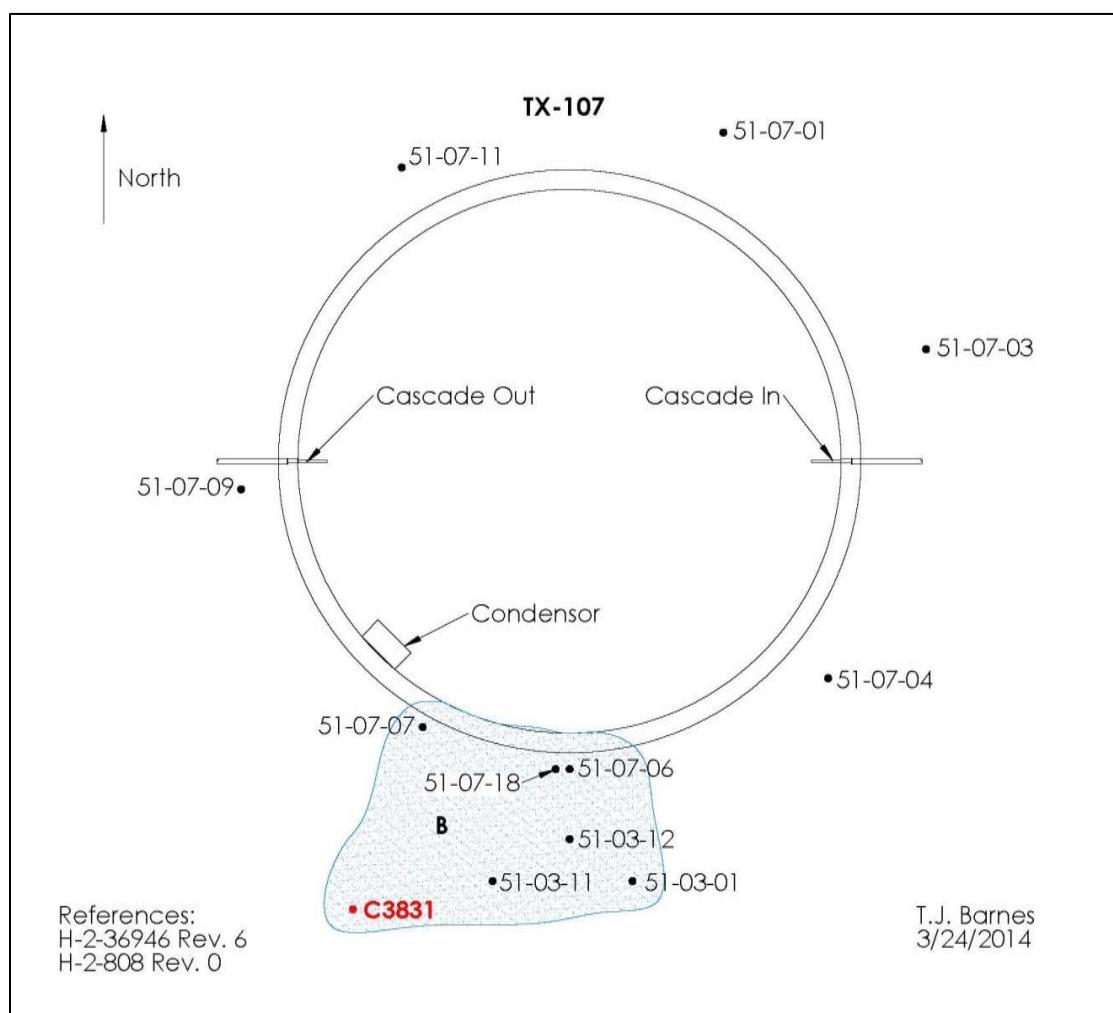
Tank TX-107 was first suspected of leaking based on radioactivity reported in drywell 51-03-12, initially detected in October 1976 which increased to above the minimum criterion in April 1977. Tank TX-107 was later confirmed as the source in June 1977 after subsequent drywells were drilled (see Section 4.5.1.13).

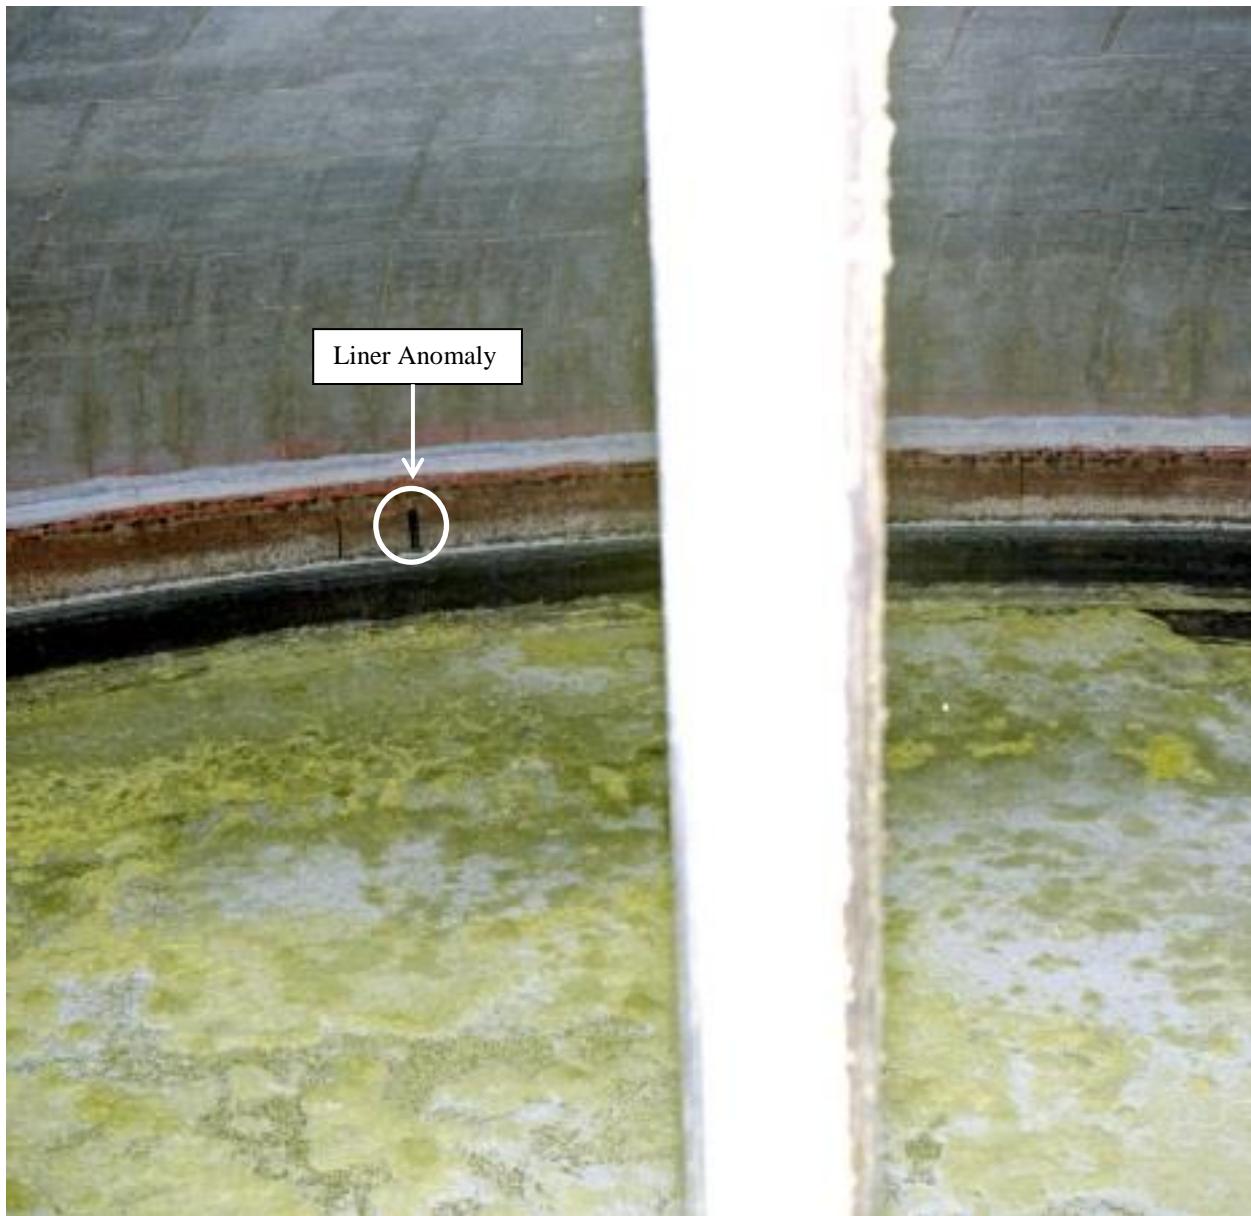
**Figure 5-4. Tank TX-114 Photograph #106996-10CN**  
**April 11, 1983**

Tank TX-114 photos indicated a possible hole in the liner below the flashing. It is unclear whether this liner anomaly is a perforation of the liner; drywell data indicates a leak site in a different location. There may be unseen similar anomalies below the level of the solids.

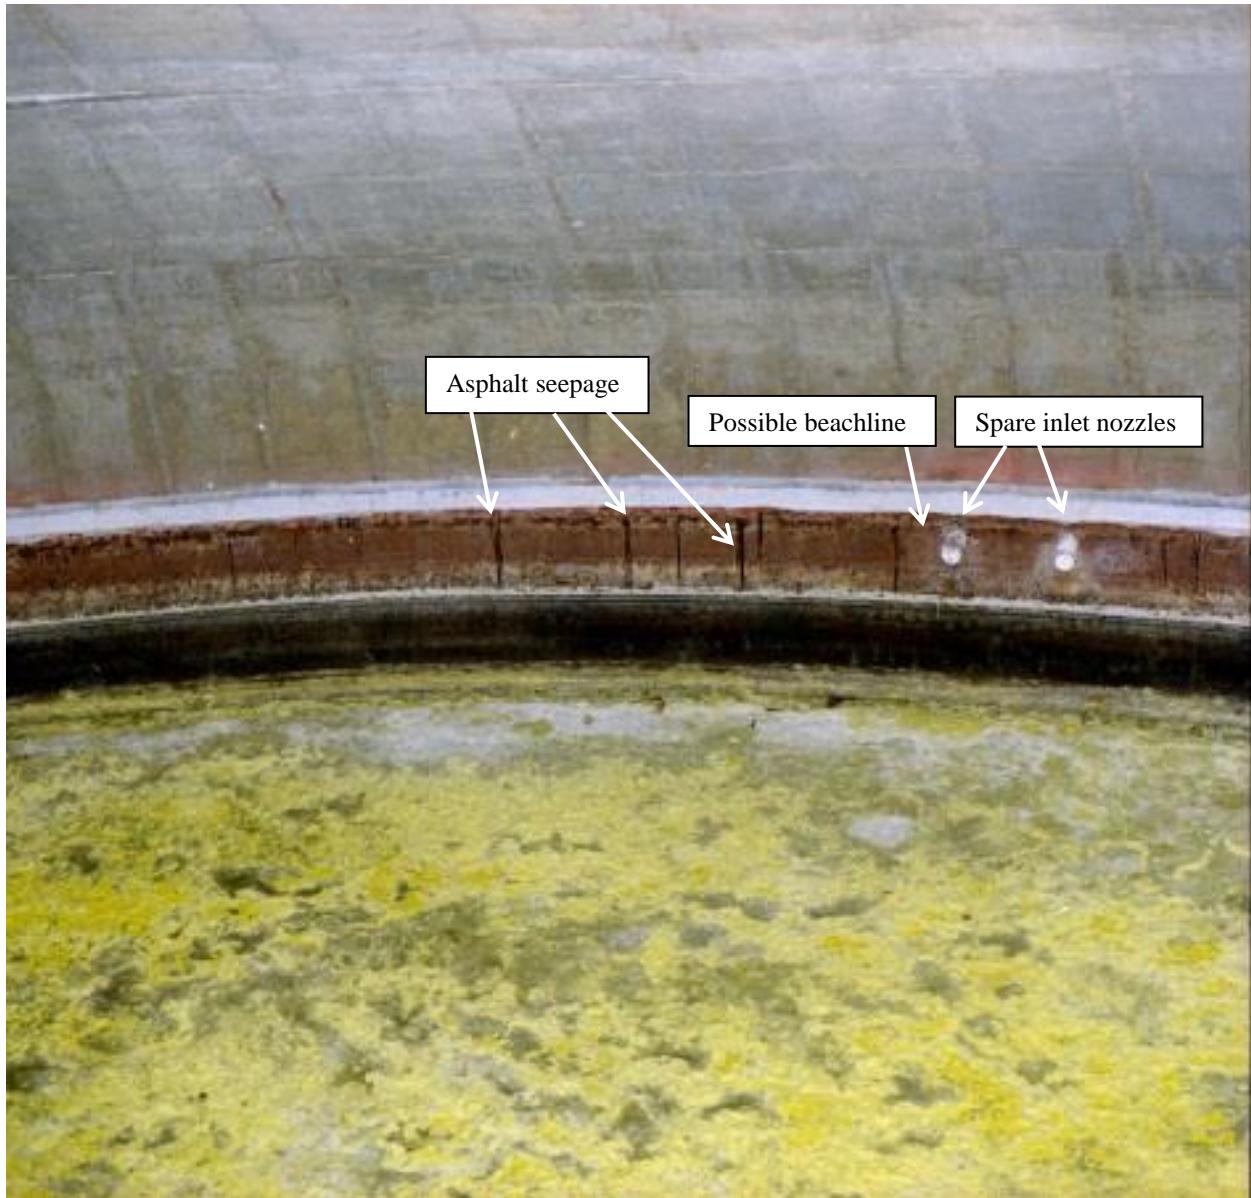
**Figure 5-5. Tank TX-114 Photograph #106996-4CN**  
**April 11, 1983**

The photograph in Figure 5-5 indicates a possible beach line from overfilling 1965 to 1967 above the spare inlet lines. The spare inlet lines are at the same level as the cascade inlet line.

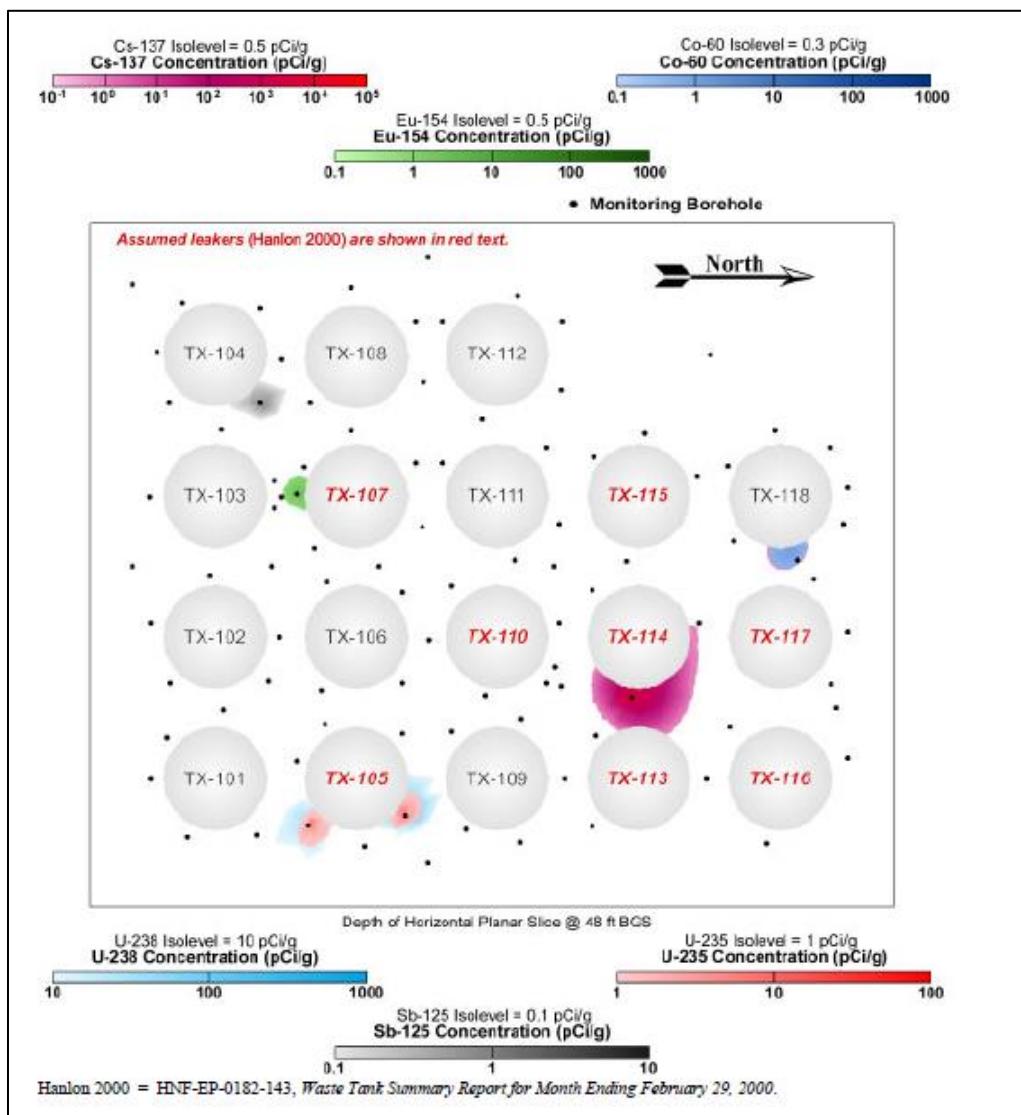
**Figure 5-12. Tank TX-114 Drywell Logging Plume Visualization (GJO-HAN-11)**

Drywell 51-14-08 first recoverable reading reported a peak of 21K cpm at 40-ft BGS on July 6, 1973. Readings then doubled to 45K cpm by the end of August 1973, and then remained relatively stable through June 1986. The source of this radioactivity is likely tank TX-114; however, tanks TX-110 or TX-115 cannot be ruled out as possible sources.

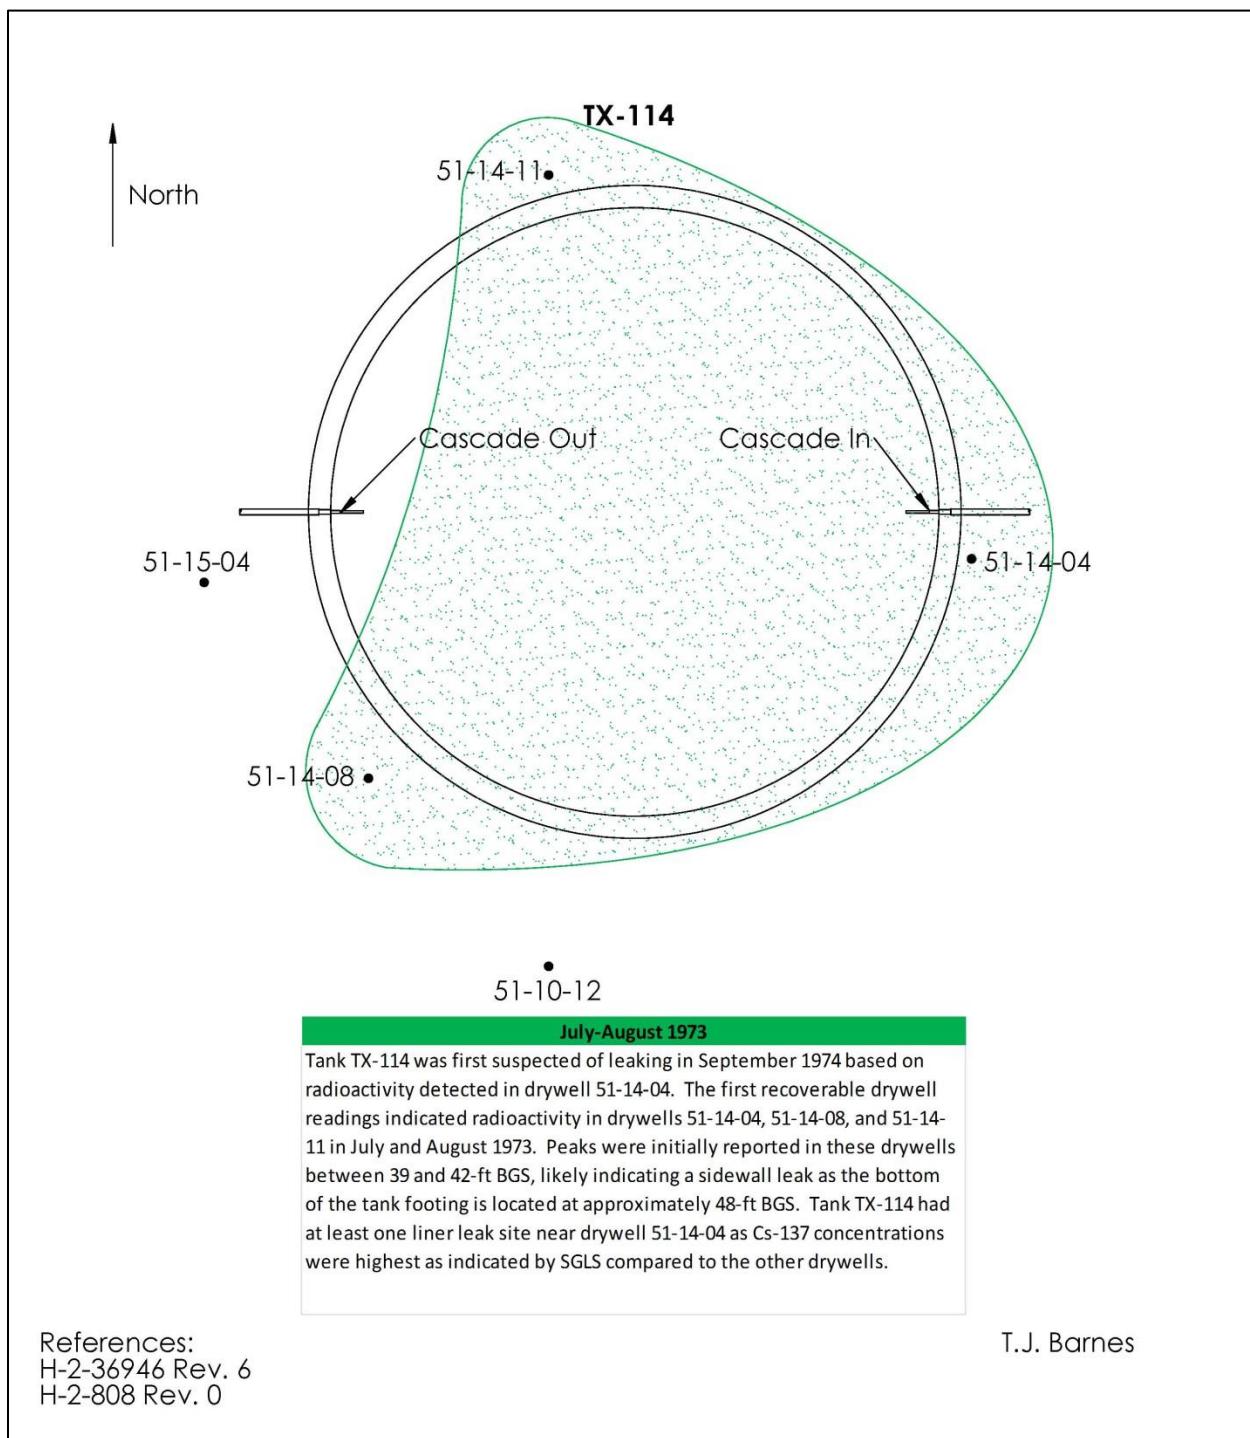
**Figure 5-13. Tank TX-114 Possible Leak Location (July-August 1974)**  
Tank inner ring is steel liner; outer ring is outer edge of tank footing

Tank TX-114 was first reported to be leaking in September 1974 based on radioactivity detected in drywell 51-14-04.
