Laser Spot Weld Repair of MC4779 Shunt Wire Resistance Weld

Dept 1813 Joining & Coating

***IMOG Joining Subgroup
March 12, 2008***

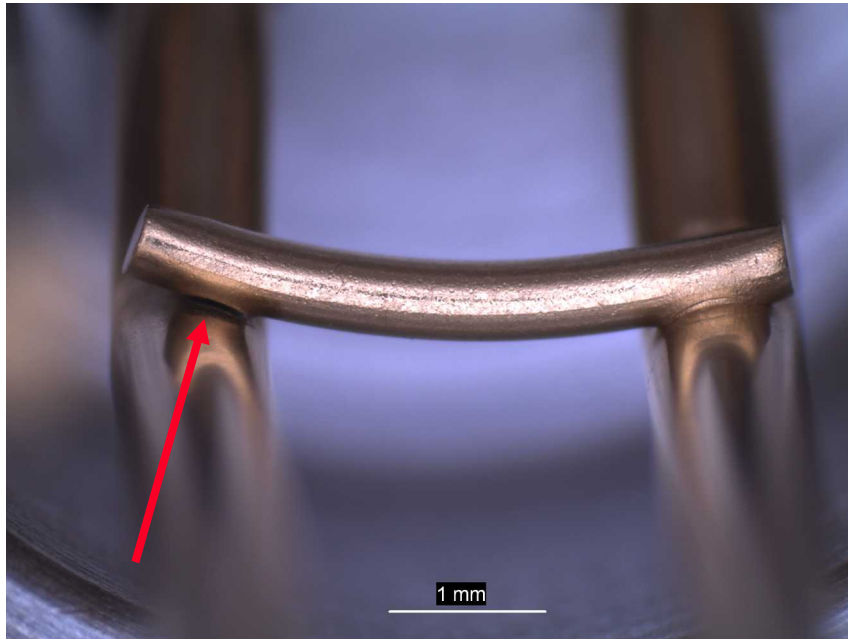
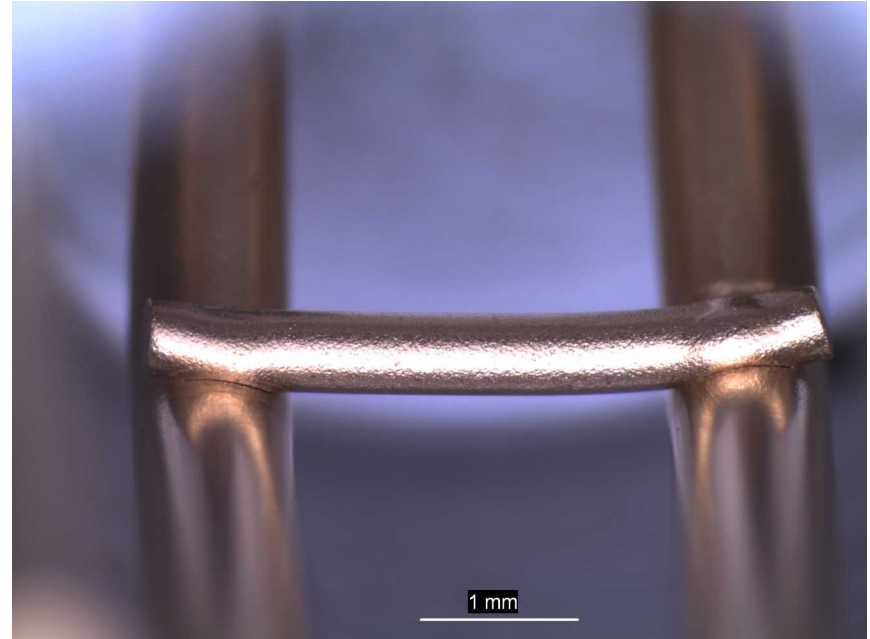
Alloy 52 Resistance Welded Shunt Wire

Normally cross-wire resistance welds are pretty bullet-proof. Not this time!

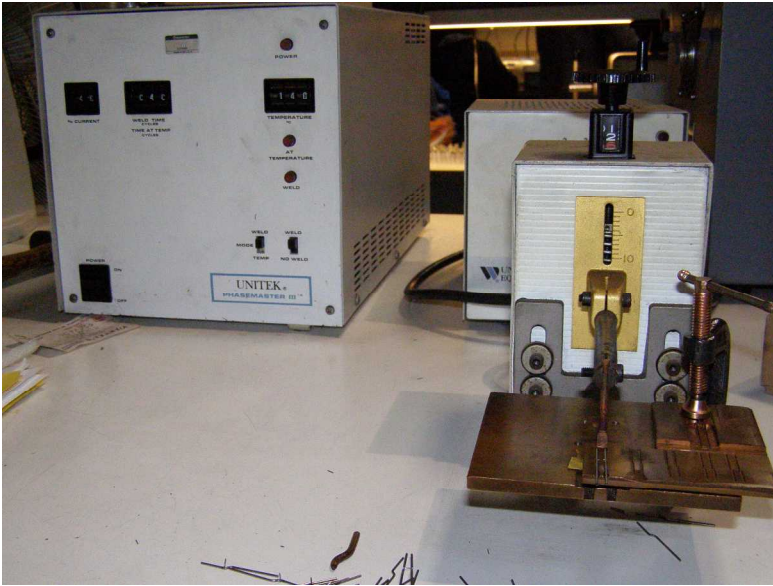
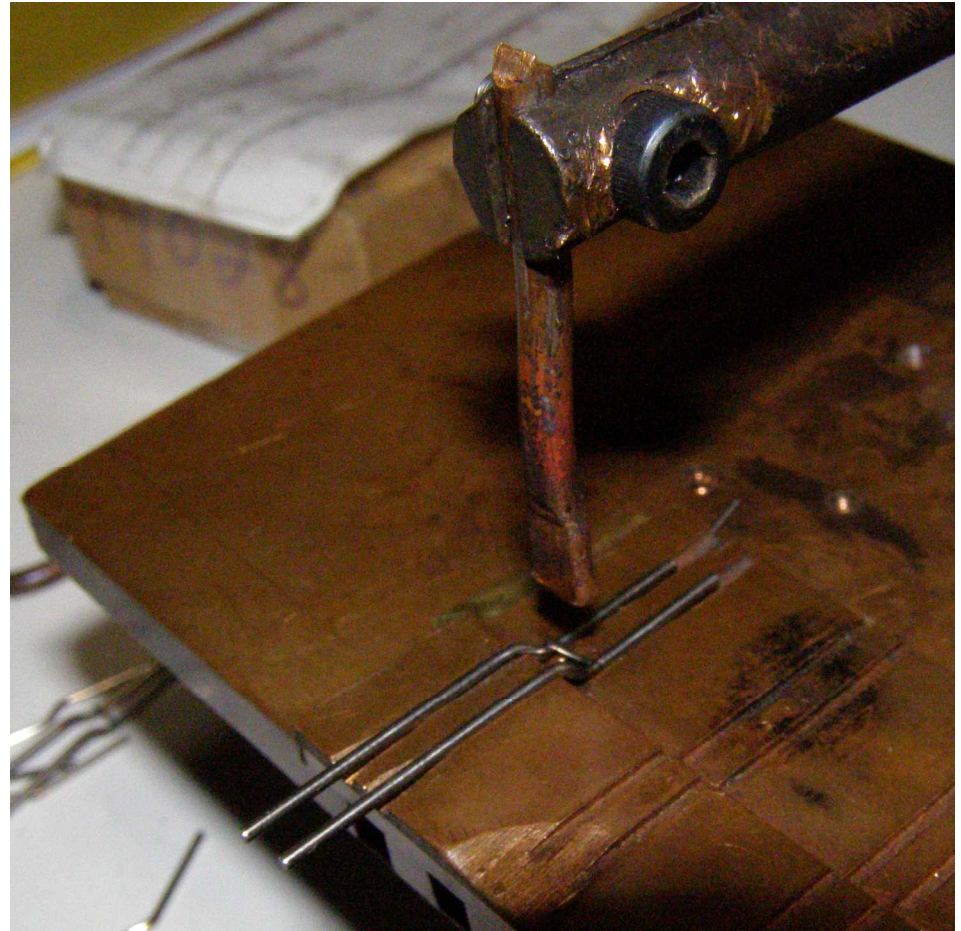
Vendor's RW Set-up

The vendor set up to make both welds simultaneously; apparently, the electrodes weren't precisely aligned and tended to underheat the right hand bond

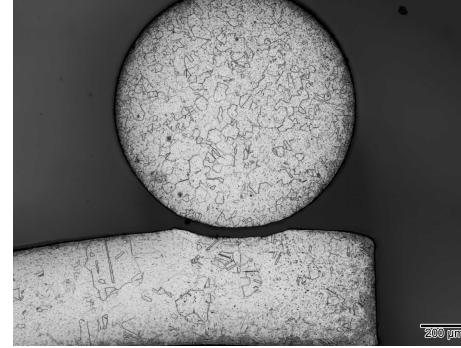
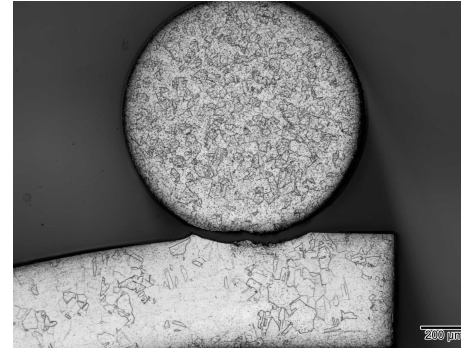
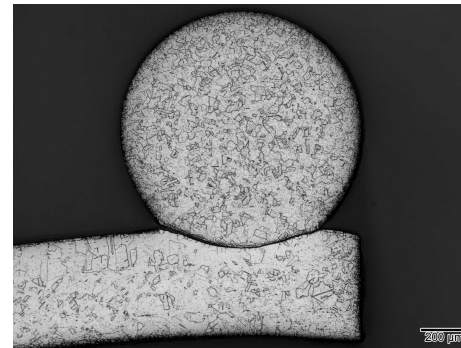
bad side

- **Vendor's cross-wire resistance welds were at best "cold" and at worst, non-existent.**
- **We proposed a pulsed Nd:YAG laser spotweld repair.**
- **Modeling showed virtually no heat rise at the powder cavity.**
- **Occasional small hot cracks were seen at the edge of the LB fusion weld; since need is for conductivity only, not thought to be a problem.**

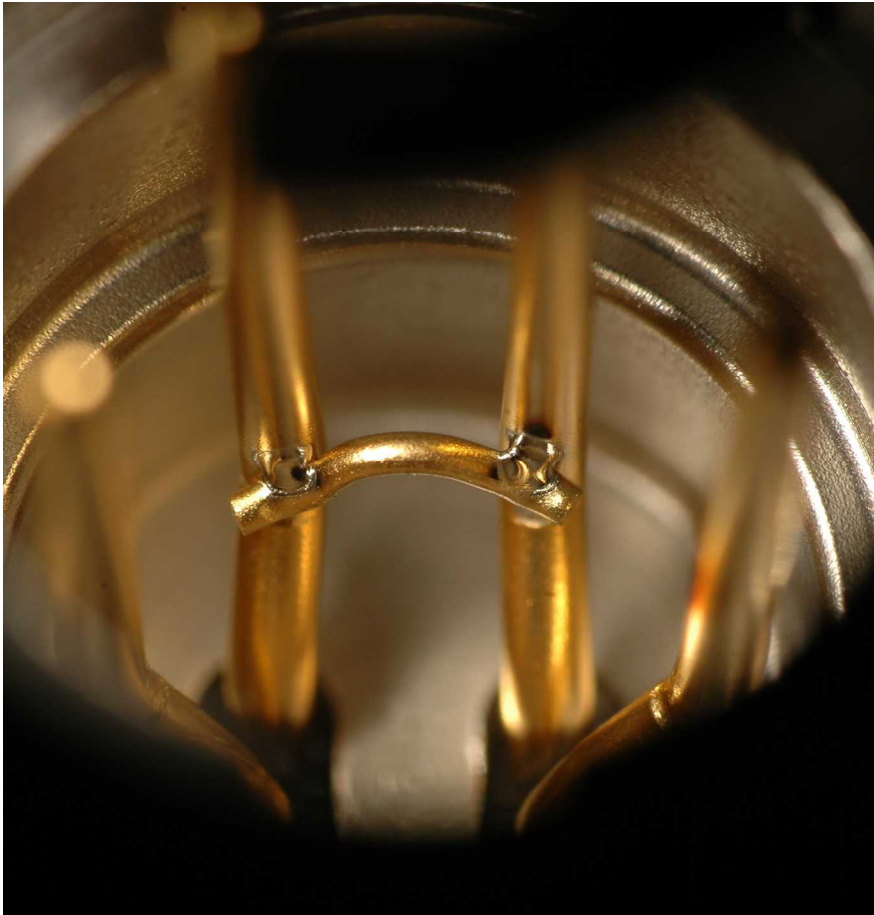
RHS: welded broken arm

LHS: welded intact arm

- 5 J/p (220 V at 1.5 Hz)
- 10 ms pulse length
- At focus with 5" f.l. lens
- Igniter Connector Pin Housing requires steep angle for weld
- No clamping of broken weld; i.e., there can exist a small initial gap for the laser spot weld to bridge
- UHP Ar shield gas

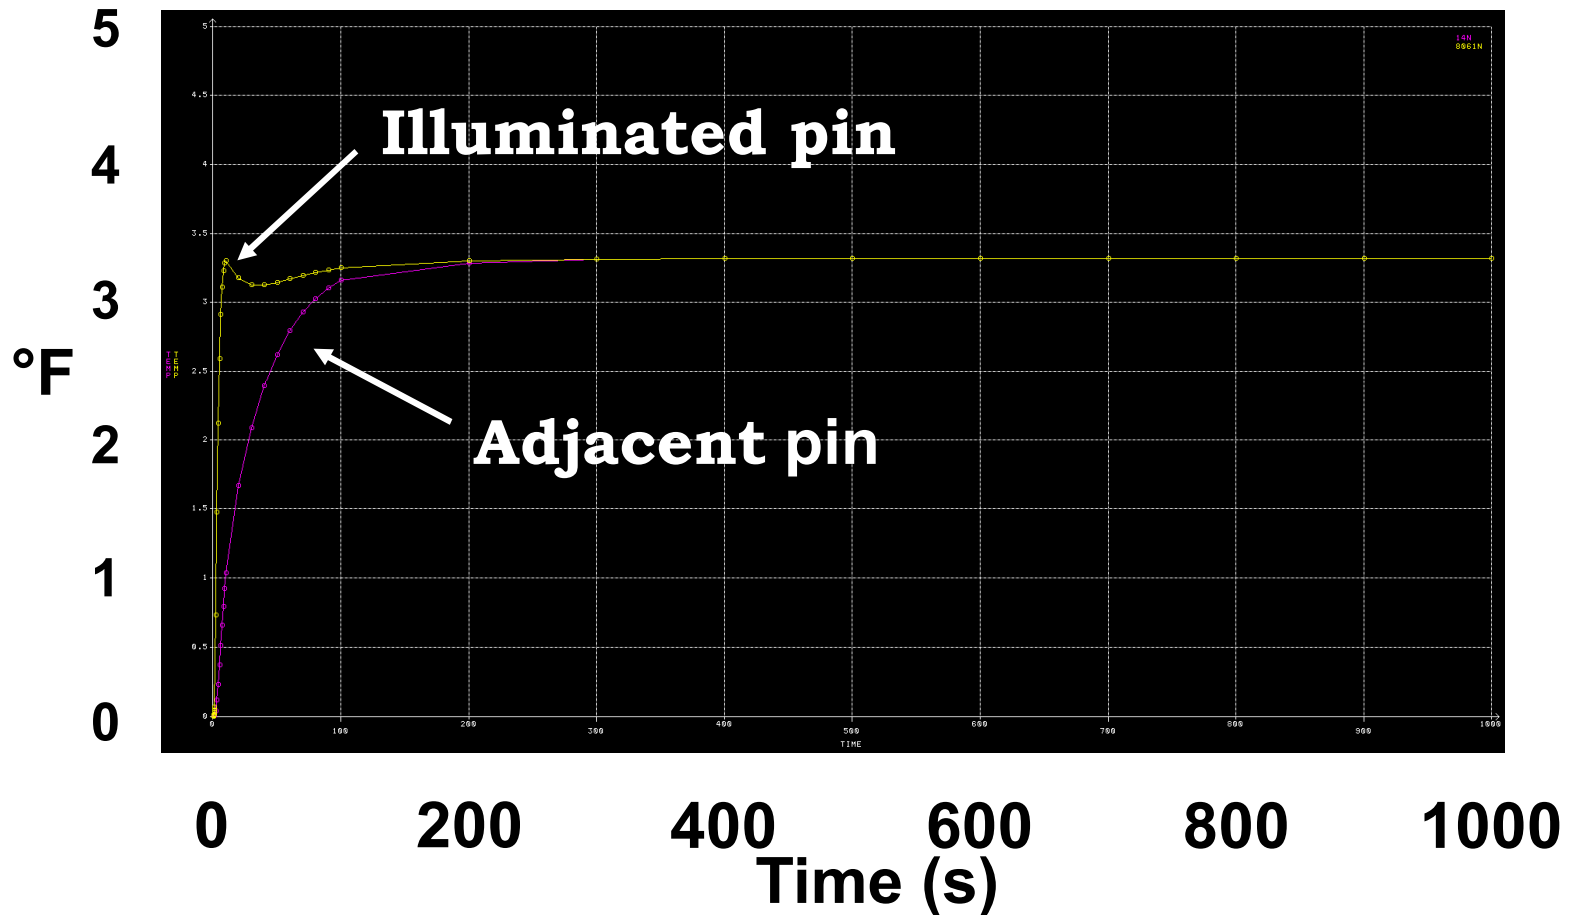
Temperature Rise Negligible

The predicted temperature RISE is 3.3 °F.

Note: *this is for a single pin.*

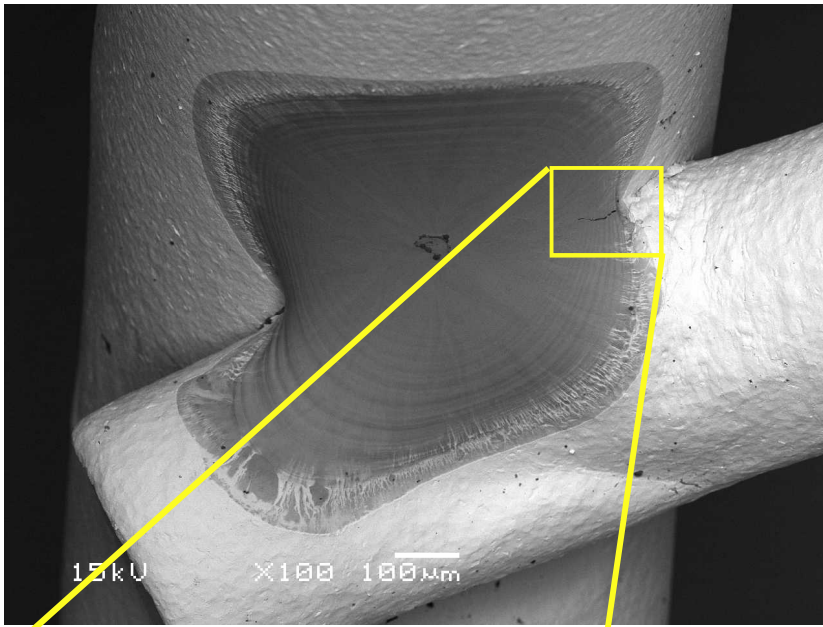
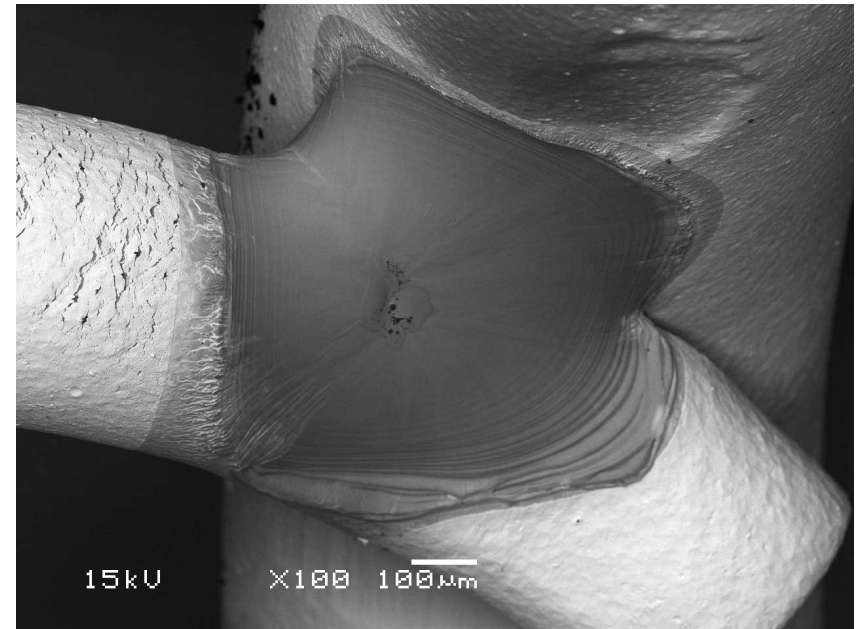
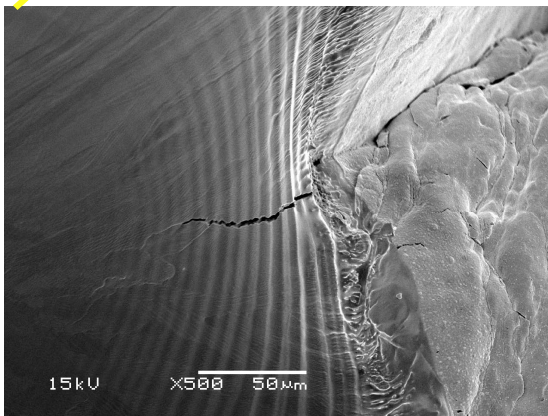
SEM of LBW

- **Au plating mixed into Alloy 52 leads to occasional hot cracks.**
- **The joint is not intended to bear a mechanical load; electrical only**

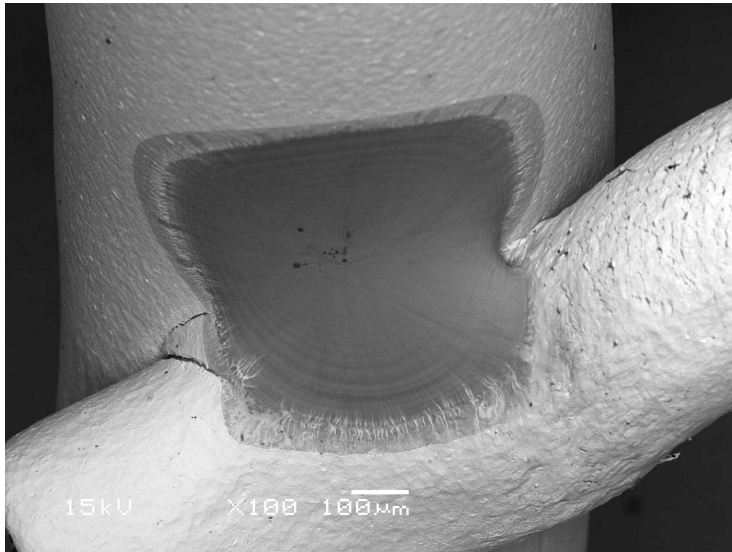
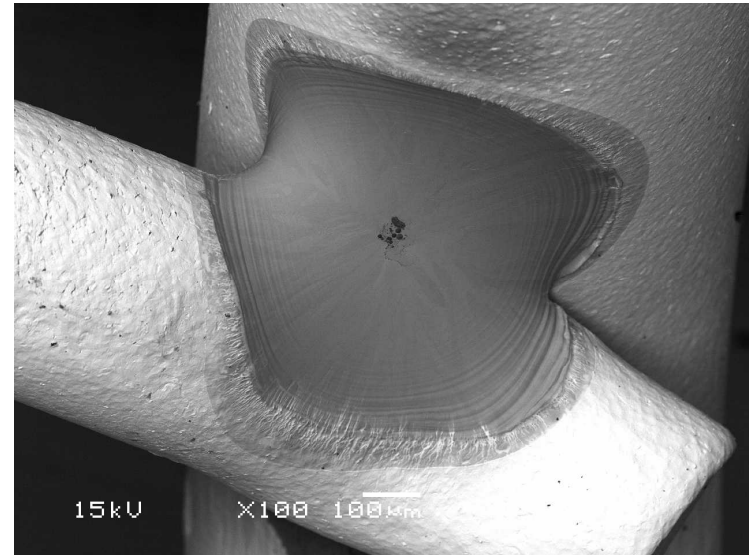
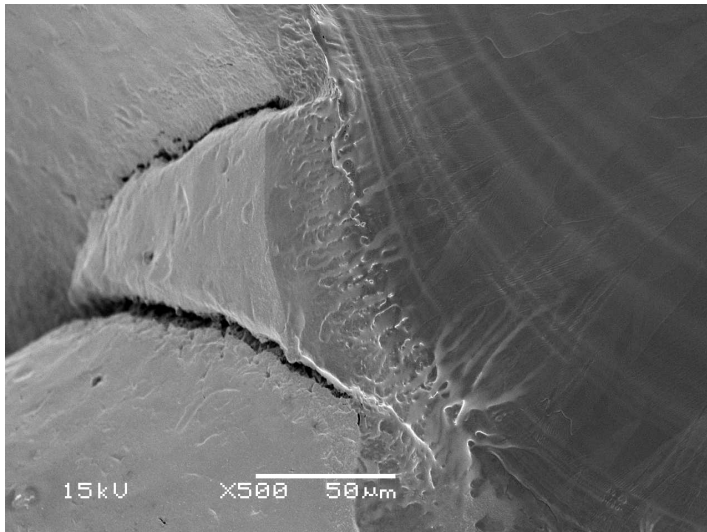
More SEM Pictures

**No pre-clamping
of shunt-wire
to pin was used.**
