| <b>DOCUMENT RELEASE AND CHANGE FORM</b> | | 1a. Doc No: RPP-RPT-54911    Rev. 01 | | | | | | | | | | | | | | | | | | | | | | | | | | | | | | | | | | | | | | | | |
|---|---|---|---|---|---|---|---|---|---|---|---|---|---|---|---|---|---|---|---|---|---|---|---|---|---|---|--|--|--|--|--|--|--|--|--|--|--|--|--|--|--|--|
| <b>2. Document Title</b><br>Hanford Single-Shell Tank Leak Causes and Locations - 241-BY and 241-TY Farm | | | | | | | | | | | | | | | | | | | | | | | | | | | | | | | | | | | | | | | | | | |

| <b>Purpose of Document:</b> Identifies leak causes and locations for BY and TY Farm tanks | |

Key Words: leak location, leak cause, tank, integrity assessment, BY Farm, TY Farm, BY-103, TY-103, TY-104, TY-105, TY-106, leak assessment

**Abstract:** This document identifies 241-BY Tank Farm (BY Farm) and 241-TY Tank Farm (TY Farm) leak causes and locations for the 100 series leaking tanks (241-BY-103, 241-TY-103, 241-TY-104, 241-TY-105, and 241-TY-106) identified in RPP-RPT-43704, Hanford BY Farm Leak Assessments Report, and in RPP-RPT-42296, Hanford TY Farm Leak Assessments Report. This document satisfies the BY and TY Farm portion of the target (T04) in the Hanford Feder

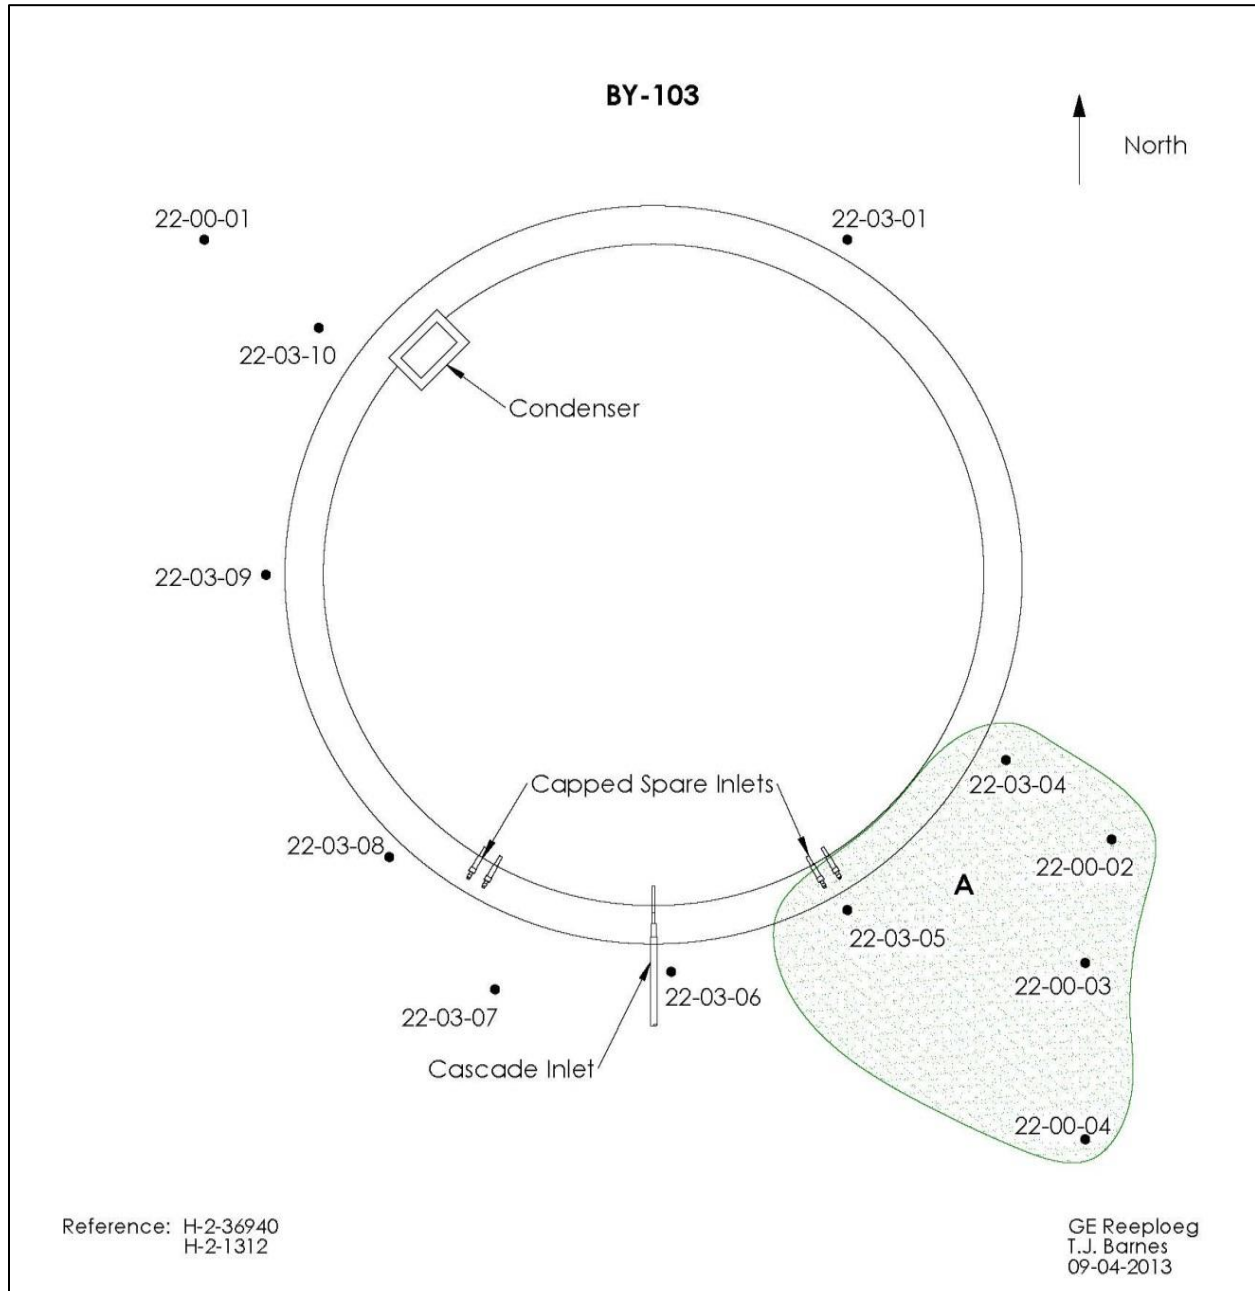
Tank BY-103 was first suspected of leaking in 1969 due to radioactivity being detected in drywell 22-00-03; however, the leak may have begun as early as 1959.

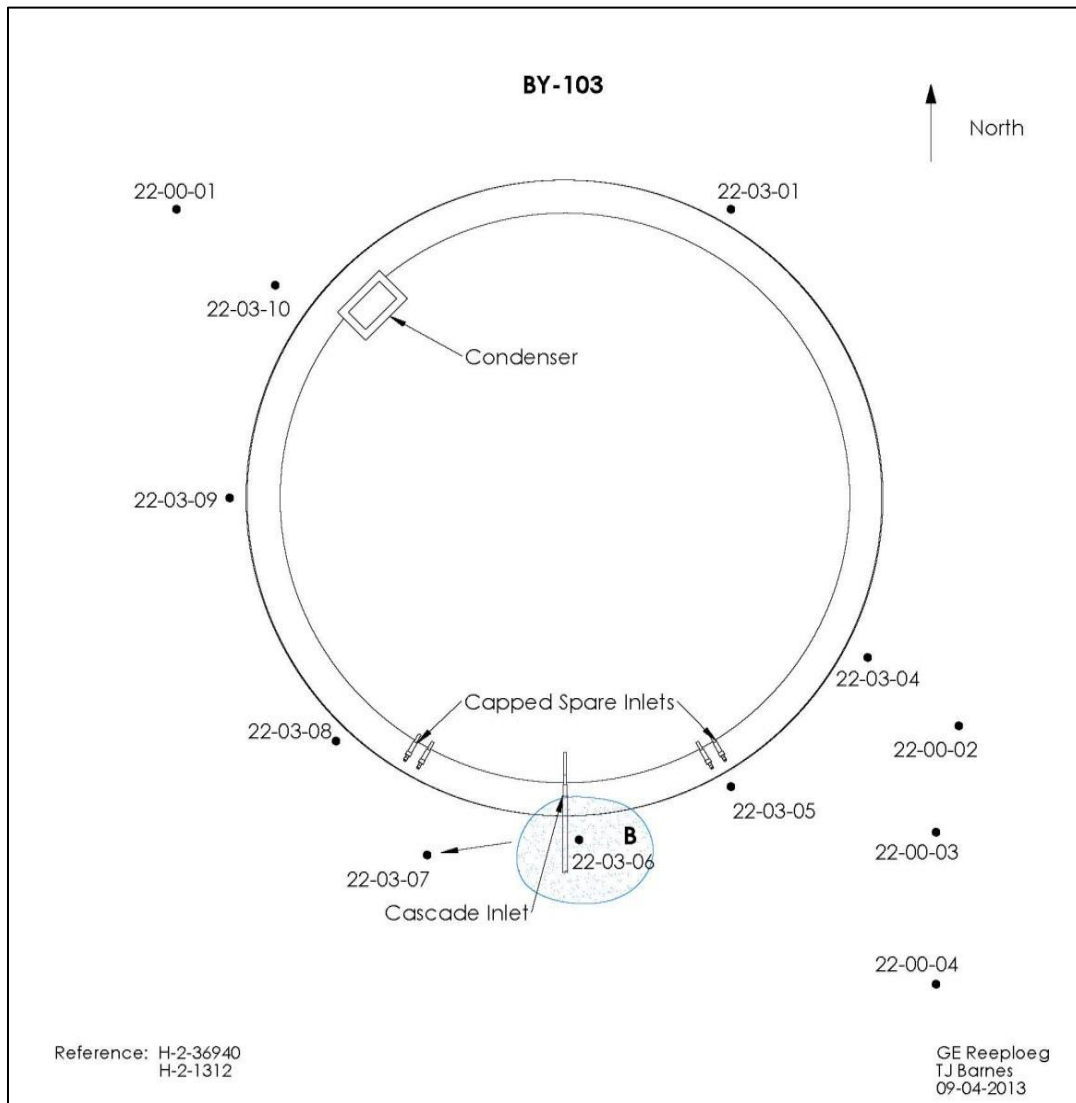
Tank BY-103 was first suspected of leaking in 1969 due to radioactivity being detected in drywell 22-00-03; however, the leak may have begun as early as 1959.

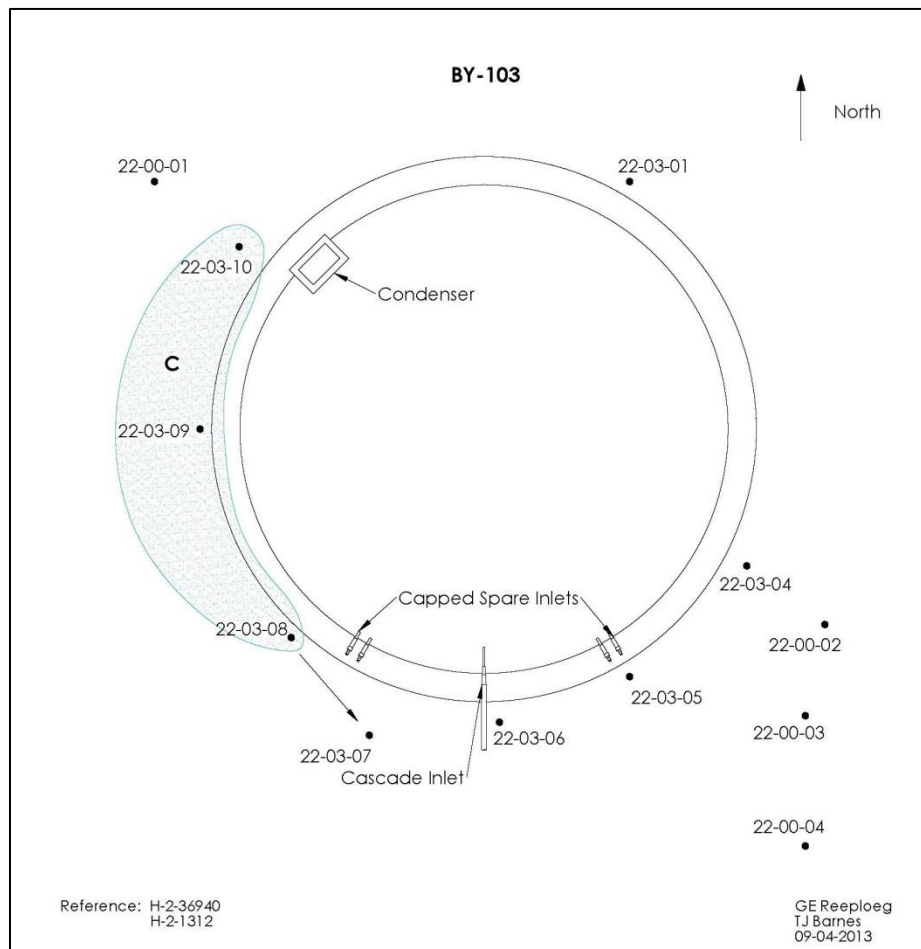
**Figure 4-19. Tank BY-103 Possible Leak Location (1972-1974)**  
Tank inner ring is steel liner, outer ring is outer edge of tank footing

Tank BY-103 was first suspected of leaking in 1969 due to radioactivity being detected in drywell 22-00-03; however, the leak may have begun as early as 1959.

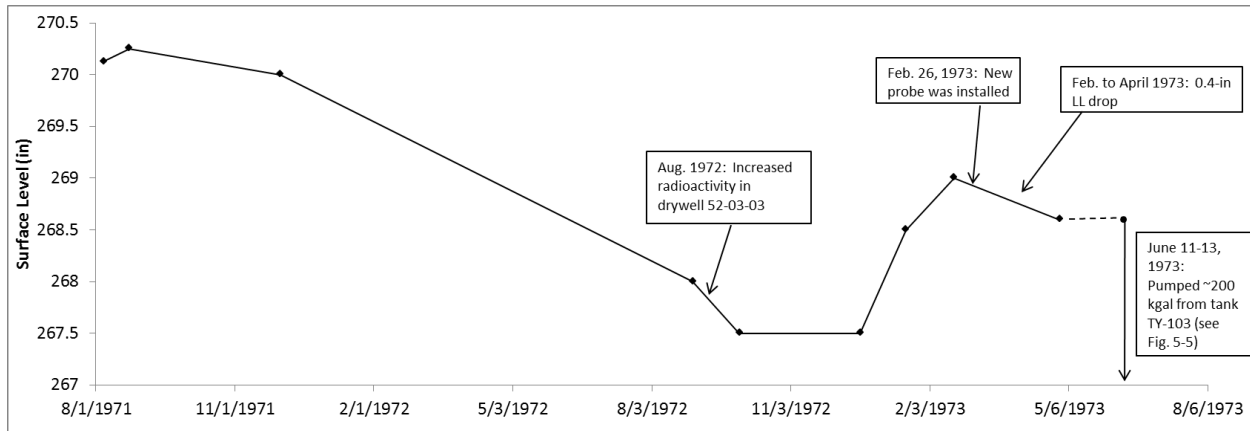
**Figure 5-4. Tank TY-103 Liquid Level August 1971 to August 1973**

On October 26, 1973 a review was performed on tank TY-103 leak events. The review states that liquid level readings from January through December 1972 indicate a loss of 3½-in (9,600 gal) by the end of 1972 with subsequent increases in radioactivity in the drywells (Draft memo Compton 1973, *Tank 241-TY-103 Review*). However, it was reported in this draft memo that liquid levels also had an unexplained increase in January 1973 of >2-in. Drywell 52-03-03 radioactivity continued to increase indicating a continuing leak. A new probe was installed February 26, 1973 (LET-ARHCO-TY-103, *Status of Tank 241-TY-103*). The next reported liquid level drop was two months later in April 1973 when a 0.4-in liquid level drop was reported (see Figure 5-4) with increased radiation readings in the drywell through May 28, 1973 when the tank was declared a suspect leaker (Draft memo Compton 1973).

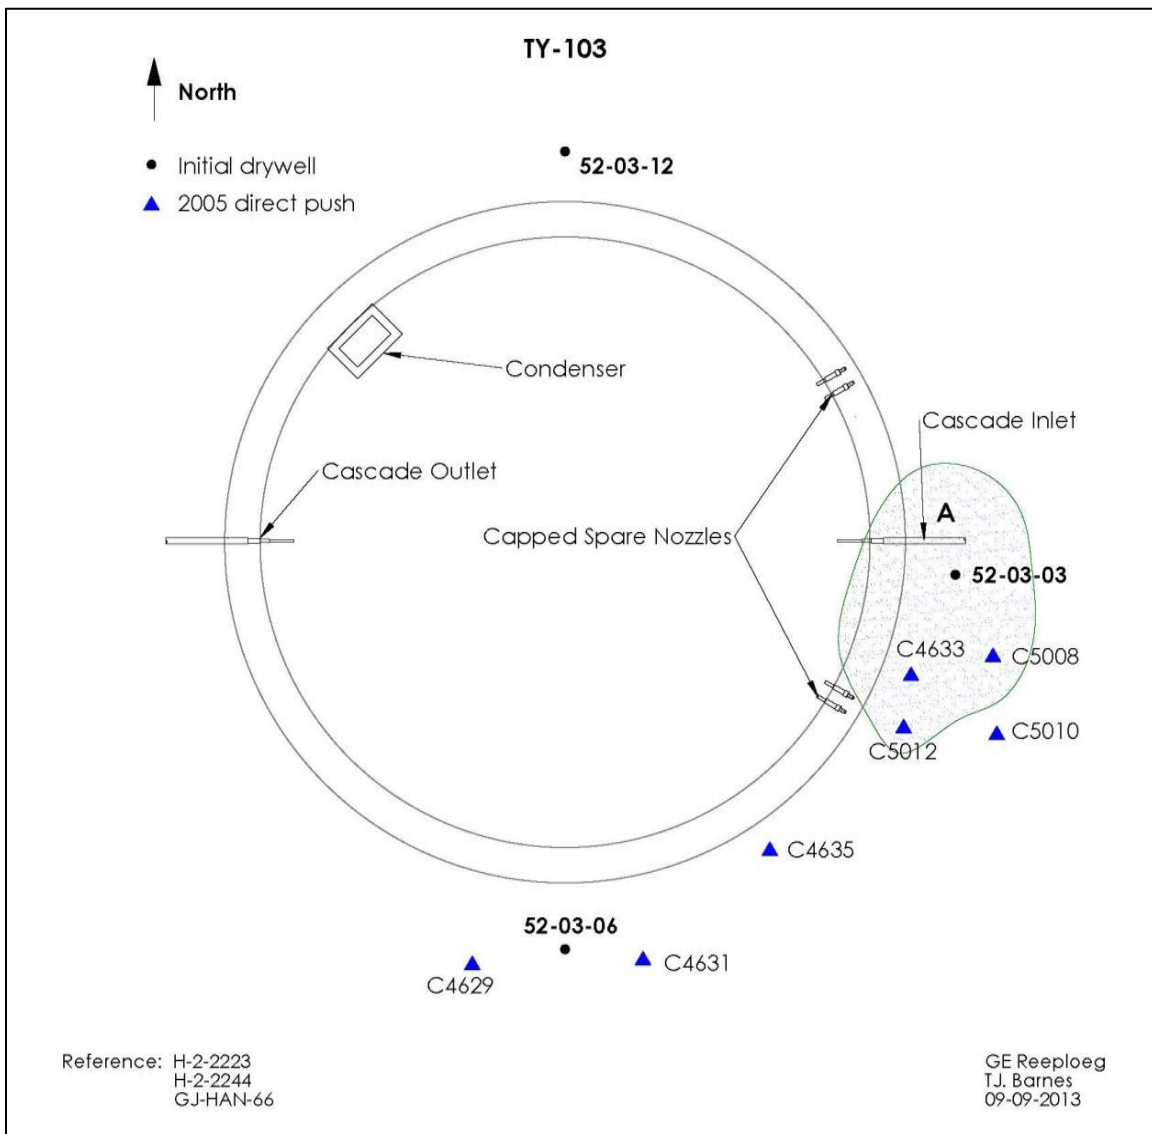
The leak from tank TY-103 was first detected in August 1971 due to a liquid level decrease and subsequent radioactivity detected in drywell 52-03-03

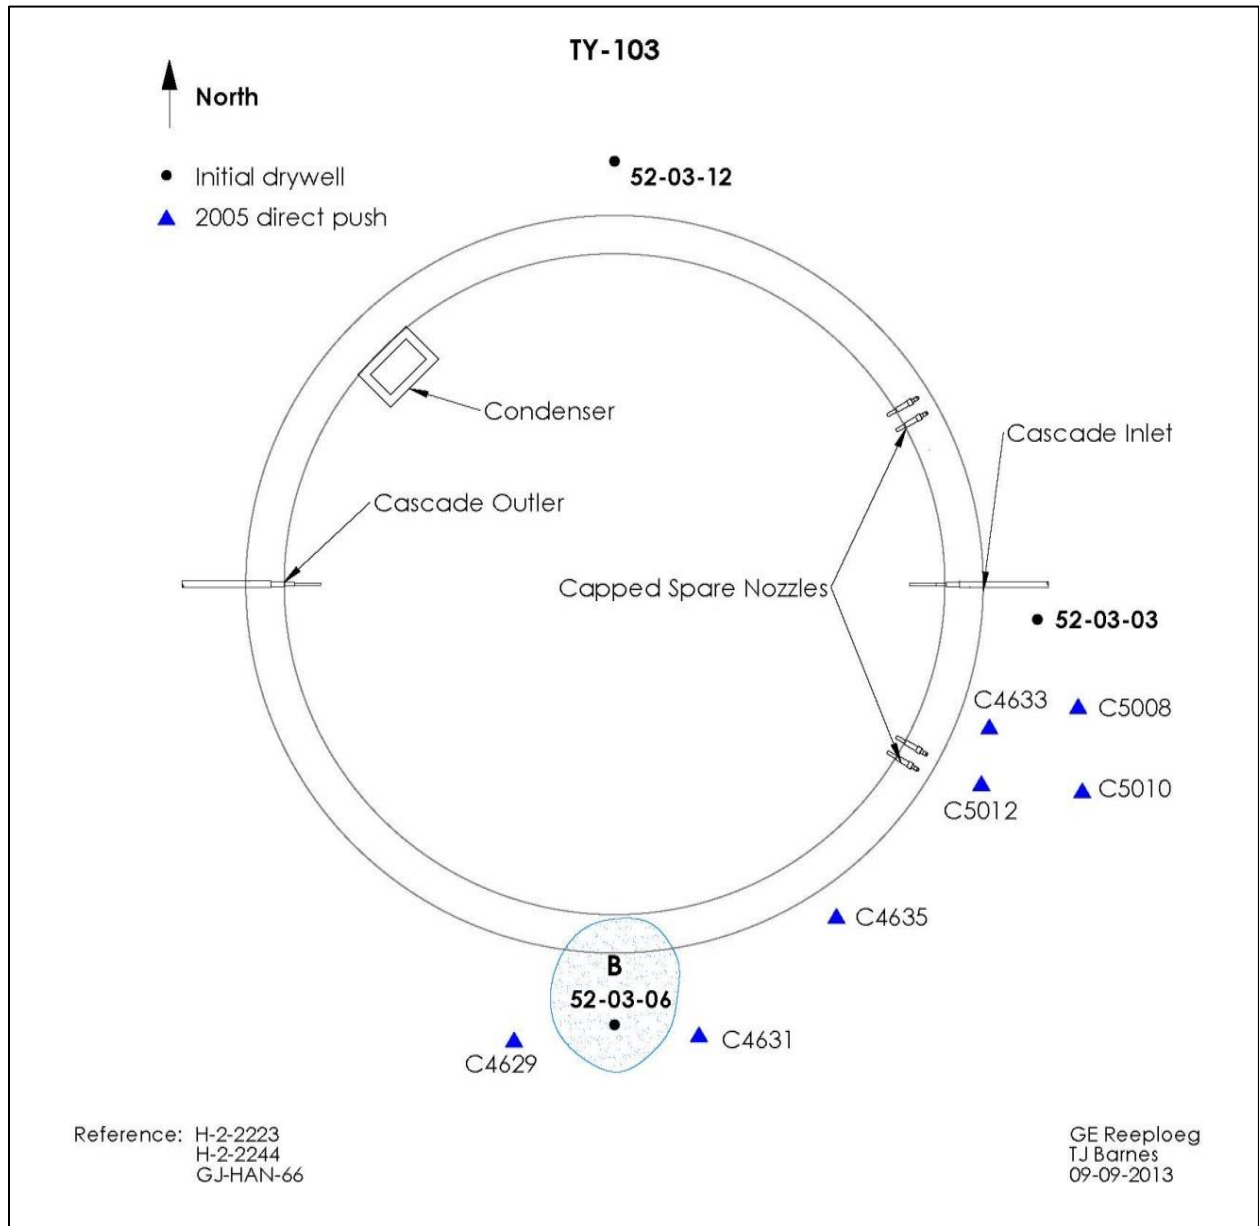
The leak from tank TY-103 was first detected in August 1971 due to a liquid level decrease and subsequent radioactivity detected in drywell 52-03-03

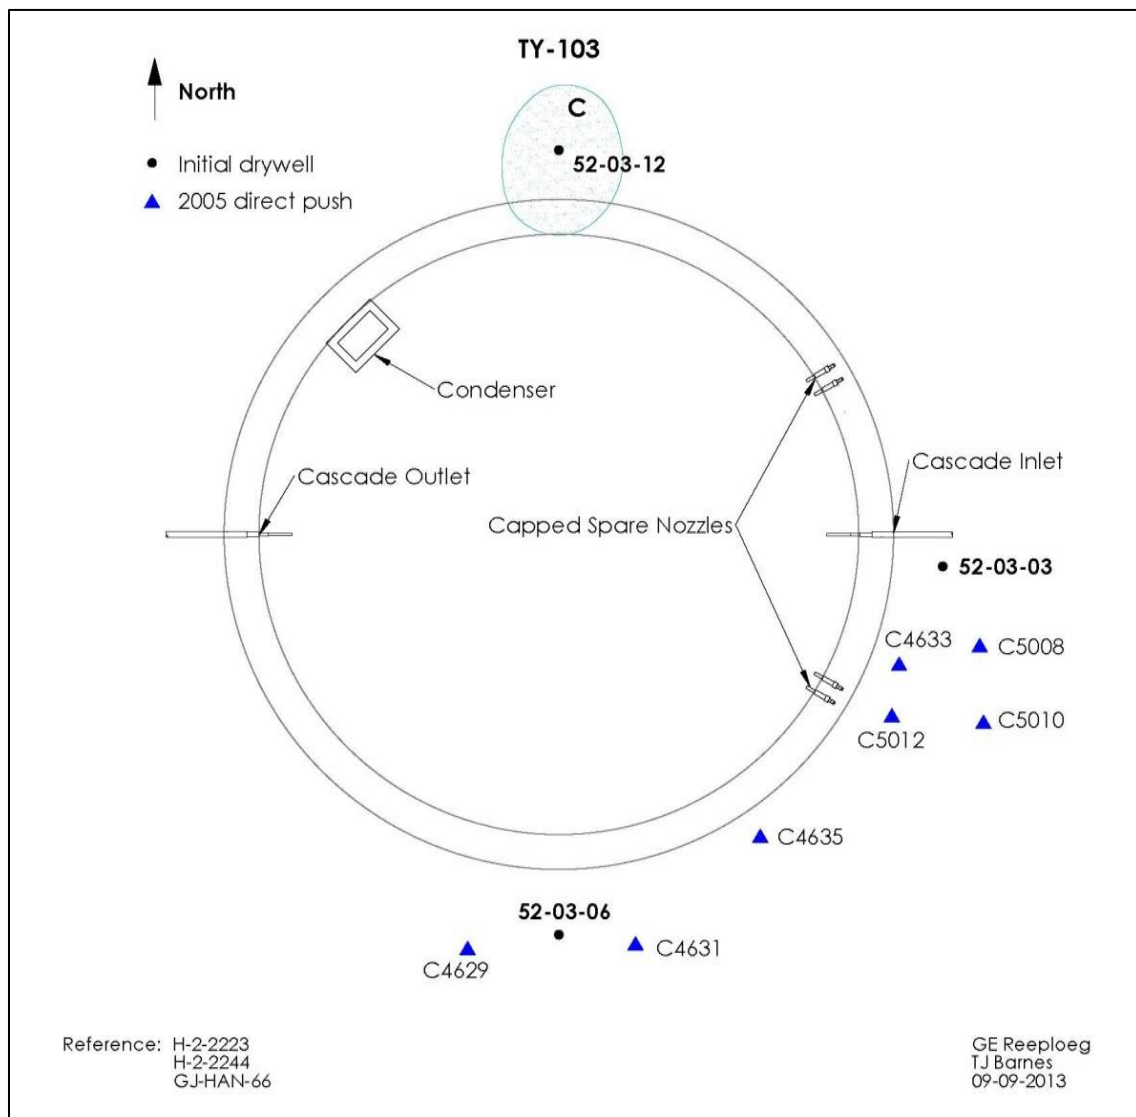
**Figure 5-11. Tank TY-103 Possible Leak Location (July 1973)**  
Tank inner ring is steel liner, outer ring is outer edge of tank footing

The leak from tank TY-103 was first detected in August 1971 due to a liquid level decrease and subsequent radioactivity detected in drywell 52-03-03

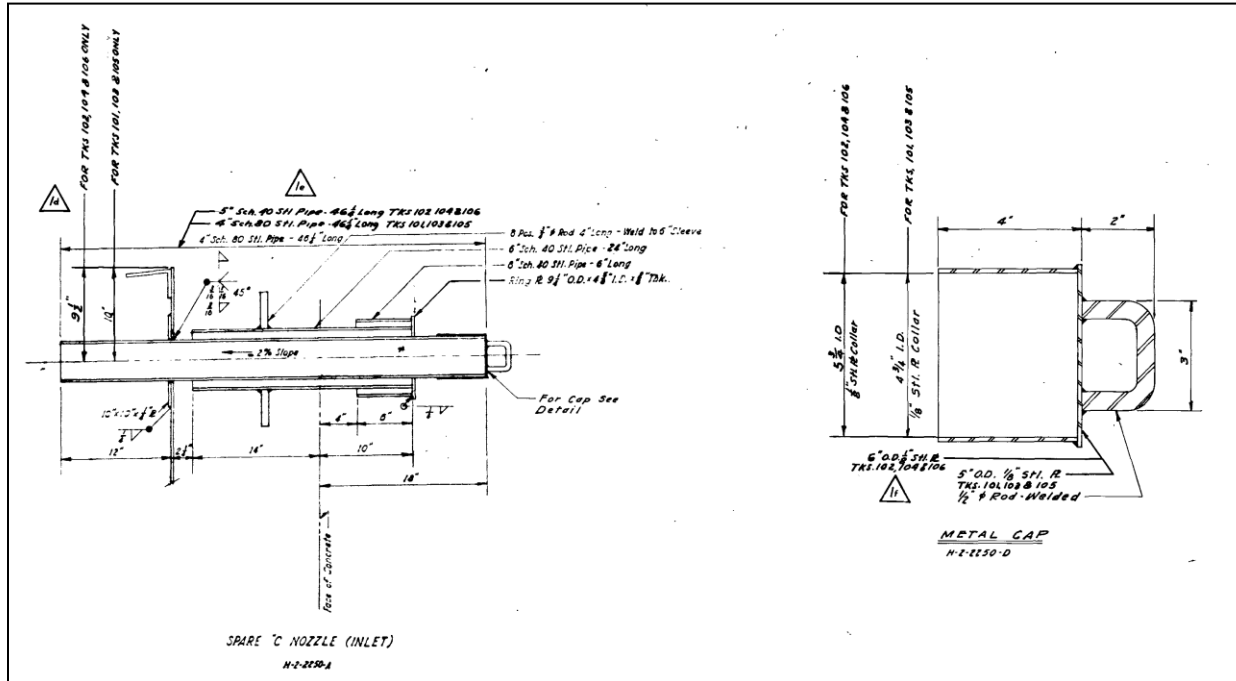
**Figure 7-10. Tank TY-105 Spare Inlet Nozzles  
(H-2-2250)**

The TBP waste was batch transferred from 221-U Plant to the WR Vault and pumped at a nominal 50 gpm to tank TY-105 which cascaded to tank TY-106. There is no record of overfilling tank TY-105 or plugging of the overflow cascade to tank TY-106 using the recovered quarterly liquid level data. No other liquid level data relative to the two year cascade period has been found. Over 5,000 kgal of TBP waste was transferred to tank TY-105 in batches which cascaded to tank TY-106. The possibility of backing up the liquid level ~ 4.4-in to the base of the spare inlet lines may exist (see Figure 7-11).

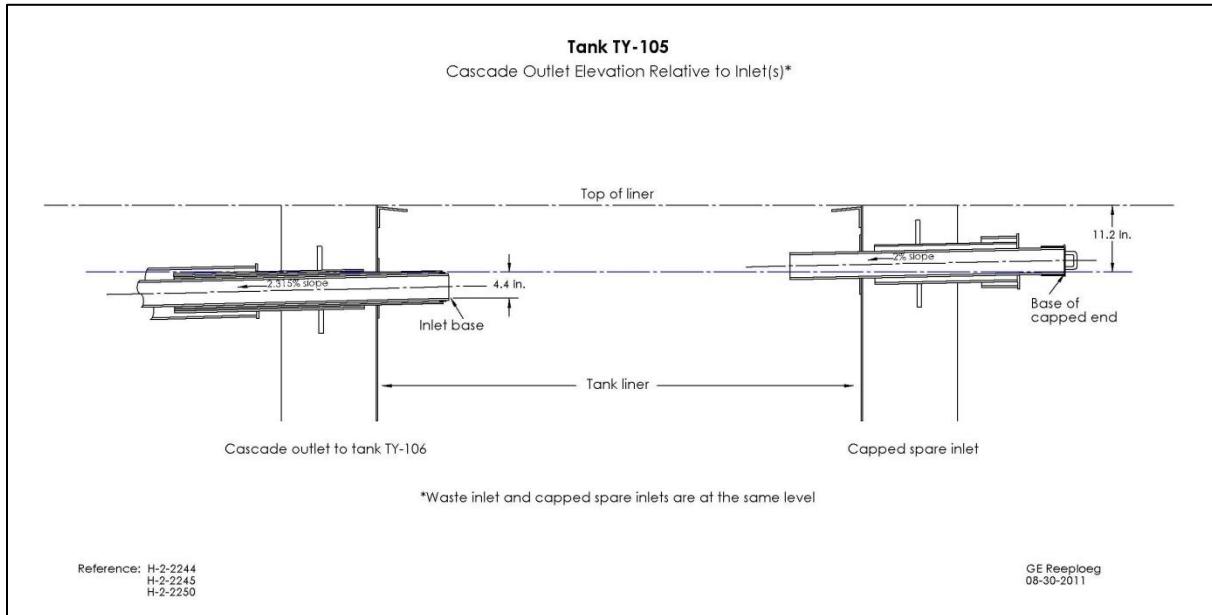
**Figure 7-11. Tank TY-105 Cascade Outlet Relative to Inlet(s)**

The slip fit capped spare inlet lines are sealed with a coating of asphalt which is covered with gunite (see Figure 7-12). Poor quality of the capped spare inlet seal system or damage during construction/backfilling could have compromised the seal resulting in the possibility of a leak should waste be backed up into the spare inlet at least to the base of the capped end.

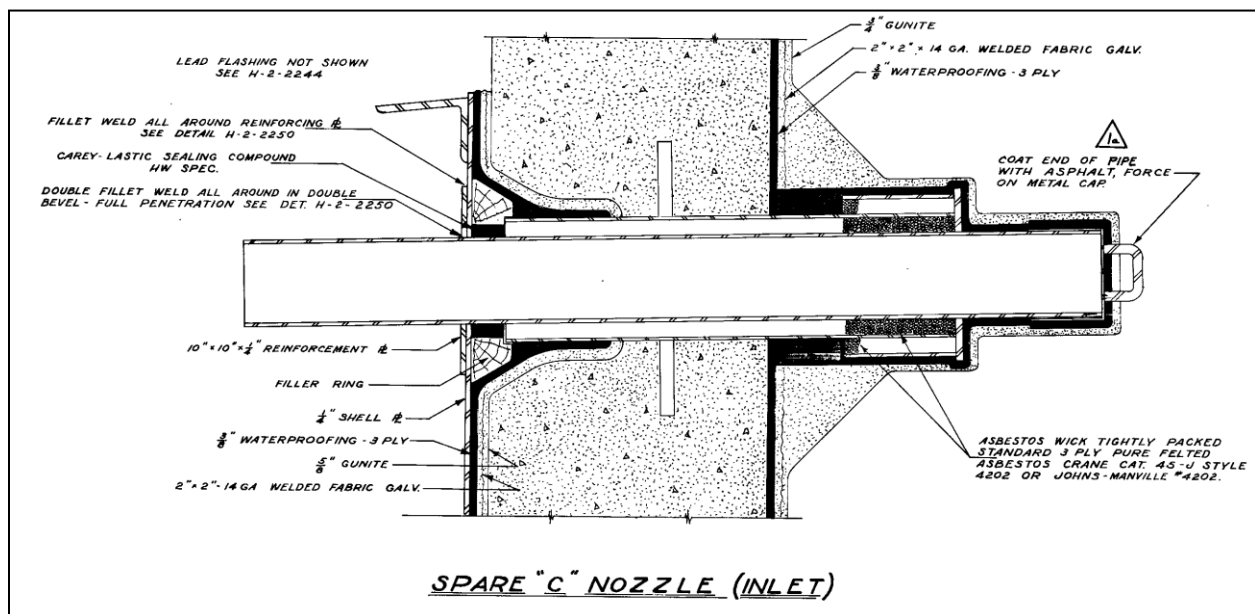
**Figure 7-12. Tank TY-105 Spare Inlet Line Asphalt - Gunite Seal (H-2-2277)**

The leakage of the spare inlet lines seems possible; however, a number of conditions as indicated need to take place for this to happen. The other possibility is that the liner leaked above the

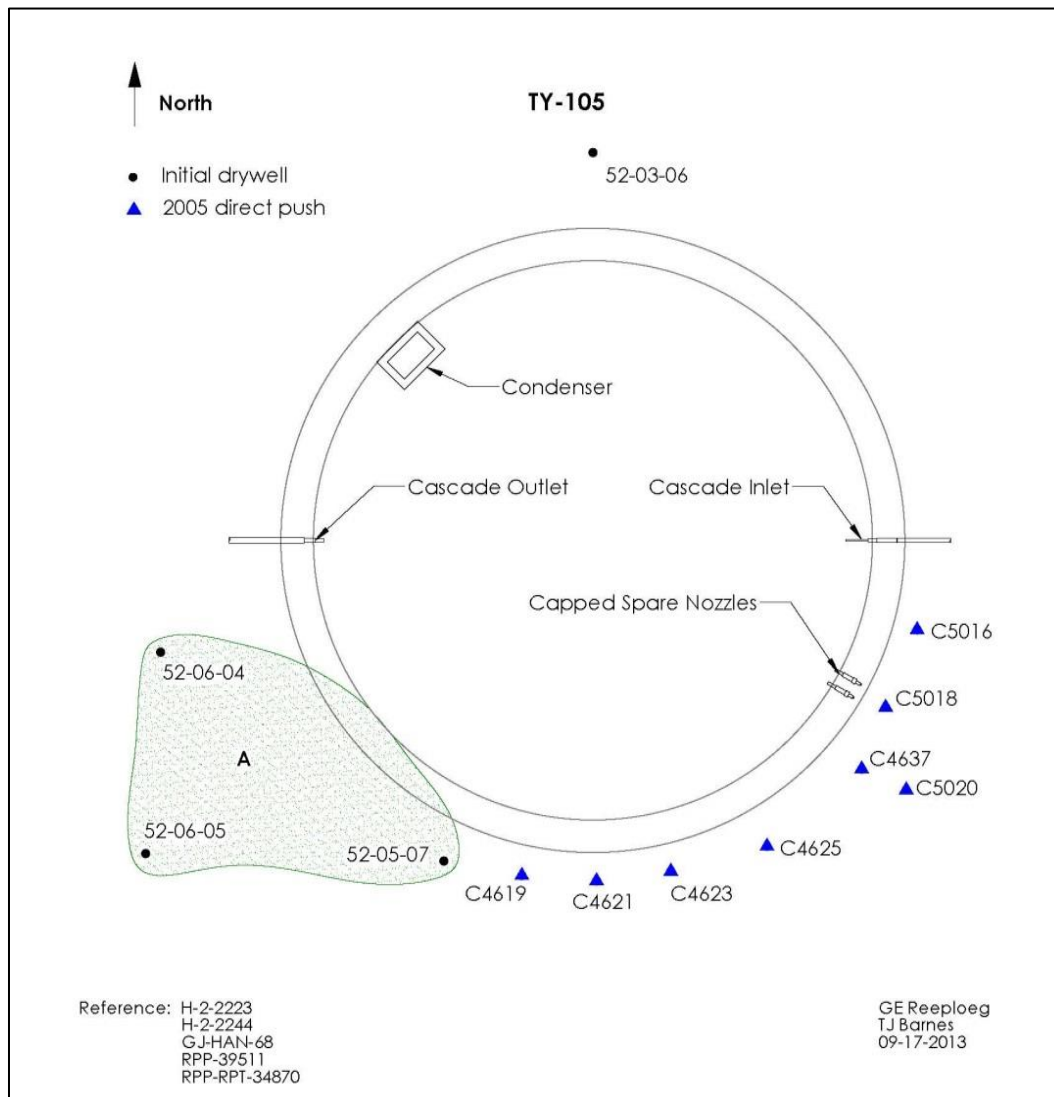
The leak from tank TY-105 was first detected in September 1960 due to liquid level decreases; however, the leak may have started as early as July 1959.

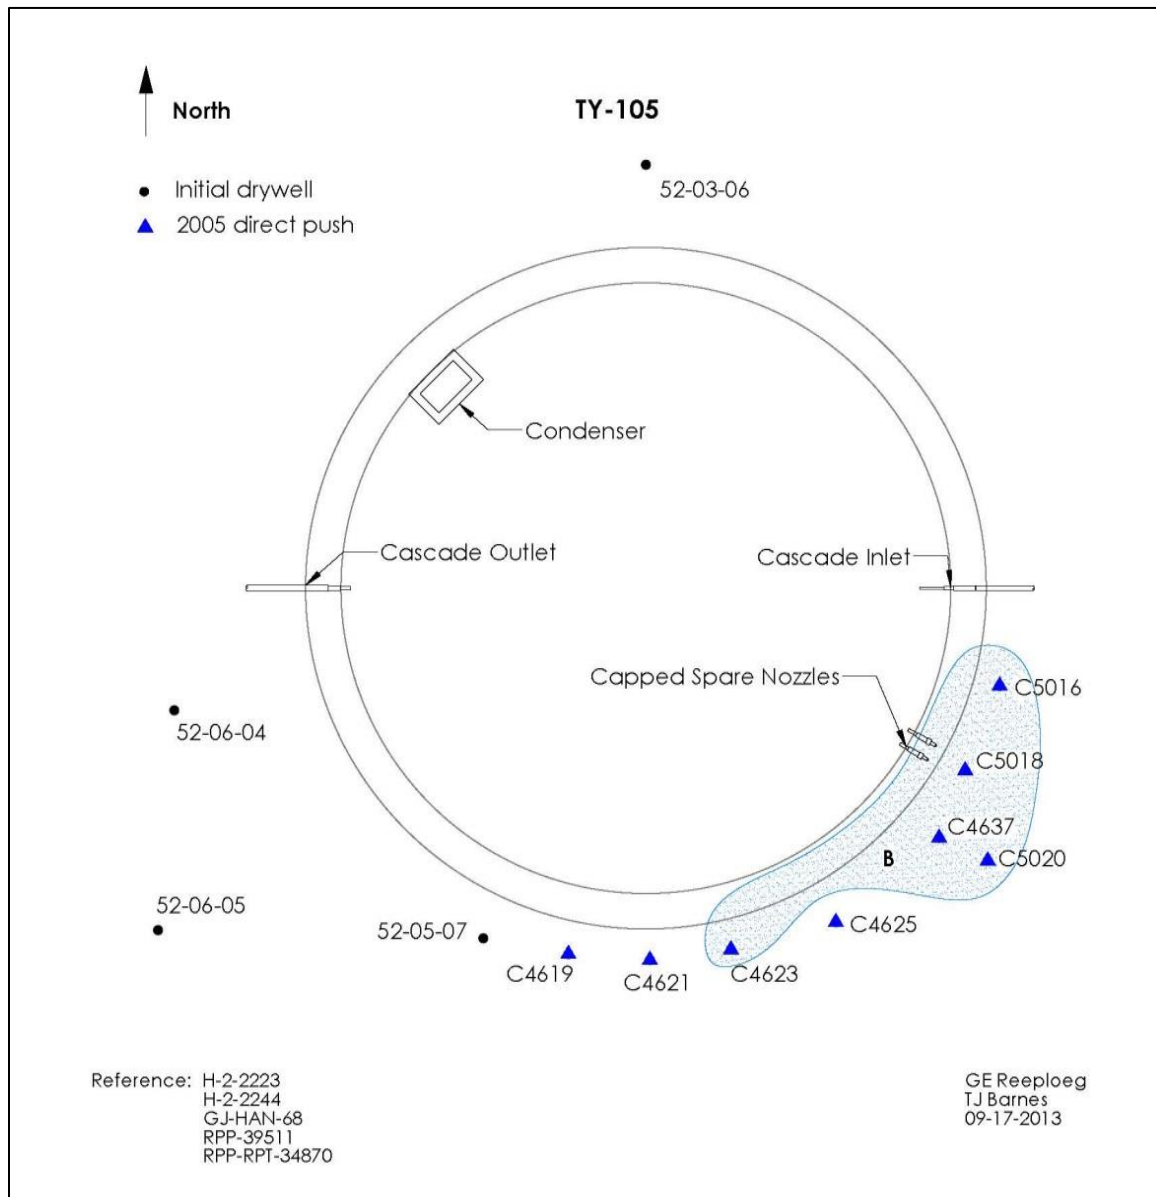
**Figure 7-14. Tank TY-105 Possible Leak Location (2005)**  
Tank inner ring is steel liner, outer ring is outer edge of tank footing

The leak from tank TY-105 was first detected in September 1960 due to liquid level decreases; however, the leak may have started as early as July 1959.

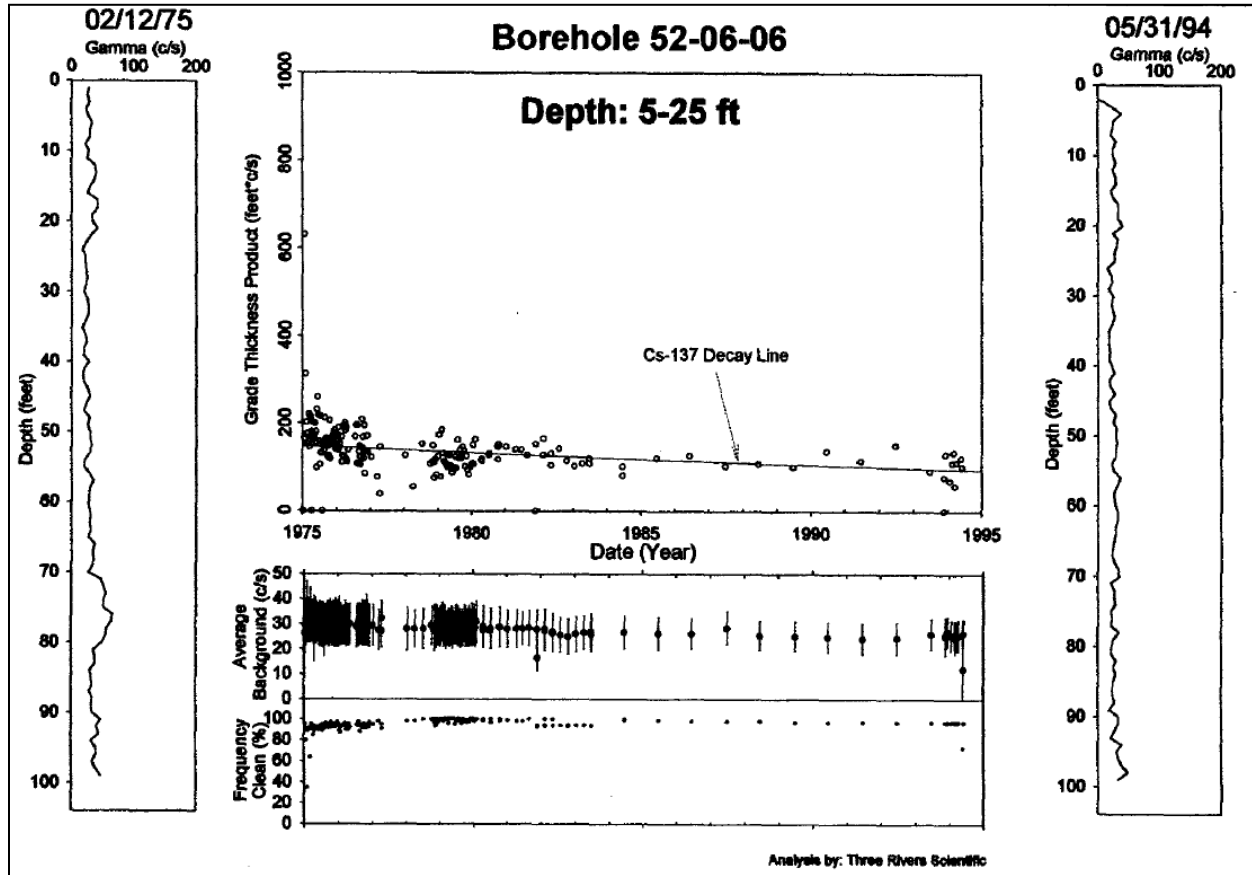
Figure 8-9. Tank TY-106 Drywell 52-06-06 Cesium (HNF-3831)

Also stated in GJ-HAN-69, "the Co-60 contamination most likely originated from a leak in either tank TY-103, TY-105, or TY-106..." It seems likely the Co-60 radioactivity detected in this drywell at the lower BGS levels was the result of some of the tank TY-106 leak as supported by the 2005 direct pushes (see Section 8.5.3). Figure 8-10 shows depths of radioactivity from 1975 to 1994 (HNF-3831).

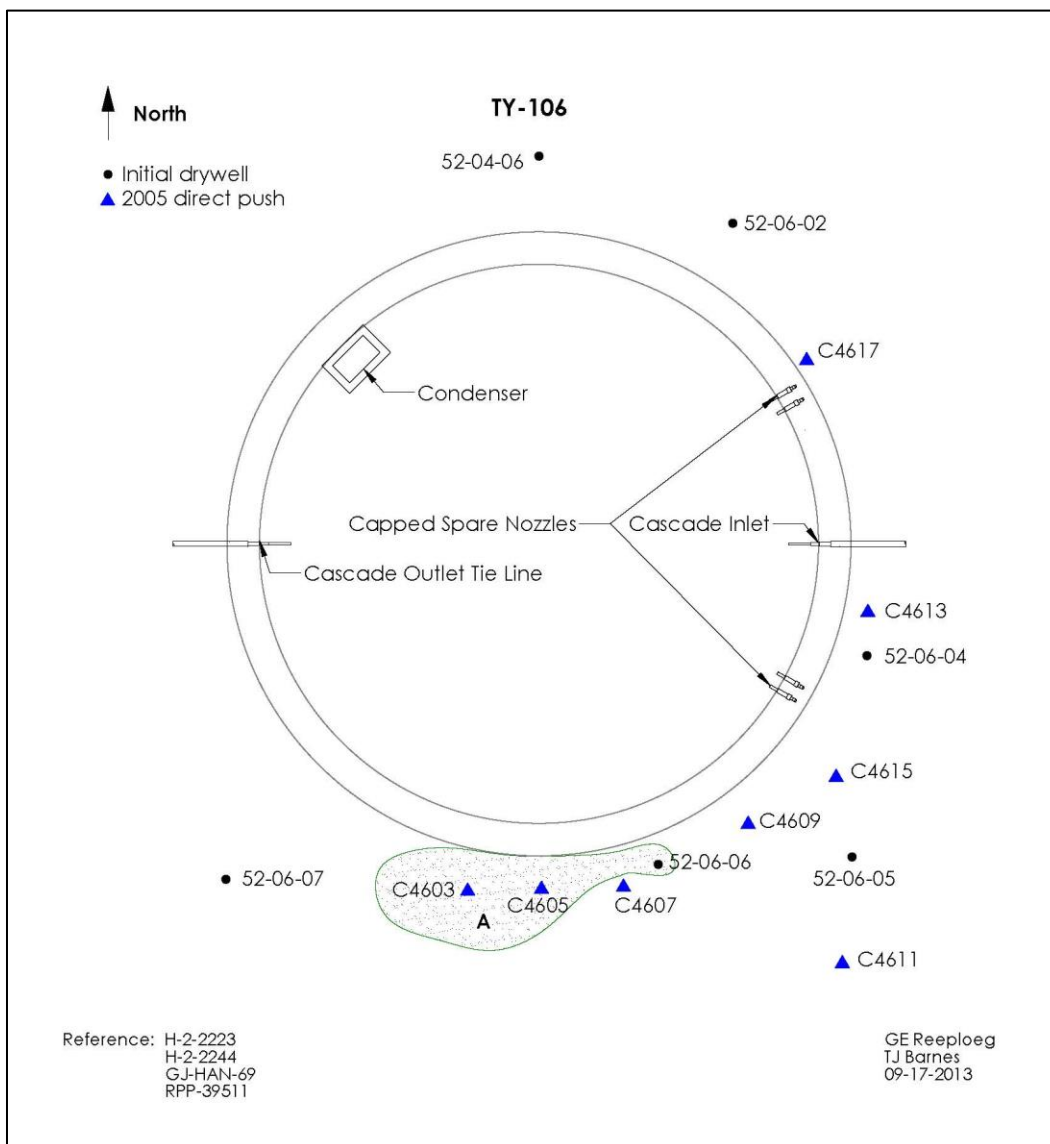
The leak from tank TY-106 was first detected in August 1959 due to liquid level decreases.

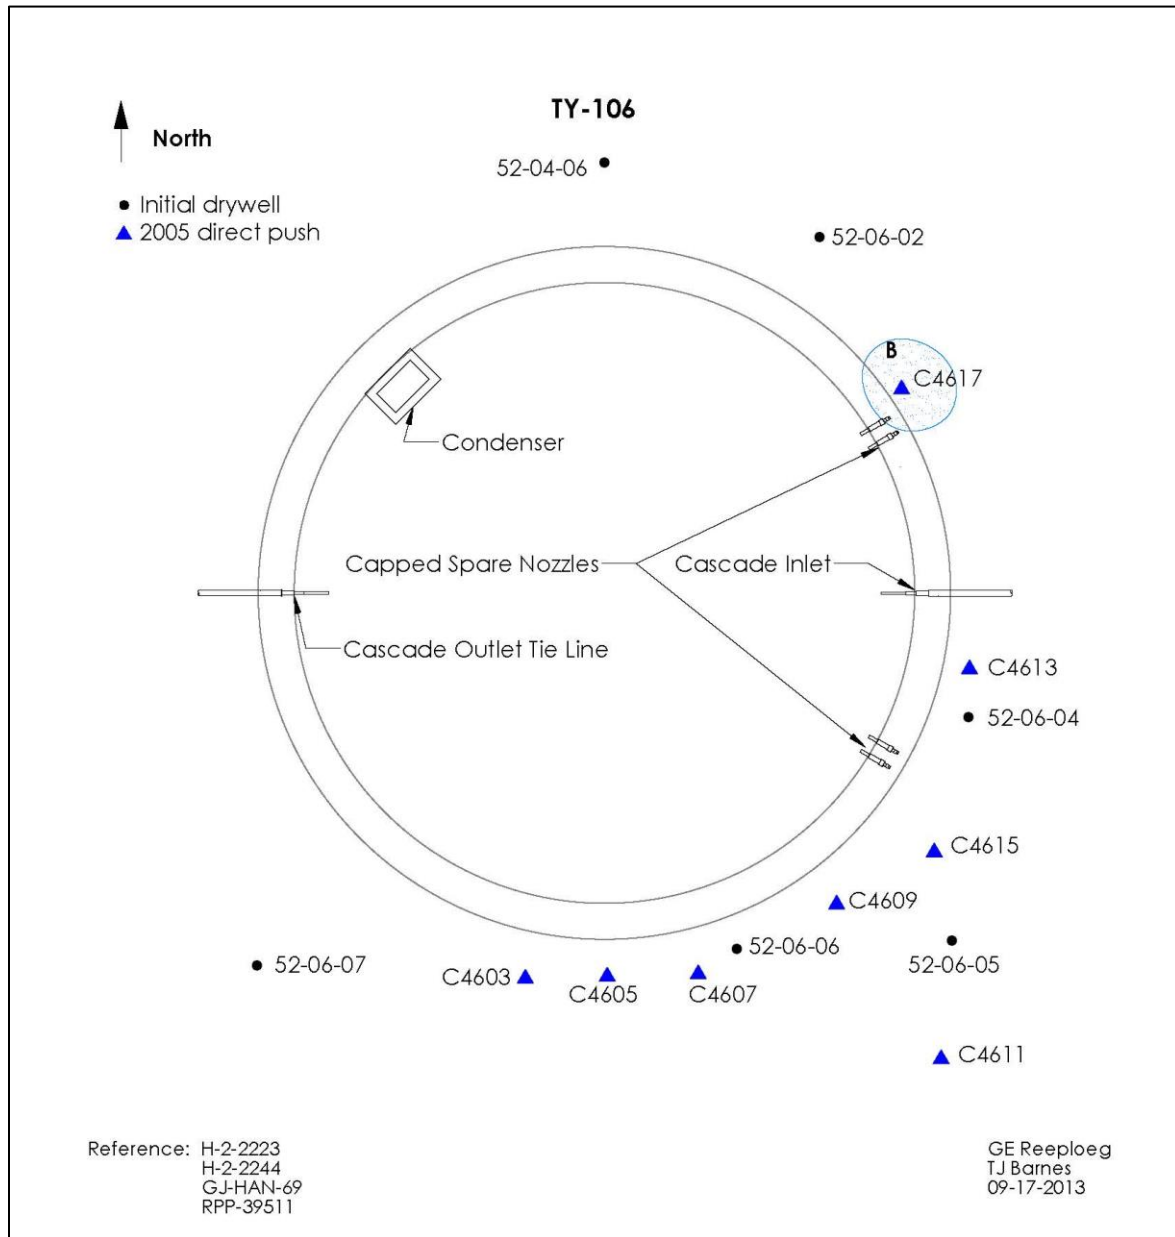
**Figure 8-13. Tank TY-106 Possible Leak Location (2005)**  
Tank inner ring is steel liner, outer ring is outer edge of tank footing

The leak from tank TY-106 was first detected in August 1959 due to liquid level decreases.

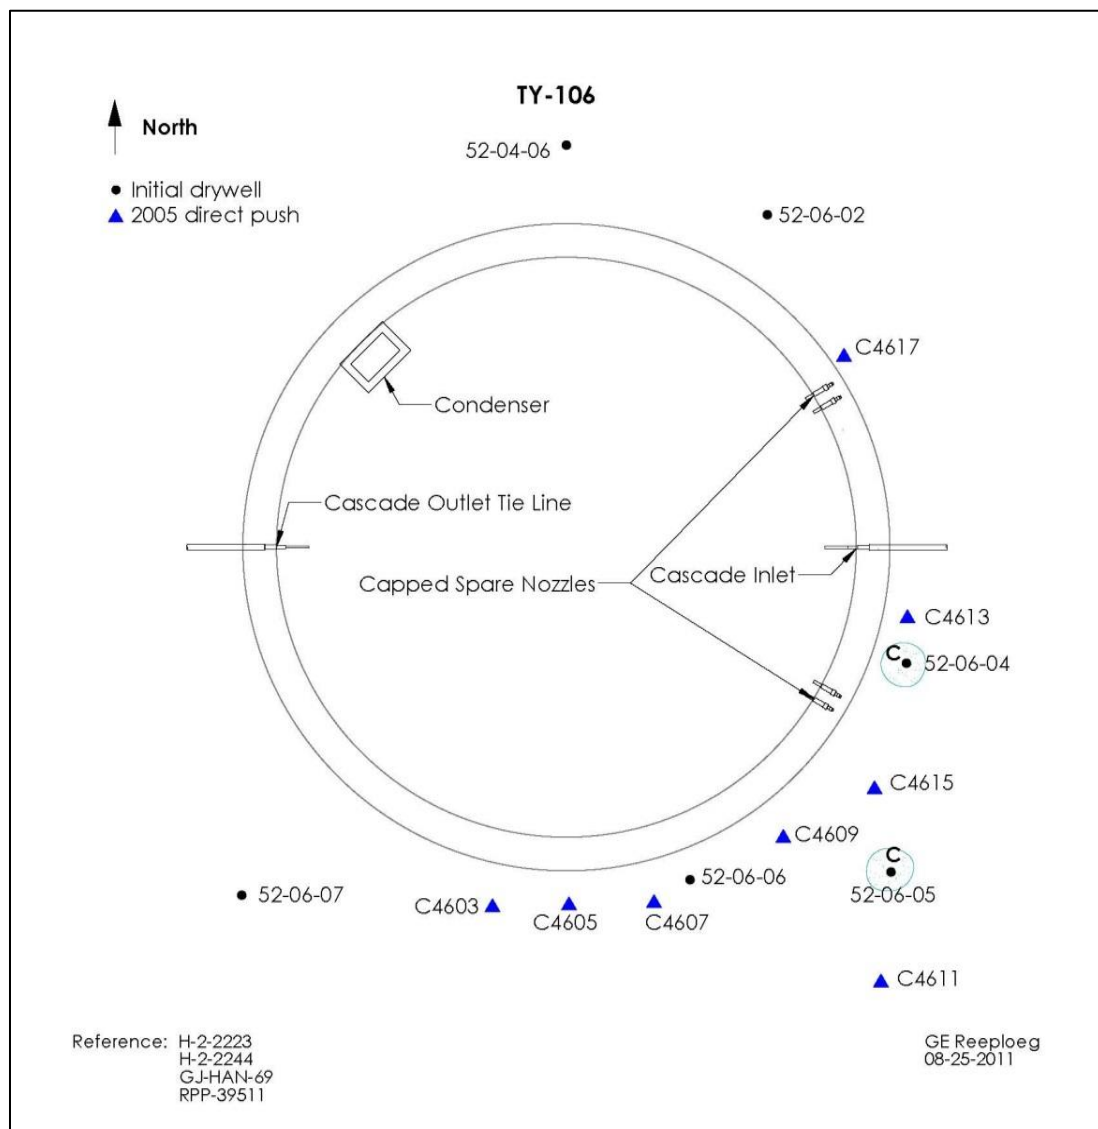
**Figure 8-14. Tank TY-106 Possible Leak Location (1973-1974)**  
Tank inner ring is steel liner, outer ring is outer edge of tank footing

The leak from tank TY-106 was first detected in August 1959 due to liquid level decreases.
