Date Published
November 2014

Hanford Double-Shell Tank Extent-of-Condition Construction Review – 15498

ABSTRACT

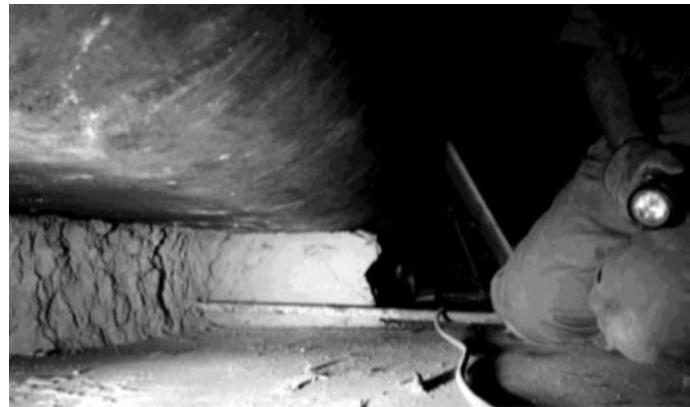
Figure 3: Refractory Repair Operations in 241-AY Tank Farm

Castable refractories are typically poured or “gunned” into place. After air drying or “curing,” the refractory is then “fired” or heated to high temperatures to convert hydrated compounds into a more durable, de-hydrated, ceramic structure. During the initial air-drying and until the firing is completed, protection from freezing and water saturation is important. During construction of the 241-AY tank farm, there were problems with both of these protections. After heat treatment and hydrostatic testing, the refractory material in both tanks was found to be badly cracked and degraded, caused in some part by poor weather protection. Concerns about lack of support in the high-stress knuckle region led to the decision to remove ~533 mm (21 in) of the refractory and replace it with structural concrete in both tanks. Given the location and access constraints, the effectiveness of this repair and proper concrete placement was identified as a concern during the leak assessment of tank AY-102. As previously mentioned, voids from primary bottom bulging that were beyond the ~533 mm (21 in) perimeter were filled with foam prior to placement of the structural concrete repair. See Figure 3 for pictures of the refractory repair in progress in the 241-AY tank farm.

During review of the construction history of the 241-AY tank farm, the most significant deficiency found in the review was the degradation and repair of the refractory in tanks AY-101 and AY-102. Both refractories were exposed to similar conditions of moisture and freezing temperatures during the curing stage, which is believed to have contributed to their friable nature and reduced vertical compressive strength. The refractory repairs required the outer 533 mm (21 in) of the periphery refractory to be chipped out all the way around the tank and replaced with reinforced structural concrete.
