DOE/NV--1530

Post-Closure Report for Closed
*Resource Conservation and
Recovery Act* Corrective Action
Units, Nevada National Security
Site, Nevada

For Fiscal Year 2014
(October 2013–September 2014)

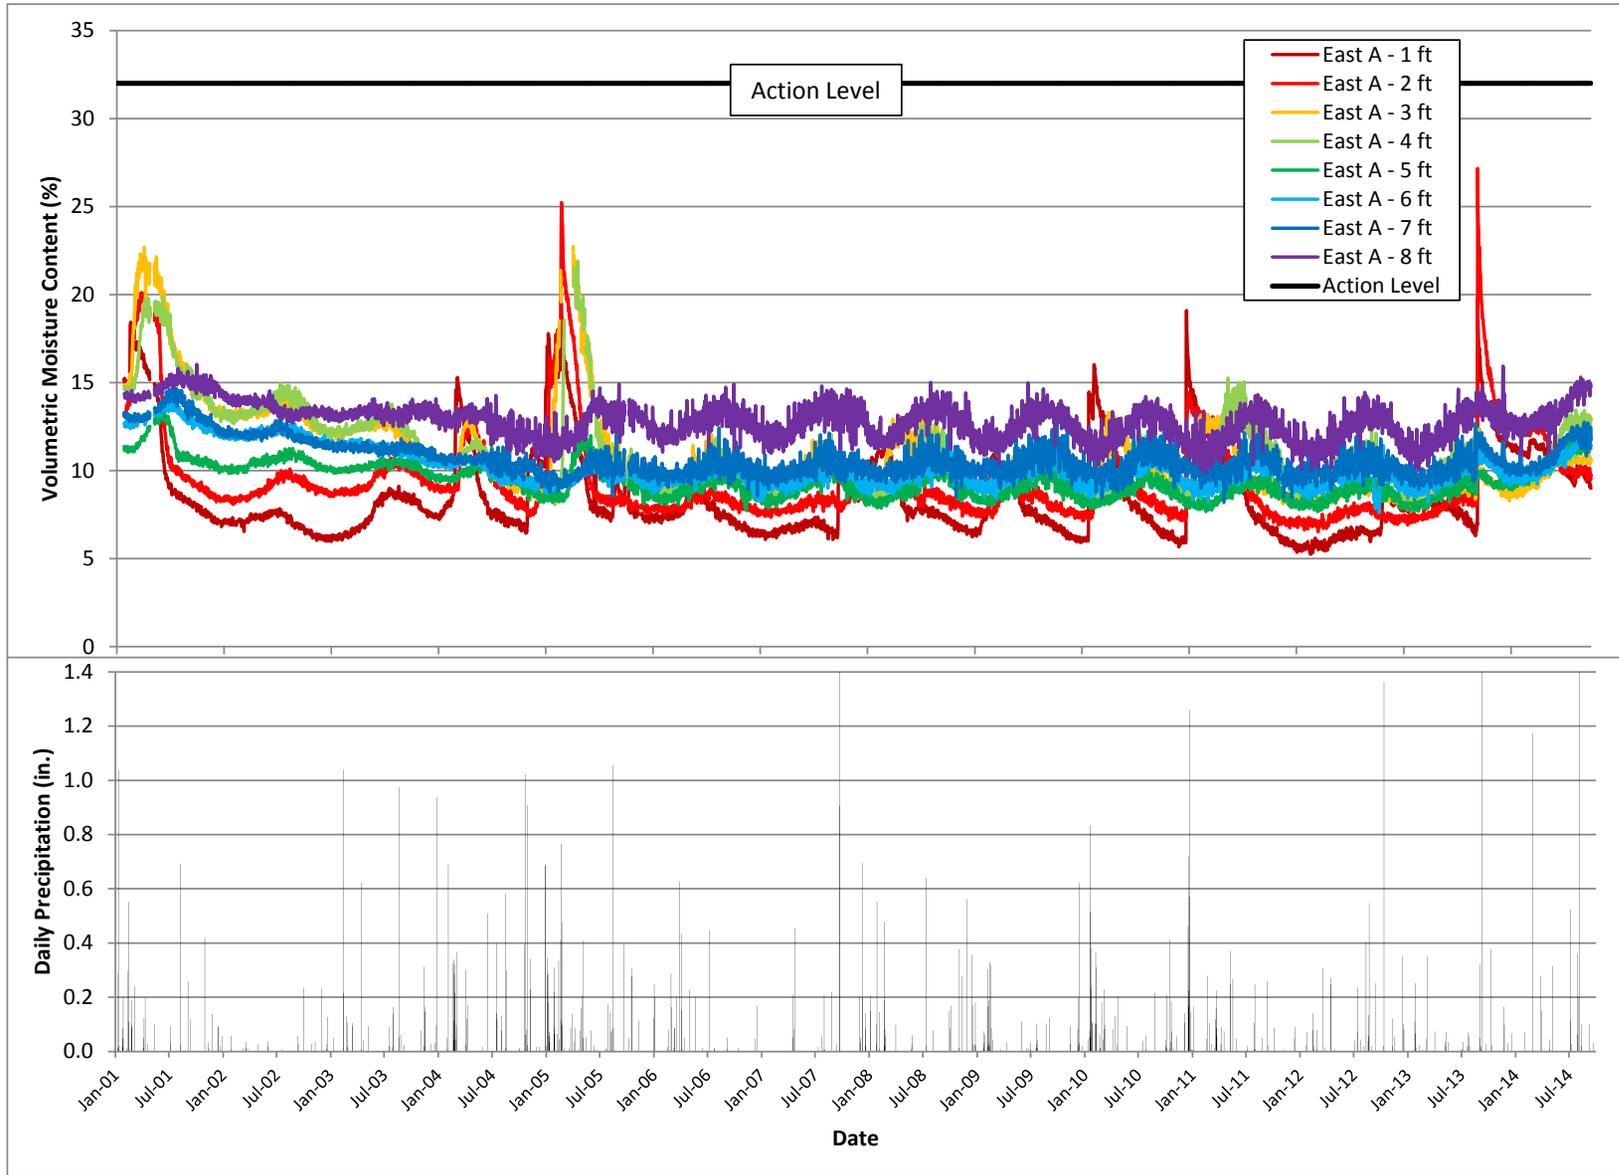
FIGURE 3. EAST TDR NEST A SOIL MOISTURE CONTENT PROFILE

The action level is illustrated in Figures 3 through 6. The action level was not exceeded.
