#15302 Hanford Double-Shell Tank AY-102 Radioactive Waste Leak Investigation Update

D. J. Washenfelder, AEMC
Washington River Protection Solutions

Date Published
January 2015

Session 6
Continued Efforts to Resolve
DOE Hanford HLW Tank AY-102

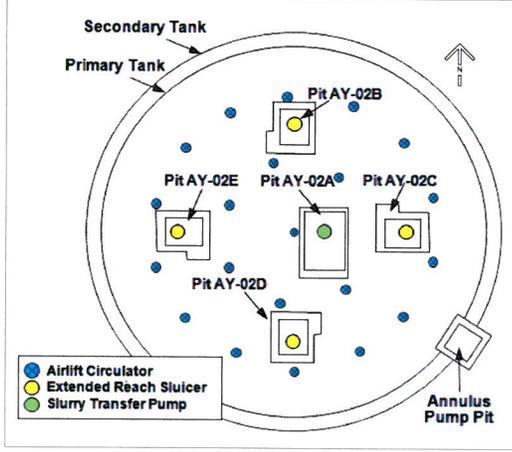
Tank AY-102 Waste Recovery Equipment Configuration

- Waste recovery with extended reach sluicers completed March, 2017*
- Cause of tank failure determined during post-retrieval forensic inspection
