DOE/NV--1535

**Post-Closure Inspection Report for  
the Tonopah Test Range, Nevada**

**For Calendar Year 2014**

U.S. Department of Energy  
National Nuclear Security Administration  
Nevada Field Office

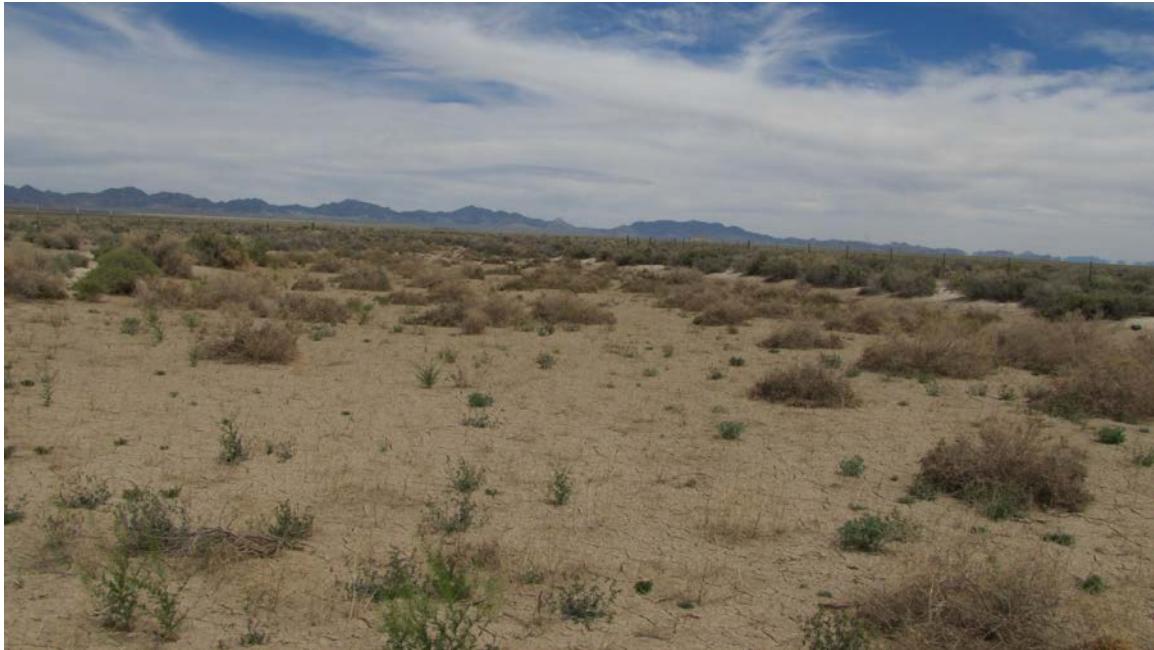
The annual inspection was conducted on May 28, 2014. Minor animal burrows were observed that did not require repair. A minor breach in the rabbit fence was observed on the south side of the site, but repair was not recommended at this time. No other issues or concerns were identified, and no maintenance or repairs were required. Inspections should continue as scheduled.

Vegetation is dry but established. Fencing is in good condition except for an area of Rabbit fence that is loose on south end. Hay bales that were placed along wash to slow down runoff until vegetation was established are washed away but no longer needed because vegetation is established.

Photograph 1: CAU 400 Five Points Landfill, Looking West, 05/28/2014

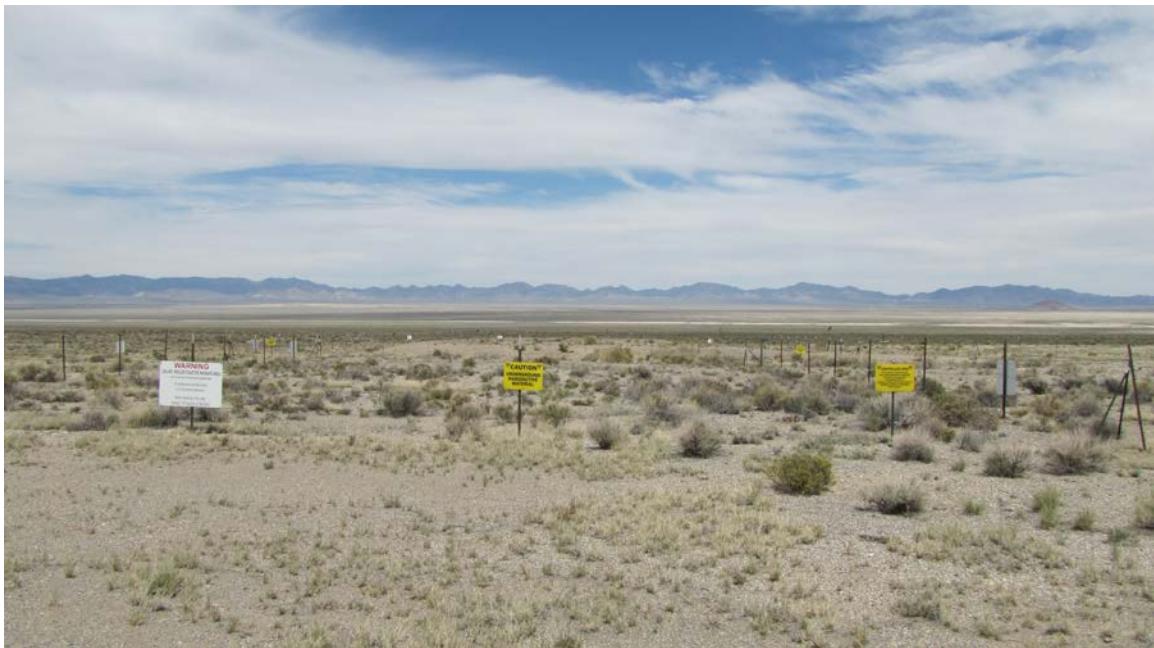
The annual inspection was conducted on May 28, 2014. Erosion rills and substantial animal burrows were observed on the cover slopes. Animal burrows were backfilled and erosion repairs were completed on July 22, 2014. No other issues or concerns were identified, and no additional maintenance or repairs were required. Inspections should continue as scheduled.

2. Field Conclusions and Repair or Maintenance Recommendations:  <i>Fence, signage and top of cover are in good condition. Cover side slopes have a lot of animal burrows, some are large &amp; deep. Erosion rills are forming on east side slope. Repair is needed.</i>

Photograph 2: CAU 407, Looking East, 05/28/2014

Animal burrows were backfilled and erosion repairs were completed on July 22, 2014. Additional maintenance or repairs were not required. Inspections should continue as scheduled. Future vegetation monitoring will be conducted on an as-needed basis if significant changes or concerns are noted during annual visual inspections.

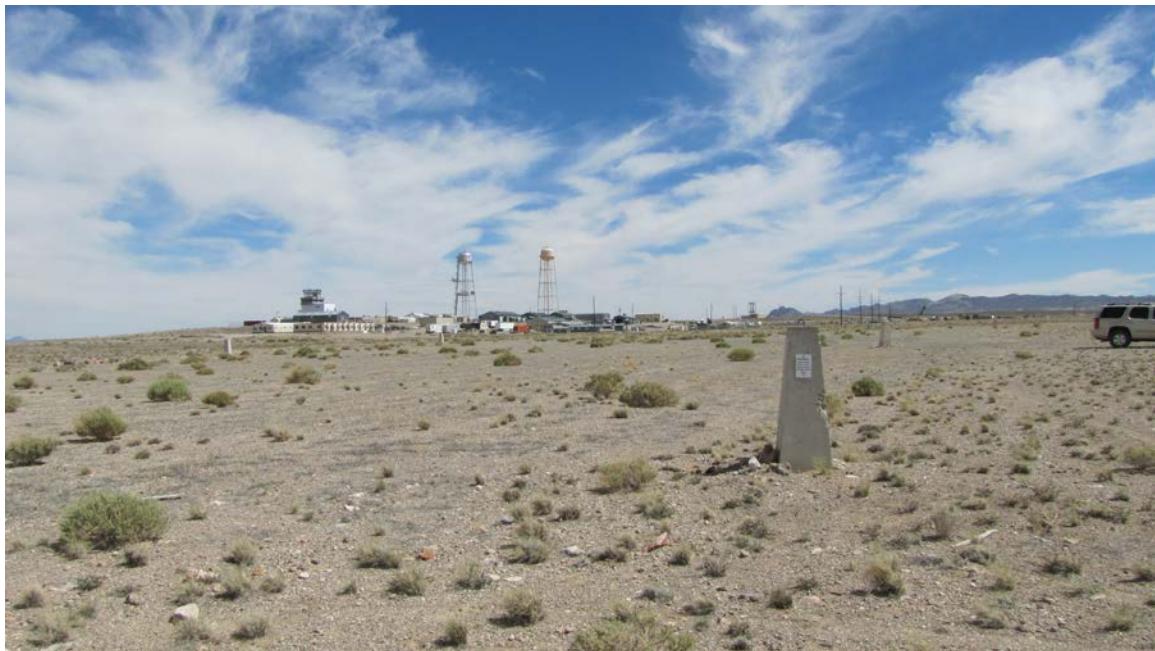
Landfill Cell A3-1 (CAS 03-08-001-A301): No issues or concerns were identified, and no maintenance or repairs were required. Inspections should continue as scheduled.

Photograph 3: CAU 424, Landfill Cell A3-1, Looking Southeast, 05/28/2014

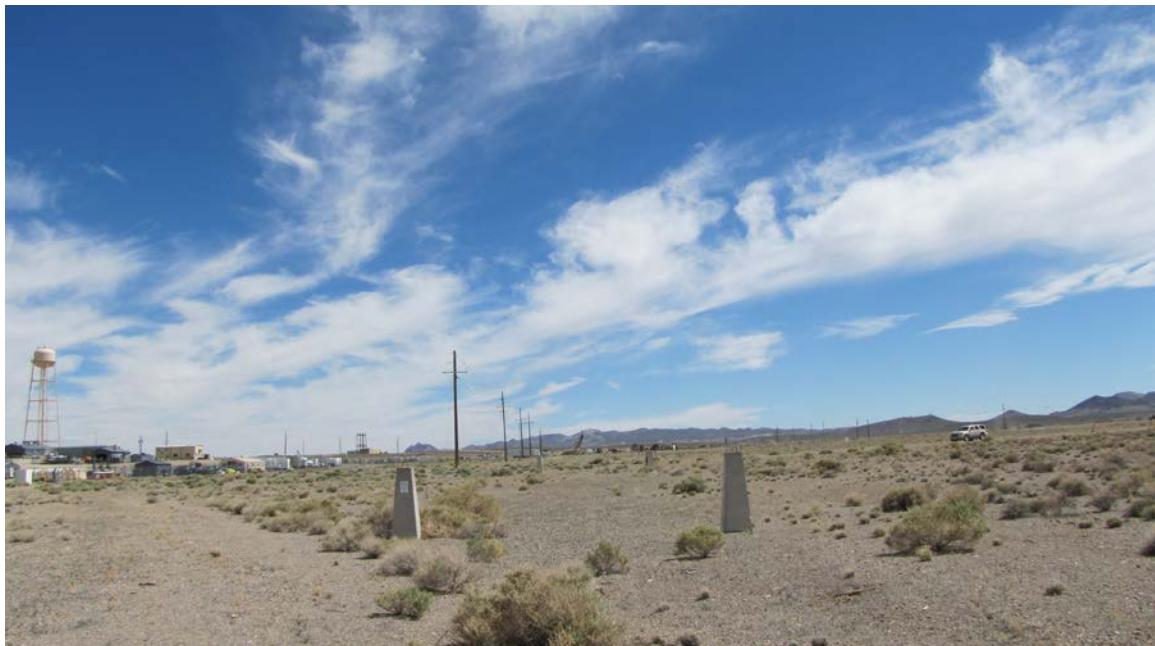
Landfill Cell A3-2 (CAS 03-08-002-A302): No issues or concerns were identified, and no maintenance or repairs were required. Inspections should continue as scheduled.

Photograph 4: CAU 424, Landfill Cell A3-2, Looking South, 05/28/2014

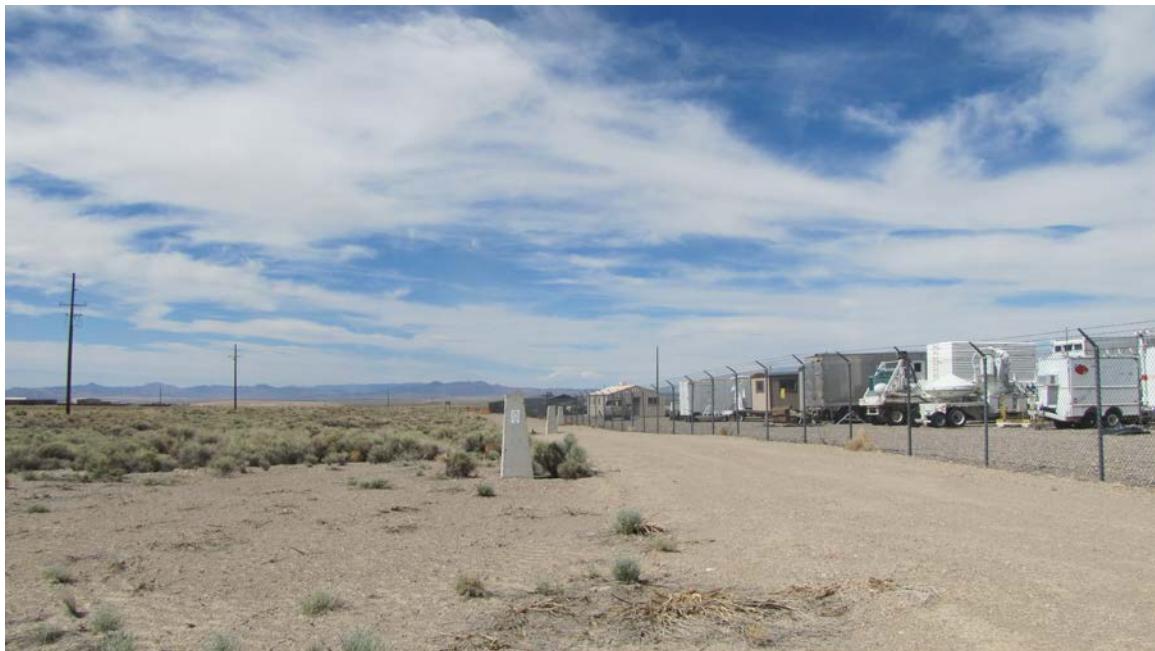
Landfill Cell A3-3 (CAS 03-08-002-A303): No issues or concerns were identified, and no maintenance or repairs were required. Inspections should continue as scheduled.

Photograph 5: CAU 424, Landfill Cell A3-3, Looking North, 05/28/2014

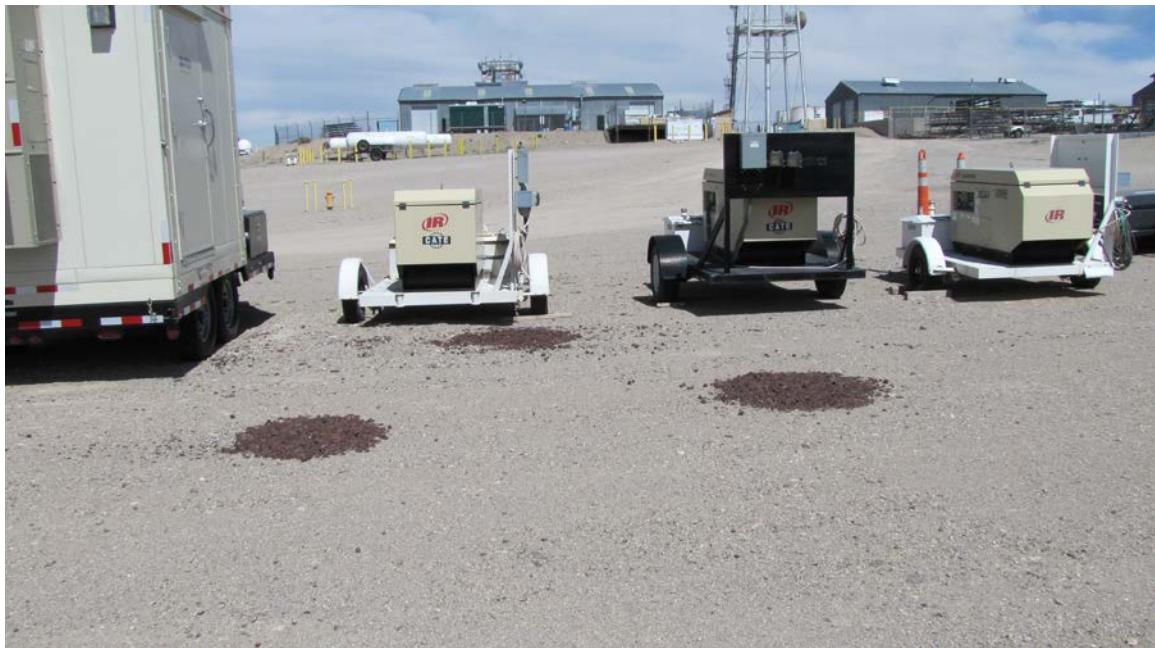
Photograph 6: CAU 424, Landfill Cell A3-3, Lava Rock Marking Surface Grade Monuments, 05/28/2014

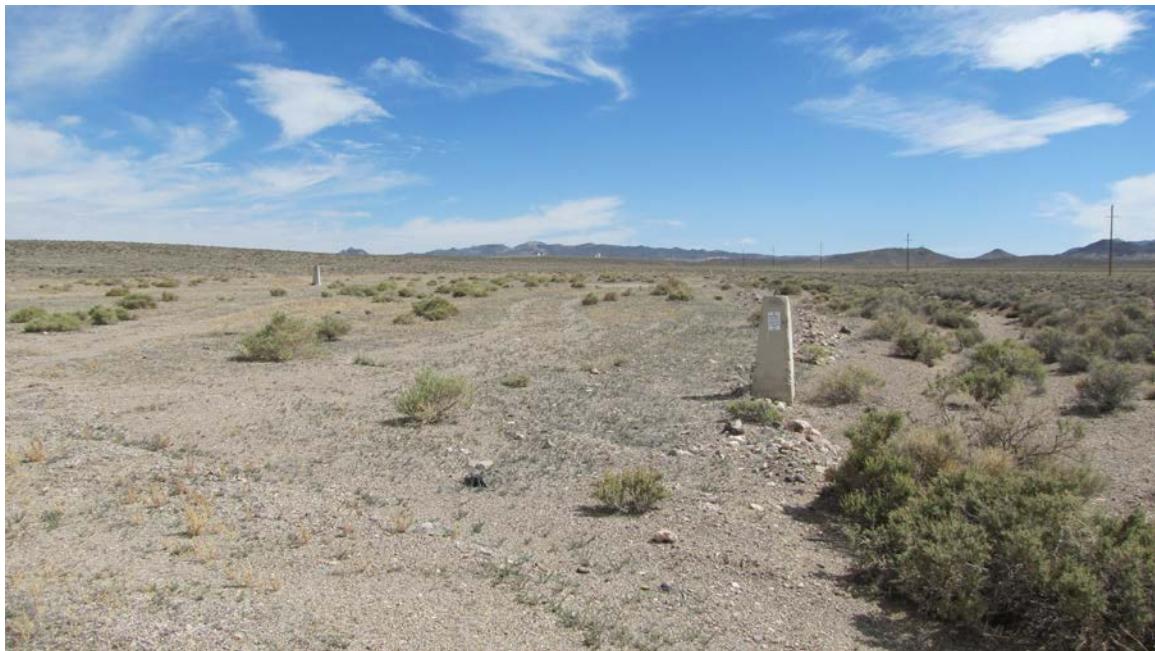
Landfill Cell A3-4 (CAS 03-08-002-A304): No issues or concerns were identified, and no maintenance or repairs were required. Inspections should continue as scheduled.

Photograph 7: CAU 424, Landfill Cell A3-4, Looking South, 05/28/2014

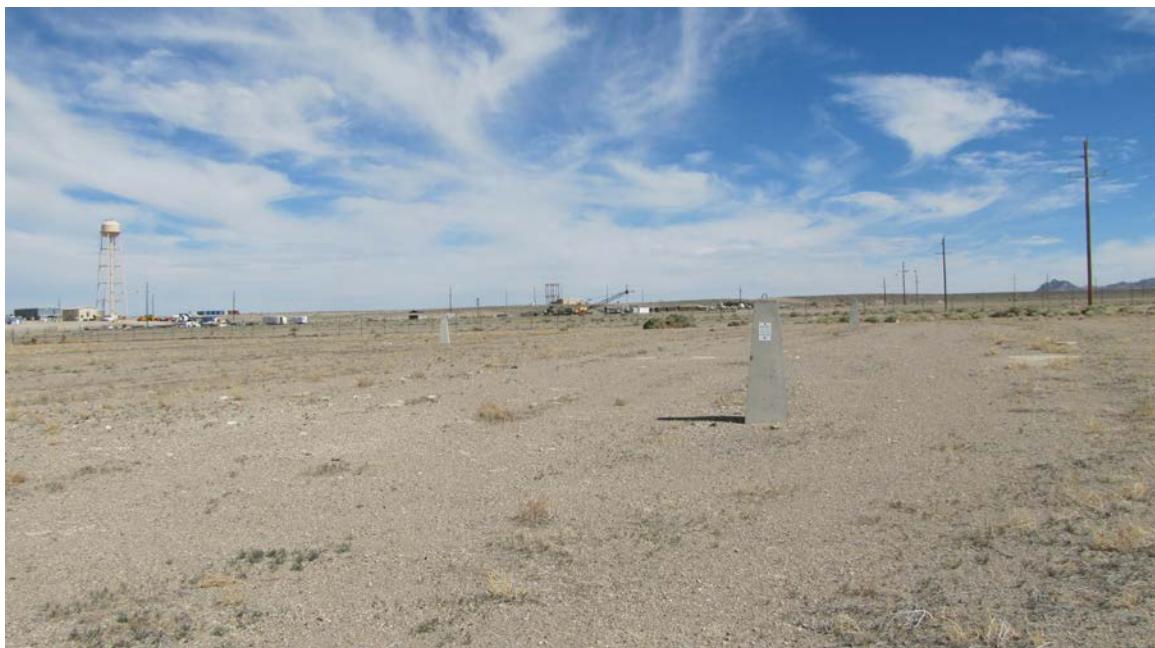
Landfill Cell A3-5 (CAS 03-08-002-A305): No issues or concerns were identified, and no maintenance or repairs were required. Inspections should continue as scheduled.

Photograph 8: CAU 424, Landfill Cell A3-5, Looking South, 05/28/2014

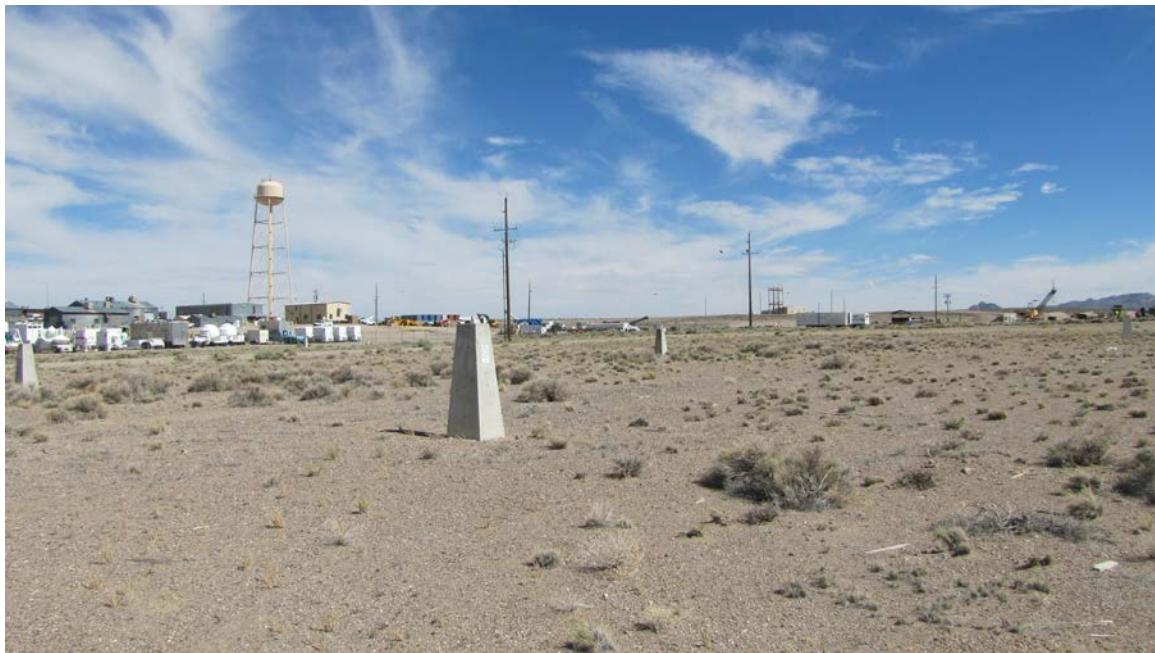
Landfill Cell A3-6 (CAS 03-08-002-A306): No issues or concerns were identified, and no maintenance or repairs were required. Inspections should continue as scheduled.

Photograph 9: CAU 424, Landfill Cell A3-6, Looking Southeast, 05/28/2014

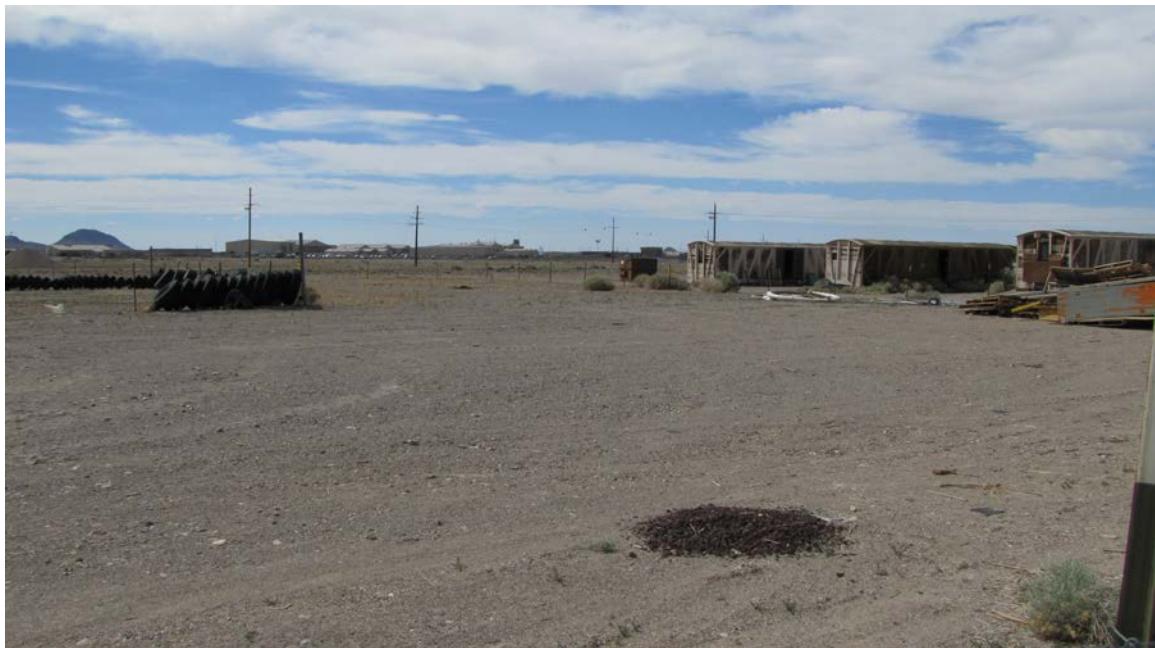
Landfill Cell A3-8 (CAS 03-08-002-A308): No issues or concerns were identified, and no maintenance or repairs were required. Inspections should continue as scheduled.

Photograph 10: CAU 424, Landfill Cell A3-8, Looking East, 05/28/2014

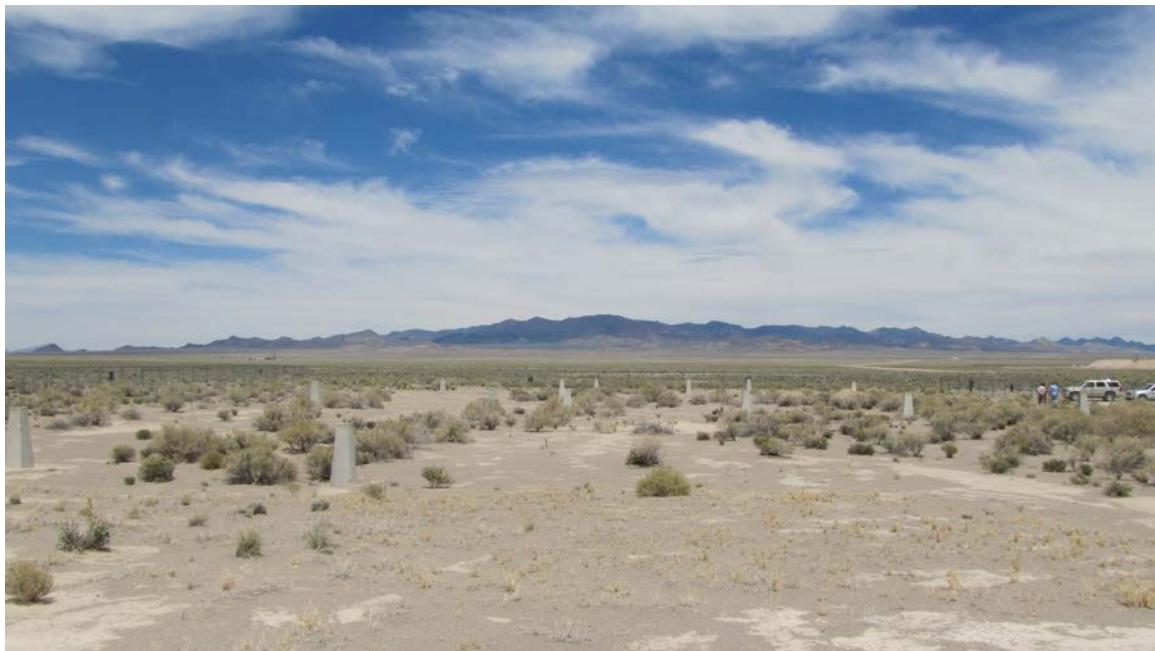
Photograph 11: CAU 453, Looking Northwest, 05/28/2014

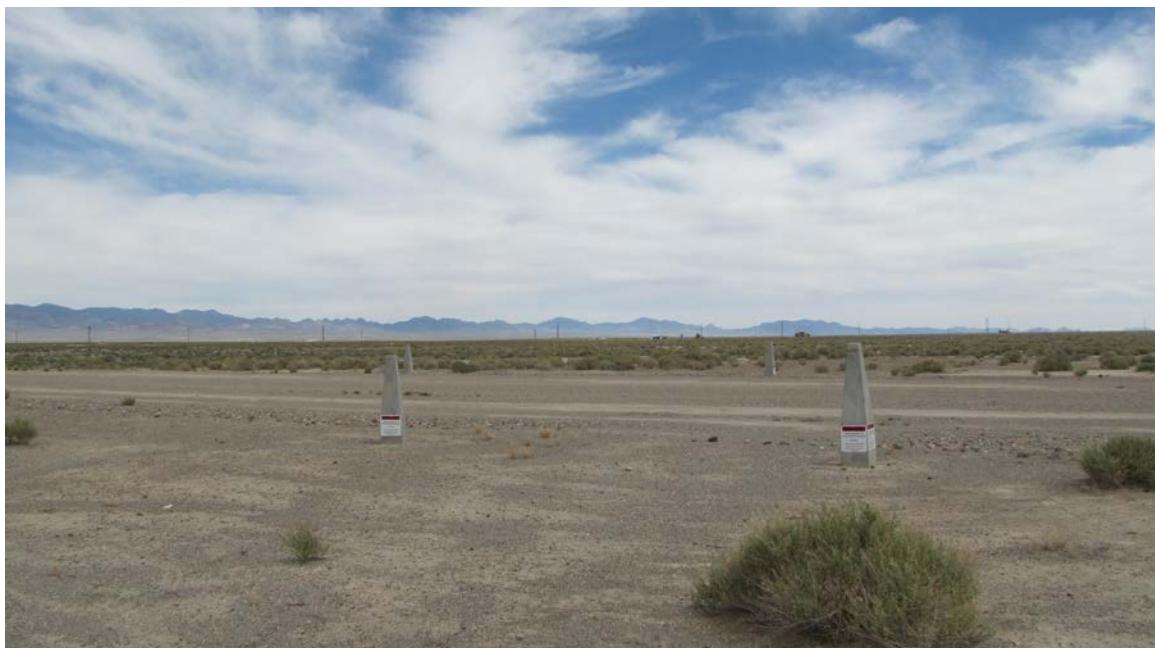
Photograph 12: CAU 487, A-8 Anomaly, Looking East, 05/28/2014

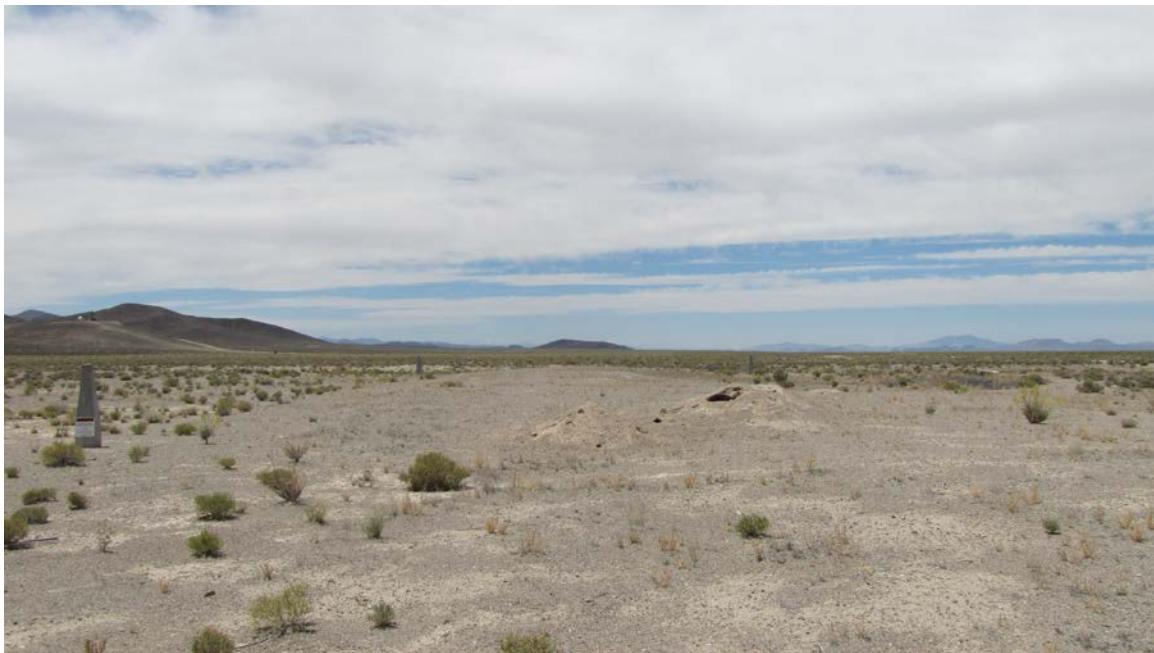
Photograph 13: CAU 487, A-17 Anomaly, Looking West, 05/28/2014
