# Wyandotte Neighborhood Stabilization Program: Retrofit of Two Homes

A. Lukachko, A. Grin, and D. Bergey  
*Building Science Corporation*

April 2013

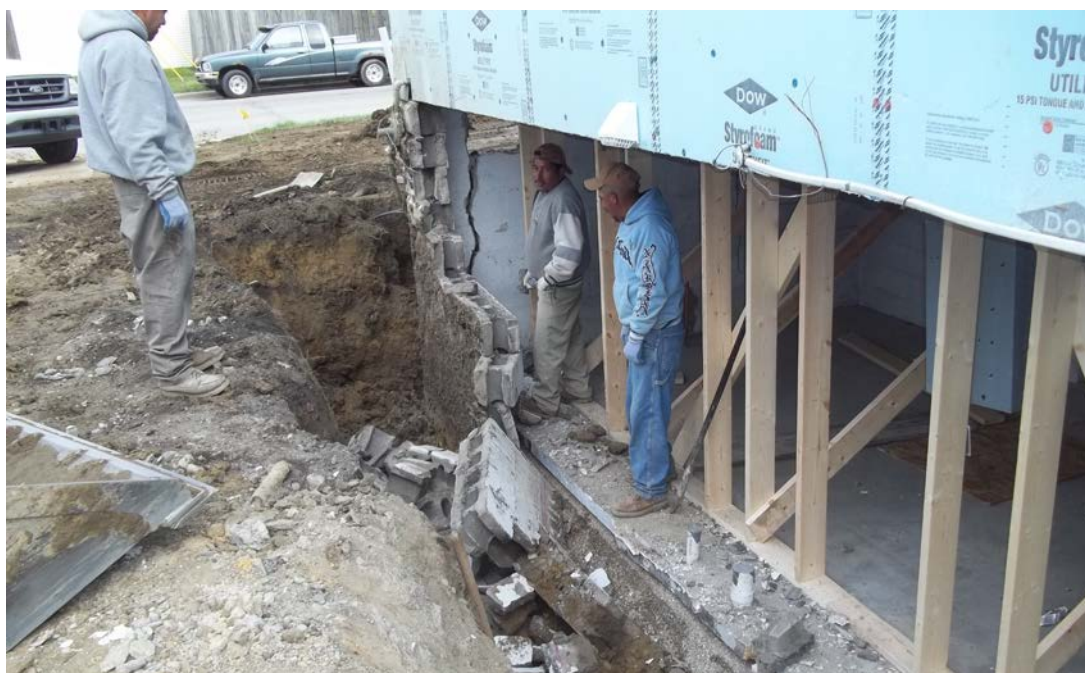
**Figure 5: Repair work on Cedar 2 foundation**

However, during demolition work on the house, the foundation wall suffered a partial collapse (see Figure 5 below). Construction work was delayed and a final retrofit solution for the foundation was not determined at the time of this report.

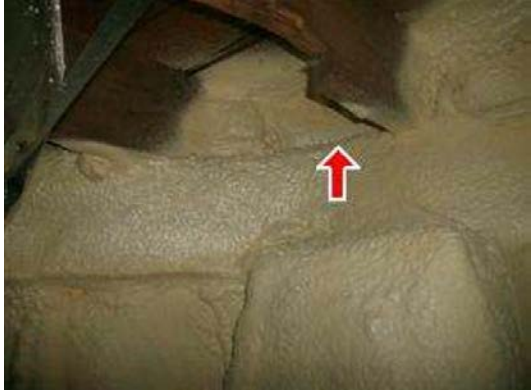
| <p>(photo courtesy of Steven Christensen, WARM Training)</p> | <p><b>#1 – Rim joists.</b> The primary issue with this location is that there may not be enough room for the installer to position the spray foam applicator so that insulation is sprayed on surfaces behind and around all sides of the rim joist. After the foam expands, this area may or may not be adequately air sealed.</p> |

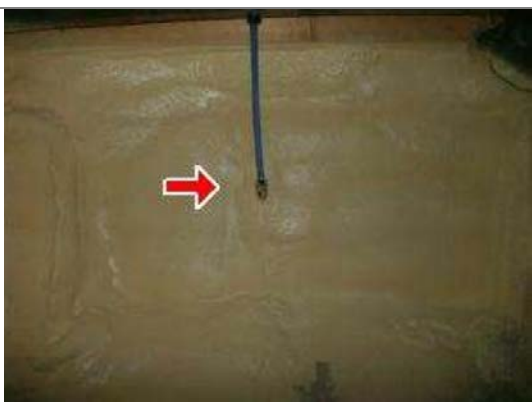
| <p>(photo courtesy of Steven Christensen, WARM Training)</p> | <p><b>#2 – Penetrations.</b> The photograph to the left shows a hose bib that has been installed after the foam has been cut away. This is a common problem where workers do not repair the air seal after the penetration for the SPF installation has been made.</p> |

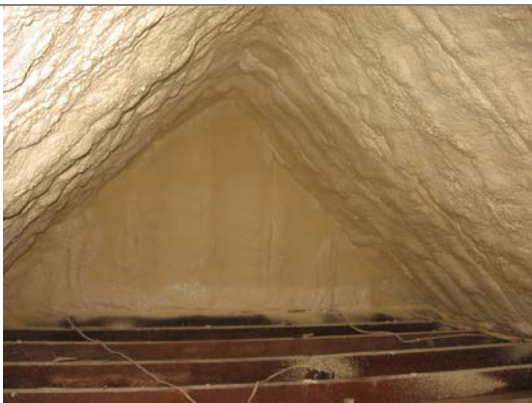
| | <p><b>#3 – Attic Rafter to Floor.</b> Although coverage of the underside of the roof with spray foam looks to be complete, it is common for leakage paths to be missed at the intersection of the attic rafters and the attic floor.</p> |

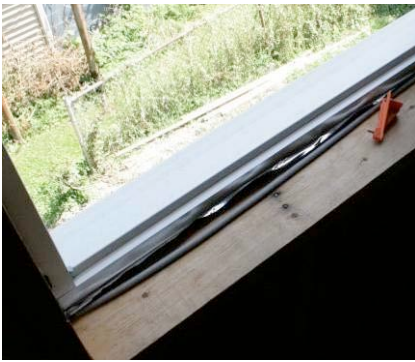
A new method of creating a back-dam on the sill was seen in this house. A back dam is used to ensure that water sitting on the sub-sill flashing cannot enter the home. In this installation a 3/8" foam backer rod was used below sub sill flashing to create this upturn. Although this has the possibility to work, it appeared that the foam backer rod did not adhere well to the flashing tape and hence did not stay in place. Alternatively a small strip of wood (or plywood) could be affixed across the full width of the rough opening and the flashing tape lapped onto the wood. This would help ensure the flashing tape has a secure, fixed substrate that has good adhesion to the tape.

2011-08-28 – Backer rod back-dam failing to adhere to the flashing tape

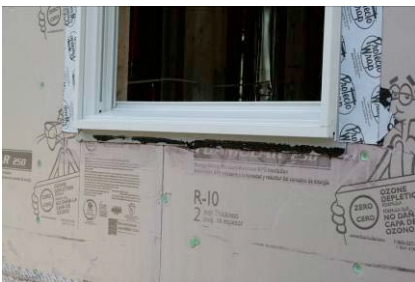
Water management details at the windows need some improvement - flashing was observed to be sealing the bottom of the window, rather than being drained. It was recommended that the flashing across the bottom of the window be slit or removed completely. BSC also recommended back dams on window openings. As recommended the flashing across the bottom of the window was removed in most areas. The east facing windows of the home on the first and second floor still require that the flashings along the bottoms of the windows be removed. There also areas within the field of the wall where the joints between the sheets of XPS must be sealed as the primary drainage plane. The windows above the front porch also require attention to repair the flashings.

Flashing at the bottom of the window removed

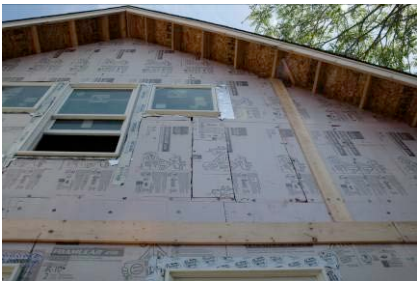
Areas in the field of the wall that require tape sealing

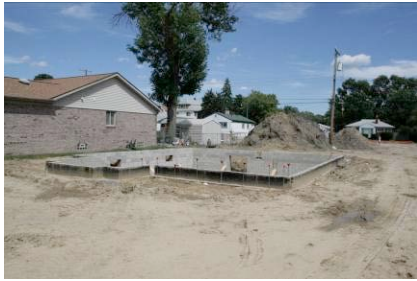
2011-08-22 – Foundation complete, capillary break not apparently present

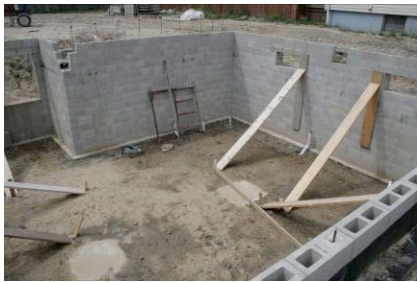
2011-08-22 – Foundation complete, missing capillary break

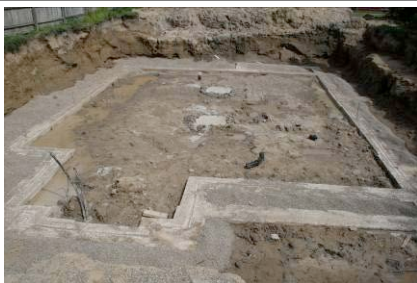
2011-08-22 – Footings complete missing capillary break

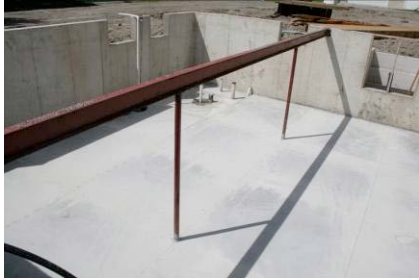
2011-08-22 – Foundation and basement floor complete. The status of the capillary break is unknown

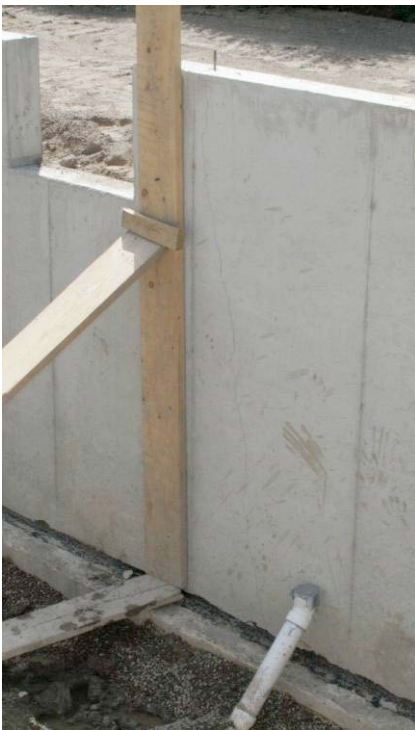
2011-08-22 – Foundation crack

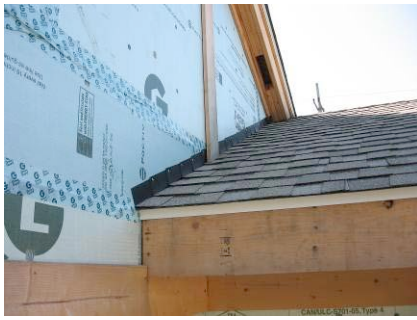
Step flashing requiring integration to the drainage plane. Details to finish this flashing with a regletted cap flashing and tape can be found at:

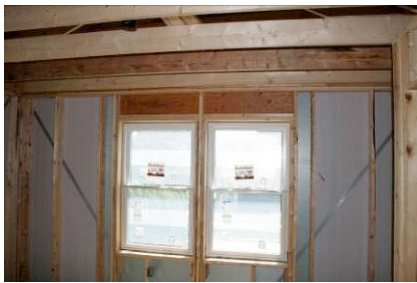
2011-08-22 – Unnecessary header above a window in a non-load bearing wall

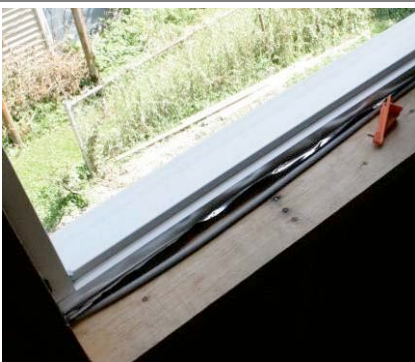
2011-08-28 – Backer rod back-dam failing to adhere to the flashing tape

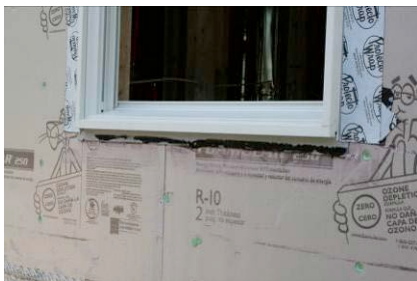
Flashing at the bottom of the window removed

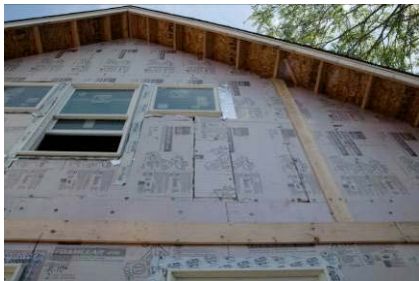
Areas in the field of the wall that require tape sealing

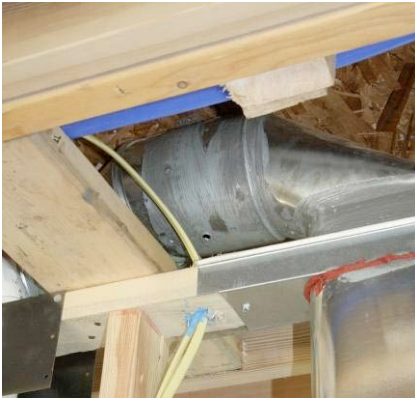
Venting hole requiring foil tape repair

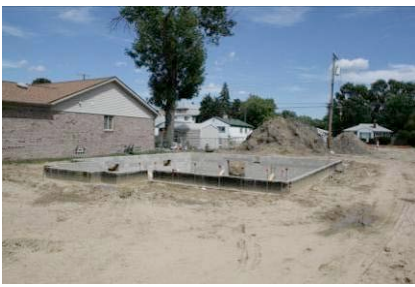
2011-08-22 – Foundation complete, capillary break not apparently present  
2011-10-06 – First floor floor framing complete

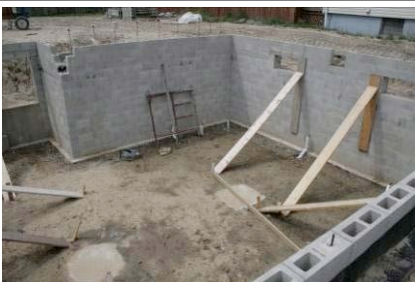
2011-08-22 – Foundation complete, missing capillary break  
2011-10-06 – Foundation complete, nothing else to report

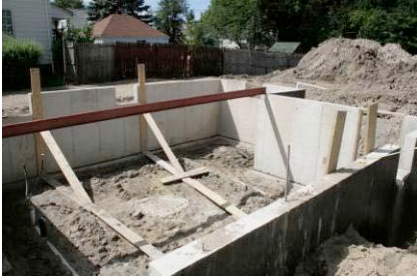
2011-08-22 – Foundation and basement floor complete. It appears that the capillary break was not properly installed between the footing and the foundation.

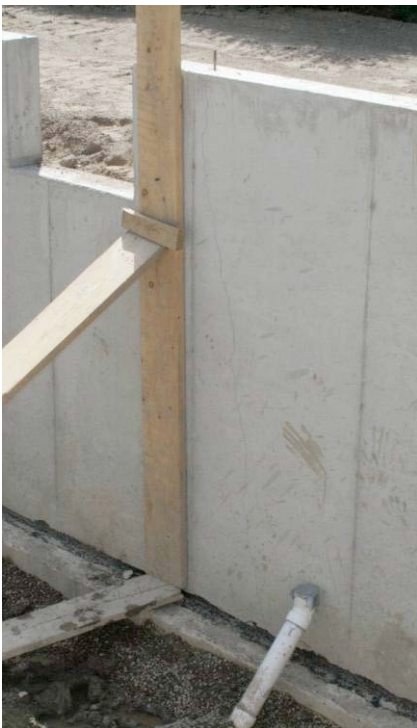
2011-08-22 – Foundation crack
