**Assessing Braze Quality in the
Actively Cooled Tore Supra Phase III Outboard Pump Limiter**

R. E. Nygren, T. L. Lutz, J. D. Miller, R. McGrath

Sandia National Laboratories, Albuquerque, New Mexico, USA*
and G. Dale

The quality of brazing of pyrolytic graphite armor brazed to copper tubes in Tore Supra's Phase III Outboard Pump Limiter was assessed through pre-service qualification testing of individual copper/tile assemblies. The evaluation used non-destructive, hot water transient heating tests performed in the high-temperature, high-pressure flow loop at Sandia's Plasma Materials Test Facility. Surface temperatures of tiles were monitored with an infrared camera as water at 120°C at about 2.07 MPa (300 psi) passed through a tube assembly initially at 30°C. For tiles with braze voids or cracks, the surface temperatures lagged behind those of adjacent well-bonded tiles. Temperature lags were correlated with flaw sizes observed during repairs based upon a detailed 2-D heat transfer analyses. "Bad" tiles, i.e., temperature lags of 10-20°C depending upon tile's size, were easy to detect and, when removed, revealed braze voids of roughly 50% of the joint area. Eleven of the 14 tub

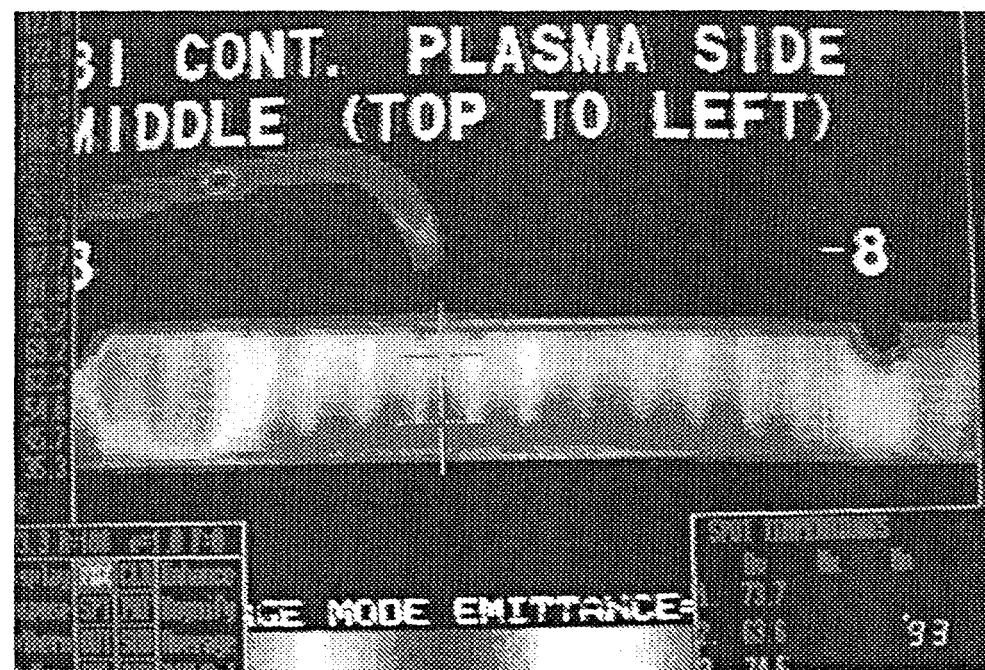
Figure 3 shows the video data (processed IR images) of a view of the central portion of Tube 3i. Here, to the left of "-8", for several tiles (Tiles 3-8), the lower portion is darker than the upper portion indicating an asymmetric temperature distribution. As noted above this, and the grouping of several adjacent tiles, suggests that cracking along the braze may have occurred, perhaps during handling of the tubes.

Figure 3. Still frame from (color) IR output for Tube 3i hot water test.

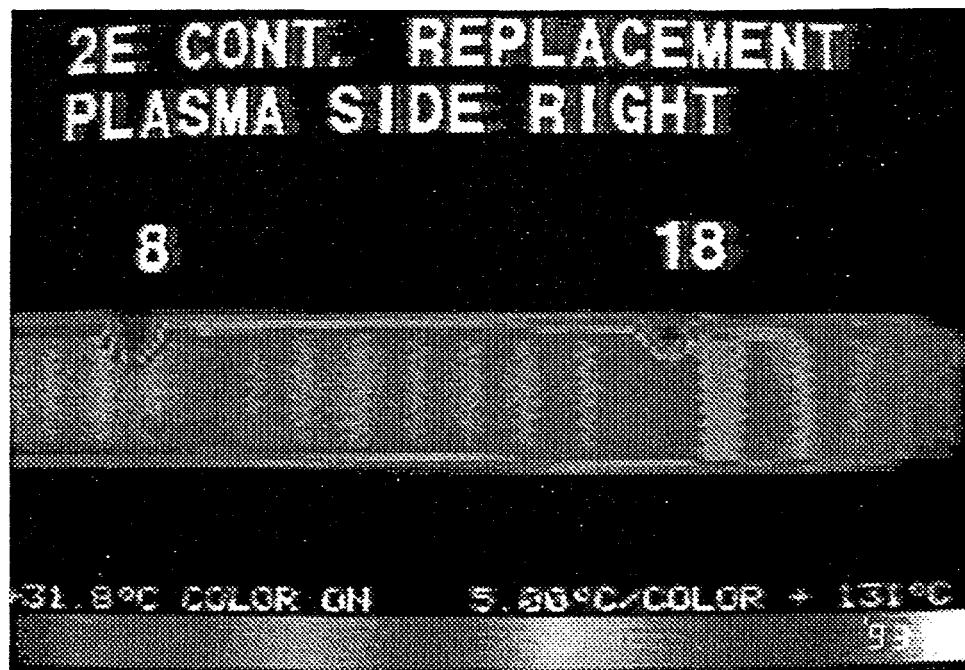
Figure 4 shows the processed IR images for the plasma facing surface of Tube 2e. The vertical bands are the edges of individual tiles. Below and to the right of the marker "18" is a light area (Tile 19). The difference in shading (color⁴) from Tiles 18 and 20 indicates a lag in temperature; the

uniformity of surface temperature across Tile 19 suggests the lag is due to a symmetric braze flaw rather than an asymmetric flaw or crack.

Figure 4. IR output for Tube 2e, plasma side, right end. Black depressions below 8 and 18 are markers.

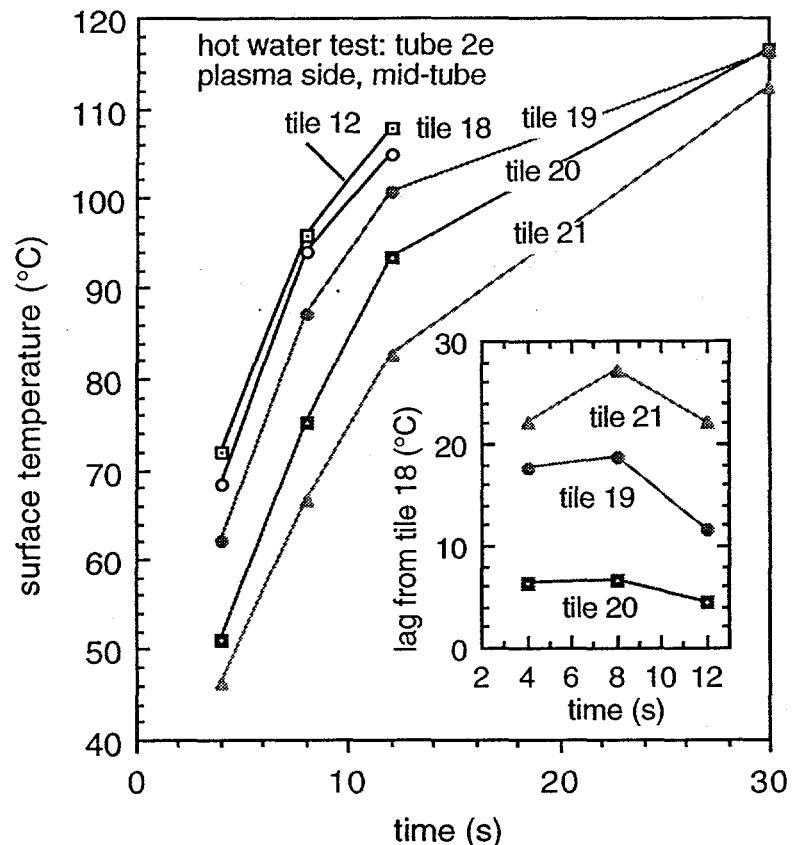
Figure 5 shows the temperature rise for selected spots on Tube 2e. The temperature lag for Tile 19 is apparent.⁵ In Figure 5, the temperature lags are also plotted directly. The coarse sampling of the IR data (every four seconds in Figure 5) was representative of the data used and was considered adequate to show the magnitude and the rise and fall of the temperature lags for the large tubes. A final point near the equilibration temperature was also used to confirm that the emissivity of the tiles being compared was nearly the same. More rapid sampling was used for the smaller tubes. Typically the individual data points were an average at the designated location of the IR readings over 20 frames. The apparent scatter of individual readings was about $\pm 2^\circ \text{ C}$ over times short compared to the rising temperature.

⁵It is also true that Tile 20 lags Tile 18 and Tile 21 is below all of them. The lag of Tile 21 is typical for all tubes. While most tiles can be idealized as blocks perpendicular to the tube, Tile 21 is far enough around the curve near the end of the tube to alter the geometry, i.e., increase the ratio of integrated heat capacity to thermal conductance.

Figure 5. Surface temperature versus time for selected points on Tube 2e during hot water test. Temperature lag is shown in the insert.
