Title: September 2013 Storm and Flood Assessment Report

LA-UR-13-28173
November 2013
EP2013-0240

September 2013 Storm and Flood Assessment Report

Prepared by the Environmental Programs Directorate

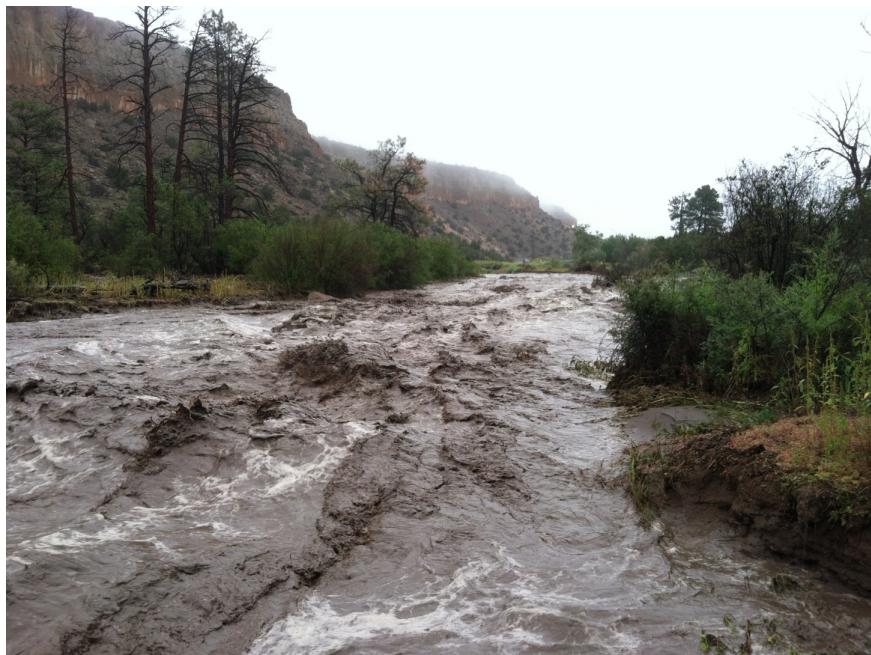
Figure 4 Flood in lower Pueblo Canyon September 13, 2013

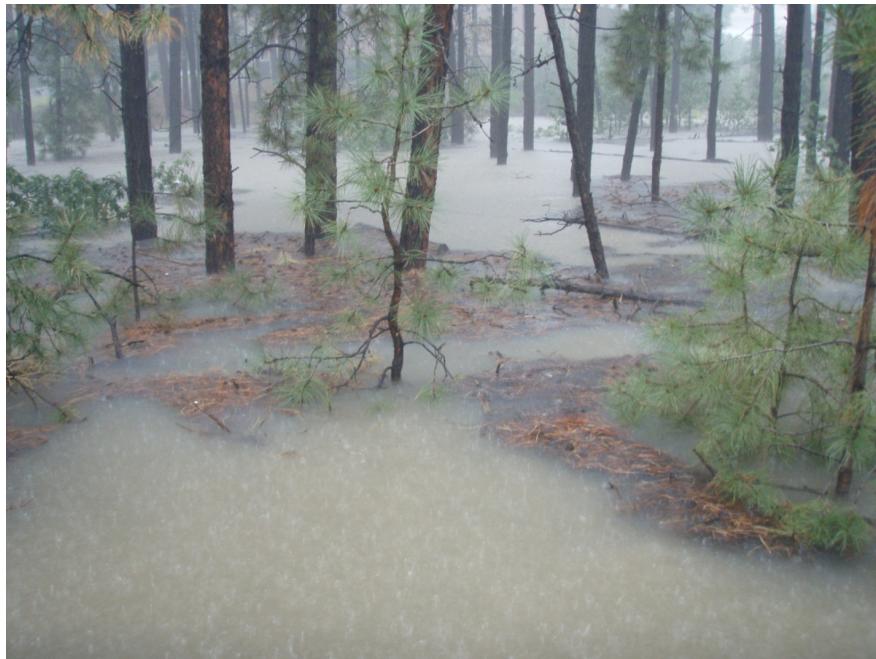
Figure 5 Flooding of drainage adjacent to the University House, September 13, 2013

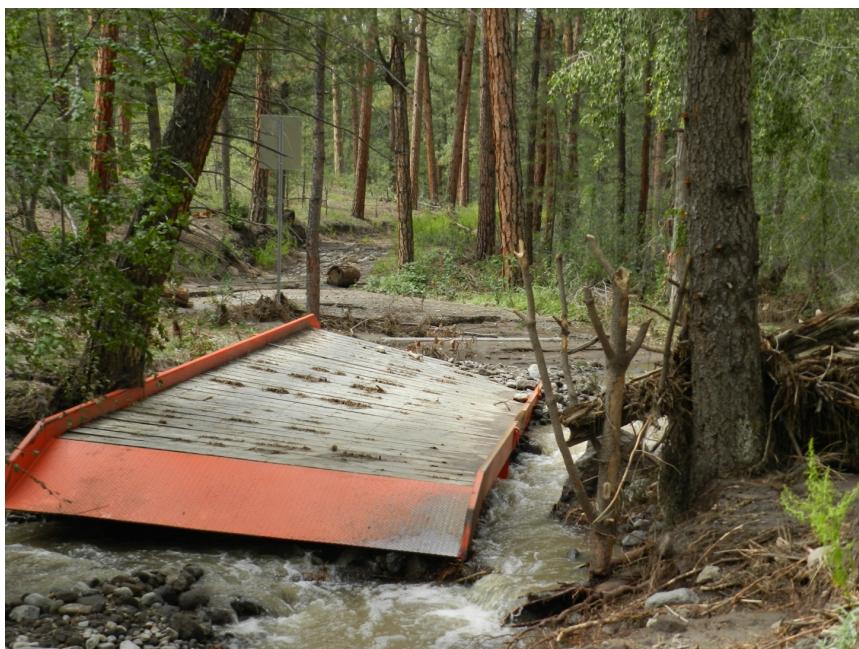
- Los Alamos Canyon access road is approximately 4.0 mi long from NM 4 to Technical Area 41 (TA-41) with 9 stream channel crossings. Impacted sections of the access road include all stream channel crossings and sections of the road within the flood plain. Four manufactured bridges were knocked off their moorings and damaged. Repair/replace damaged road sections and bridges (\$850K).

Figure 6 Damage to bridge and access road in Los Alamos Canyon

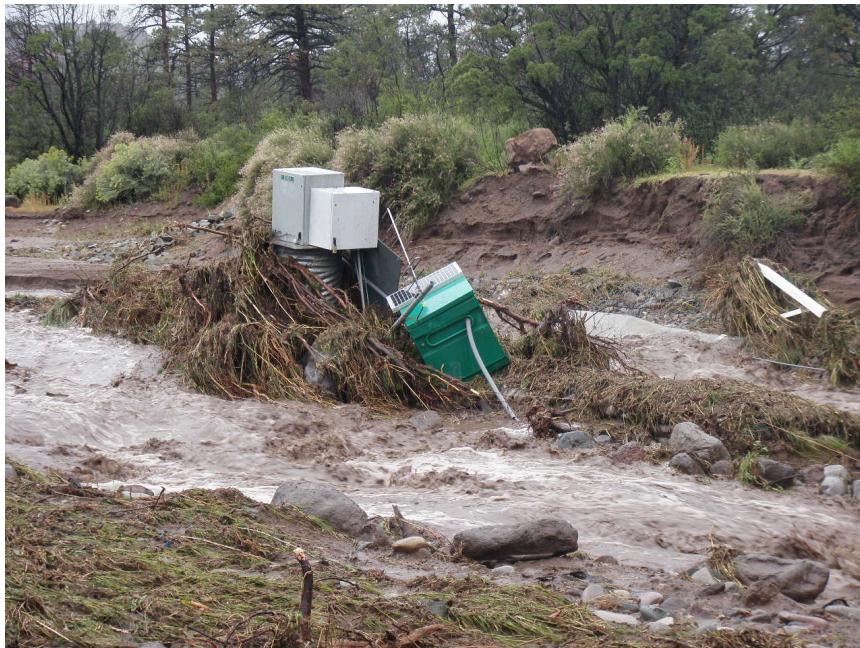
Figure 7 September 13, 2013, flood damage to gage station E060.1

- ❖ E060.1: Replace ISCOs, batteries, and ultrasonic probe; straighten stilling well and probe arm; install concrete pad for access to Hoffman box and Greenlee box stabilization; install jersey barriers with backfill to protect right bank and redirect high flows towards flume; backfill left downstream bank behind gabion baskets; straighten channel upstream of flume; and install access road (\$100K)

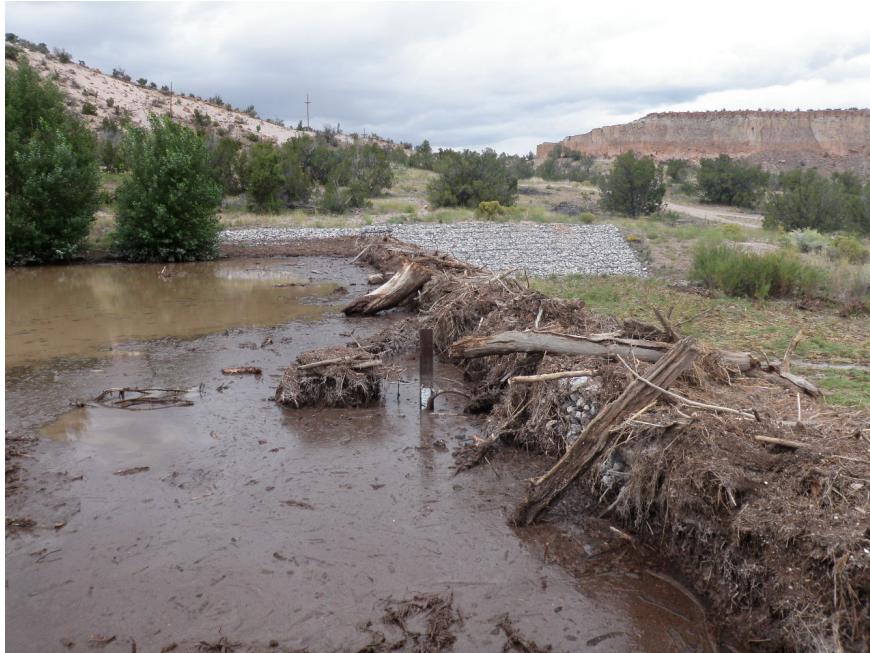
- Pueblo Canyon grade-control structure: Minor damage to main structure, riprap repair, debris cleanup (\$25K)
- Los Alamos Canyon retention ponds: Moderate damage to lower pond retaining berm, spillway repair (\$50K)
- DP Canyon grade-control structure: No damage, debris cleanup (\$5K)
- Los Alamos Canyon weir: No damage to structure, debris removal from structure, sediment clean out from ponds (\$150K)

Figure 8 Flood debris at the Los Alamos Canyon weir spillway

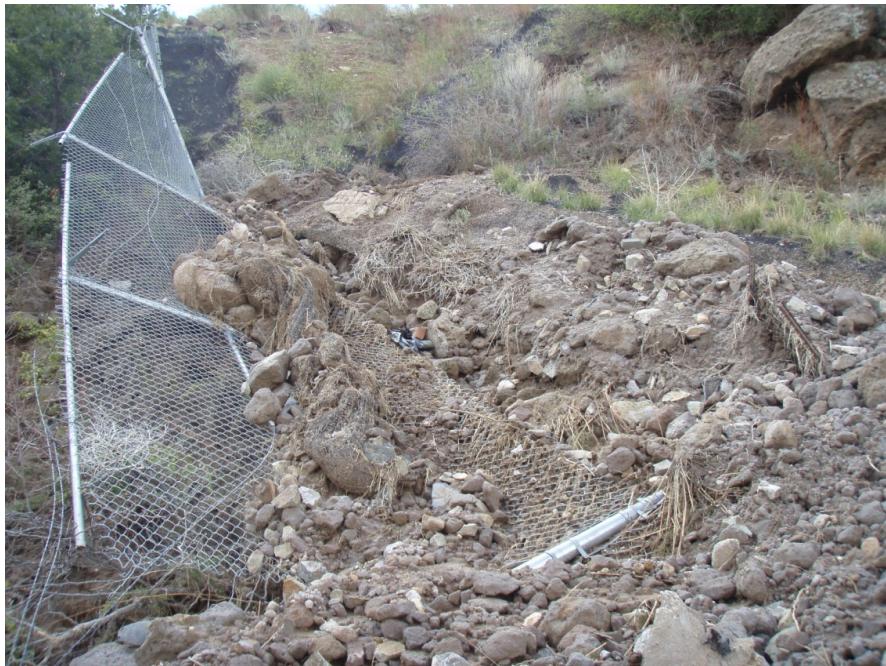
- ❖ P-SMA-1: Failure of engineered slope, repair rock channel, repair small detention ponds (3), repair of multiple areas with rilling (\$75K+)

Figure 9 Slope failure at P-SMA-1

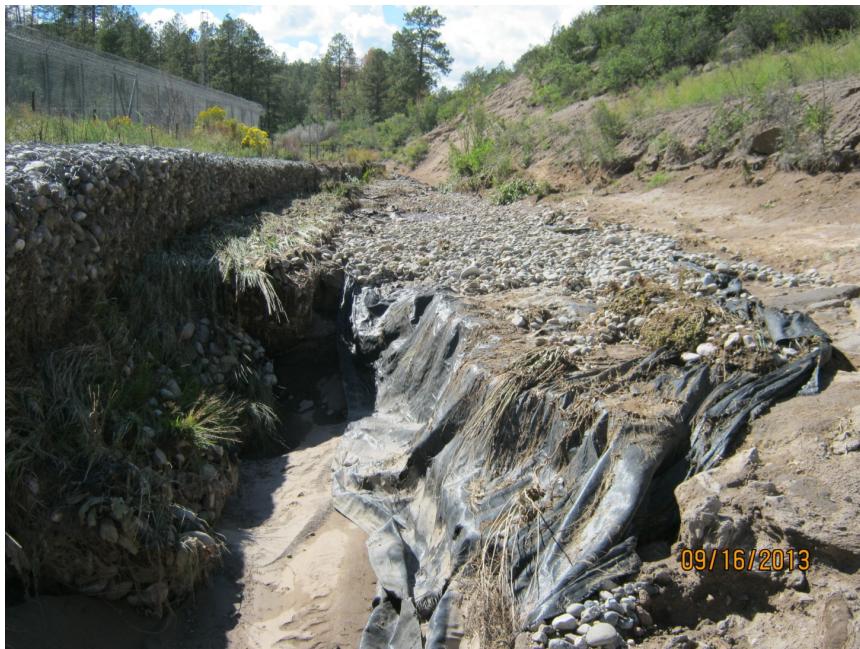
- Threemile Canyon access road within and above TA-18 is approximately 0.75 mi long with 2 stream channel crossings. Access is through the channel along the Casa and is washed out. Recommend rerouting section of road (\$120K).

Figure 10 Damage to Threemile Canyon access road

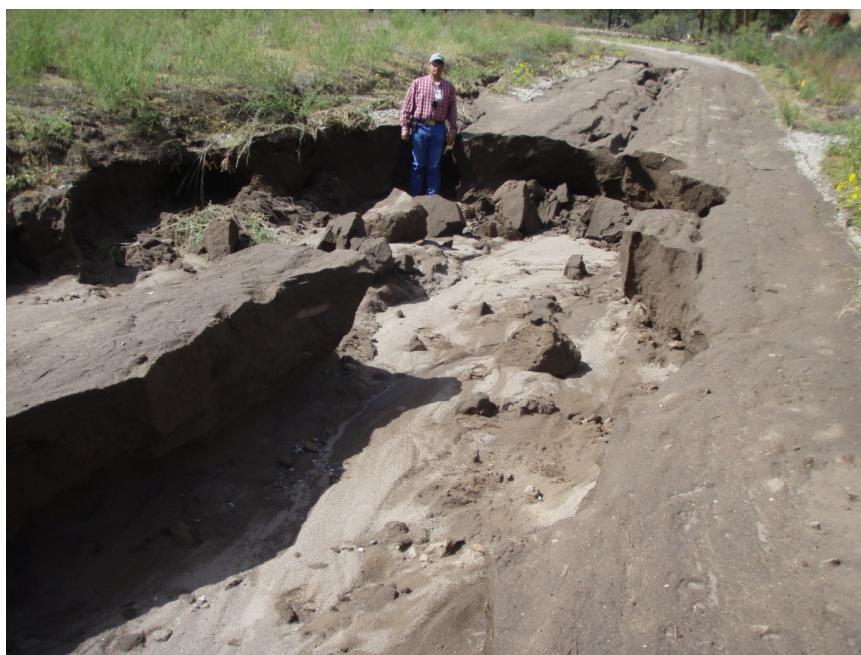
Figure 11 Damaged access road Mortandad Canyon

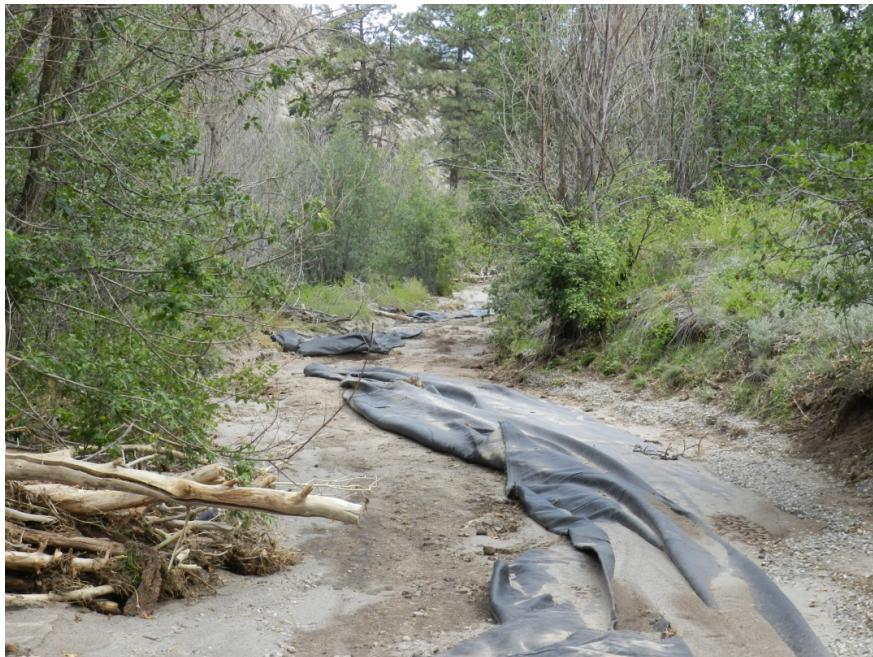
Figure 12 Damaged access road above sediment traps in Mortandad Canyon

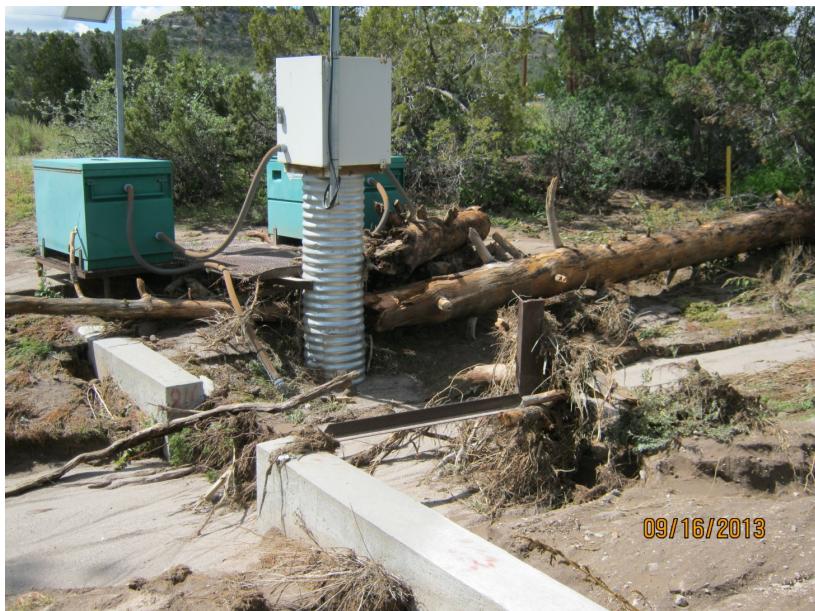
Figure 13 Debris at Sandia Canyon gage E125

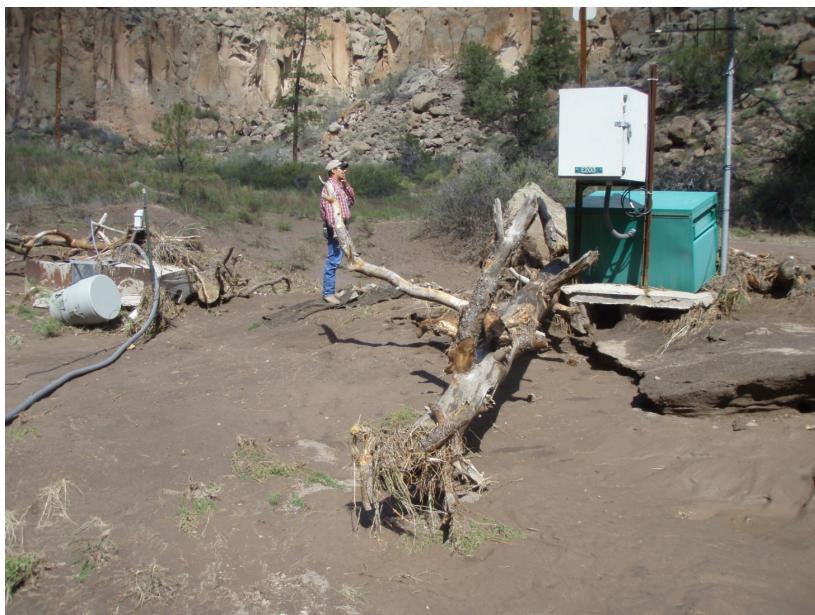
- Sandia grade-control structure: Currently under construction, no associated costs under the assessment estimate
- Mortandad sediment traps: Major damage to 3 large sediment traps will require sediment cleanout, berm repairs, and channel repairs (\$200K)

Figure 14 Damaged equipment at the Mortandad sediment traps

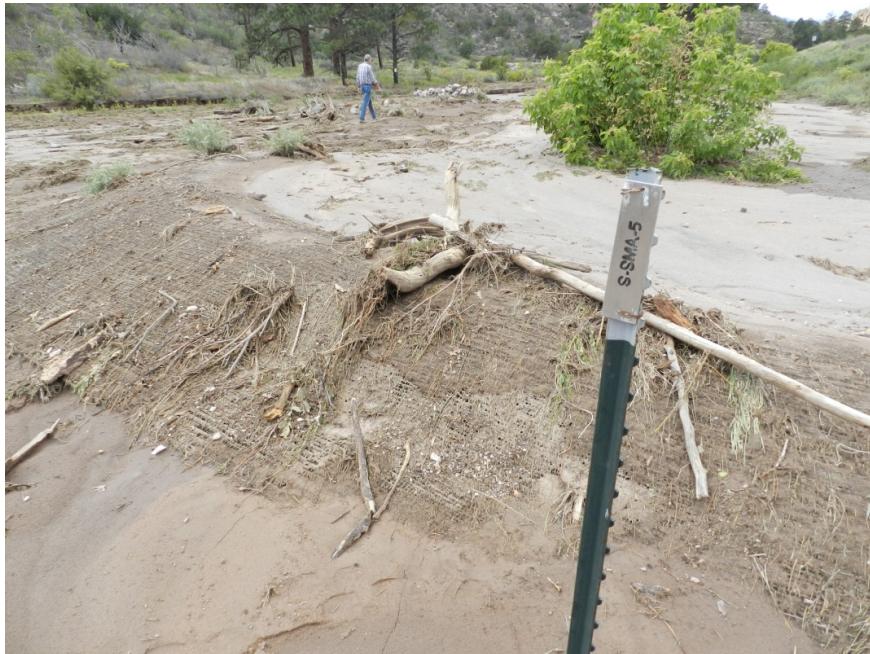
Figure 15 S-SMA-5 Control berm damaged and filled with sediment. ISCO automated sampler and battery found downstream.

- ❖ S-SMA-3.53: Reshape channel, extend riprap (\$15K)
 - ❖ S-SMA-4.1: Replace wattles (5), repair berm, seed and mulch area (\$12K)
 - ❖ S-SMA-5: Remove sediment, repair riprap and spillway (\$15K)

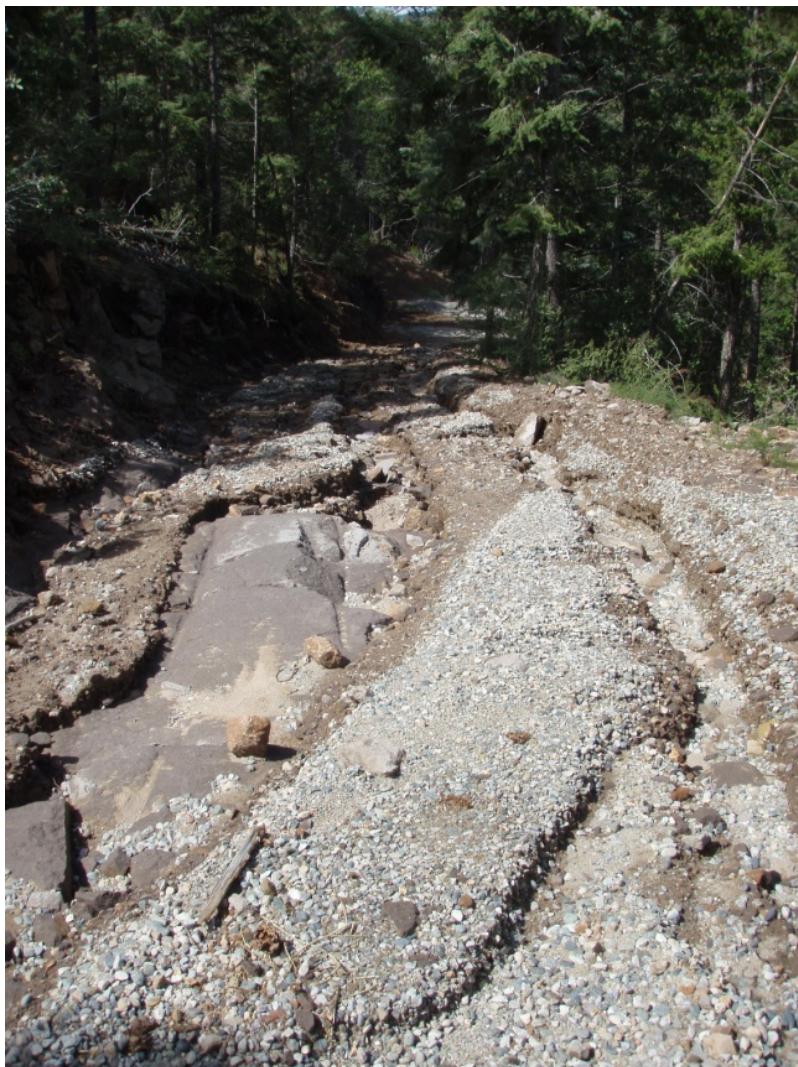
- Cañon de Valle access road is approximately 0.25 mi long from the Burning Ground to stream gage E256 with one stream channel crossing. Impacted sections of the access road will require the addition of base course and regrading (\$60K).

Figure 16 Damage to Cañon de Valle access road

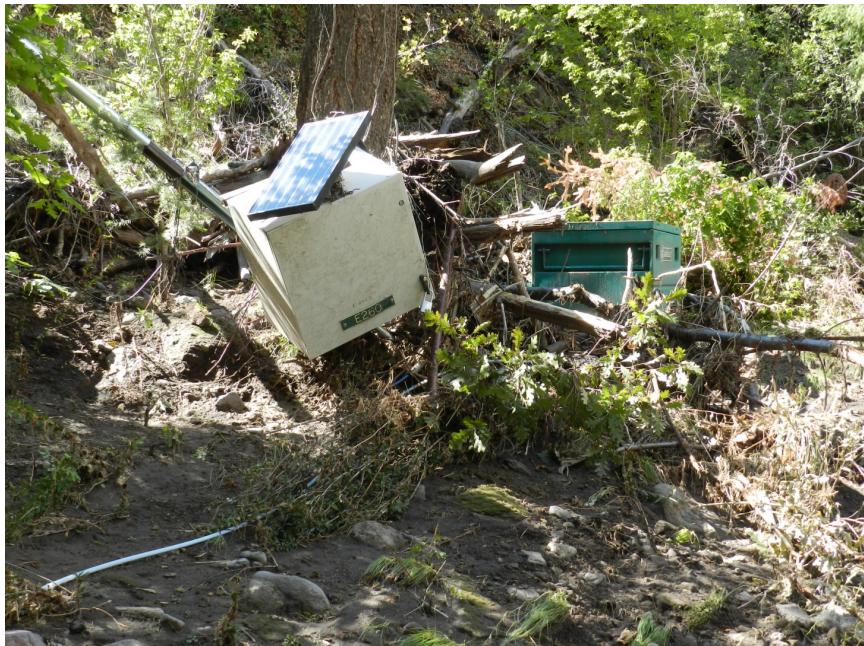
Figure 17 Damaged gage station in Water Canyon

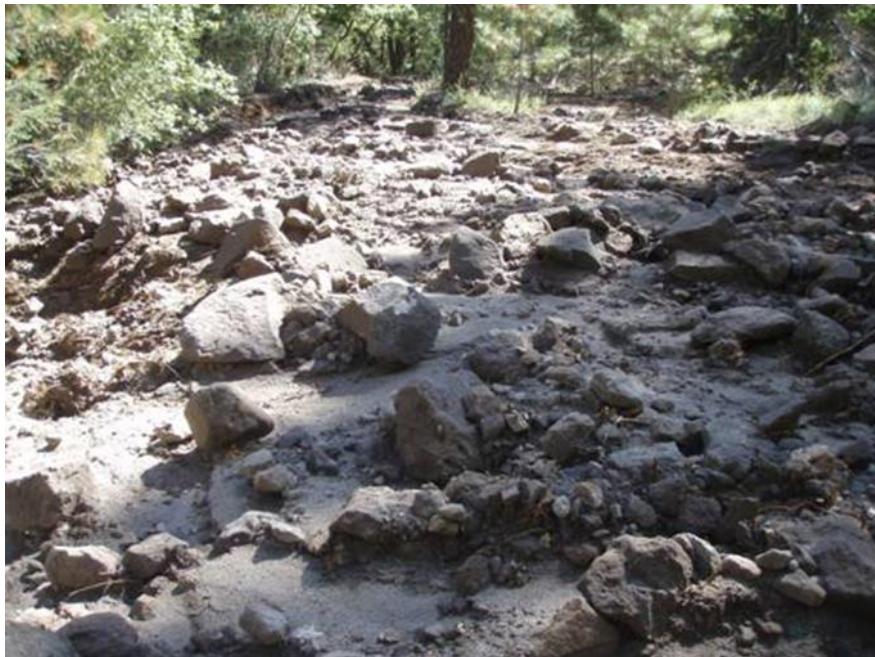
- Water Canyon access road is approximately 3.5 mi long from NM 4 to monitoring well CdV-37-1i and has 6 stream channel crossings. Significant damage to the road and stream crossings was observed. It is recommended that an assessment of rerouting the road out of the channel/flood plain and installation of up to three bridges be completed before any road repairs are undertaken. Temporary road repairs are required for access (\$840K).

Figure 18 Damaged access road in Water Canyon

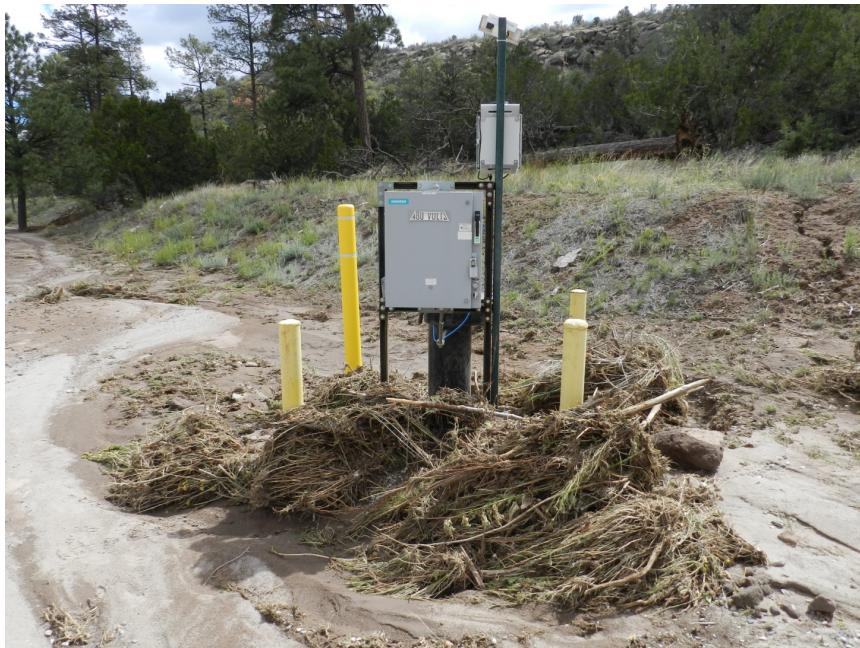
Figure 19 Flood debris at monitoring well R-11

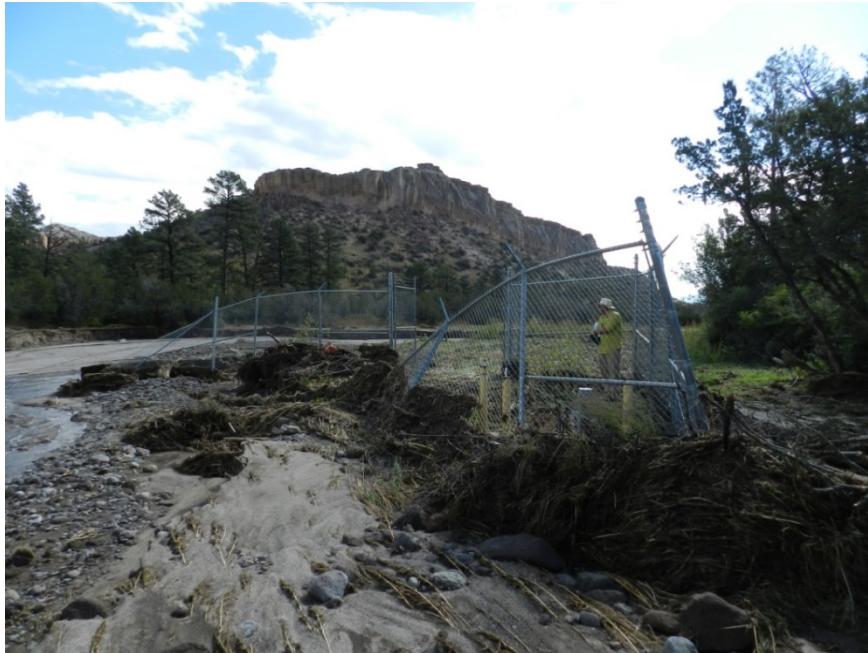
- 2 wells were identified with major damage
 - ❖ APCO-1: Alluvial monitoring well destroyed, large portion of pad eroded, and fence heavily damaged. Replace with new well, pad, and fence (\$80K)
 - ❖ MC0-3: Radioactive liquid waste discharge permit alluvial monitoring well destroyed. Replace with new well and pad (\$60K)

Figure 20 Damage to well APCO-1 and pad

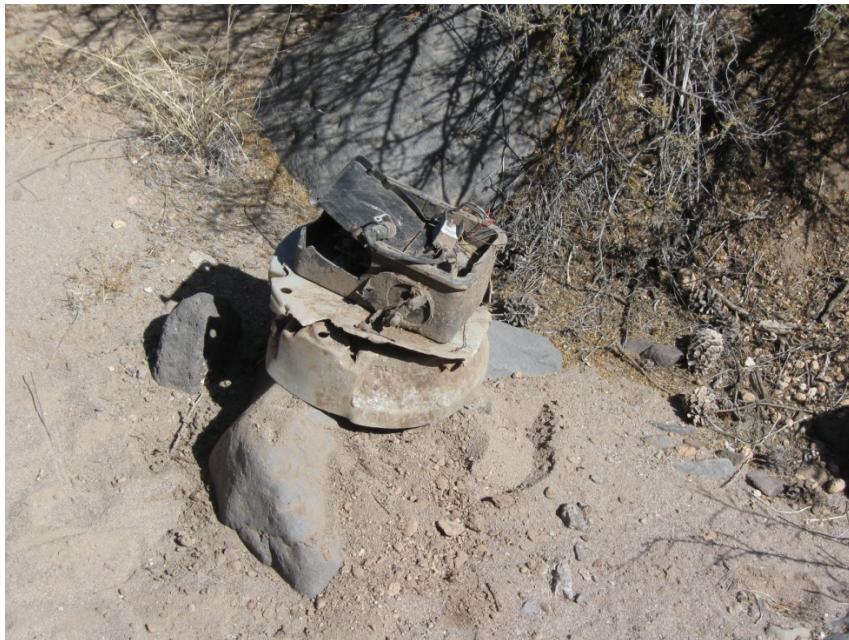
- 15 ISCOs were damaged and require repair (\$15K)
- 5 ISCOs were lost in the flooding (\$20K)

Figure 21 Damage to the top of an ISCO automated sampler
