# Field Testing of an Unvented Roof with Fibrous Insulation, Tiles, and Vapor Diffusion Venting

K. Ueno and J. W. Lstiburek  
*Building Science Corporation*

February 2016

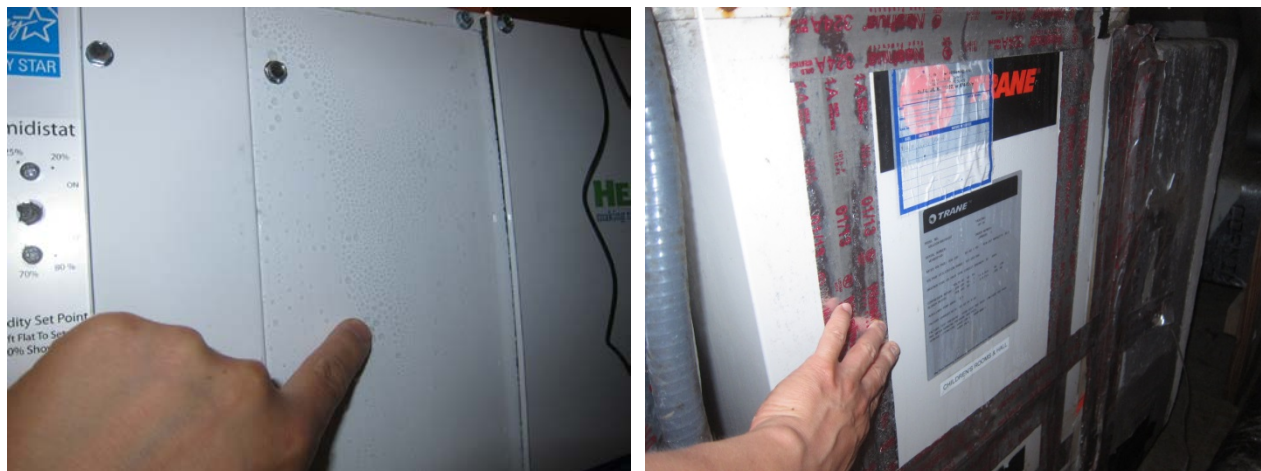
equipment surfaces compared with high-dew-point attic (essentially exterior) air (Figure 5). This condensation adversely affects durability of mechanical equipment over time.

**Figure 5. Condensation on HVAC equipment located in vented attic (CZ 2A)**

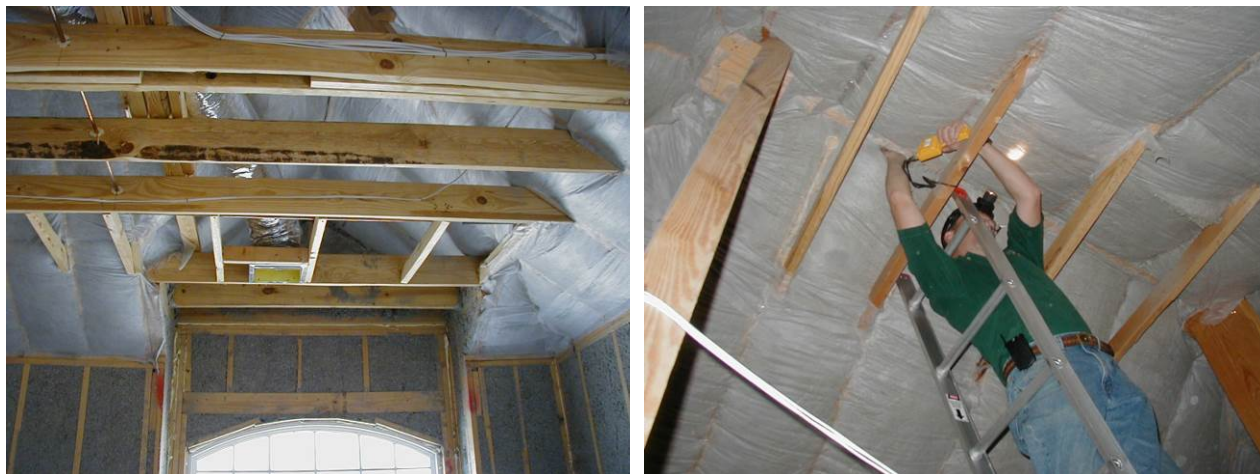
During the first fall of operation, the homeowner reported seeing reflections of moisture condensation and dripping from the ridge of the unvented attic from the interior. Site investigations (Figure 9, right) revealed elevated wood MCs at the ridge and evidence of previous condensation (such as rusted staples).

**Figure 9. Netted and blown cellulose roof insulation in Houston (left); MC at the roof ridge (right)**

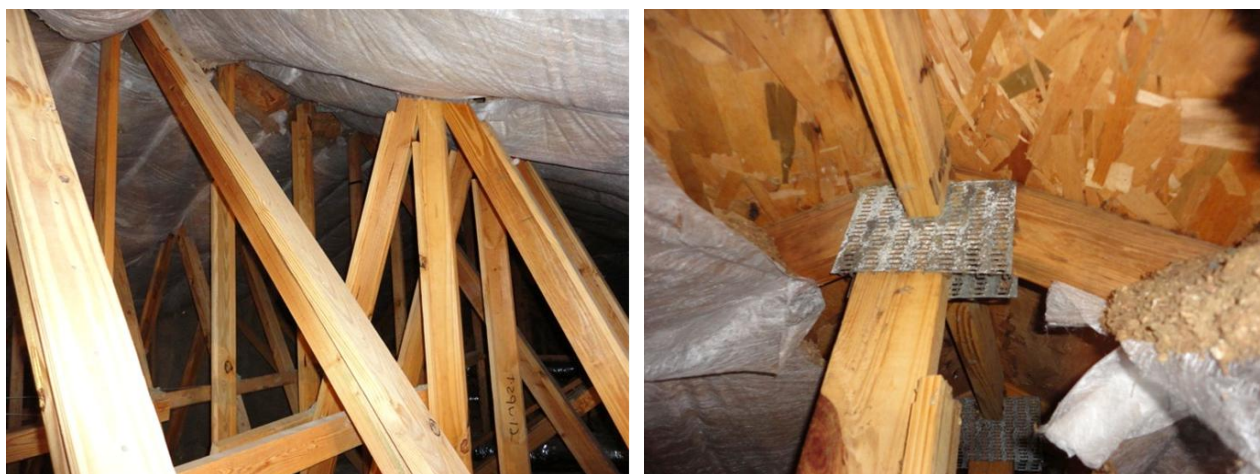
During a site visit, the cellulose and roof sheathing were wet to the touch, and the steel truss plate was corroded; however, the wood had not decayed. In response, the insulation was removed near the ridge (roughly 2 ft; Figure 10, right) to increase surface temperatures at the condensing roof sheathing surface. This roof has been rechecked over time (circa 2003 and as recently as March 2014); roof sheathing conditions remained dry with this assembly.

**Figure 10. Cellulose roof insulation in Jacksonville (left); corrosion of ridge truss plate (right)**

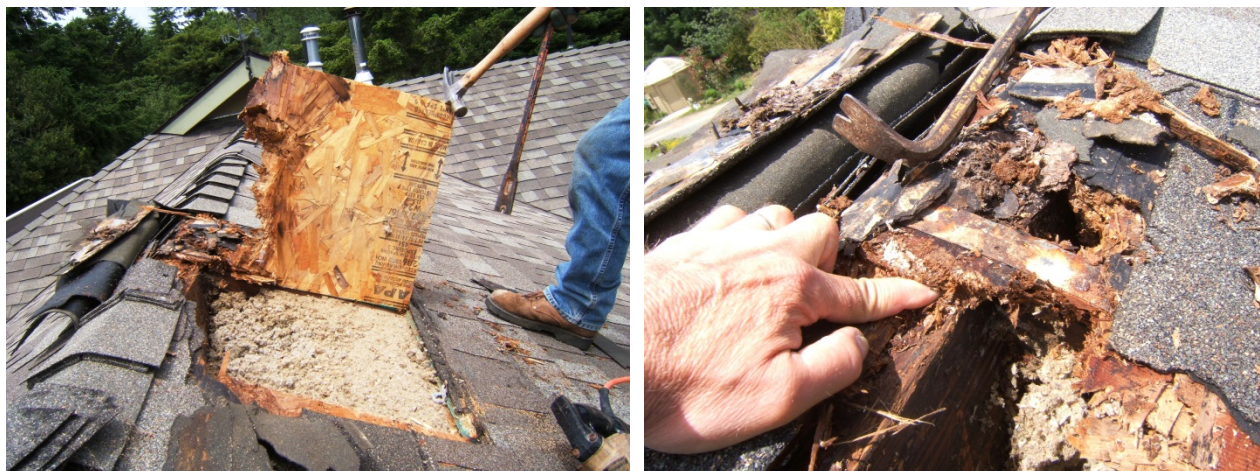
Moisture issues in unvented roof assemblies often manifest in the form of damage to the sheathing at the ridge of a sloped roof, colloquially known as *ridge rot*. An example is shown in Figure 11, which was a dense-pack cellulose roof in a northern California location (CZ 3C).

**Figure 11. Ridge sheathing degradation with dense-pack cellulose in northern California**

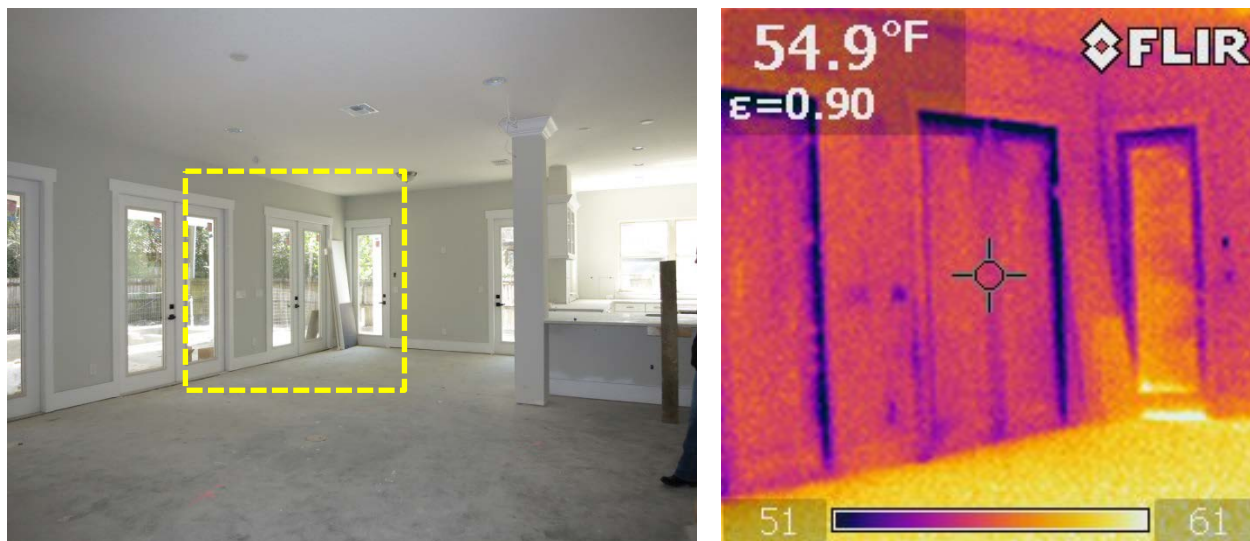
**Figure 36. Visual (left) and infrared (right) image during depressurization testing, showing door leakage**

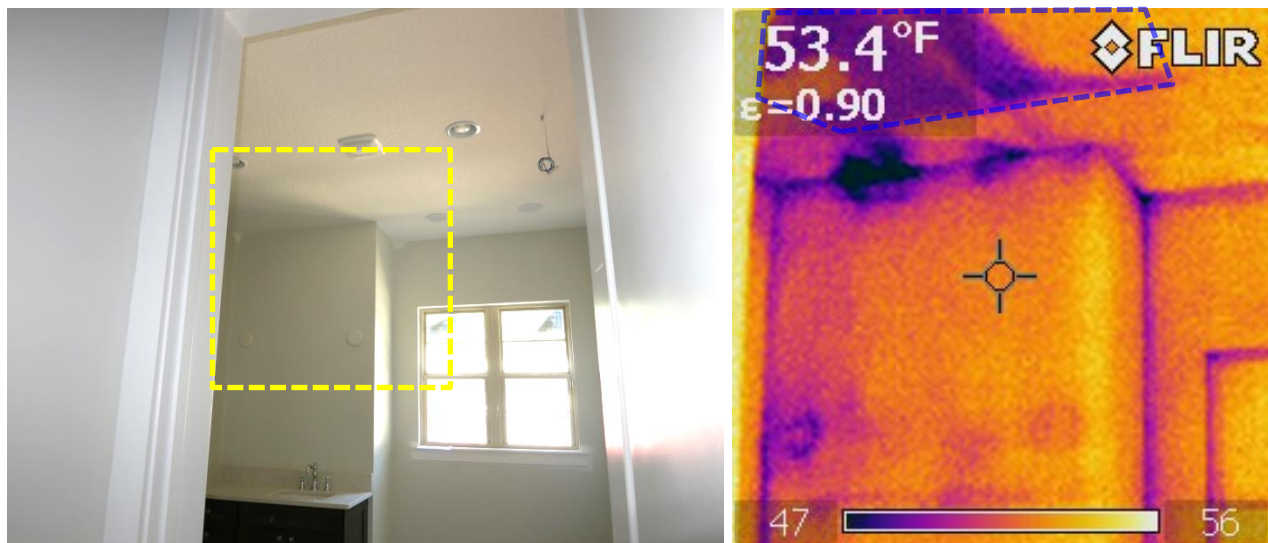
**Figure 41. Bathroom ceiling air leakage at roof-wall interface; water leak in blue (Location A)**

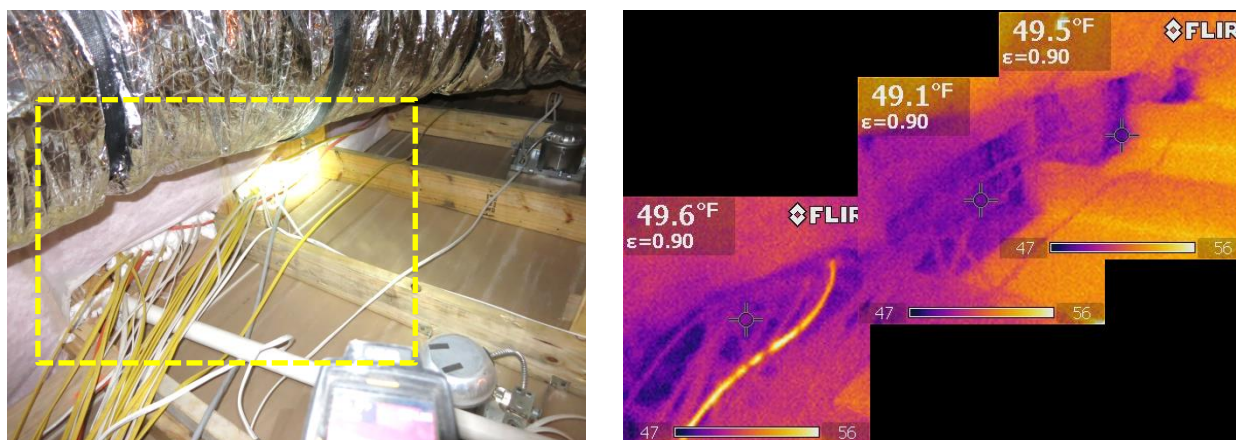
**Figure 43. Air leakage at wiring penetrations at garage wall-top plate (Location B)**

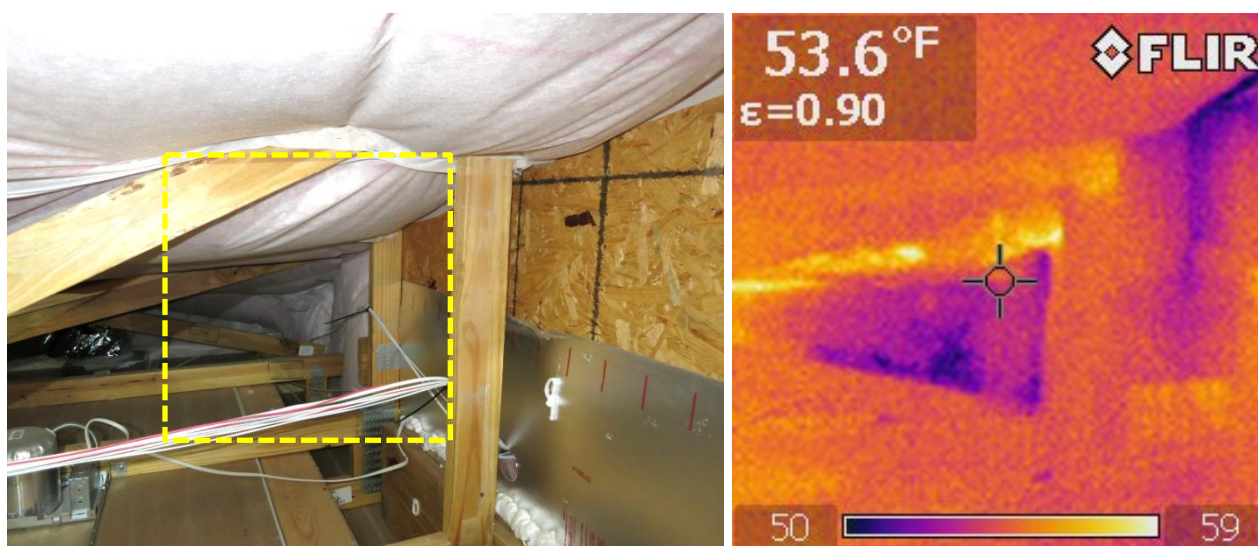
**Figure 45. Air leakage at roof-wall interface, and at unconditioned porch attic (Location D)**
