# Public Housing: A Tailored Approach to Energy Retrofits

J. Dentz, F. Conlin, D. Podorson, K. Alaigh,  
and T. Davis

February 2016

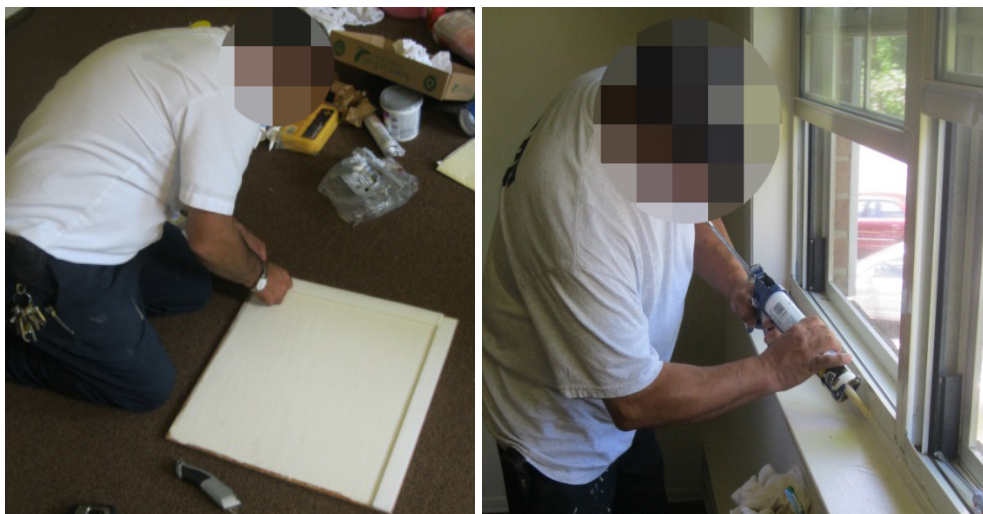
**Figure 4. Installing gasket on attic hatch (left); caulking gap around window (right) at IHA**

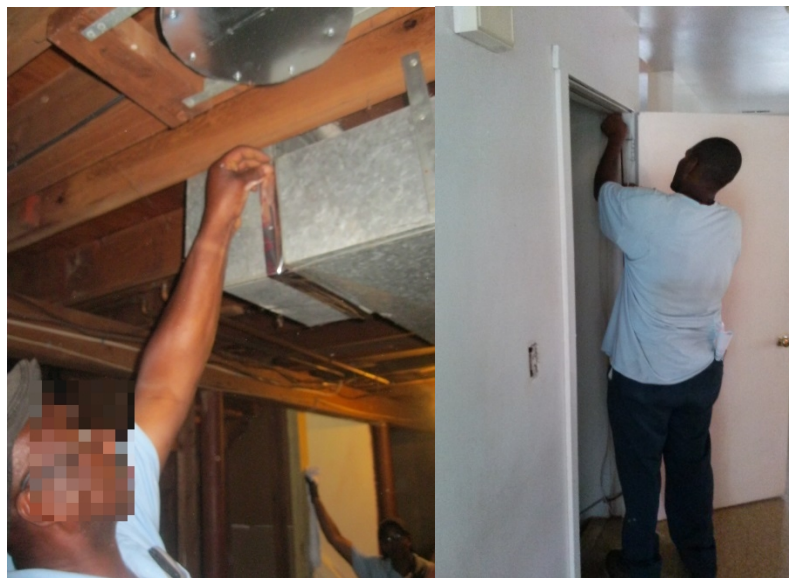
**Figure 17. Sealing ductwork with Underwriters Laboratories-181 tape (left); installing weather stripping on door to unconditioned basement (right) at NHA**

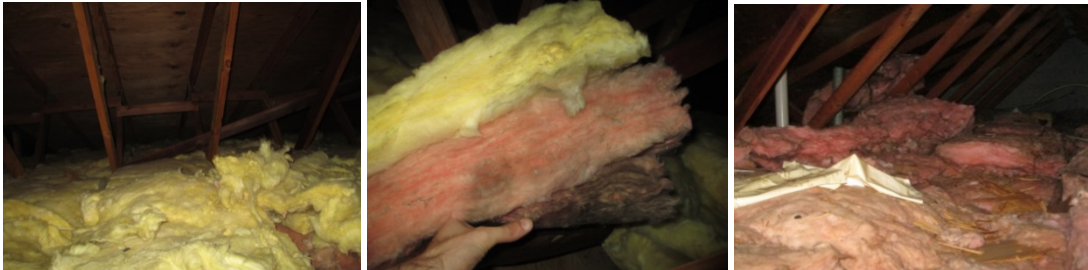
| | LOCATION | INSTRUCTIONS | MATERIALS | PHOTOS |
|---|---|---|---|---|
| | 20. Attic insulation depth and distribution | Check that ceiling insulation is dispersed evenly without gaps, is free of water damage, and covers rafters and other framing members fully to the exterior walls. Re-arrange insulation or supplement if necessary. | Flashlight, attic insulation | <p>Poor insulation condition:</p> |

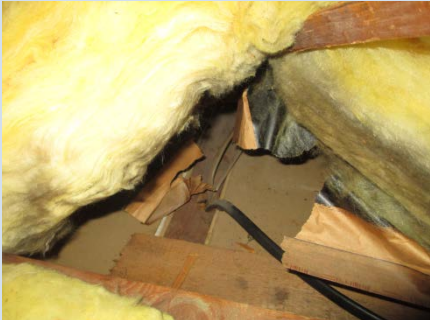
| | LOCATION | INSTRUCTIONS | MATERIALS | PHOTOS |
|---|---|---|---|---|
| | 21. Wall top plates intersection with attic | When/if replacing attic insulation over framed walls, foam penetrations where accessible. Also foam wire penetrations in top plates that are within reach. | Foam, flashlight | <p>Electrical penetration at top plate:</p> |
