Excess Fluxes and Defluxers: High Reliability Electronics Risk

Rochelle Piatt, Kim Archuleta and Walter Olson - Dept. 1832, Coatings and Surface Engineering

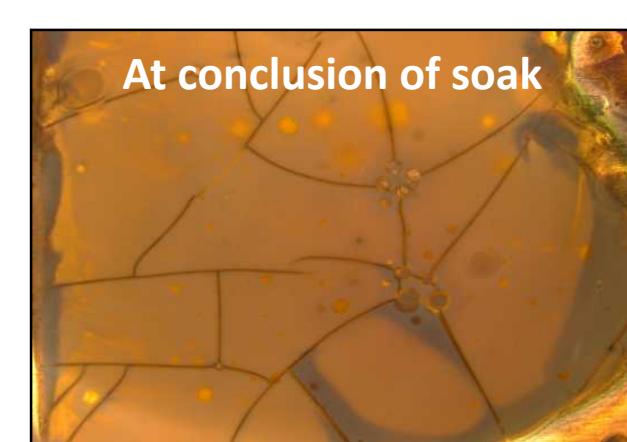
Figure 1: Case 1 Best of Low Temp; Kester 197 RMA, DI Water

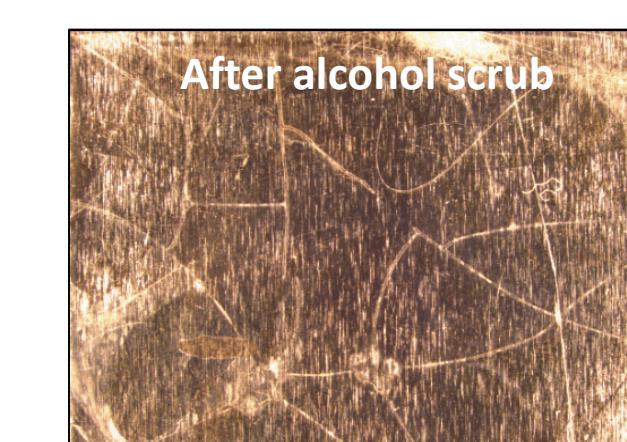
Figure 2: Case 1 Best of High Temp; Alpha NR330, Precision V

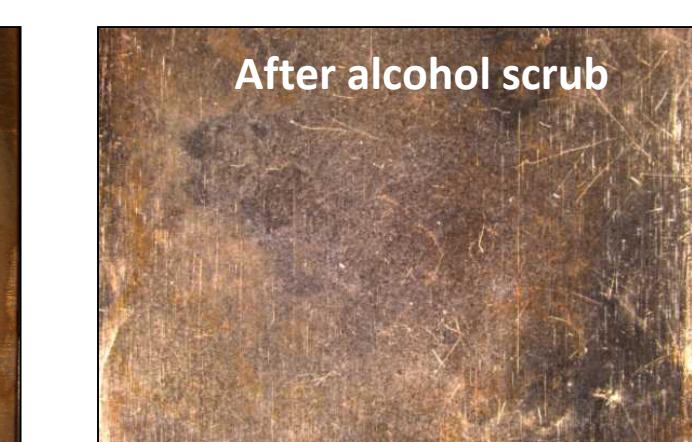
Figure 3: Case 1 Worst of Low Temp; Alpha NR330, Vigon N600

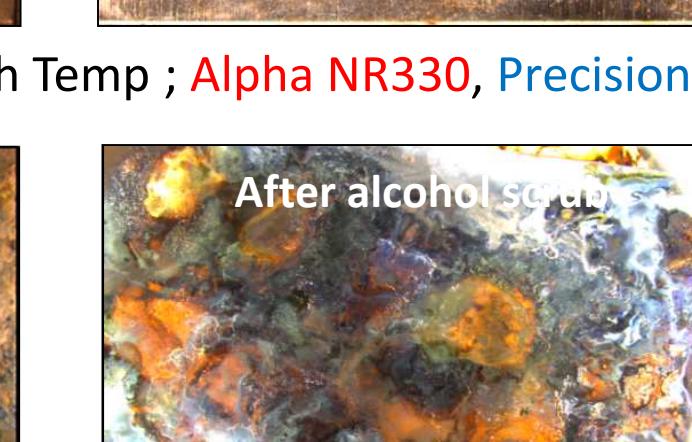
Figure 4: Case 1 Worst of High Temp; Kester 2331-ZX, Vigon N600

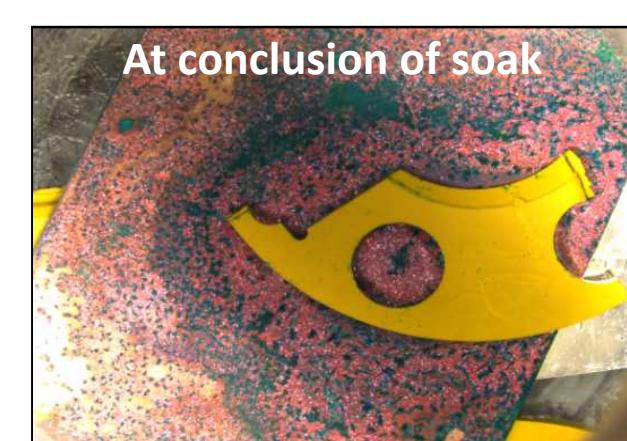
Figure 5: Case 2 Clean A, best 185 RMA, Vigon N600

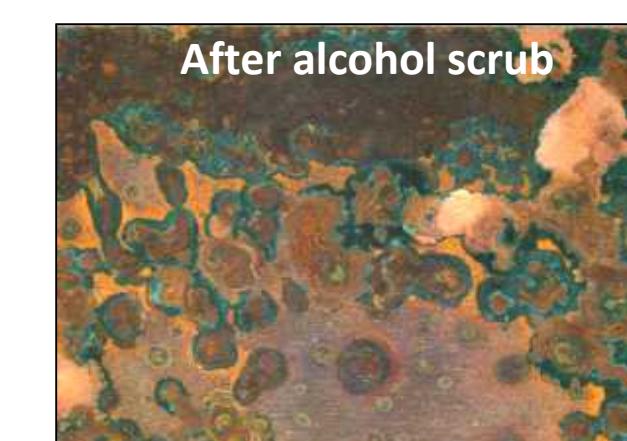
Figure 6: Case 2 Clean A, worst Kester 2331-ZX, Vertrel SDG

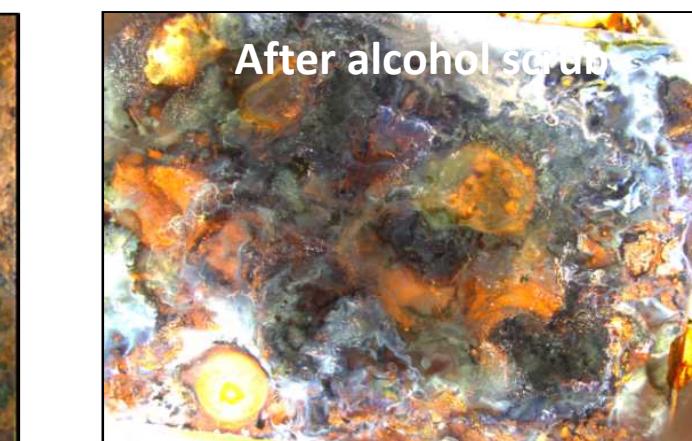
Figure 7: Case 2 Clean B, best 185 RMA, DI water

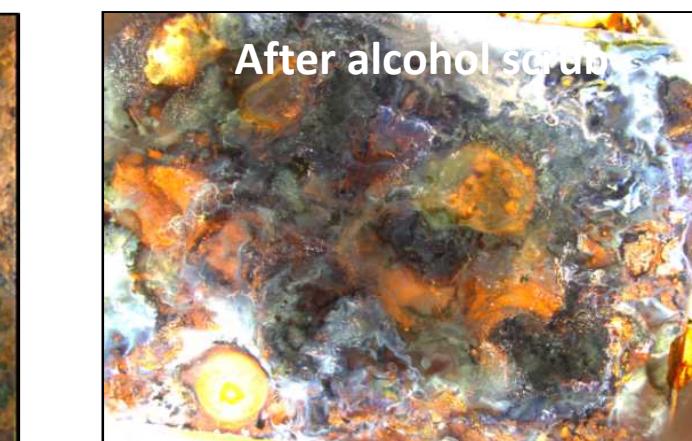
Figure 8: Case 2 Clean B, worst Kester 2331-ZX, AK-225
