THE ANNULAR CORE RESEARCH REACTOR ROD CONTROL MODIFICATION PROJECT

Sandia National Laboratories

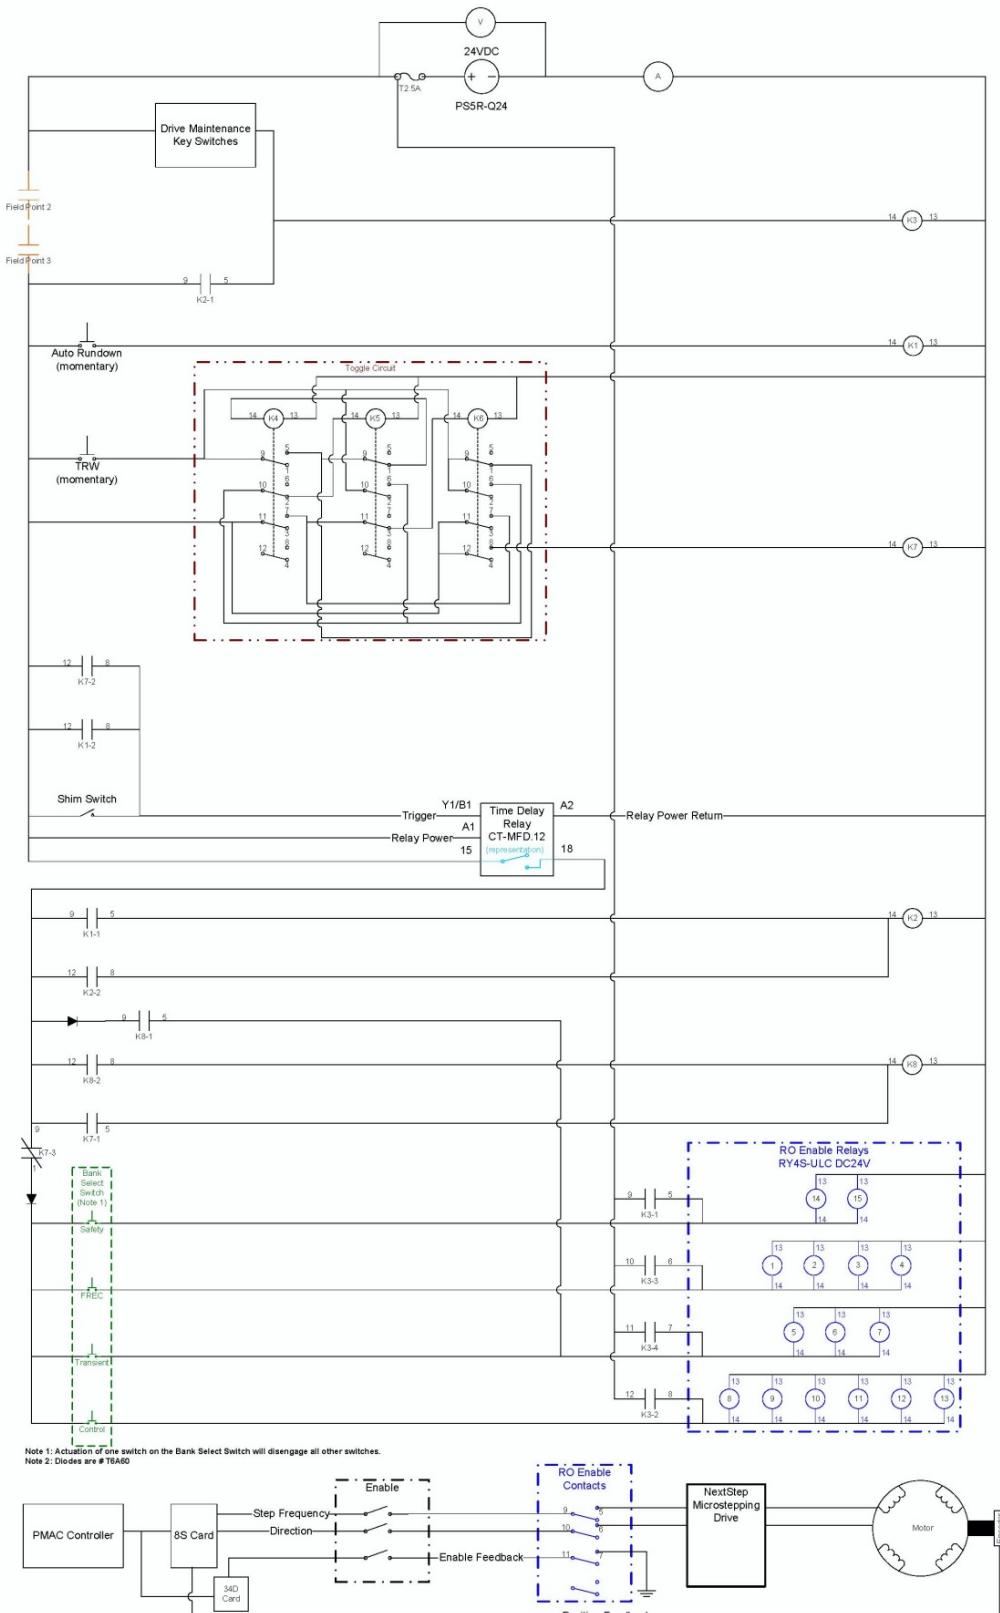
Figure 1: RO Enable Relay Circuit

The intention of this modification was to add a direct operator controlled relay between the PMAC and the motor. There was a new relay added in series between the existing PMAC controlled Allen-Bradley enable relay and the Next Step drive. There is a relay for each drive axis and the new relays are controlled by the reactor operator through the shim switch and the bank select switch. This only allows a motor’s relay to be energized (i.e. drive signals able to be sent to the motor) when the operator selects the bank the motor is in and moves the shim switch to the UP or DOWN position, except during ARDN, TRW MODE, and the new DRIVE MAINTENANCE keyswitch. The shim switch will default to the STOP or neutral position when the operator is not actively holding it in the UP or DOWN position, which will de-energize the new relays. The system of new relays only allows one bank of regulating rods to be enabled at a time except during ARDN and the DRIVE MAINTENANCE function. ARDN requires that all of the new relays be energized at once and the DRIVE MAINTENANCE function allows all the RO enable relays to be energized from the high bay so maintenance procedures can be conducted directly from the PMAC computer. The existing ARDN function will be rewired and re-programmed so that the reactor operator has to actively hold the button during the ARDN sequence. TRW MODE will remain operational by allowing the TRW CONNECT push button to energize the new relays for the TR. The RO Enable relay circuit is shown in detail in figure 1 below. A consequence of this modification will be the loss of automated SS functions (i.e. AUTO MODE and AUTO LEVEL). These features were removed from the Lab View and/or PMAC code.
