Multifamily Housing Rehabilitation Process Improvements

Marshall L. Sweet, Abby Francisco, and
Sydney G. Roberts
Partnership for Home Innovation

March 2016

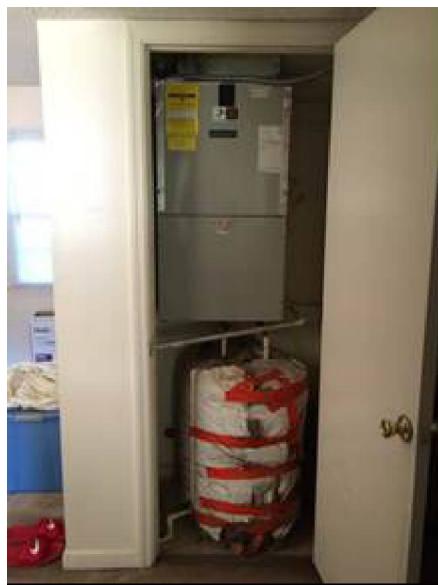
water heater is positioned directly below the air handling unit. The HVAC filter rack was positioned at the base of the air handler, making it difficult to visually inspect and to change the filter.

Figure 5. Mechanical equipment inside utility closet pre-rehabilitation

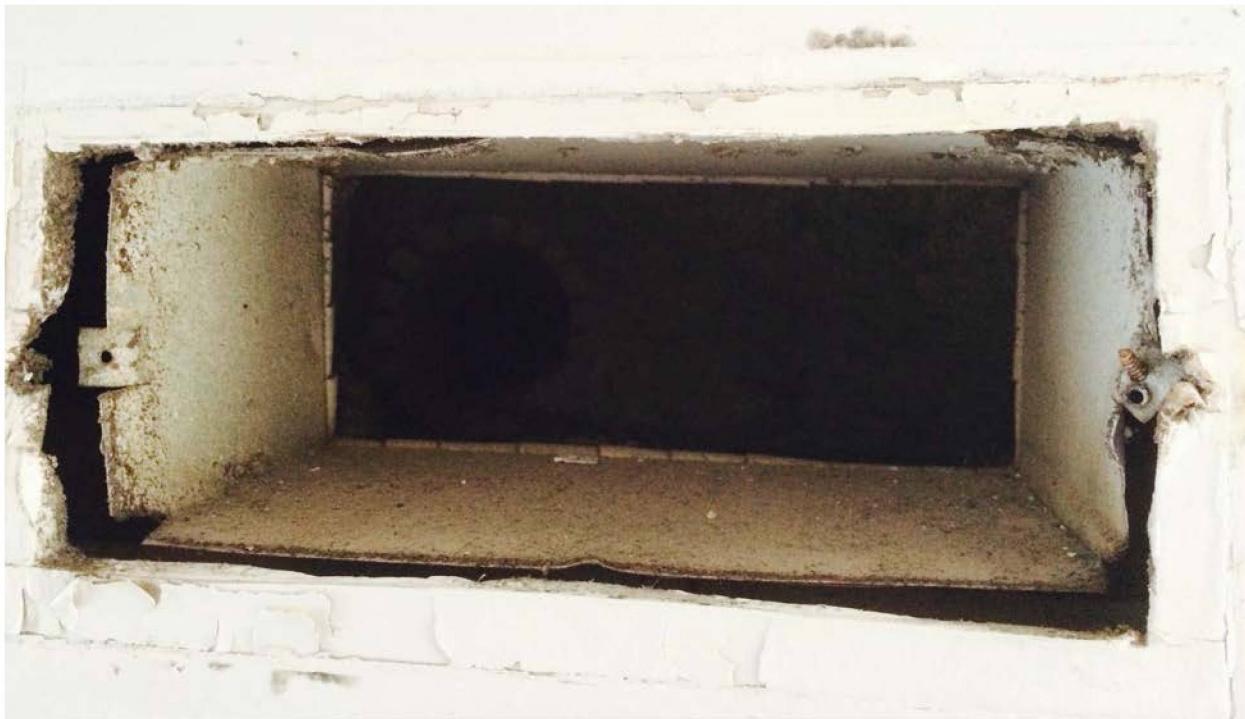
Figure 6. Duct boot not sealed to drywall

Within the SOW, the rehabilitation did not include enclosure air sealing, and none of the tradespeople made conscientious efforts to perform any air-sealing measures. However, replacing the windows and doors did reduce enclosure air leakage in most cases. Improved airtightness was included as a measure in the Beacon energy model and qualified the homes for utility rebates. During the test-out inspection at Hidden Creek, enclosure air leakage significantly increased at the first two units tested. The test-out inspection was halted so air-sealing measures could be performed to qualify the units for HEIP rebates. Although the average envelope leakage at each site decreased, the envelope leakage actually increased in several units. The increase is believed to have been caused from holes in the drywall behind the new kitchen cabinets. Figure 7 through Figure 9 show infrared images of air leakage through the enclosure while the building was depressurized. These images were taken in the winter, and the darker shading indicates cold surfaces where cold air from outside is being drawn in through leaks in the building enclosure.

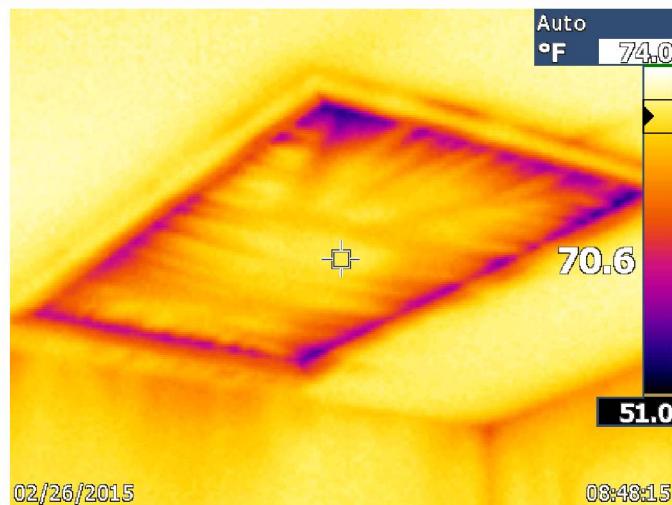
Figure 7. Thermal image of attic hatch when the induced building pressure is -50 Pa

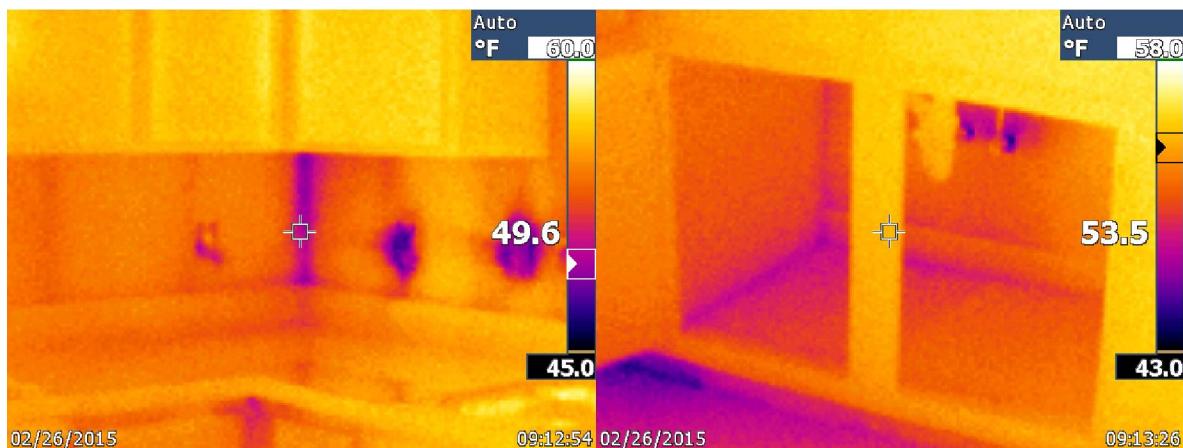
Figure 8. Penetrations in kitchen walls indicate the top plates were unsealed for light switches and outlets above kitchen counter (left); sink plumbing penetrations below counter (right)

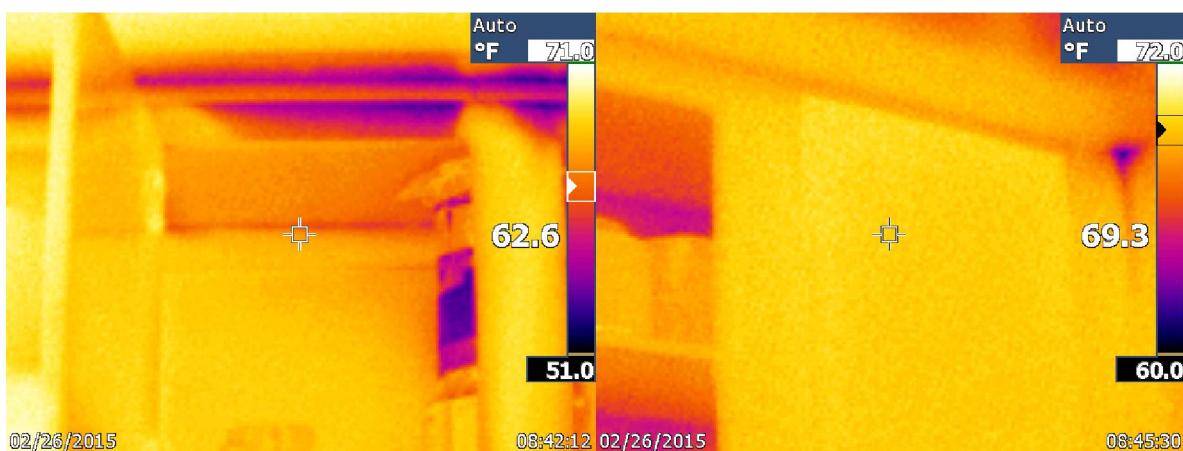
Figure 9. Thermal images of kitchen cabinets with doors open: above kitchen hood vent showing exhaust duct (left); open cabinet next to a closed cabinet (right)
