15th International ASTM/ESIS Symposium on Fatigue and Fracture Mechanics  
(40th National Symposium on Fatigue and Fracture Mechanics)  
May 20-22, 2015, Anaheim, CA

### *Cracking in a Flame-Sprayed Epoxy*

### **Abstract Summary**

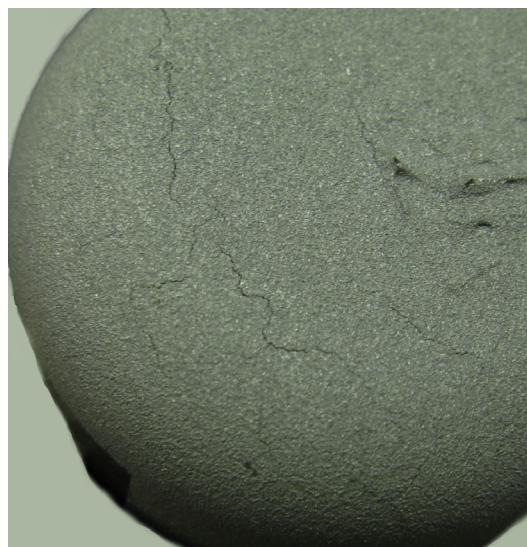
We first noticed damage imparted by flame spray on an epoxy substrate in electrical experiments involving flame-sprayed epoxy cylinders. In all of these tests, the cylinders were temperature-cycled and electrically tested. In some cases, cracking in the flame spray was noted. In one round of tests, epoxy cylinders coated in aluminum flame spray were temperature-cycled 60 times from room temperature down to -55 °C with a 5-hour dwell at the temperature extremes to saturate the cylinder. After the series of tests had finished, cracking in the flame spray was visible with the naked eye. See Figure 1. An adhesion test was done on the resulting cracks to show that the region around the cracks had delaminated from the epoxy substrate. The adhesion test involved placing a piece of tape on a non-cracked region to show that it would not peal of the epoxy. The same type of tape was then stuck to the cracks in Figure 1 to show that the flame spray peals off around the cracks.

Figure 1: A photo of the cracks in the flame spray of the epoxy cylinder that was taken to -55° C 60 times.

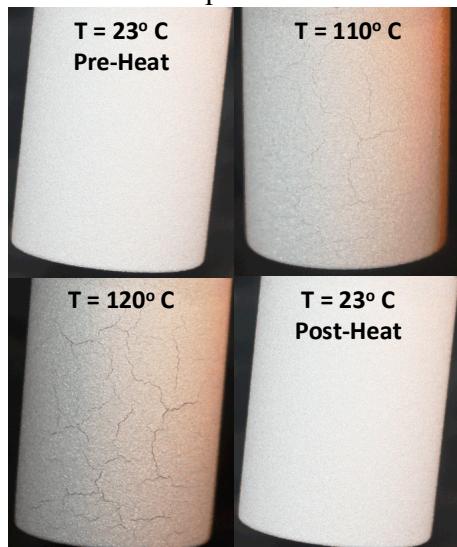
The first experiment was done to identify a temperature at which tensile cracking occurs in a flame-sprayed 826-CTBN (DEA) cylinder and verify that the cracking propagates into the epoxy. After the flame spray process, the cylinders were heated at a rate of approximately 2 °C/min and visually inspected through a window in the heating chamber for cracks. The first inspection occurred at the post-gelation cure temperature of 70 °C, which corresponds to the glass transition temperature of the epoxy. Additional inspections were made in 20 °C increments. Faint cracking was observed at 90 °C. At 110 °C, the cracking in the flame spray had progressed to such a point that it could be captured with a camera. The cylinder was further heated to 120 °C and soaked at for 4 hours to reach thermal equilibrium. After the high temperature soak the cylinder was cooled back down to room temperature. After the temperature cycling, cracks could not be seen with the naked eye on the surface of the flame spray (Figure 4). The cylinder was cross-sectioned and examined under an optical microscope; cohesive cracks were found in the epoxy that were approximately 1 mm long. Each of the cohesive cracks in the epoxy corresponded to a surface crack in the flame spray, but every surface crack did not correspond to cohesive cracking. No cracks were detected in the control cylinder that was sand blasted but not flame sprayed when subjected to the same temperature environments.

Figure 4: Photographs of the same flame-sprayed 826-CTBN (DEA) epoxy cylinder at different temperatures to show how cracking varied.

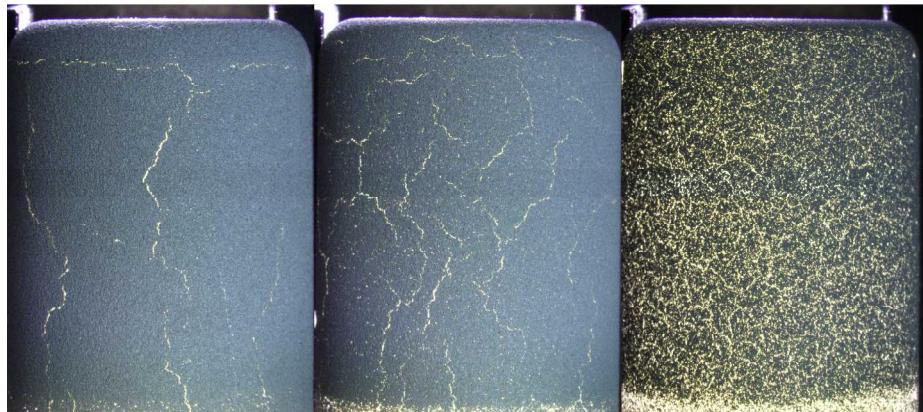
Each of the cylinders described above were cross-sectioned and illuminated to show cracks that would otherwise be invisible to the naked eye at room temperature. The illuminated cross-sections for the 100 °C samples in Figure 5 and the 155 °C samples in Figure 6 look similar. The thick samples have less cracks in the flame spray, although the cracks open wider when the cylinders are taken to temperature. The crack pattern observed in the thicker specimens is less connected than that of the nominal case. The cylinder with the nominal coating taken to 155 °C has more channel cracks than the equivalent specimen that was only cycled to 100 °C. The twice nominal coating has nearly the same number of flame spray cracks at 100 °C as it does at 155 °C. The half nominal cylinder has a low enough splat density of the flame spray that the light shines through.

**Figure 5:** Optical image of the cracks in the twice nominal (left), nominal (middle), and half nominal (right) with cracks at room temperature that resulted from heating to 100 °C. The cracks are seen by shining a light through the epoxy substrate; they are not visible at room temperature otherwise.

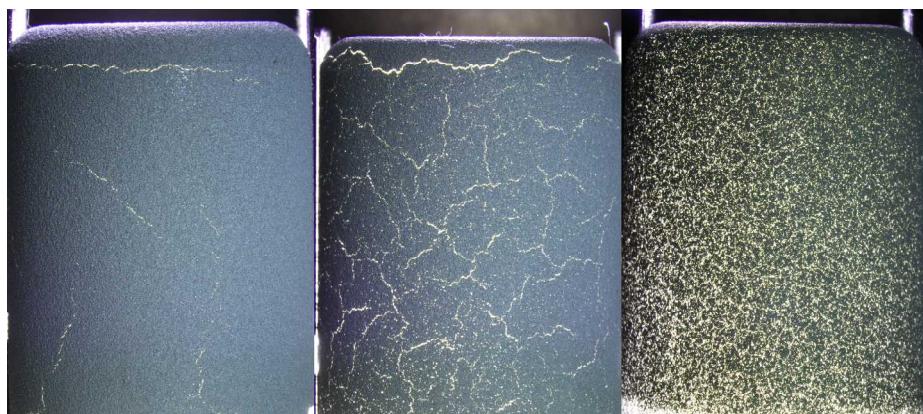
**Figure 6:** Optical image of the cracks in the twice nominal (left), nominal (middle), and half nominal (right) with cracks at room temperature that resulted from heating to 155 °C. The cracks are seen by shining a light through the epoxy substrate; they are not visible at room temperature otherwise.

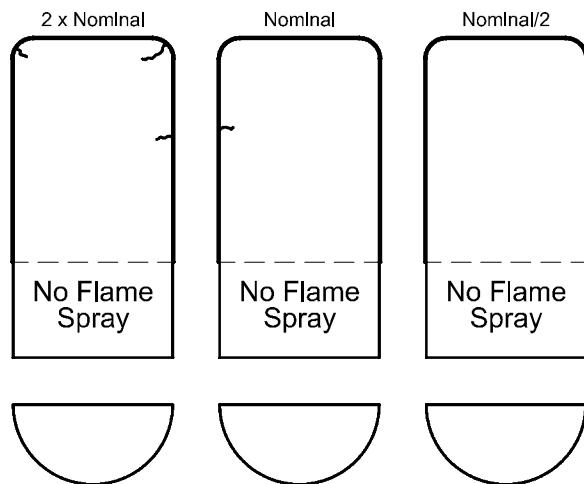
The epoxy side of the cross-sectioned cylinders was examined for cohesive substrate cracks with an optical microscope. The entire perimeter of each cylinder was inspected and charted in Figure 7 and Figure 8. The cylinders that were taken to 100 °C had only 1 cohesive crack in the nominal case and 3 cracks in the twice nominal case. In contrast, the cylinders that were taken to 155 °C had 8 substrate cracks on the twice nominal case and 5 cracks on the nominal case. There were not cracks on the half nominal in any set. Although the cracks in Figure 7 and Figure 8 are not drawn exactly to scale, their relative size and direction are representations that can be used for comparison. The longest observed crack (Figure 9) occurred in the twice nominal case taken to 155 °C.

**Figure 7: A chart showing the locations of epoxy cracks as observed with a microscope on the cross-sectioned surface after being heated to 100 °C .**

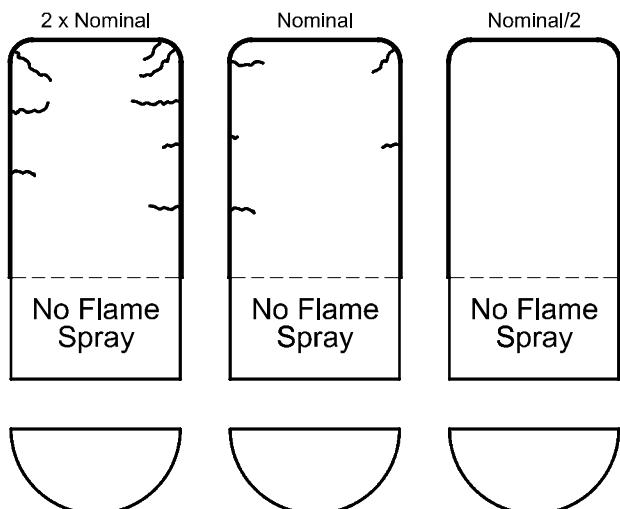
**Figure 8: A chart showing the locations of epoxy cracks as observed with a microscope on the cross-sectioned surface after being heated to 155 °C .**

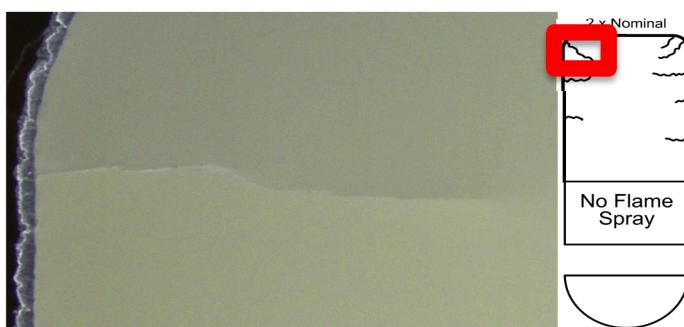
**Figure 9: Optical microscope image of a cohesive crack near the top right fillet of the twice nominal cylinder taken to 155° C.**
