Failure and Repair of the Mach 5 Heater for Sandia's Hypersonic Wind Tunnel

**Engineering Sciences Center
Sandia National Laboratories
Albuquerque, NM, U.S.A.**

**STA1 105th Meeting
14-16 May, 2006
St. Paul, MN**

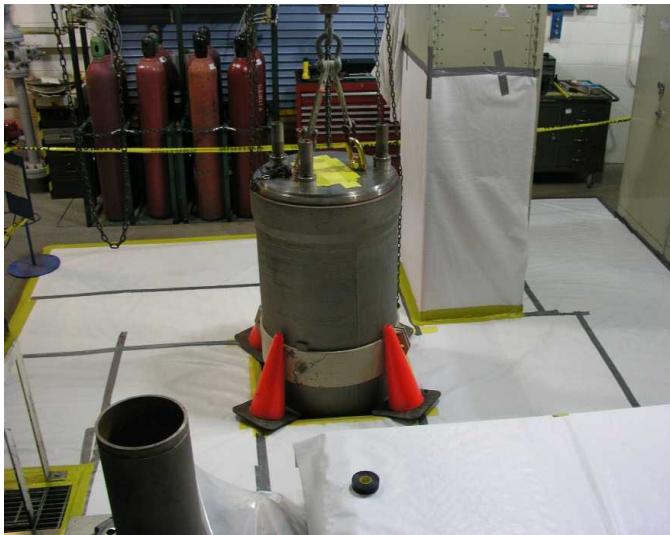
As the heater was hoisted out of its pressure vessel, it was quickly obvious that this was not simply a screen rupture.

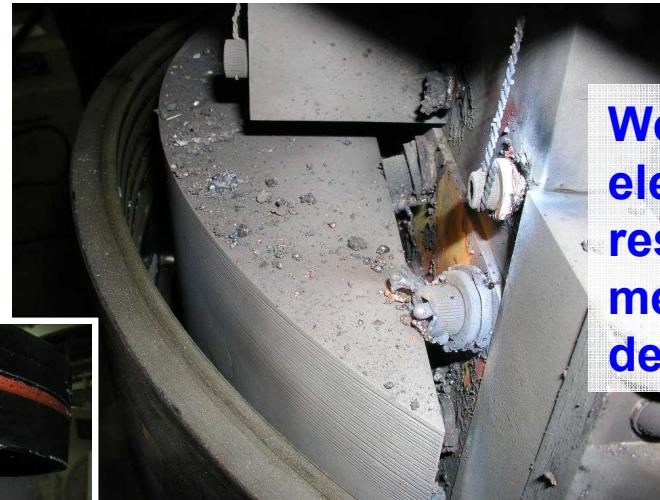
We found marks from electrical scorching, residue of slagged metals, and melted and deformed bolt heads.

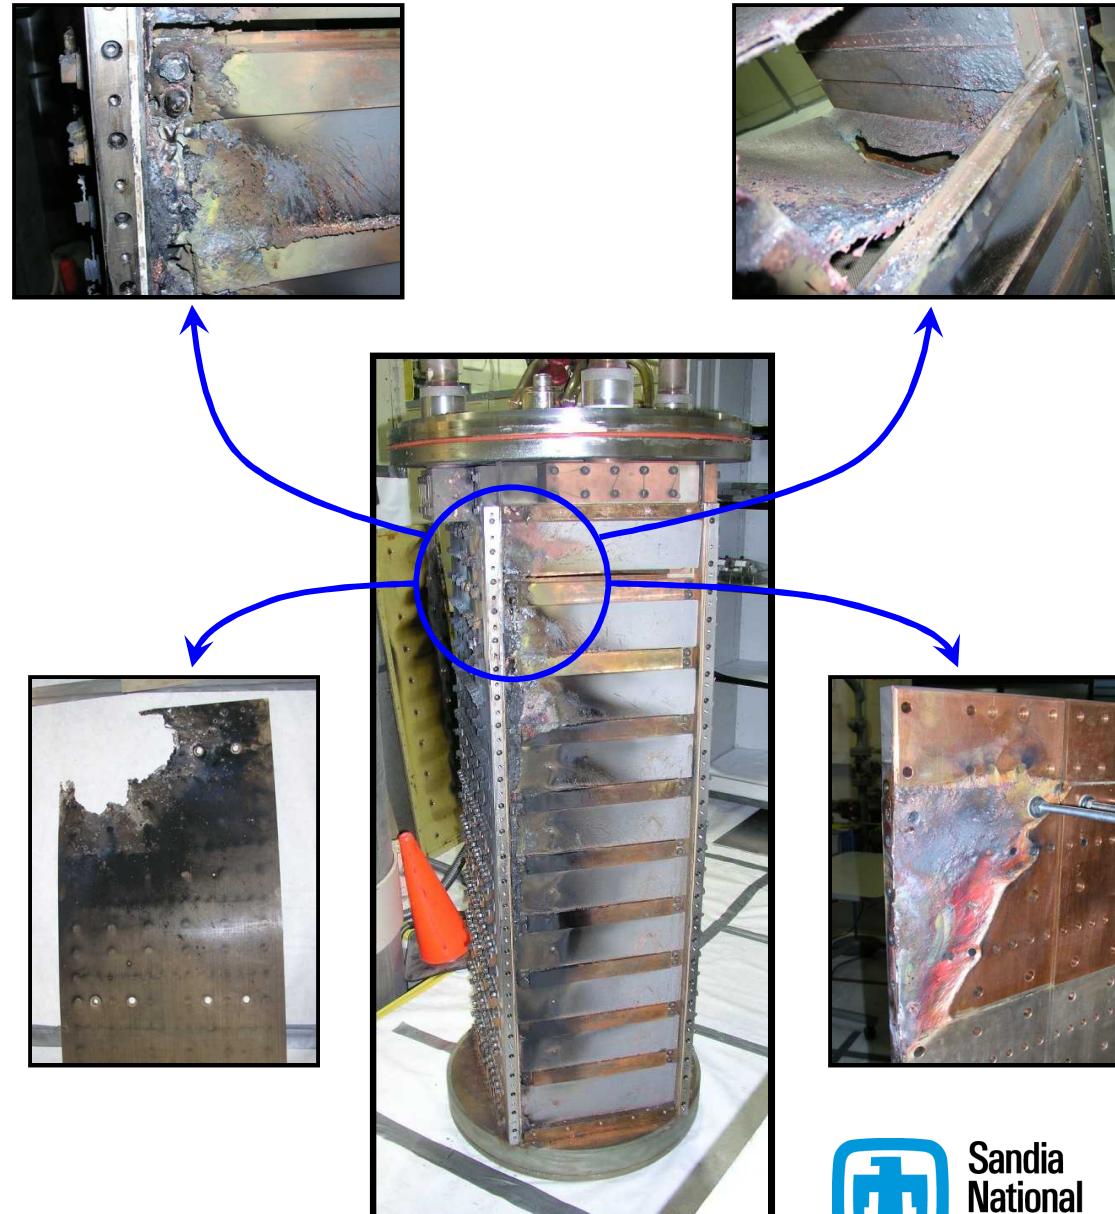
- Copper blocks eroded to $\frac{1}{2}$ " depth
- Shattered glass insulators
- Multiple torn screens
- Insulation breach
- Metal debris, molten copper, and carbon dust deposited on components

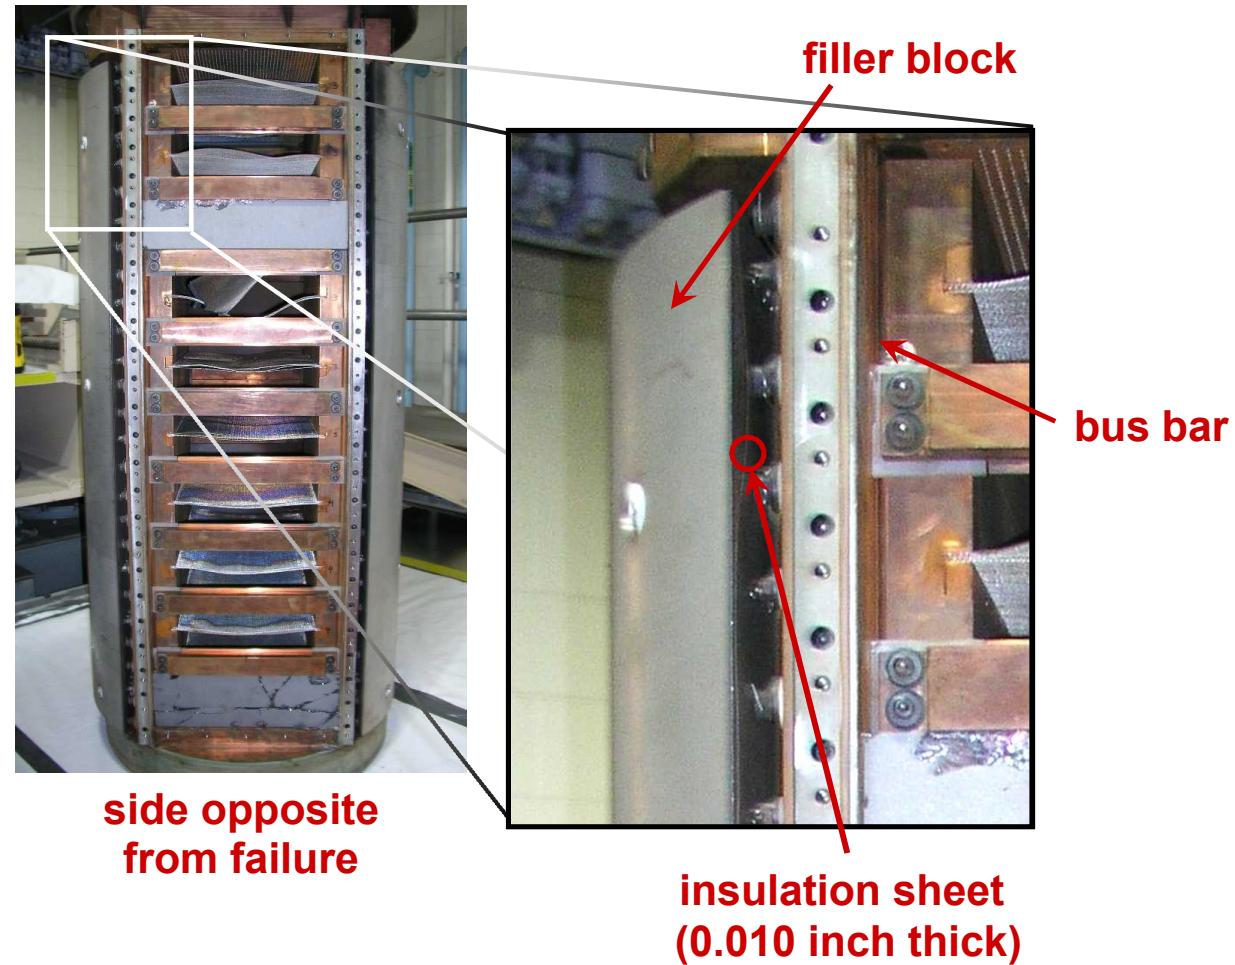
A sheet of teflon fiberglass laminate insulates between bolts through the bus bars and a filler block at floating potential.

The insulation has a small degree of freedom to flutter in this gap.

Our leading theory is that the insulation wore through after years of cycling. This allowed the filler block to make contact with two phases.

Replace the thin insulation whose breach is believed to have initiated the failure

- Use a thicker sheet of G10 fiberglass laminate
- Plane the filler block to create space

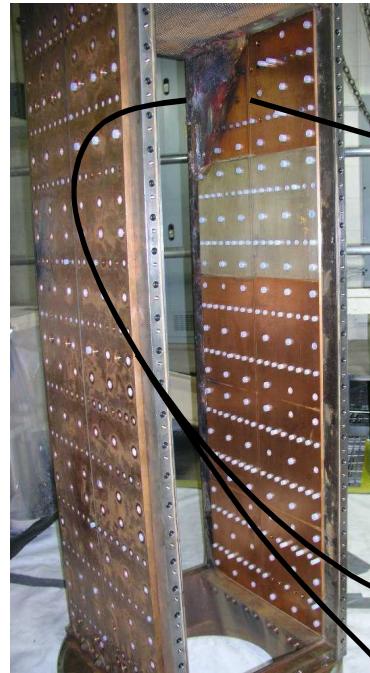
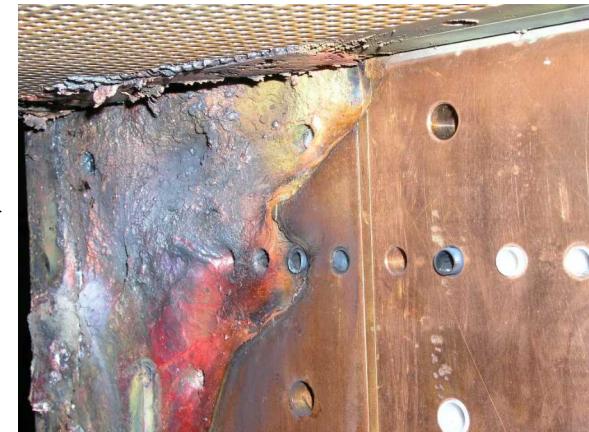
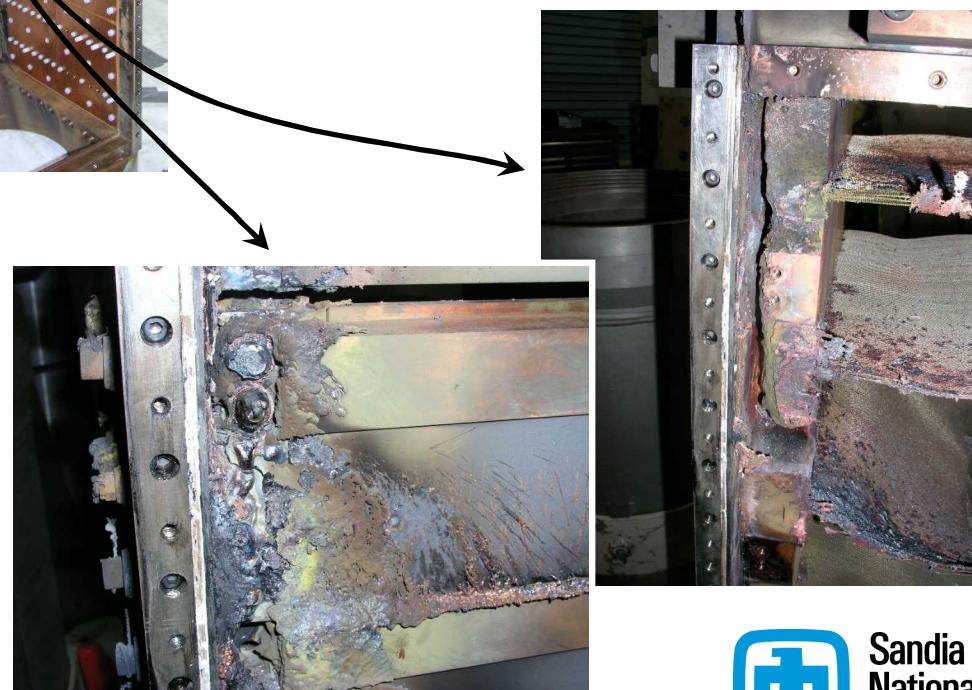
Contact between electrical phases created I^2R heating.

This melted portions of the copper bus bar and the adjacent screen blocks.

Erosion depths reached 0.5 inch.

Steel bolts melted and deformed.

Molten copper flowed downstream.

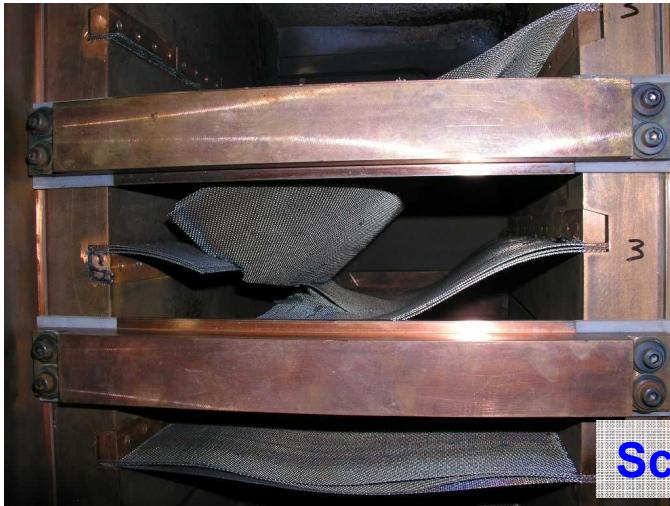
Screens were torn.

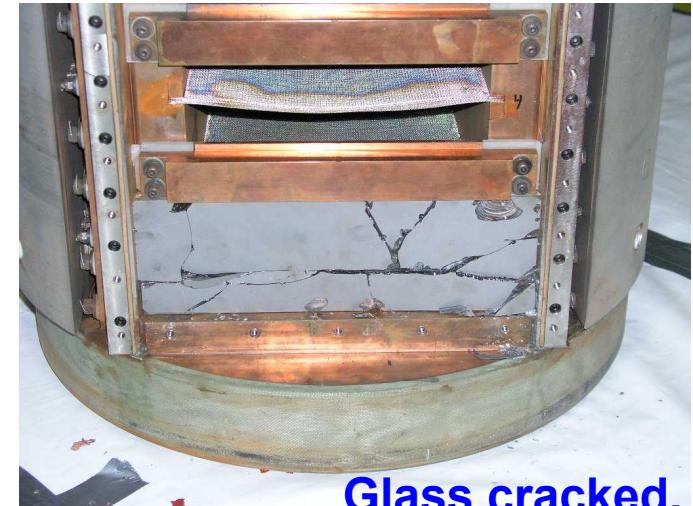
Glass cracked.

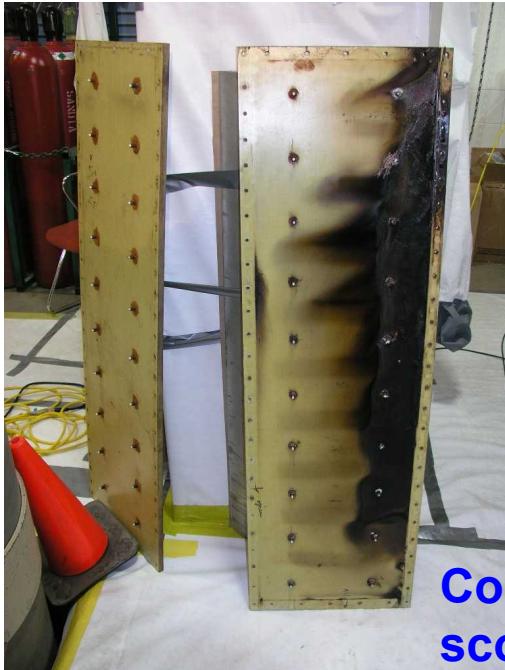
Components were scorched.

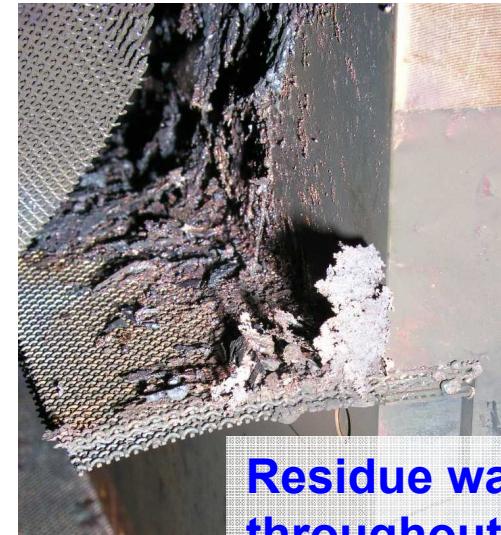
Residue was deposited throughout the heater.

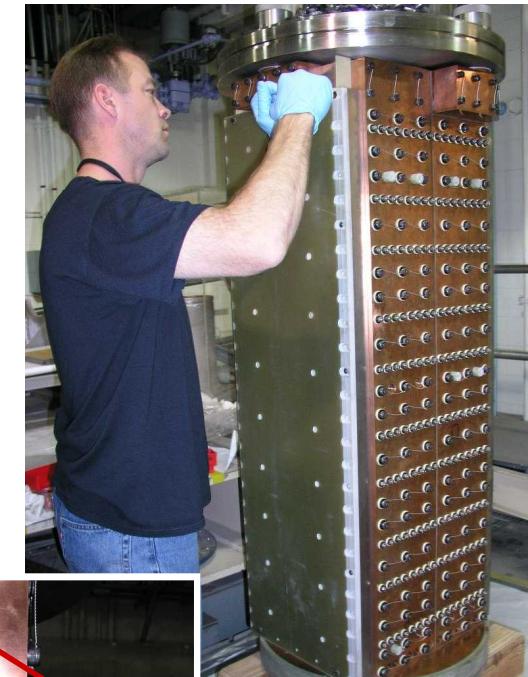
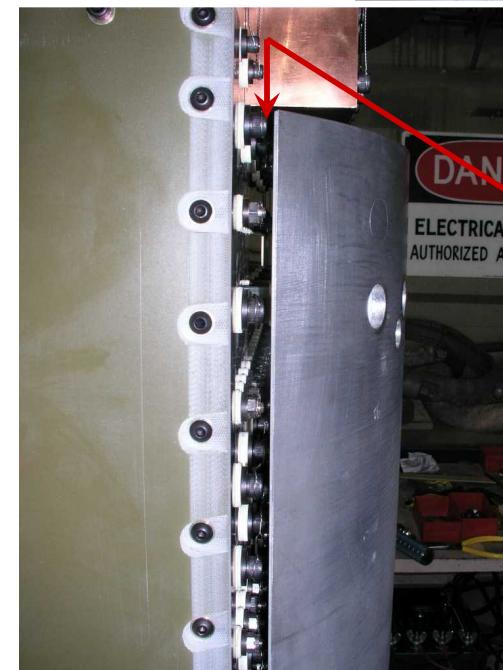
- Stray bits of metal punctured thin sheets of glass-fiber insulation and created shorts

A whole lot of cleaning!
