# Defect Characterization for Material Assurance in Metal Additive Manufacturing

Bradley Jared, Brad Boyce, Jon Madison,  
Jeff Rodelas, Brad Salzbrenner

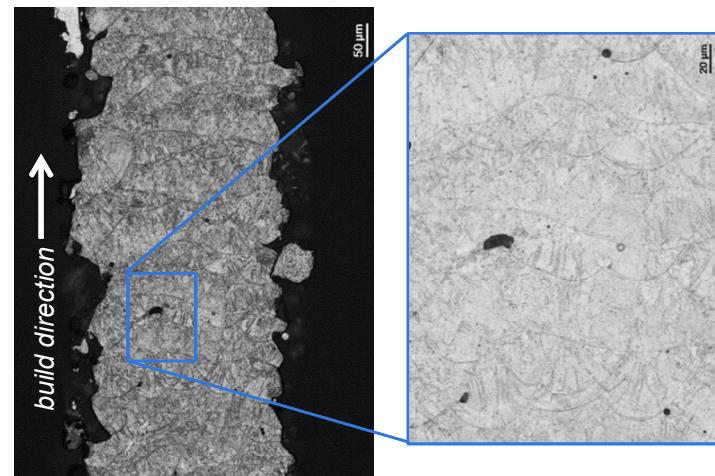
defects in 17-4 PH w/ 0.015" nominal wall thickness

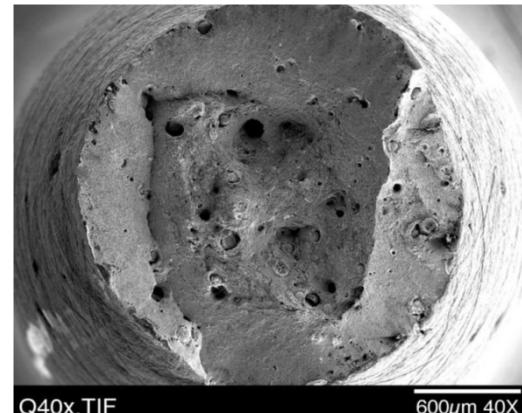
ductile fracture initiated by LENS® defects in PH13-8Mo\*

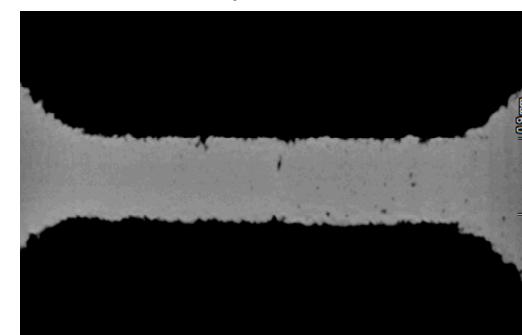
CT of 17-4PH dogbone sample

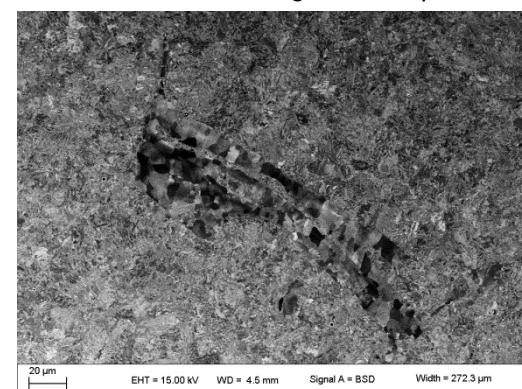
untransformed Martensite in 17-4PH

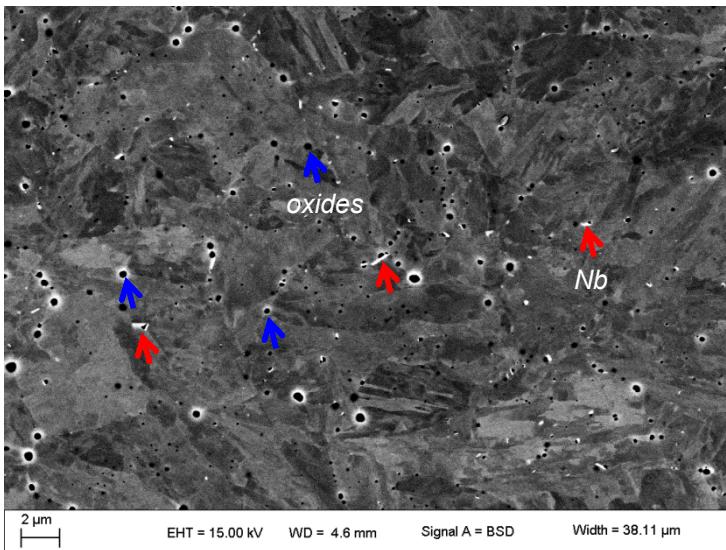
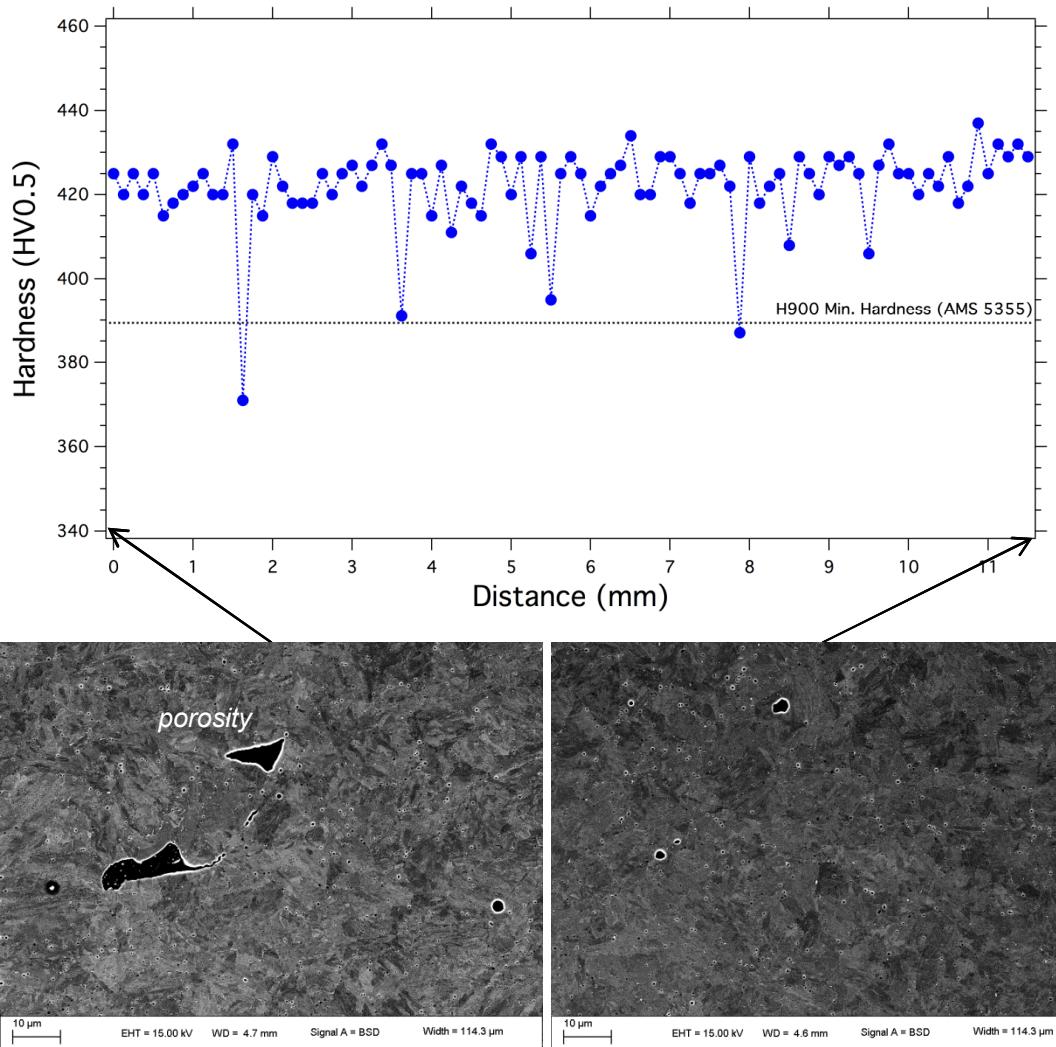
- Consistent w/heat treated 17-4
  - fine scale martensite
  - sub-micron **oxides**
  - **Nb-rich** intergranular phase
- No variation in microhardness or microstructure along build height

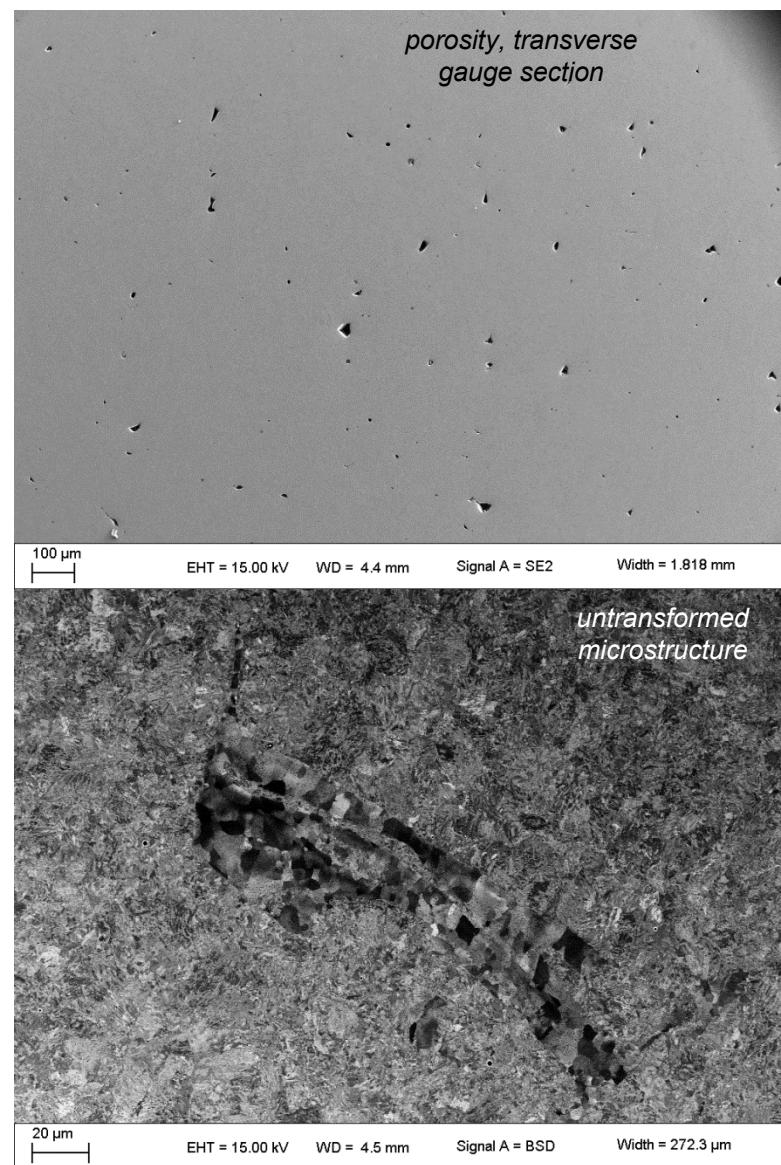
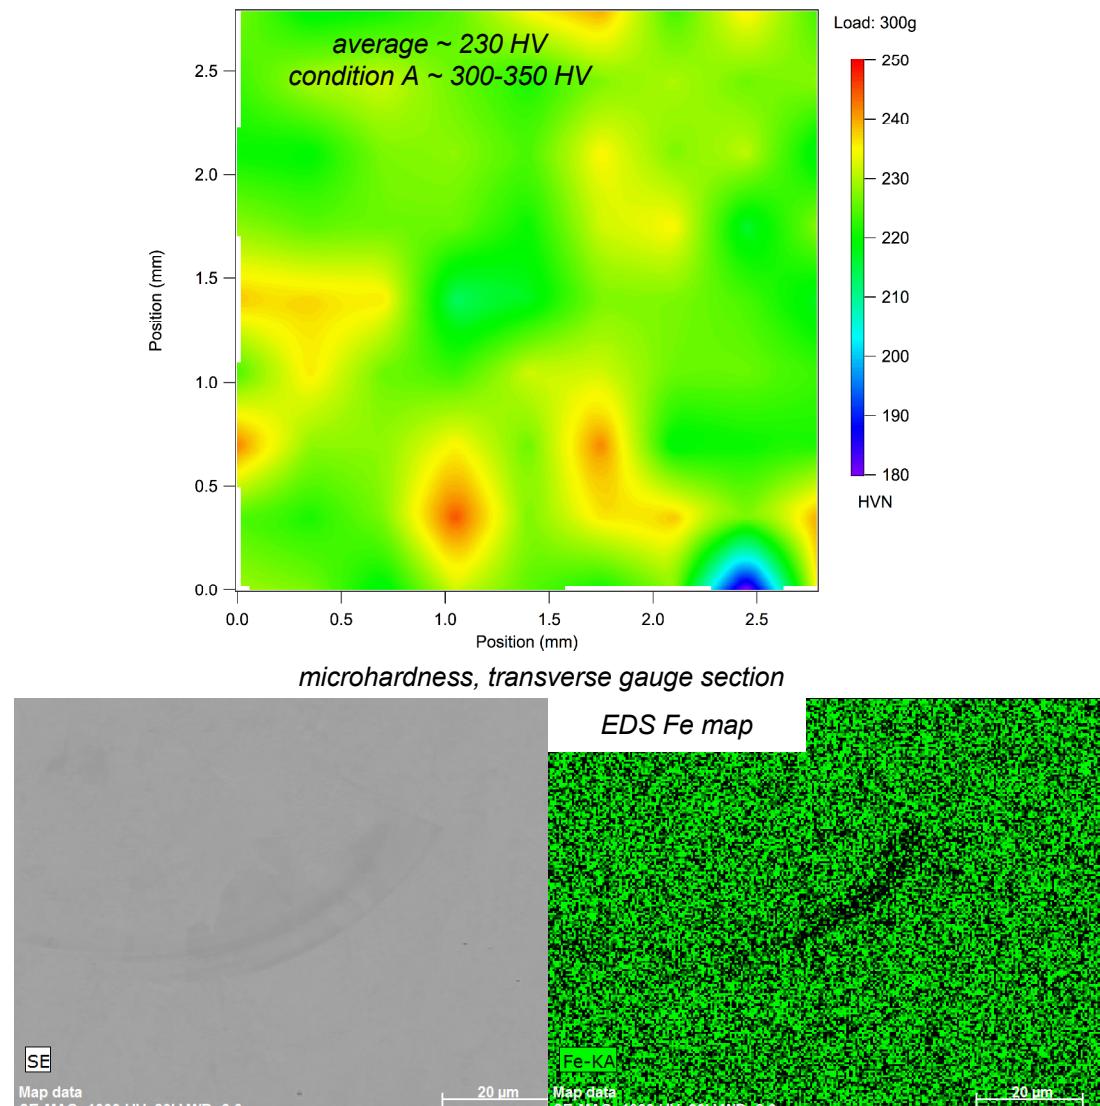
untransformed regions are Al-rich compared to surrounding martensite

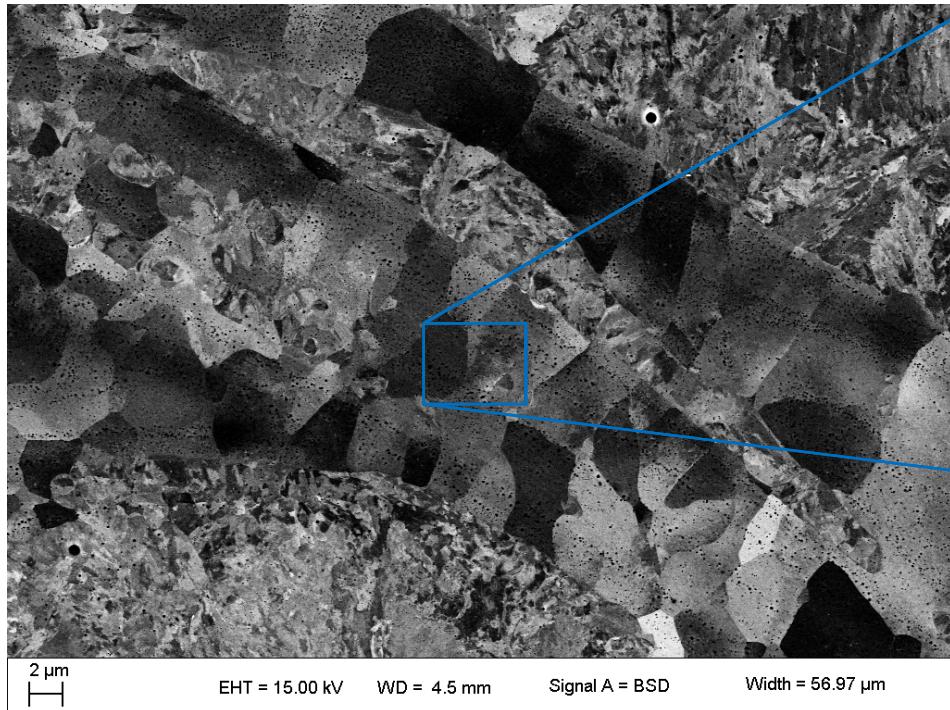
*backscatter electron image shows crystallographic content*

- Suspect over tempered martensite & equiaxed ferrite + austenite phases

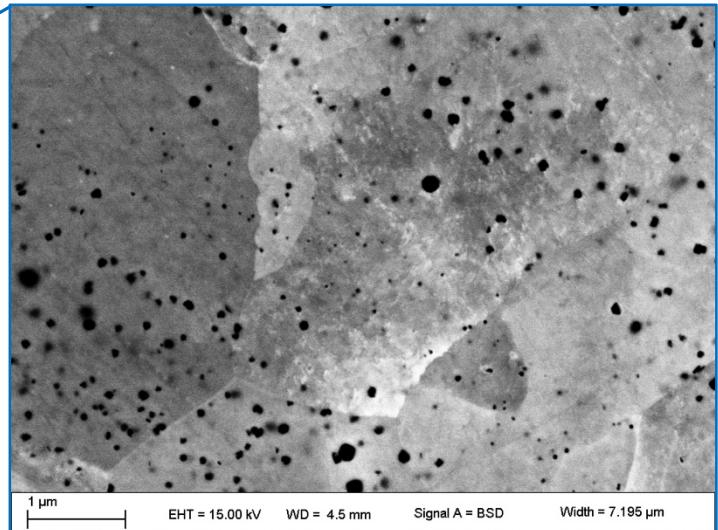
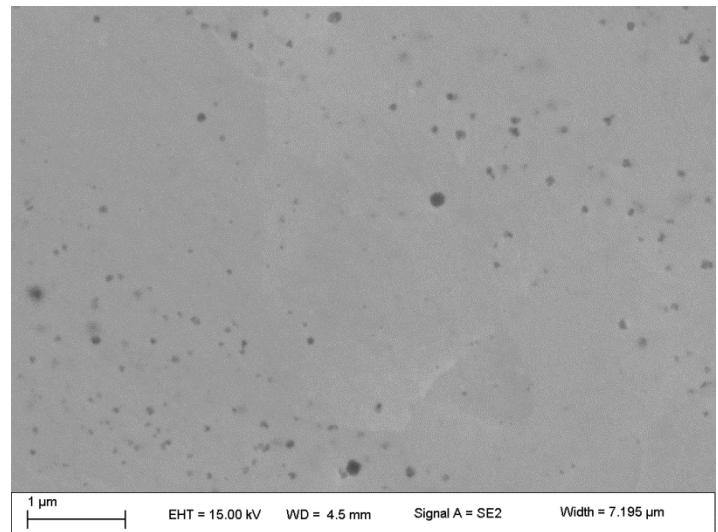
*secondary electron image shows topology => oxides not porosity*

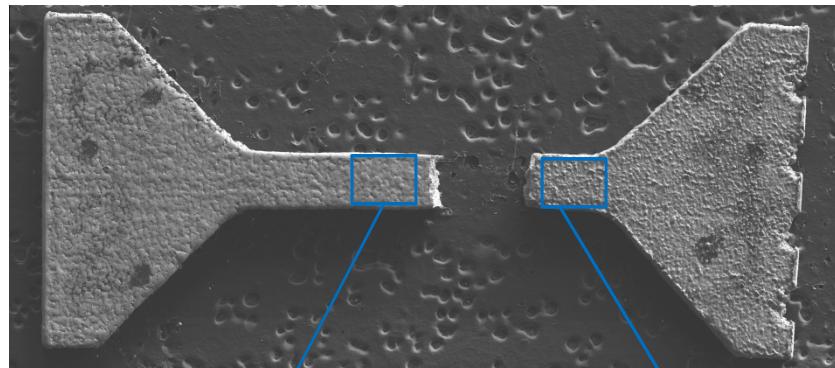
Vendor #1, "brittle" mode-I fracture plane

- limited area reduction consistent w/“brittle” behavior
- no clear point of crack nucleation
- voids at lack-of-fusion boundaries are likely culprits

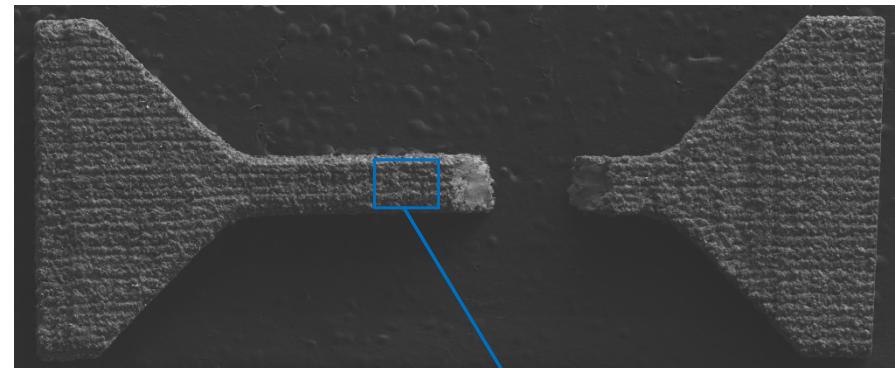
Vendor #2, "ductile" ~45° slant shear fracture

- modest reduction in area
- surface consistent w/shear-lip tensile failure
- fine ductile dimples & planes of shear rupture are present
- spherical particles & voids again suggest lack-of-fusion boundaries for nucleation

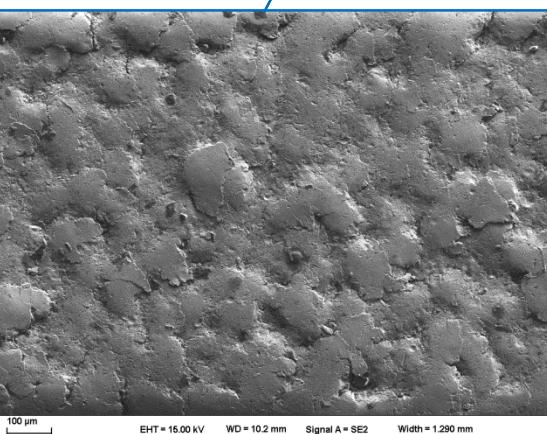
exterior surface w/heavier bead blasting

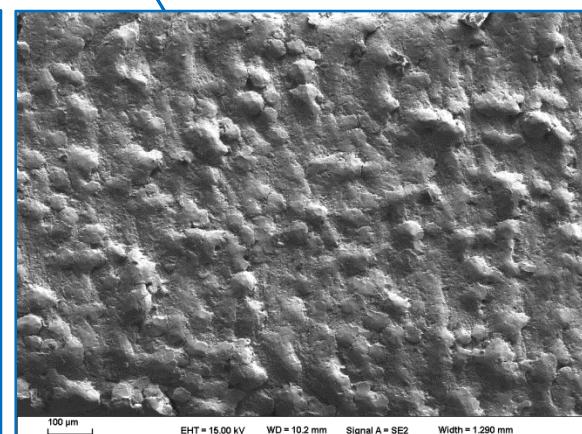
interior surface w/less bead blasting

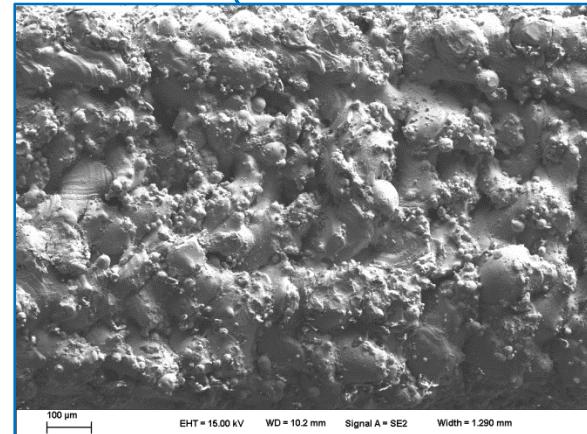
untreated surface

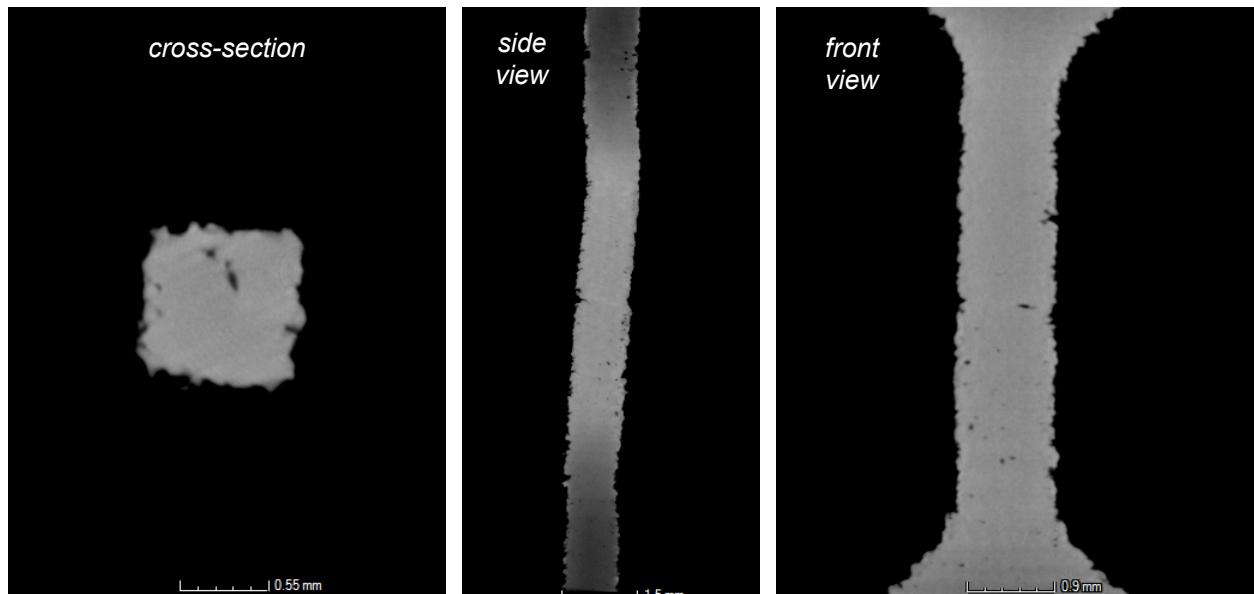
CT model of 1x1 mm test sample

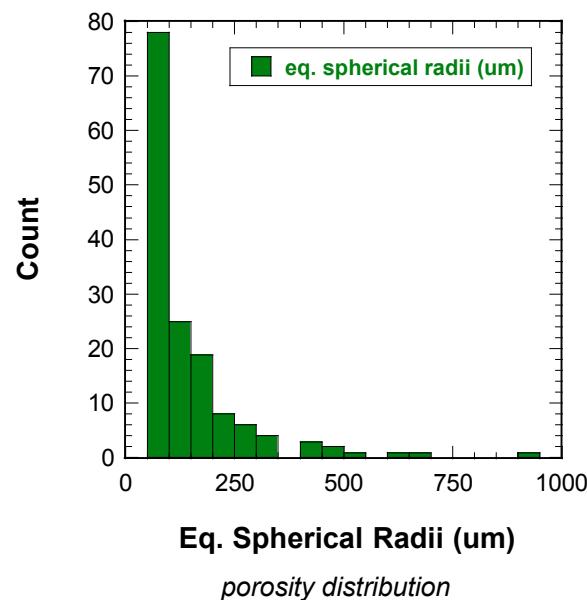
CT sections of 1x1 mm section, 7.3  $\mu\text{m}$  per voxel edge resolution

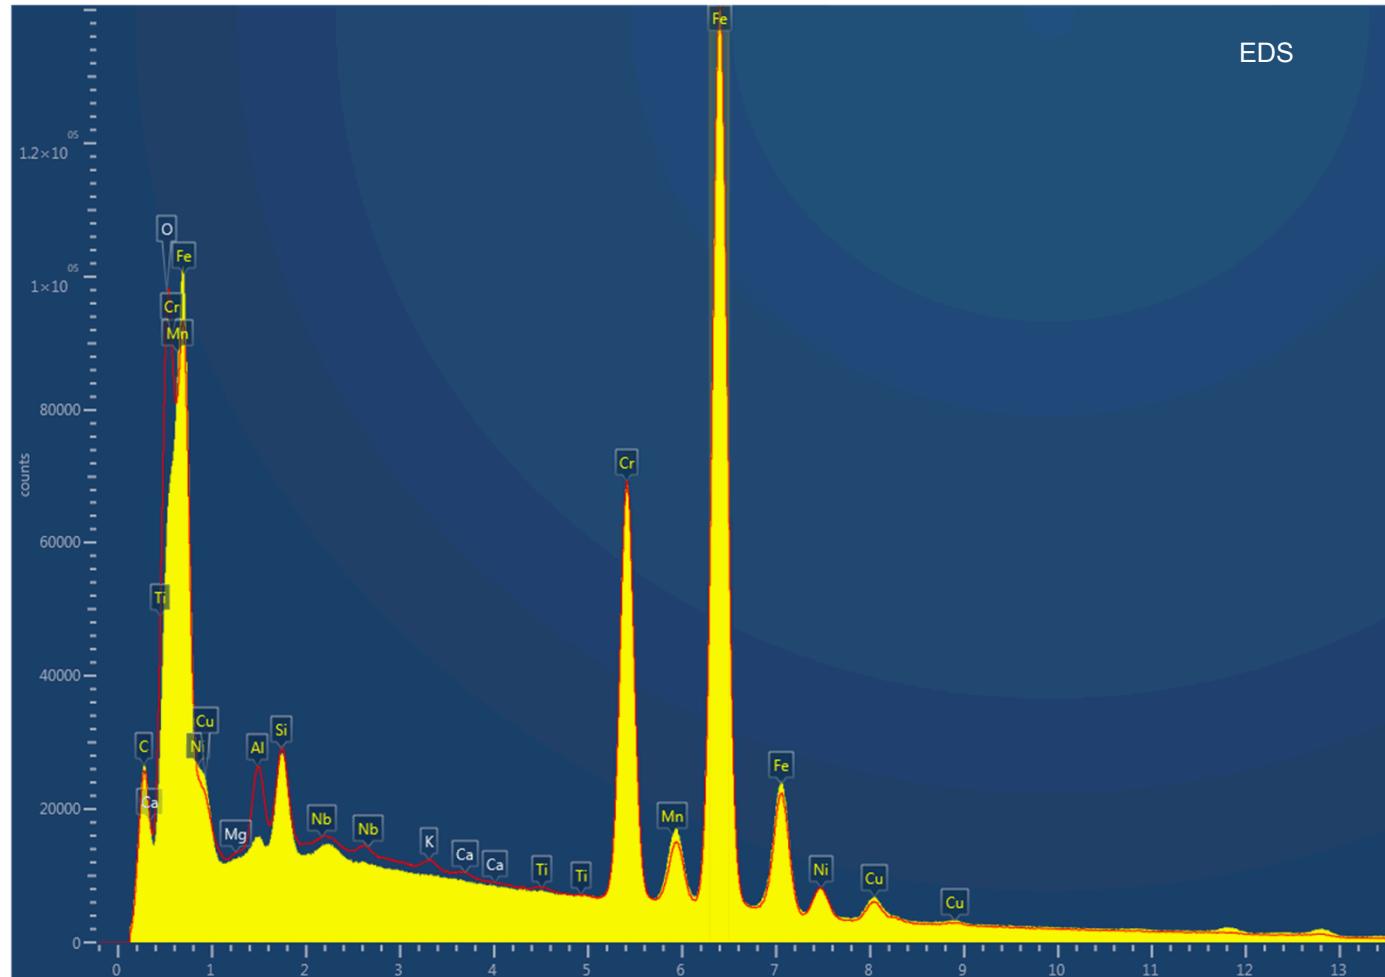
While chemically similar, vendor #1 shows excessive Al & O<sub>2</sub>. O<sub>2</sub> may come from either a thick oxide formed during heat treat, or surface alumina particles from bead blasting. The Al is also likely associated with alumina particles from bead blasting.
