## Investigation of a light fixture fire

# Investigation of a light fixture fire

On the morning of October 16, 2015 at 11:22 a.m., the Los Alamos Fire Department (LAFD) went to the north side of Technical Area 46, Building 25 in response to a fire alarm.<sup>5</sup> The

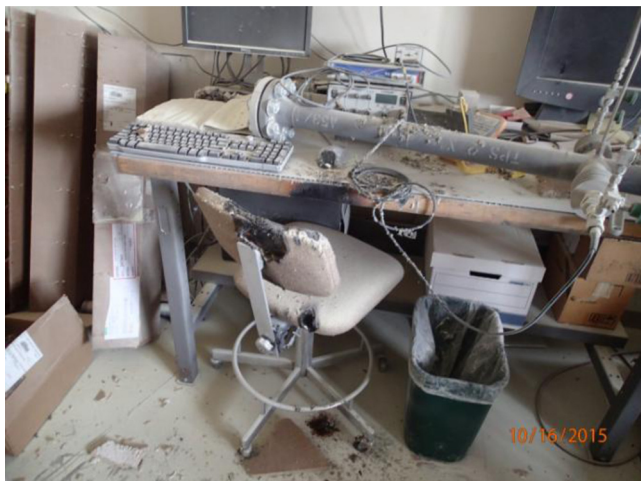
Special care must be taken when storing flammable, combustible, or oxidizing materials under metal-halide lamps. If the fixture has no secondary containment, e.g., a lens, then the extremely hot pieces of debris will fall down onto people and property below the light, likely resulting in serious injury, damage, and possibly causing a building fire. See Figure 1.

**Figure 1. Serious property damage after a metal-halide bulb non-passive failure.**

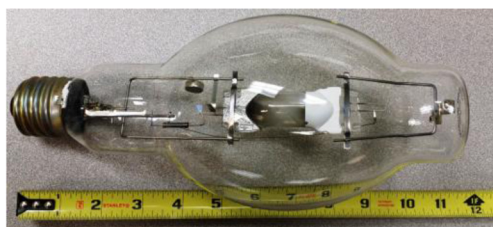
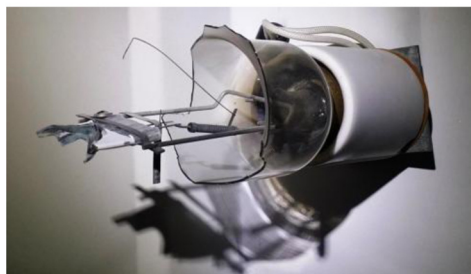
LAFD found a broken mercury halide 400 W lamp bulb. See Figure 2.

**Figure 2. Metal-halide bulb non-passive failure.**

An apparent cause has been concluded from this causal analysis: a wrong metal-halide lamp bulb caused a small fire. The acrylic lens material exacerbated the incident. The engineer should have required lenses that are compatible with metal-halide lamps instead of acrylic lens. The worker should have known that he or she was installing the wrong bulb. The worker's supervisors should have checked the worker's task

and discovered that the wrong bulb was installed. The worker's manager should have monitored the worker's task and discovered that the wrong bulb was installed and known that acrylic lens material could not contain hot lamp fragments up to 1100 °C for quartz. Implementing Lessons Learned from two previous incidences could have prevented the small fire.<sup>11,12</sup>

- Position all metal-halide lamps in one direction.
- Store only one type of metal-halide lamp bulbs that are designed for the assigned position.
- Replace acrylic lens with lenses that are compatible with metal-halide lamps.
- Iterate the importance of management monitoring programs.
- Iterate the importance of the Lessons Learned Program.

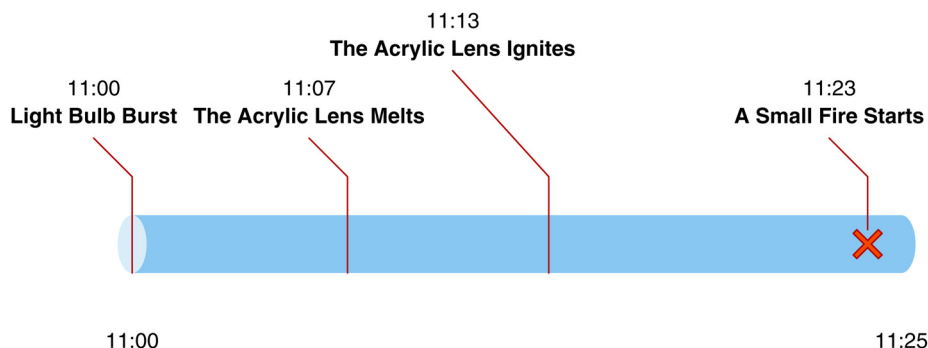
A Fact Finding was held to discuss activities leading up to this incident. The incident timeline shown in Figure 3 was developed.

Figure 3. Metal-halide lamp fire timeline.

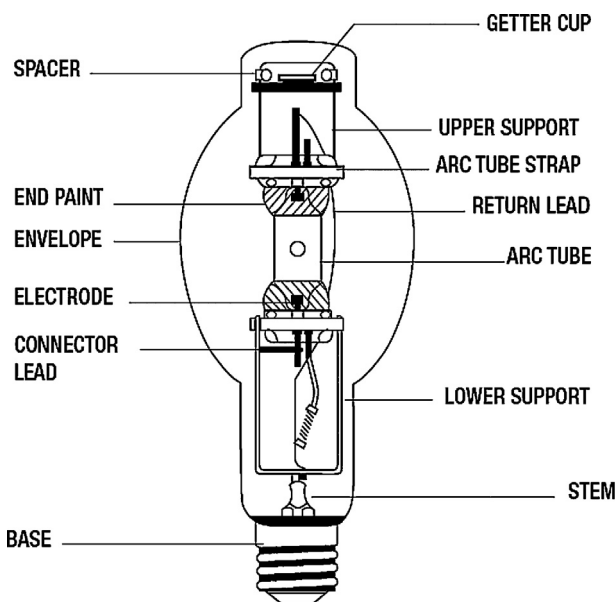
quartz or ceramic tube and electrodes is commonly called the arc tube. The arc tube is mounted to a metal frame, sealed within a glass outer bulb, and fitted with a base to form a lamp. See Figure 4.

Figure 4. Metal halide lamp.

Position dedicated metal-halide lamps exhibit improved performance over standard, universal operating metal-halide lamps of similar wattage. The metal-halide lamp that failed was in the horizontal position, as shown in Figure 4. Enclosed metal-halide bulbs rely on the fixture lens or diffuser as another layer of protection. Because people and combustible material are near, metal-halide lamps require suitable lenses, i.e., those made from material able to contain hot lamp fragments up to 1300 °C for quartz. The acrylic lens was unsuitable.

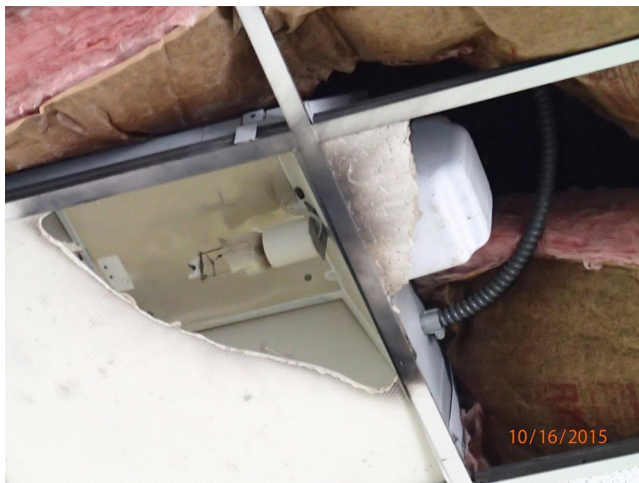
- The arc tube temperature range is between 1000 °C and 1300 °C during normal operations.
- This type of metal-halide lamp (ANSI M59/S)<sup>6</sup> is position dedicated, i.e., they are specifically designed to be run in particular operating positions. This type of metal-halide lamp is suitable only if operated vertically  $\pm 15^\circ$ , and provided the installation is not near people or flammable or combustible material.
- The lamp rated life is 20,000 hr.
- The lamp position was horizontal as shown in Figure 5.
- The fixture had a horizontal lamp holder, compatible magnetic ballast, i.e., 400 W, and an acrylic lens. The acrylic material has a flash point  $>250^\circ\text{C}$  and an auto-ignition temperature  $>400^\circ\text{C}$ .

**Figure 5. Metal-halide lamp position.**

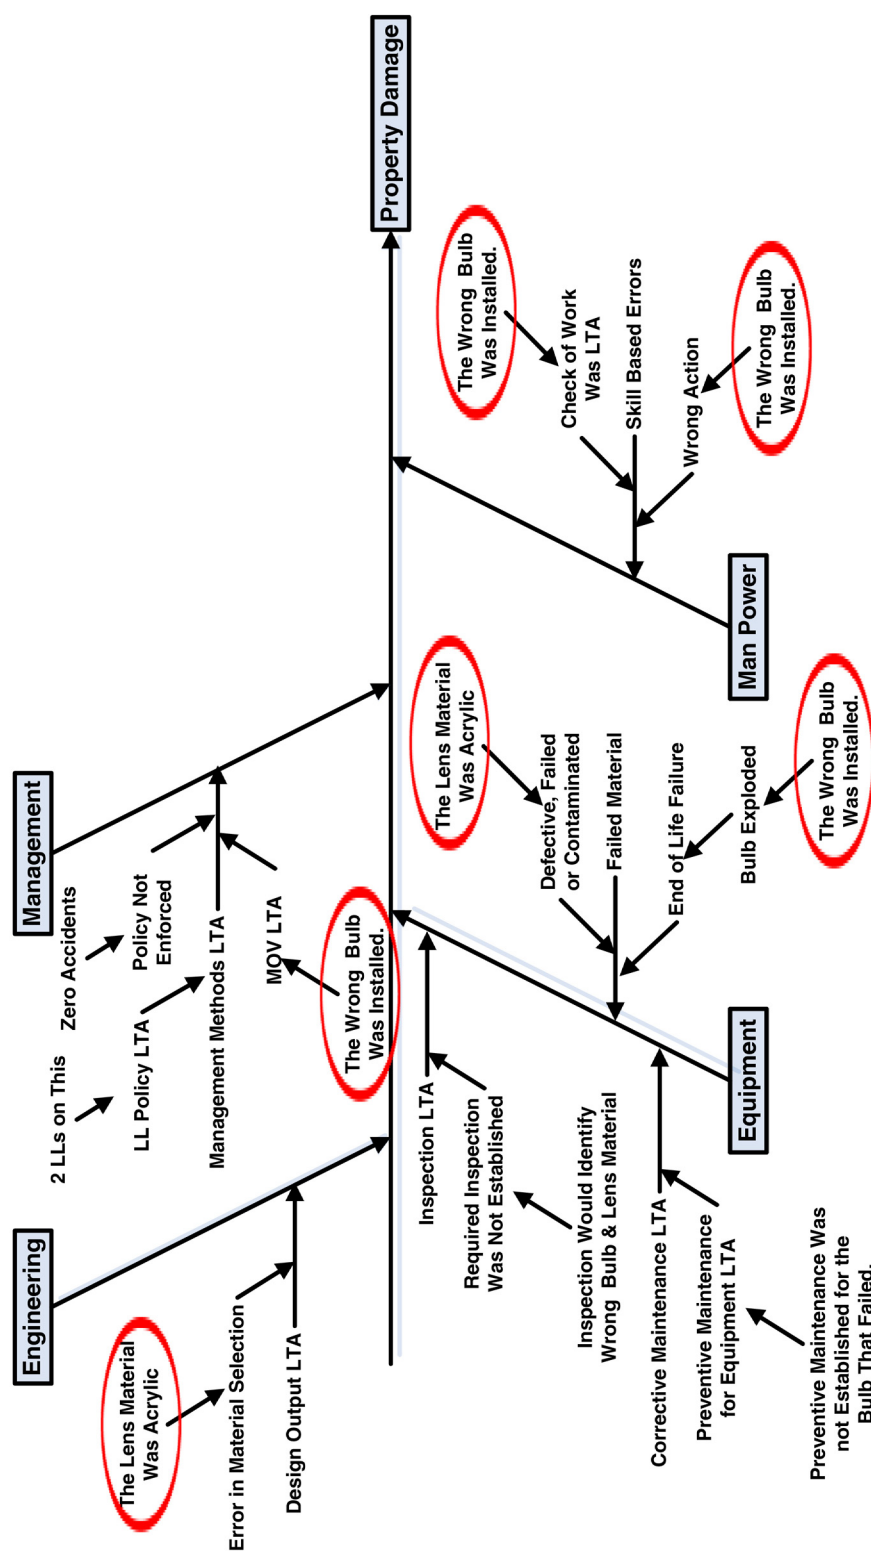
**Causal Factors.** A cause-and-effect diagram was used to systematically review the causal factors that contributed to the incident. See Figure 6. LTA is an acronym for less than adequate. MOV is an acronym for management observations and verification. MOVs were previously discussed as management walk-arounds in this Journal.<sup>7</sup>

The cause-and-effect diagram identified two apparent root causes: the lens material was acrylic and the wrong type of bulb was installed, as shown in Figure 5. The ten causal codes identified organizational weaknesses in skill-based tasks and management methods, as shown in Table 1. Peer checking would reduce the skill-based errors.<sup>15</sup> Peer checking is a series of actions by two individuals working together at the same time and place, before and during a specific action. Peer checking augments self-checking by the performer—it does not replace it. The purpose of peer checking is to prevent an error by the performer. Peer checking focuses on performing the correct act. Peer checking is the least rigorous of the checking and verification tools.

Figure 6. Light fixture fire cause and effect diagram.
