Inspection Methods for Characterizing Subsurface Impact Damage in Solid Laminate Aerospace Composites

**Stephen Neidigk, Dennis Roach,
Tom Rice, Randy Duvall**
FAA Airworthiness Assurance Center
Sandia National Labs

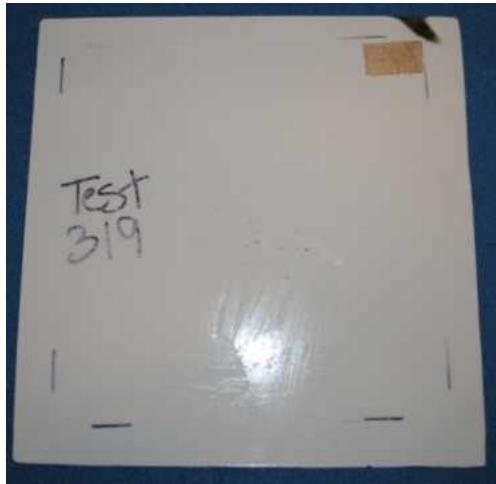
Internal delamination from ice impact

Extent of visible damage

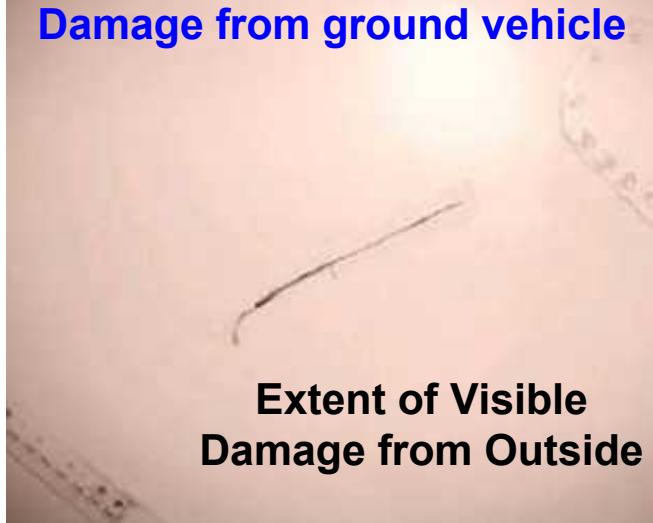
Damage from ground vehicle

Extent of Visible
Damage from Outside

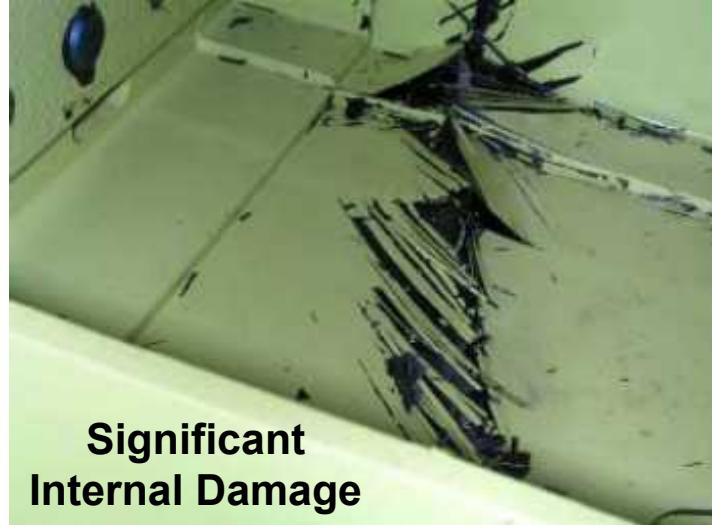
Significant
Internal Damage

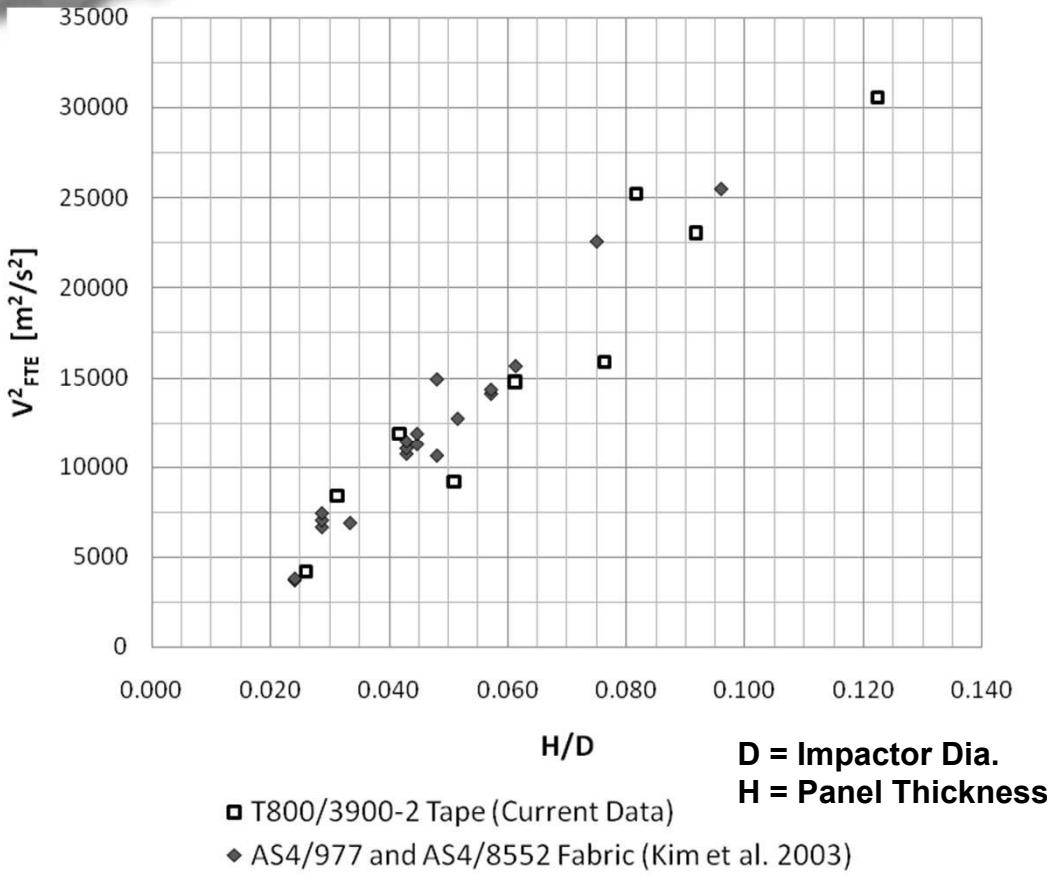
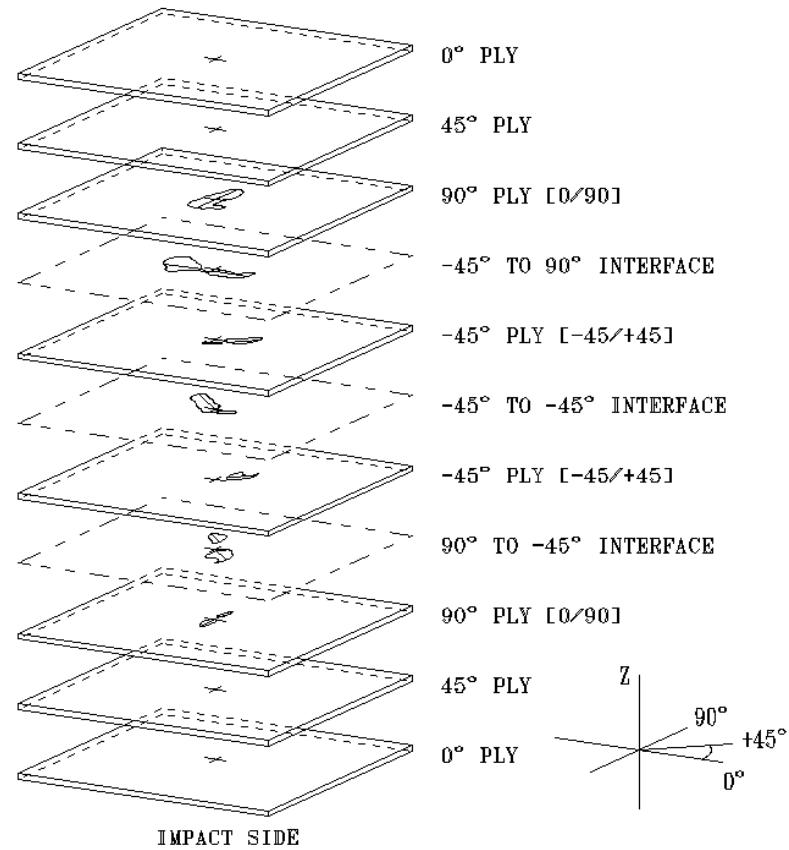
Impact-Induced Damage Morphology for 8 Ply Panel; 42.7 mm Ice at 120.4 m/s (267 J)

Selected panels were sectioned and observed by microscopy to map out the damage. The laminates develop the series of classic peanut shaped delaminations/fractures that stack together to give the overall appearance shown in the scans

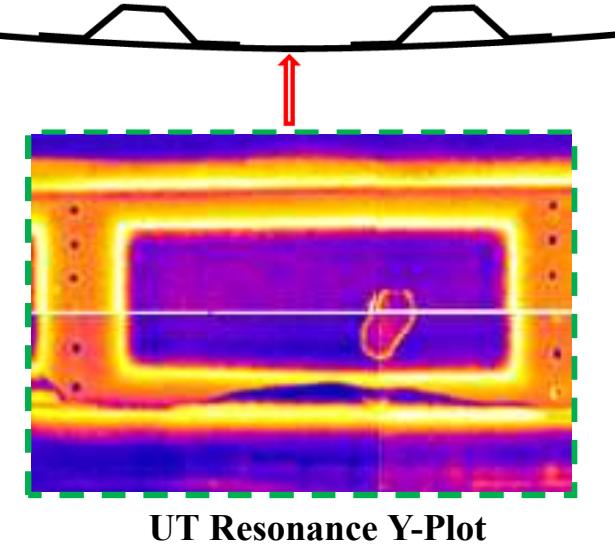
UT Resonance Y-Plot

2.4 in diameter simulated hail impact tests were conducted between 50 and 120 m/s.

- Induce both interply delamination and substructure disbonding
- No damage was visually detectable from the surface
- Damage was initiated at approximately 230 Joules (~67 m/s)

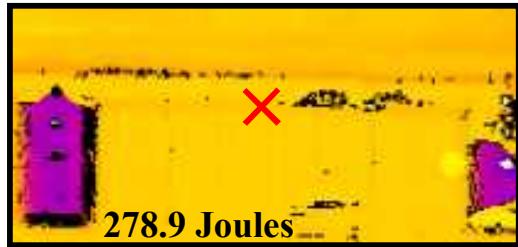
278.9 Joules

- Induce only substructure flange disbonding
- No damage was visually detectable from the surface
- Damage was initiated at approximately 170 Joules (~56 m/s)

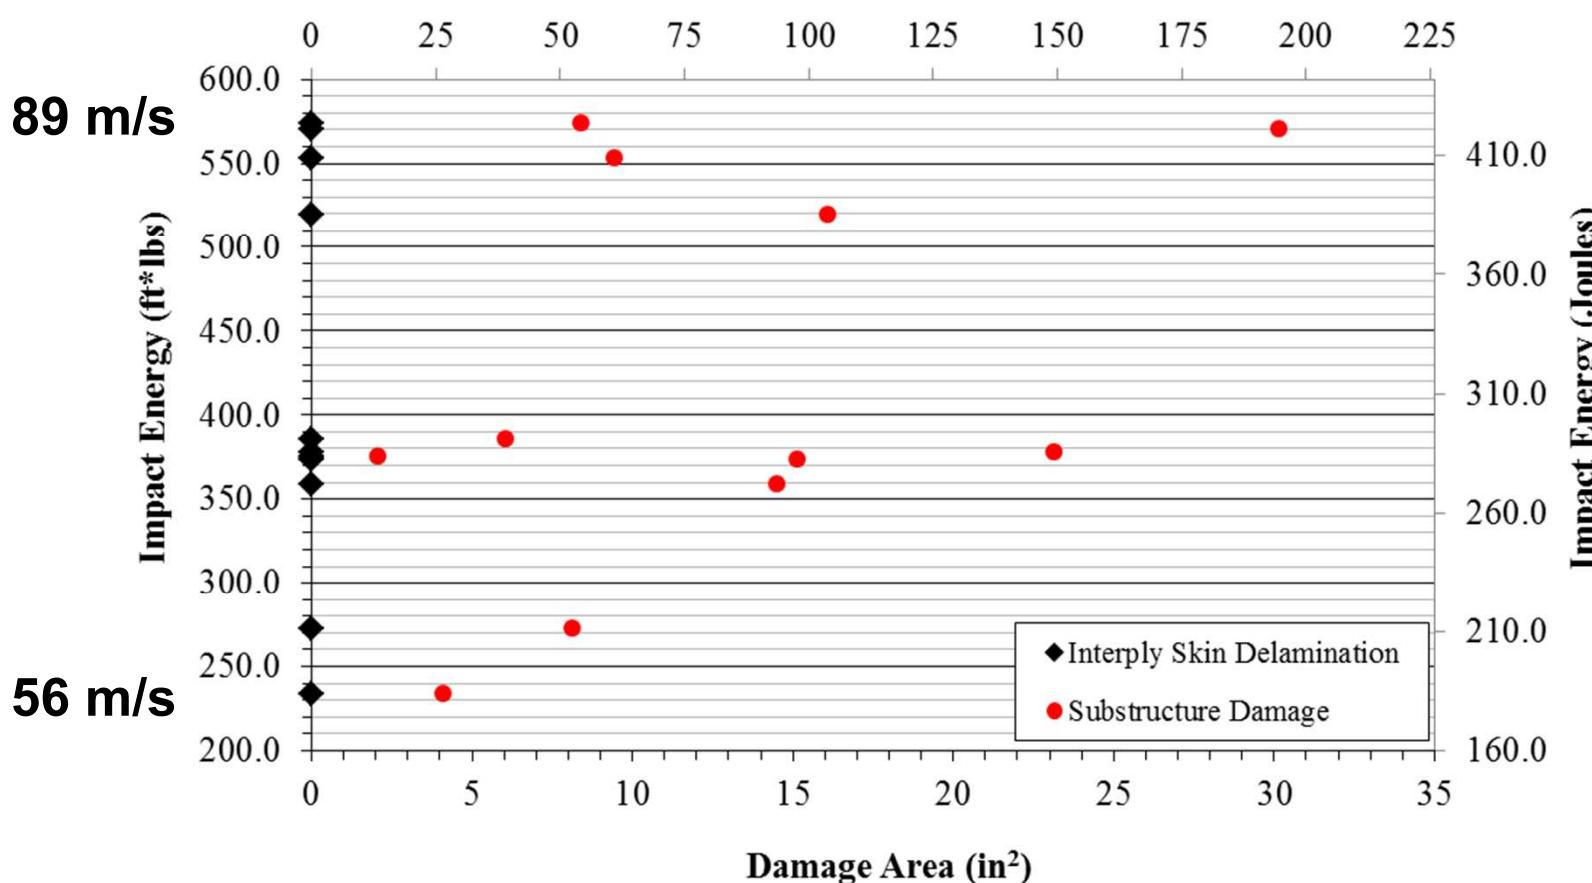
Initiated substructure disbonding only, no interply delamination detected with these impacts

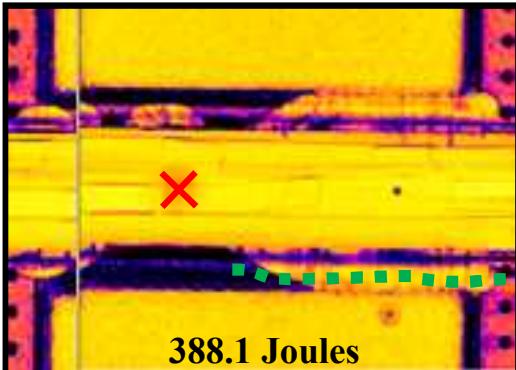
- Induce both interply delamination and substructure disbonding (mostly flange disbonding)
- No damage was visually detectable from the surface
- Possible to initiate damage at less than 400 Joules

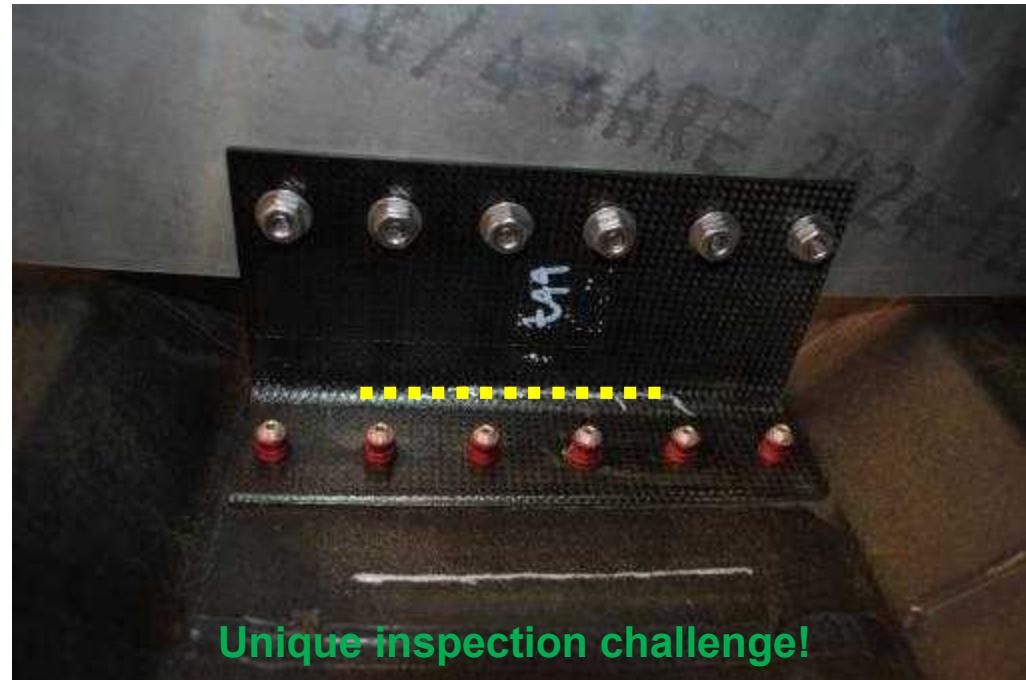
- Induce built-up pad section delamination and cracked shear ties
- Damage was visually detectable from the surface (cracks, surface markings at approximately 700 Joules (115 m/s))

All shear tie impacts cracked the impacted shear tie

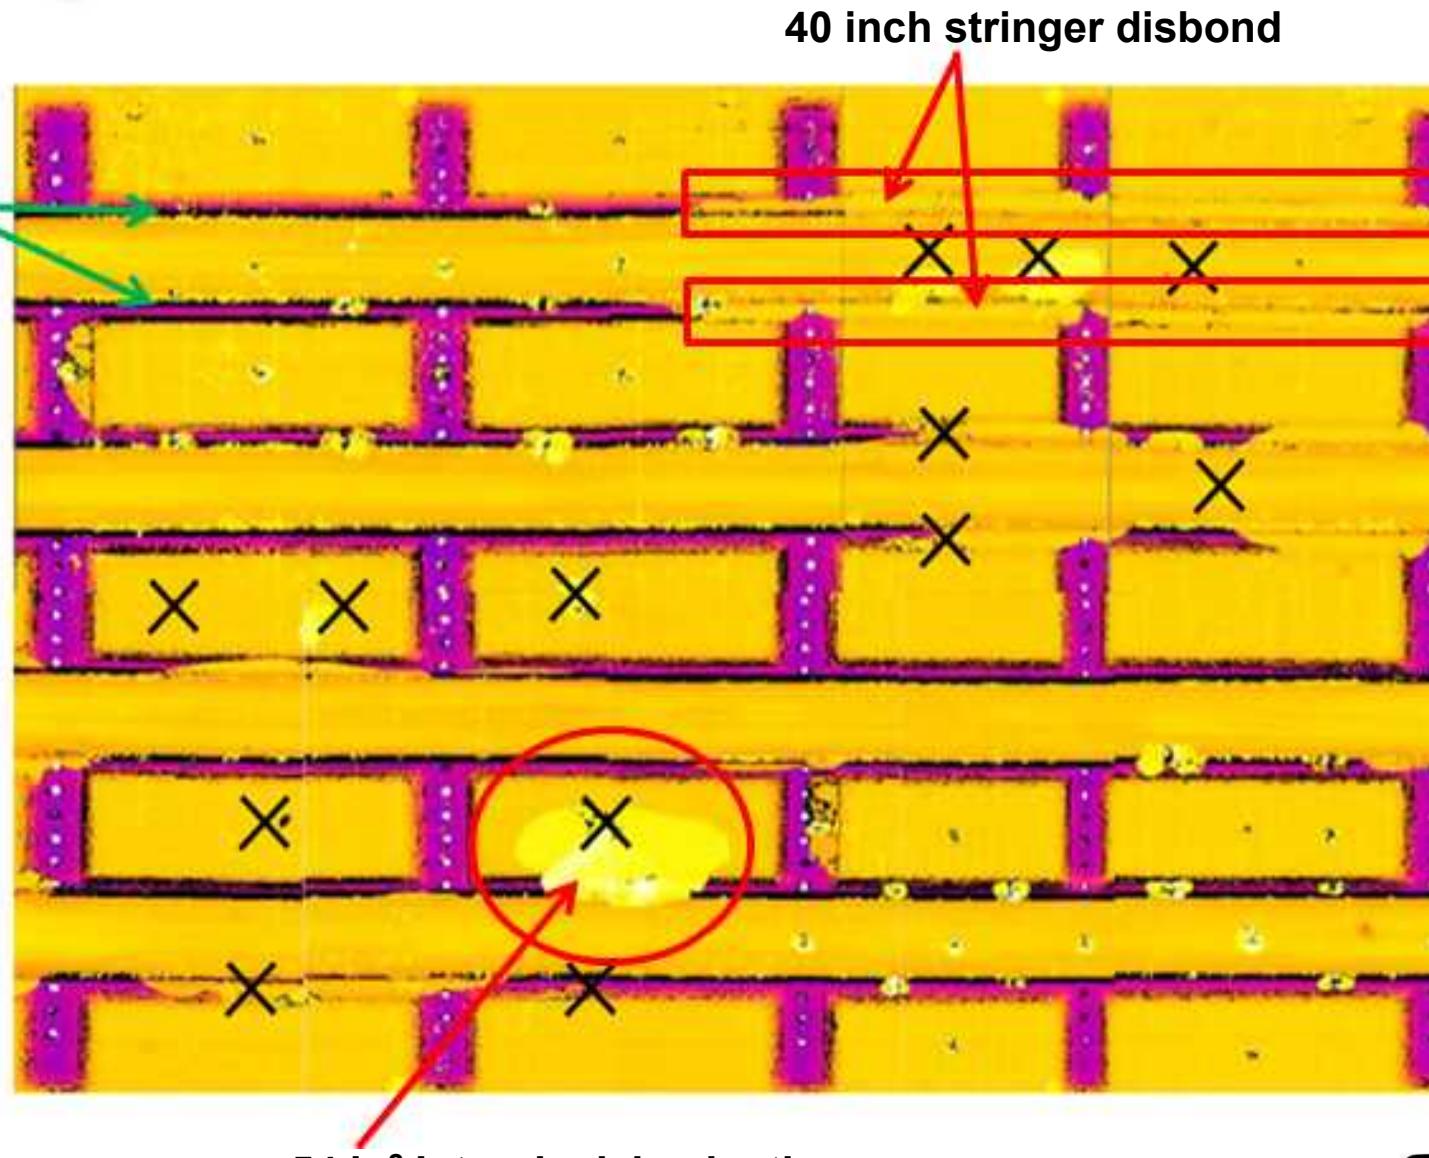
Significant Damage with No Visual Indication
