# **SANDIA REPORT**

SAND2014-20656

## **A COMPILATION OF BOILING WATER REACTOR OPERATIONAL EXPERIENCE for The UNITED KINGDOM'S OFFICE FOR NUCLEAR REGULATION'S ADVANCED BOILING WATER REACTOR GENERIC DESIGN ASSESSMENT**

Timothy A. Wheeler and Huafei Liao

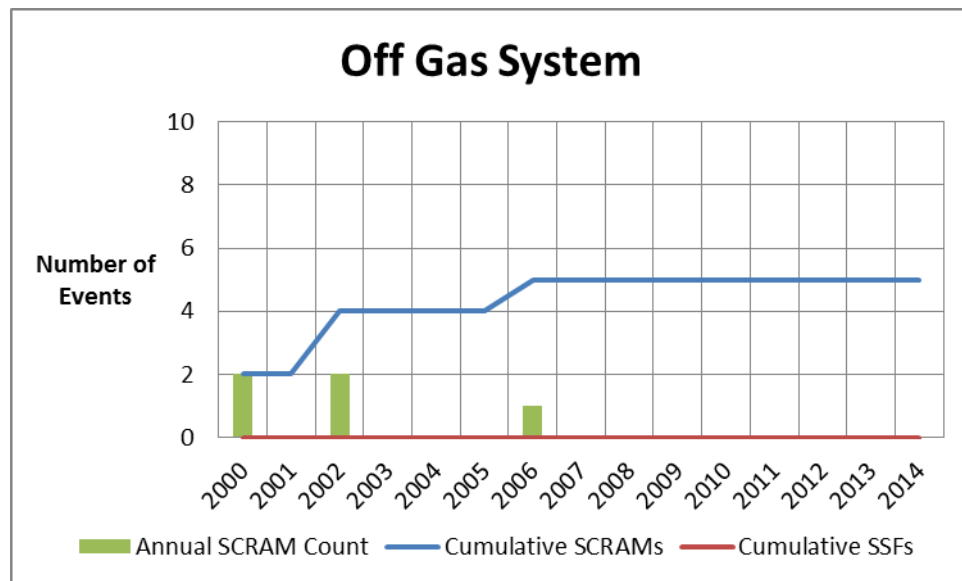
Figure 2-1 Off Gas System Operational Experience

Five SCRAM events have been identified out of the LER database since 2000. Off Gas system events involved loss of condenser vacuum, high back pressure to the condenser, high Hydrogen off gas concentration, and high temperature in the Off Gas system recombiner. Four of the five events involve the Off Gas system perturbing the back-pressure of the condensate system,

resulting in an undesirable operating condition for the power conversion system, resulting in a plant trip, either manually or automatically. Only one event involved an undesirable condition in the Off Gas system itself (high temperature in the recombiner, creating the necessary conditions for an operator initiated manual SCRAM. No incidences of excessive releases of radioactive gases were reported.

Only one SCRAM was automatic, caused by a maintenance error on a 120 VAC breaker. All others were manual in response to improper pressure or temperature indications in the condenser or Off Gas system.

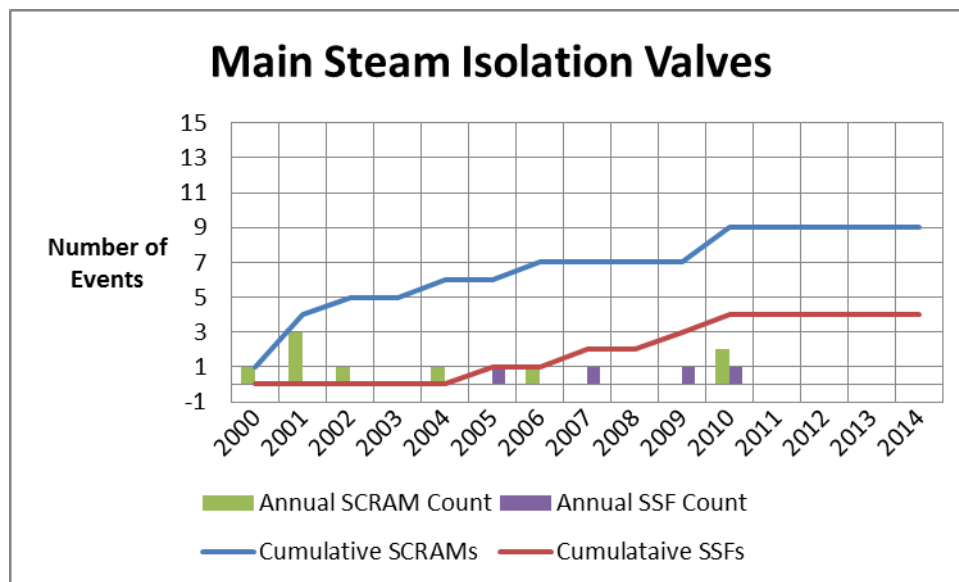
Figure 2-2 MSIV Operational Experience

Nine SCRAM events have been observed since 2000, all automatic trips at operating power levels from 20% to 100%. In all events the reactor automatically trip due to conditions initiated by and unintended closure of at least one MSIV. Six events were due to equipment faults, two to procedural problems, and one to human error.

The equipment faults included failure of valve internal components, air supply failures and drain system issues. The two procedure SCRAMs occurred during testing of the MSIVs, and the human error induced SCRAM MSIV instrumentation was accidentally bumped by a worker.

Four MSIV SSF events were observed since 2000. These are summarized in greater detail in Appendix C 2.2.

Three events involved failure of an MSIV Local Leak Rate Test (LLRT) such that 10 CFR 100 limits could have been exceeded during a design base accident. These MSIV failure events were observed at power and during refueling. Either degradation of valve internals or improper sizing

of valve internals was identified as root causes. Another event involved failure of the isolation flow sensor, which would have indicated lower than actual flow.

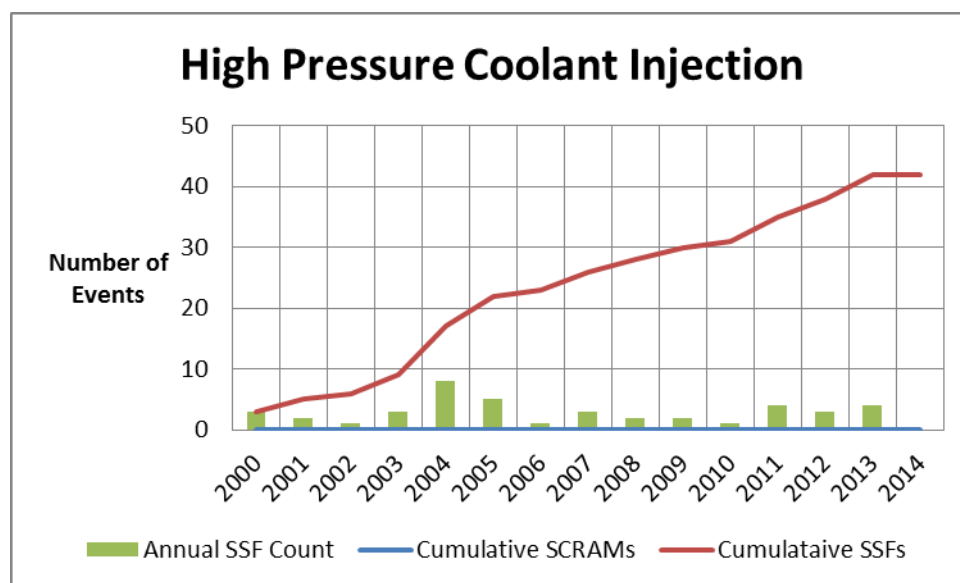
Figure 2-3 HPCI operating experience

There were 43 observed failures of the HPCI system since 2000, 33 of which were equipment failures, two procedure related failures and eight human error related failures. All events occurred at power, between 23% and 100% power.

- 11 in the discharges line, 10 equipment related and one human error,
- 14 in the suction lines, 13 equipment related and one human error,
- 3 in the minimum-flow lines, all equipment related,
- 3 system isolation failures, one equipment related and two human errors,
- 2 failures of the HPCI high reactor water level trip mechanism, both human errors,
- 4 related to pump motor issues which cannot be readily distinguished as unique to steam turbine pumps, one is equipment related, two human errors and one procedural issue.
- 3 turbine pump failures, all equipment related.
- One room cooling procedural failure.

Min-flow, discharge and suction line events involve issues including air in the lines, valve malfunctions due both to electrical faults in MOVs – including a total of five involving fuse failures – and leaking check valves. Suction events also included faults that would prevent realignment from the Condensate Storage Tank (CST) to the torus. Human error events tended to be involved with improperly returning HPCI back into service after maintenance.

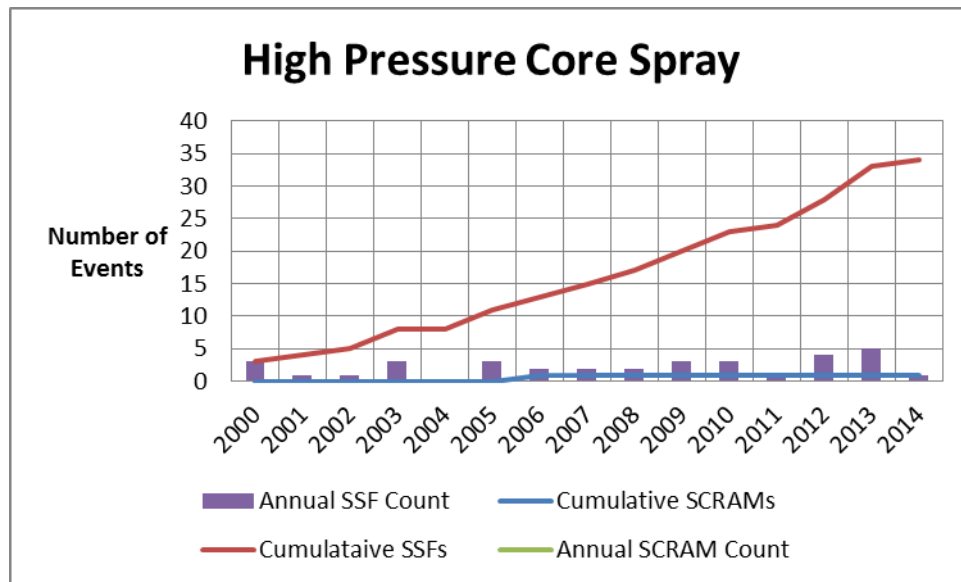
Figure 2-4 HPCS operating experience

Thirty four HPCS SSFs were observed since 2000, 22 are equipment related, four procedural and seven human errors. Two events occurred at very low power – hot shut down and 5%, the rest at power levels above 90%.

- 6 related to pump motor, four equipment related, one human related and one procedural.
- 2 room cooling events, both equipment related.
- 2 minimum-flow line failures, both are equipment related.

Mark III BWRs have a dedicated safety related electrical system, including an emergency diesel generator. Sixteen total events involve the dedicated safety related electrical. As with the HPCI system, both suction and injection line failures were observed, including the possibility of injection line water hammer and loss of suction, both due to air in the lines.

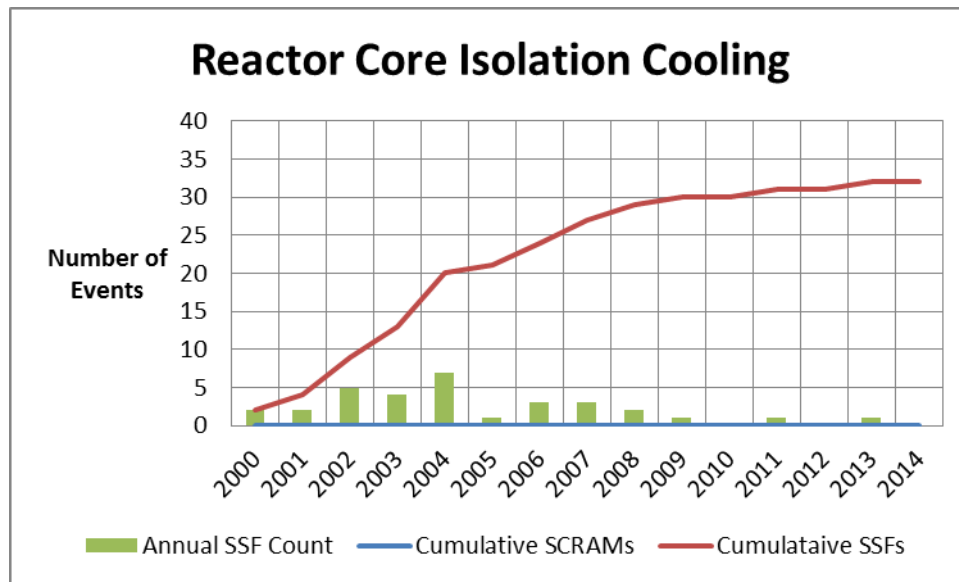
Figure 2-5 RCIC operational experience

Thirty two SSF events have been observed since 2000, 25 are equipment related, four procedural and three involving human error. The events occurred during power levels between 8% and 100%, with most being at high power levels. Failures include:

- 3 suction line events, all equipment related involving either air in the lines or inadequate suction pressure.
- 2 discharge line events, one equipment related involving loss of control of the injection valve, and one procedural that could have induced water hammer in the discharge line had RCIC been initiated.

- 5 flow-control events, 4 equipment related and one human error. The flow-controller failures cause RCIC to trip.

As with HPCI and HPCS operating experience, both suction and discharge line faults were observed, including the possibility of injection line water hammer and loss of suction, both due to air in the lines.

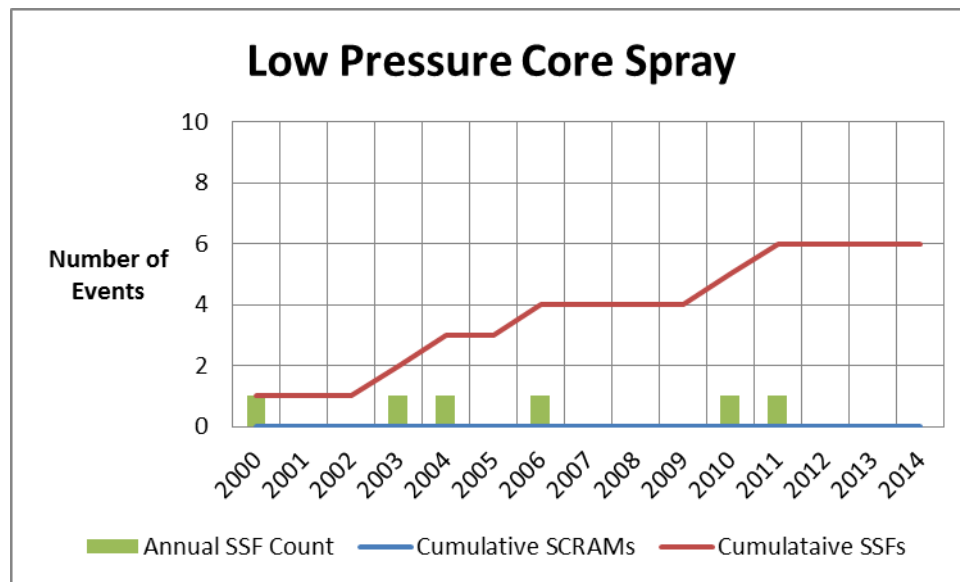
Figure 2-7 LPCS operational experience

- One electrical event wherein failed contacts in a relay would have rendered the pumps inoperable upon receipt of an actuation signal.
- One 10 CFR 50 Appendix R event. An Appendix R assessment regarding LPCS was discovered to be incorrect due to inadequate separation between trains of cables.

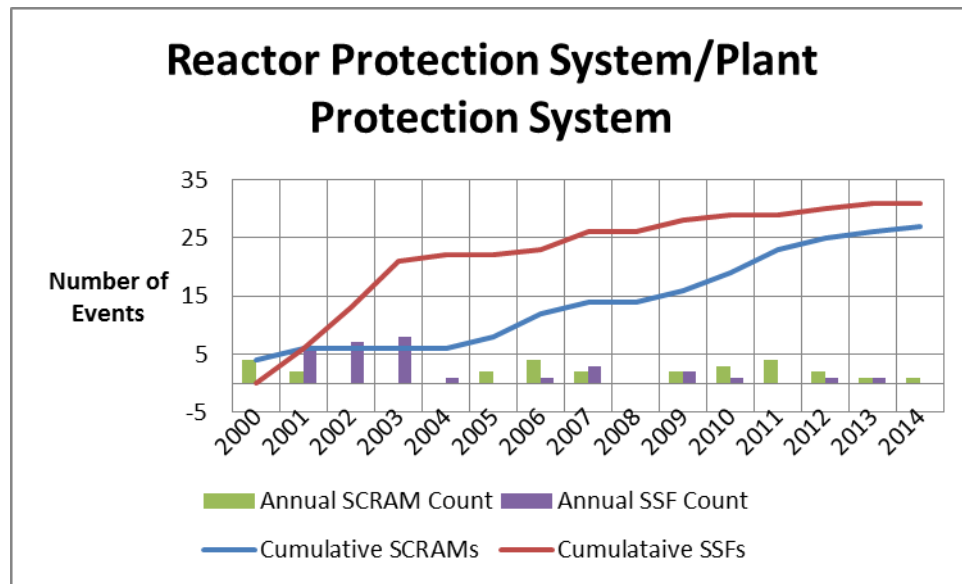
Figure 2-8 RPS/PPS operating experience

Twenty seven SCRAM events involving RPS/PPS have been observed since 2000. Of those, three were manual and 24 automatic. Sixteen events were equipment related, five procedural and 6 involved human errors. Events occurred from 0% to 100% power.

The human error events involved maintenance activities which perturbed the plant protection system, resulting in an automatic trip. One event, at Nine Mile Point 2 (LER 4102010001) involved tripping the plant while performing maintenance on the RHR system by performing a maintenance action on an instrumentation line common to the RHR and the RPS.

The five procedural related events involved three events where an item of the PPS was being either tested or returned to service, and two events in which the procedures led to an improper response to a startup condition and a power/load imbalance situation.

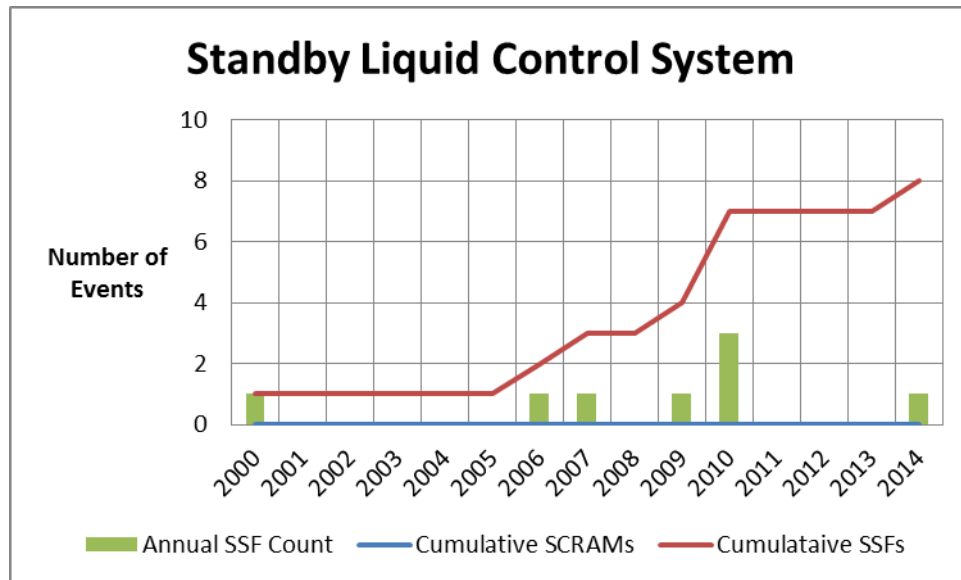
Figure 2-10 SLC operating experience

Eight SSF events have been observed since 2000, seven equipment related and one human error. Four of the equipment events involve the SLC tank being seismically unqualified when water is left in the tank. Failure of the test tank from a seismic event could lead to failure of other SLC components. The other equipment events involve leaks (2) and a technical specification violation

of Sodium Pentaborate concentration. The human error event involved the discovery of plastic trash bags left in the storage tank. This type of event has been the topic of an NRC generic communication, Information Notice IN02005. See Section 3.4.

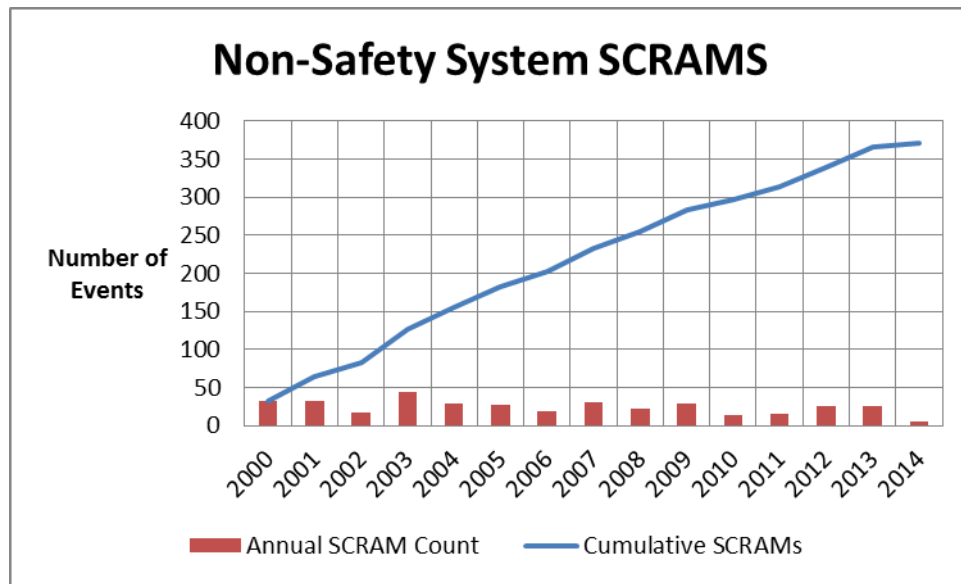
Figure 2-13 Non-safety system SCRAMs

Two BWR specific systems induced SCRAMs – the Drywell Environmental Control System (DECS) (two manual SCRAMs) and the Reactor Recirculation system (26 manual SCRAMs and five automatic SCRAMs). Both drywell related events occurred at 100% power, were categorized as equipment related and involved manual SCRAMs upon:

1. a rise in drywell temperature ultimately due to a loss of drywell cooling from a fault in the component cooling water system (LER 24920001003).
2. Excessive leakage into the drywell (LER 3412005001).

The 31 Recirculation system events all occurred at power, from 24% up to 100% power. . Twenty five of these events involve recirculation pump trips or poor operating performance of one or more recirculation pumps which lead to either the operators manually tripping the Recirculation system or to an automatic tripping of the Recirculation system. Two events involve leaking from the Recirculation piping, and four involve automatic tripping of the recirculation pumps upon indication of unacceptable dry-well temperature or leak conditions.
