Title: Learning Team Review 2016-0001 Installing Outlets for Programmatic Equipment

Learning Team Review 2016-0001

Installing Outlets for Programmatic Equipment

Brief Description of Event:

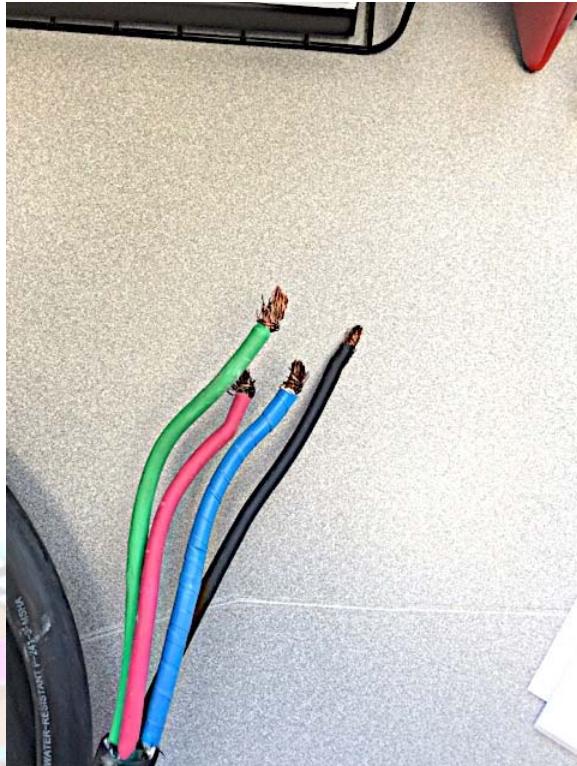
Excess cord remnant with original taping

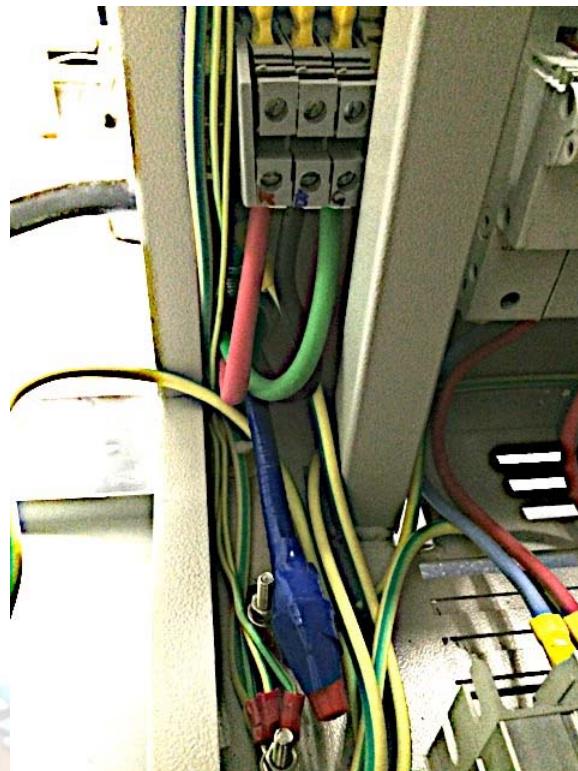
Current configuration:

Note: Red "R", Blue "B", Black "G" marked prior to disconnecting original wiring to document original wiring. Blue "B" was intentional to differentiate from Black, which was capped and left loose. Did not have green marker available for "G." This shows how things are currently configured. There is now a white wire taped blue. This wire was connected in the original configuration to the Blue

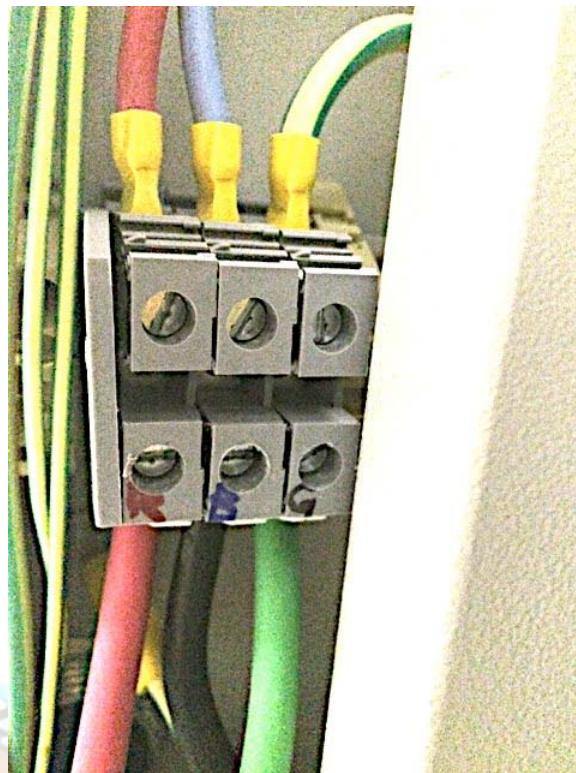
Current configuration:

The ESO inspected the furnace again and opened up the furnace cabinet and the cord cap that had been sealed by electricians. At this point it was discovered that the wiring had been performed incorrectly. The cord cap and wire included a dead leg not necessary for single phase operation. However, it appears that the electricians had mislabeled or lost track of which wires were connected to the cord cap; one phase of the wiring was wired incorrectly left dead and capped inside the furnace cabinet. The conductor was not touching anything, it was not a safety issue but a functional issue. The ESO wired the plug correctly and MST-7 replaced a fuse.

Note: Dead leg is a white conductor wrapped in blue tape. Was originally placed in center hot terminal to recreate original wiring.
