LAWRENCE
LIVERMORE
NATIONAL
LABORATORY

LLNL-TR-715377

Rotary Valve FY 2016 Highlights

December 16, 2016

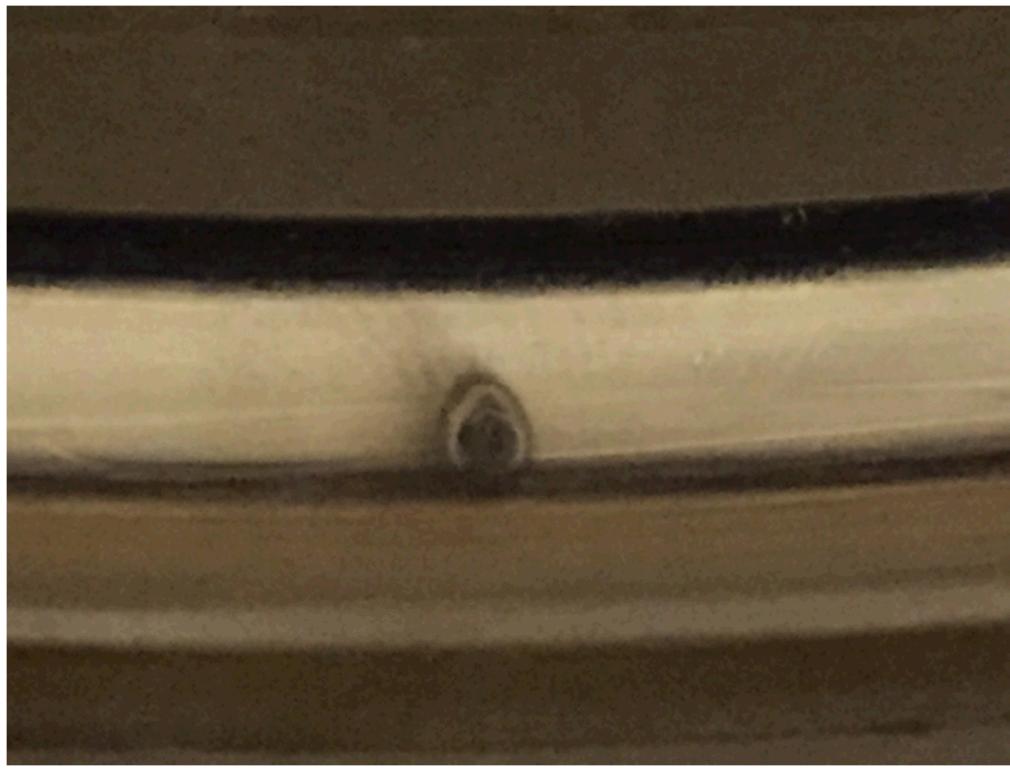
The fiscal year started with the Rotary Valve (RV) being reassembled after having crashed in June of 2015. The crash occurred when the RV inner surface contacted the housing. The cause of the crash was never confirmed. No particles were found in the 2.5 thousandths of an inch gap and the filters the helium gas passed through were all clean. There were marks on the bearings that looked like electrostatic discharge as shown below in Figure 1. These marks hadn't been seen before and there were similar discharge marks on some of the ball bearings. Examples of this were found in a literature search of bearing failures. This leads to a possible cause due to this arcing affecting the rotational accuracy of the bearings driving the RV into the housing.

Figure 1: Arcing on the RV's support bearings.

We had another set of NSK bearings that were originally installed when the RV had four bearings. These had been removed when we went to a two-bearing setup. These bearings replaced those with the arcing. They were inspected, cleaned and greased before installation in the RV.
