SAND2017-2306

## **Analysis of Corrosion Residues Collected from the Aluminum Basket Rails of the High-Burnup Demonstration Cask**

Charles R. Bryan

On September, 2015, an inspection was performed on the TN-32B cask that will be used for the high-burnup demonstration project. During the survey, wooden cribbing that had been placed within the cask eleven years earlier to prevent shifting of the basket during transport was removed, revealing two areas of residue on the aluminum basket rails, where they had contacted the cribbing. The residue appeared to be a corrosion product, and concerns were raised that similar attack could exist at more difficult-to-inspect locations in the canister. Accordingly, when the canister was reopened, samples of the residue were collected for analysis. This report presents the results of that assessment, which determined that the corrosion was due to the presence of the cribbing. The corrosion was associated with fungal material, and fungal activity likely contributed to an aggressive chemical environment. Once the cask has been cleaned, there will be no risk of further corrosion.

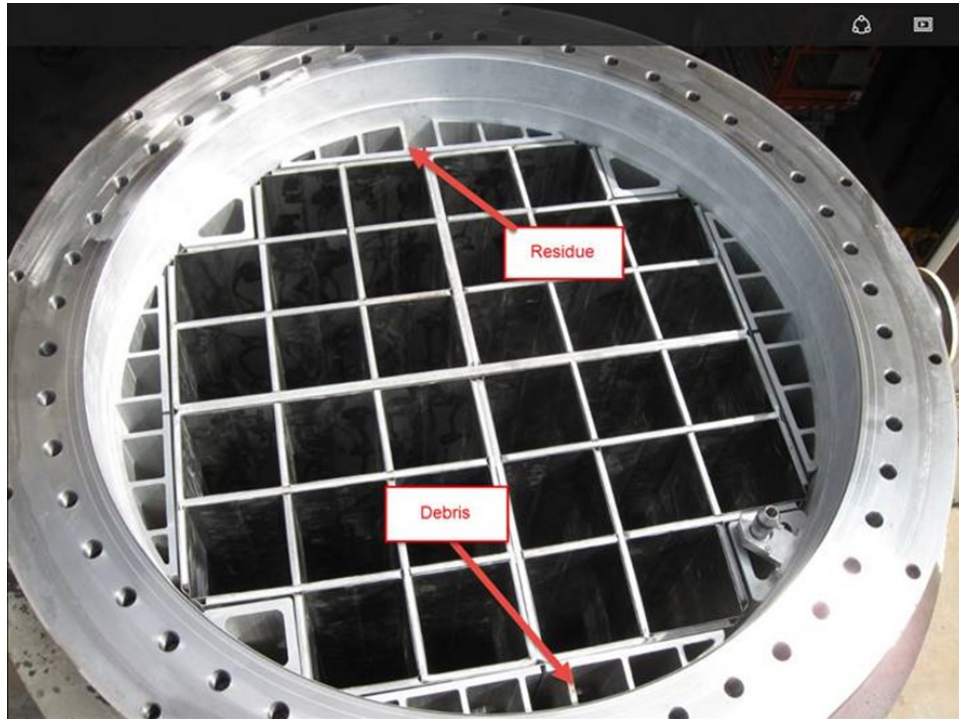
**Figure 1. Photograph of the storage cask, with the lid removed. The locations of the two areas with apparent corrosion residue are shown.**

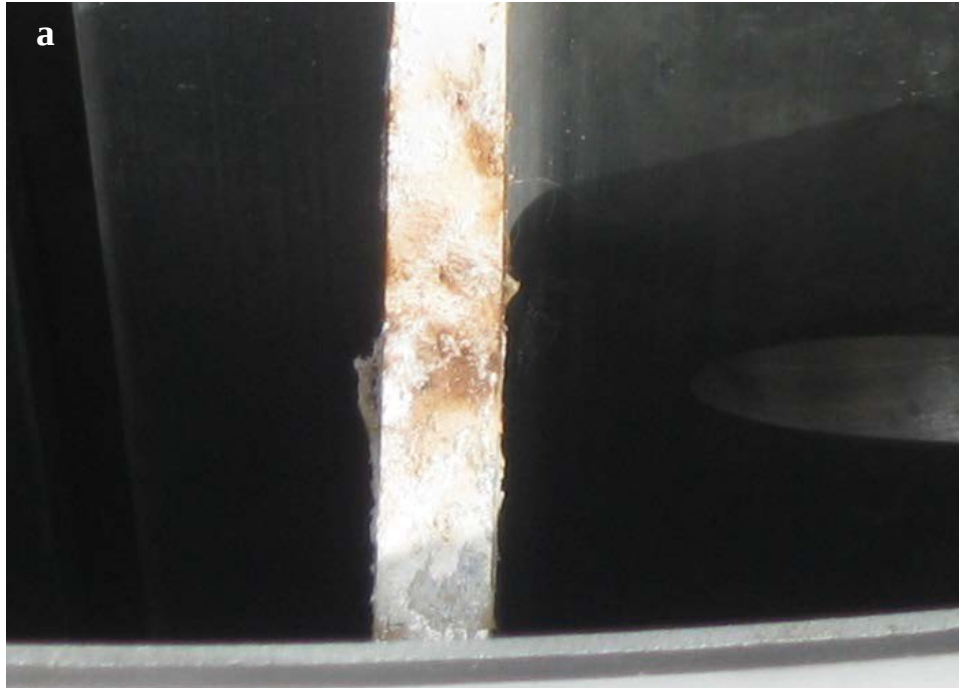
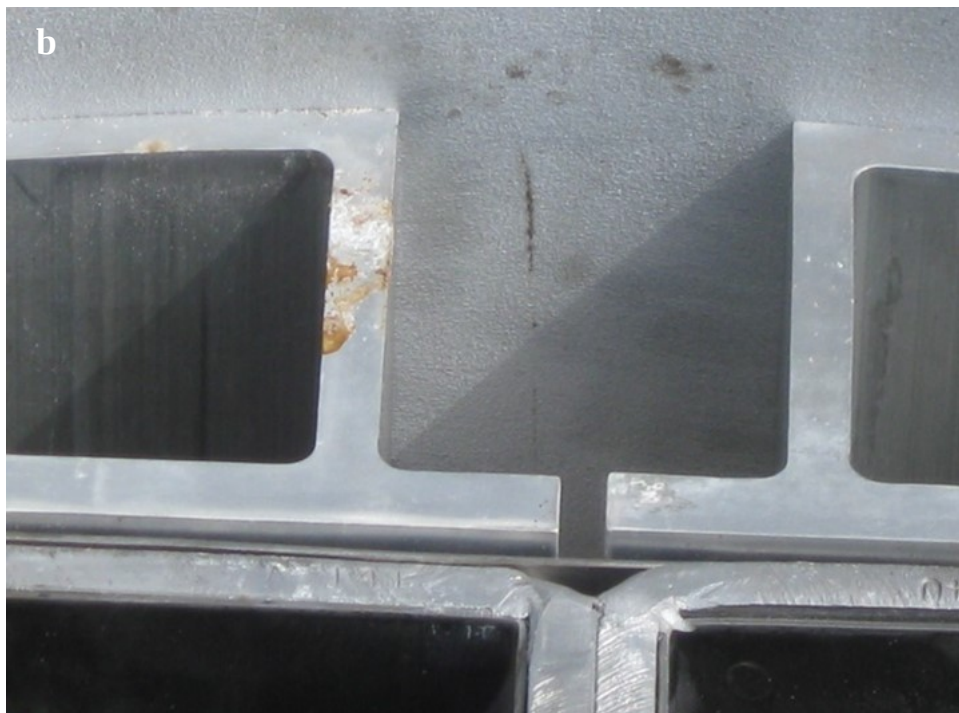
**Figure 2. Photographs of a) the “debris” on the basket rail (near side), and b) the “residue” on the basket rail (far side).**

Samples were collected from two locations on the aluminum basket rails, the “Debris” side, and the “Residue” side. The Debris side had finely fibrous mat of material that was partially detached from the surface (Figure 2a). The Residue side had a thin coating of material that was more strongly attached to the rail (Figure 2b). During sample collection, tweezers were used to collect a fragment of the loose debris from the Debris side. The material consisted of the fibrous base, with sand-sized grains attached and embedded in the fibrous material. The mat was stained brown in some areas, and the grains, although mostly white, were also stained in some areas. The debris sample was slightly over 1 cm in diameter. Following collection of the debris, swipes were taken of both sides, first a dry swipe, and then two wet swipes. The round 5” filters were folded and placed in 50 ml polypropylene sample vials for shipment to Sandia. Upon delivery to Sandia, the samples were photographed, and then a small piece of each was taken for SEM analysis. For chemical analysis, the two wet swipes from each location were combined, as there was no reason to analyze them individually. The samples are listed in Table 1 below. Images of the samples are shown in Figure 3 (note that only one of each pair of wet swipes is shown). The residue itself appeared to be a finely fibrous brown material, with white particles scattered across the top, and adhering to the fibers. The residue on the dry filters appeared to be a brown stain, finely granular. The residue on the damp filters was also a brown stain, but was more coarsely granular, with brown or white sand-sized grains.

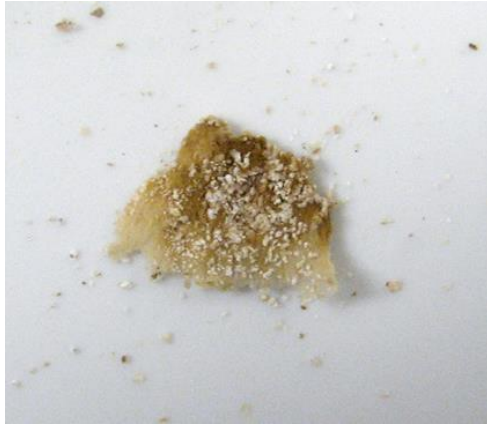
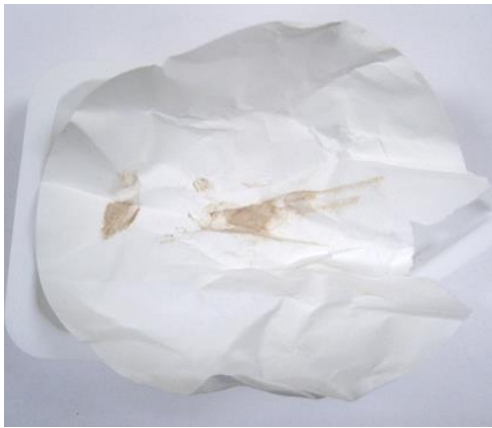
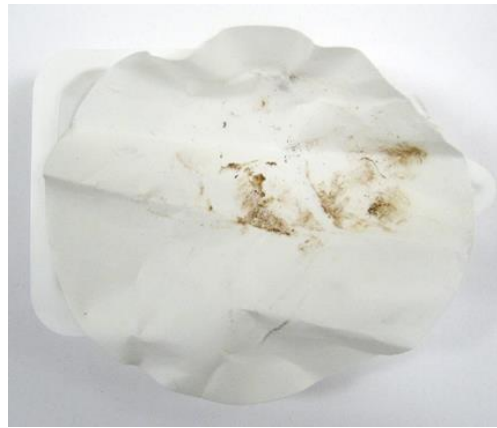
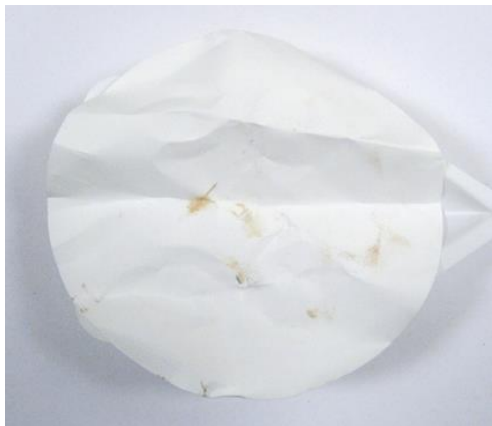
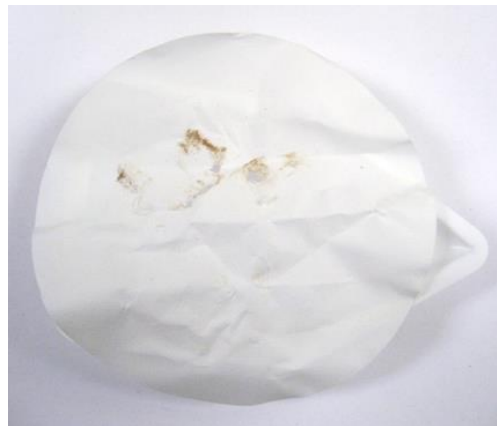
**Figure 3. Photographs of high-burnup demonstration cask corrosion samples.**

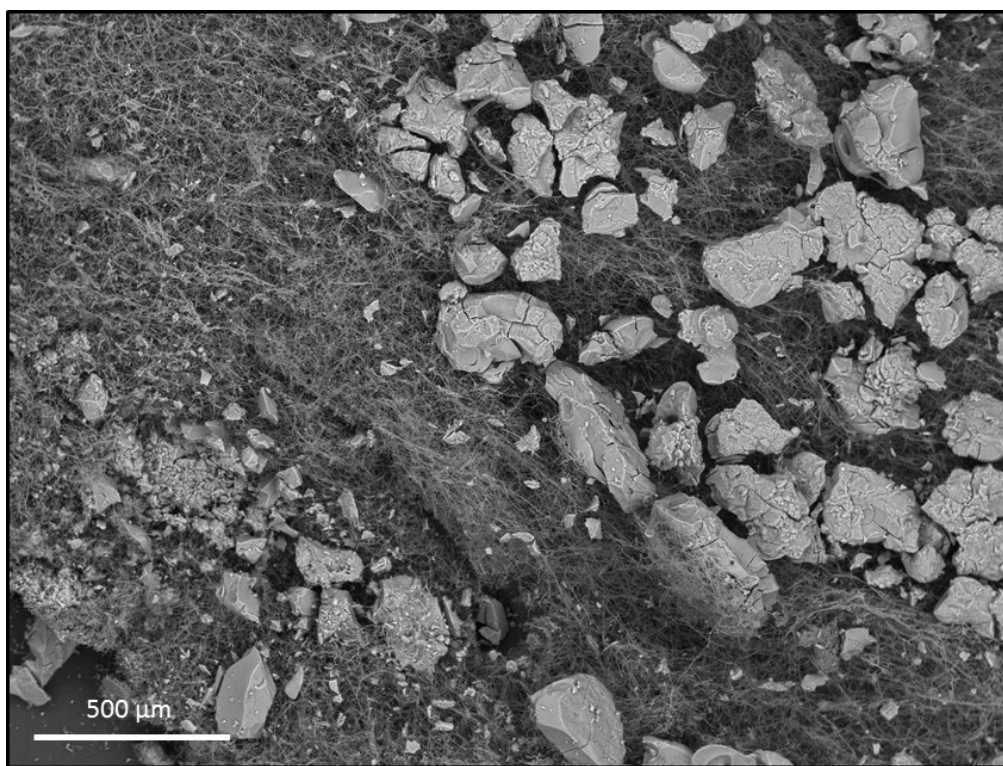
**Figure 4. SEM BSE image of the Debris sample, showing the filamentous fungal matrix and the adhering amorphous aluminum hydroxide.**

It is clear from the SEM photos (Figures 4,5, and 7) that the fungi were present before or during the corrosion process, as the corrosion products are deposited on top of the fungal mat, and as small particles scattered throughout the mat. Moreover, it is clear from the morphology of the fungal mycelium (Figure 2a), that the fungus grew over the surface of the aluminum. Hence, fungus growth occurred after the cribbing was placed in the cask and the cask was sealed. Similarly, the dead insects in the bottom of the cask suggest that living beetles were present when the cask was sealed. If they are indeed wood beetles, as we hypothesize, it seems likely that the insects actually pupated in the wood and bored out during storage, dying in the sealed cask.

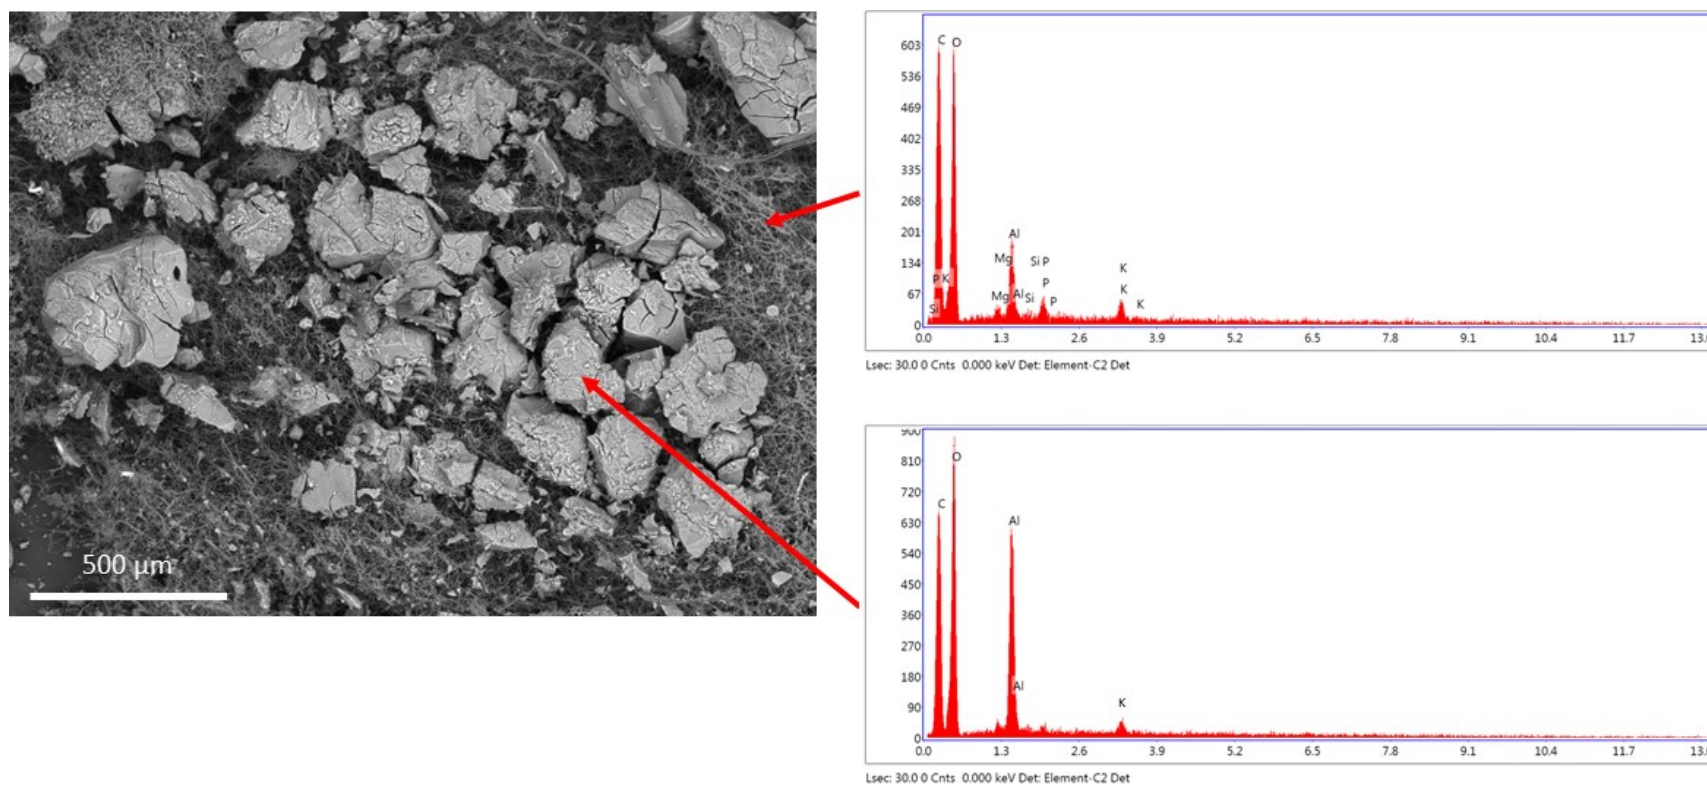
**Figure 5. SEM BSE image of the Debris sample, showing the filamentous fungal matrix and the adhering amorphous aluminum hydroxide.**

Fe, and also K and P, which are not present in AA 6061-T6 in significant amounts, cannot be sourced solely to the aluminum. These elements are in or on the fungal material itself (Figure 5), but also are present in the dark stain on the dry swipes (Figure 9), which consists of stained particles of aluminum hydroxide. Based on the SEM results, the aluminum hydroxide itself does not display X-ray peaks for these elements (Figure 15), or displays only very small peaks (Figure 11). It is inferred that these elements are concentrated within the fungal matter, but also within the organic material forming the dark stain. The brown coating is probably mostly organic in nature, and contains compounds such as organic acids that complex the metal species present, including the Fe, K, and P.

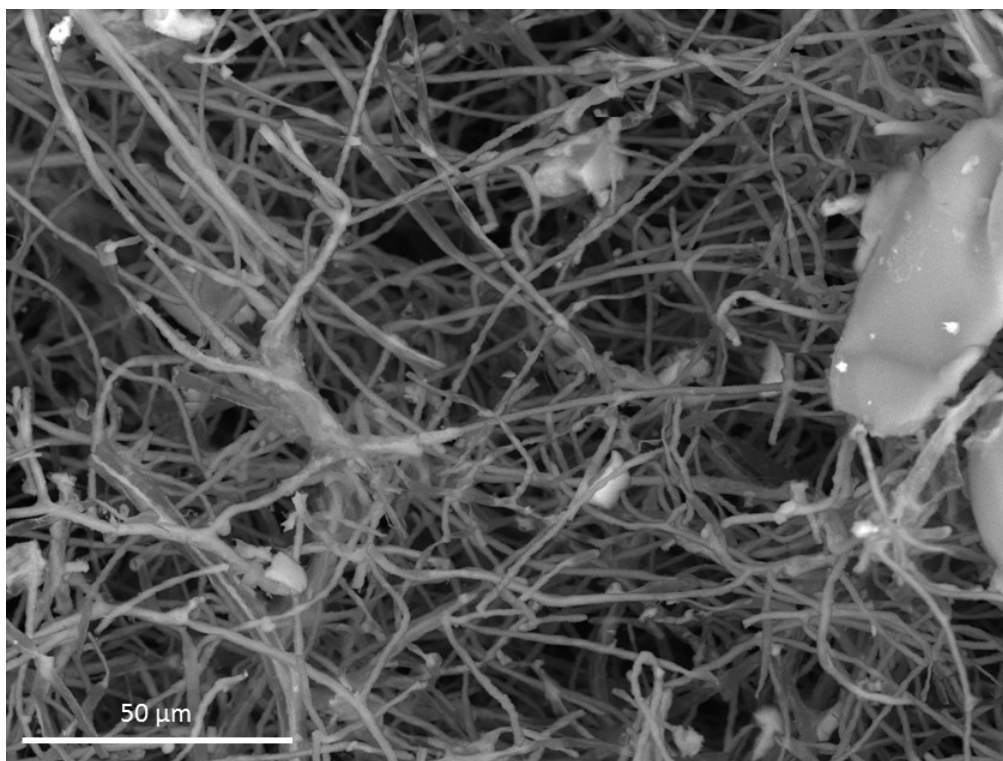
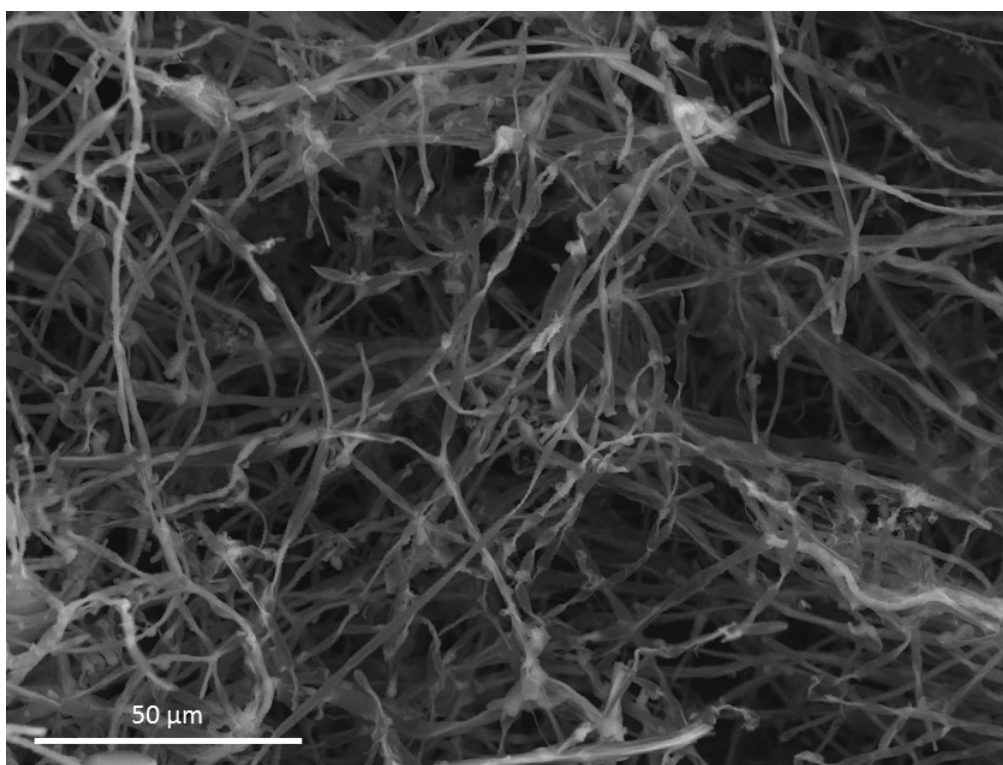
Figure 6 shows the fibrous organic material at higher magnification. The material is a tangled mass of intergrown branching and anastomosing fibers. This material appears to be a fungal mycelium, consisting of branching filamentous hyphae. Figure 7 illustrates the texture of the granular material; it is generally covered with shrinkage cracks, and in areas, shows a botryoidal structure, indicating it formed as a gel. During mapping and point analysis (when the beam current was increased), heating by the electron beam caused decrepitation of the sample, indicating that it contained water. The material is interpreted to be hydrous amorphous aluminum hydroxide, consistent with the lack of diffraction peaks when analyzed by XRD (Section 3.2). Hydrogen is not detectable by X-ray analysis, and aluminum oxide would show an identical EDS X-ray spectrum; however, aluminum oxide does not generally form an amorphous phase (Lee et al., 2009). To verify the identity of the phase, particles were analyzed by Fourier Transform Infrared Spectroscopy (FTIR), and Raman Spectroscopy. FTIR spectra showed very broad peaks due to the amorphous nature of the material, and were dominated by peaks for water/OH and for Al-O bonds. No carbonyl or carbonate signal was detected, but a single peak was present that did not

**Figure 6. SEM BSE images of the Debris sample, showing close-up images of the fungal mat.**

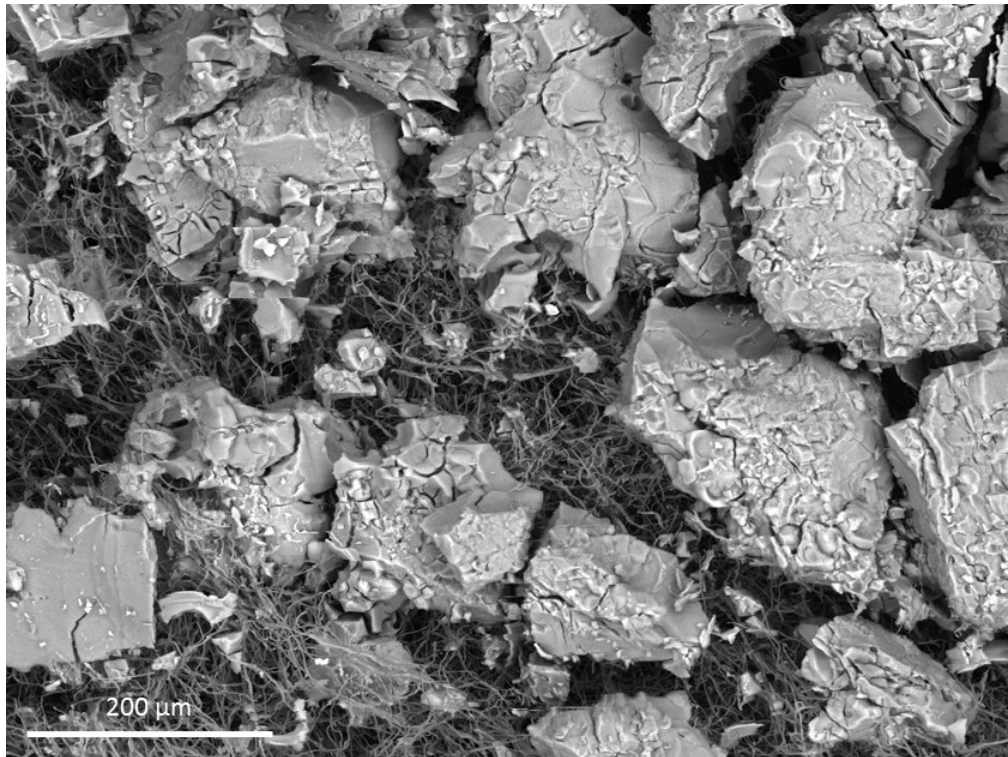
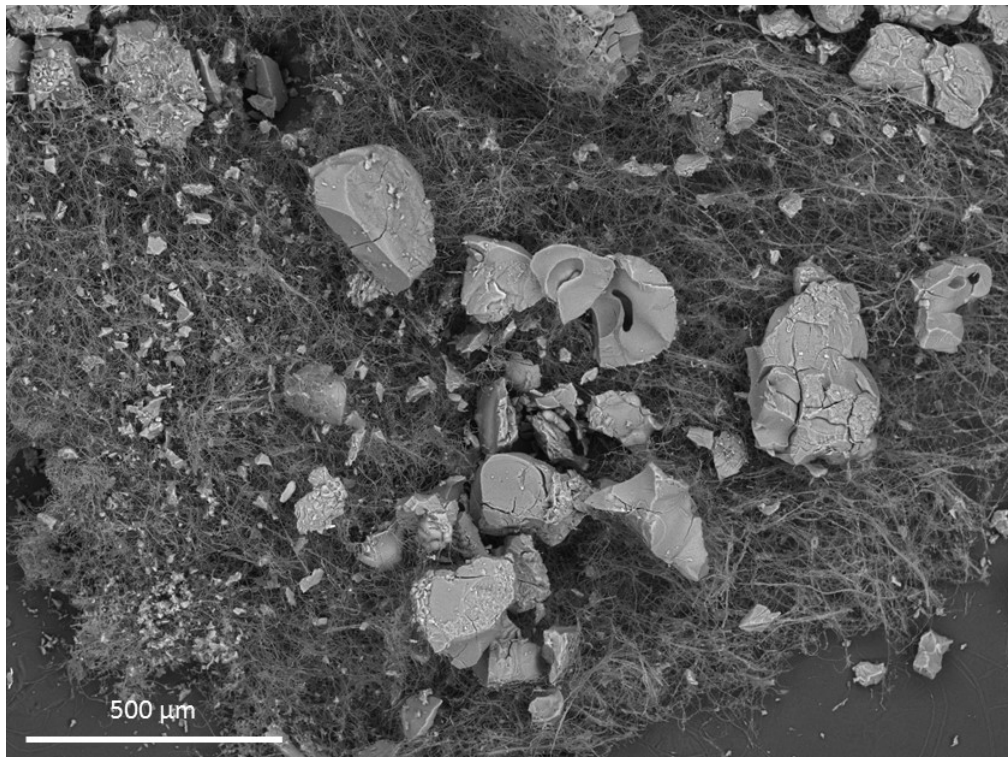
**Figure 7. SEM BSE images of the Debris sample, showing the distinctive shrinkage cracks and in some areas, botryoidal morphology of the aluminum hydroxide.**

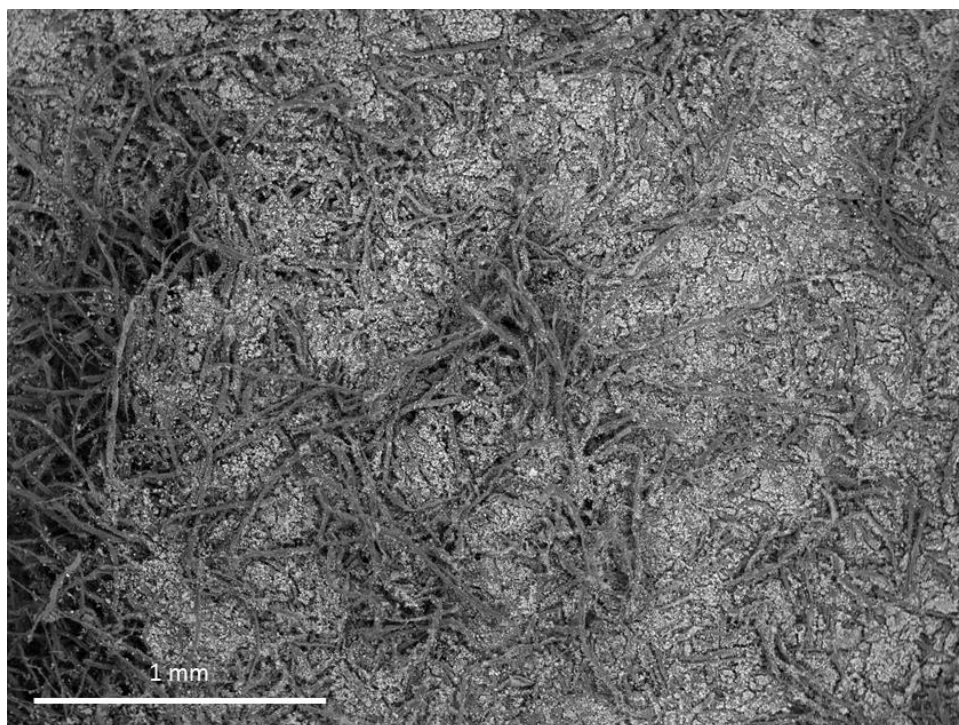
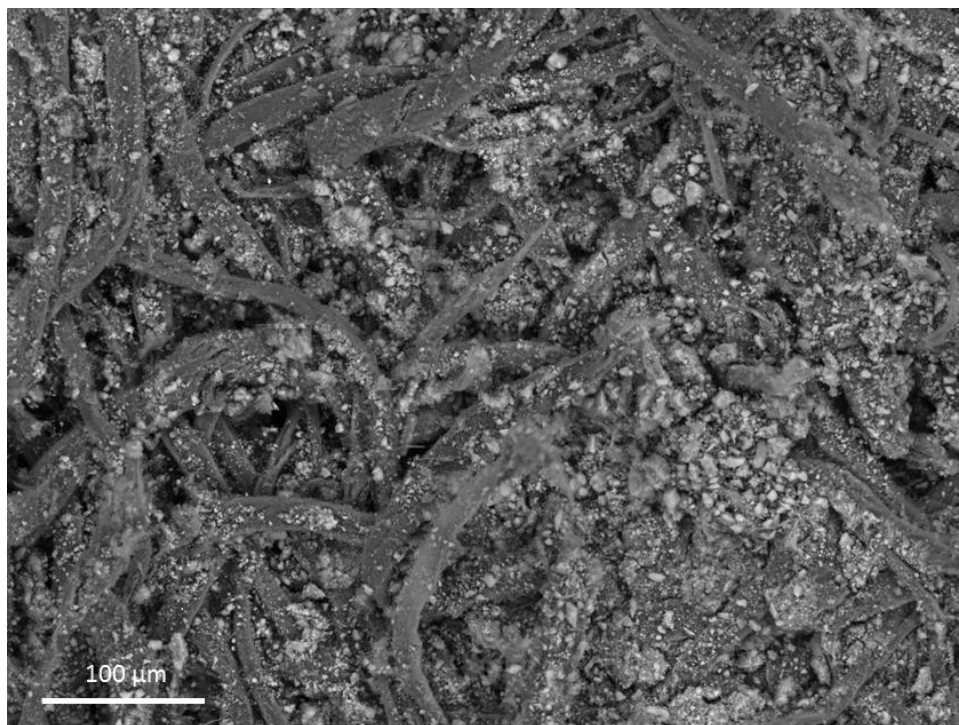
The dry swipe from the debris side had a brown discoloration, consisting of fine, dry material, that could be readily dislodged from the filter. A fragment of the filter was cut from the stain and analyzed by SEM. Figure 8 shows BSE images of the sample, illustrating the fine particles adhering to the fibrous filter. Figure 9 shows a SE image, element maps, and X-ray spectrum for the material on the filter. Spectral analysis of areas of the filter coated with many particles indicates that the material consists largely of aluminum hydroxide, but high concentrations of potassium are also present. The stain on the filters was brown in color, and it was originally considered possible that iron nails in the cribbing might have corroded to produce iron oxides. However, no separate iron phase was observed with the SEM. This was true for all locations examined. It seems likely that the brown discoloration is due to organic compounds (e.g., humic acids) derived from the wooden cribbing, rather than to iron oxides.

**Figure 8. SEM BSE images of the dry swipe from the debris location, showing the aluminum hydroxide particles adhering to the filter.**

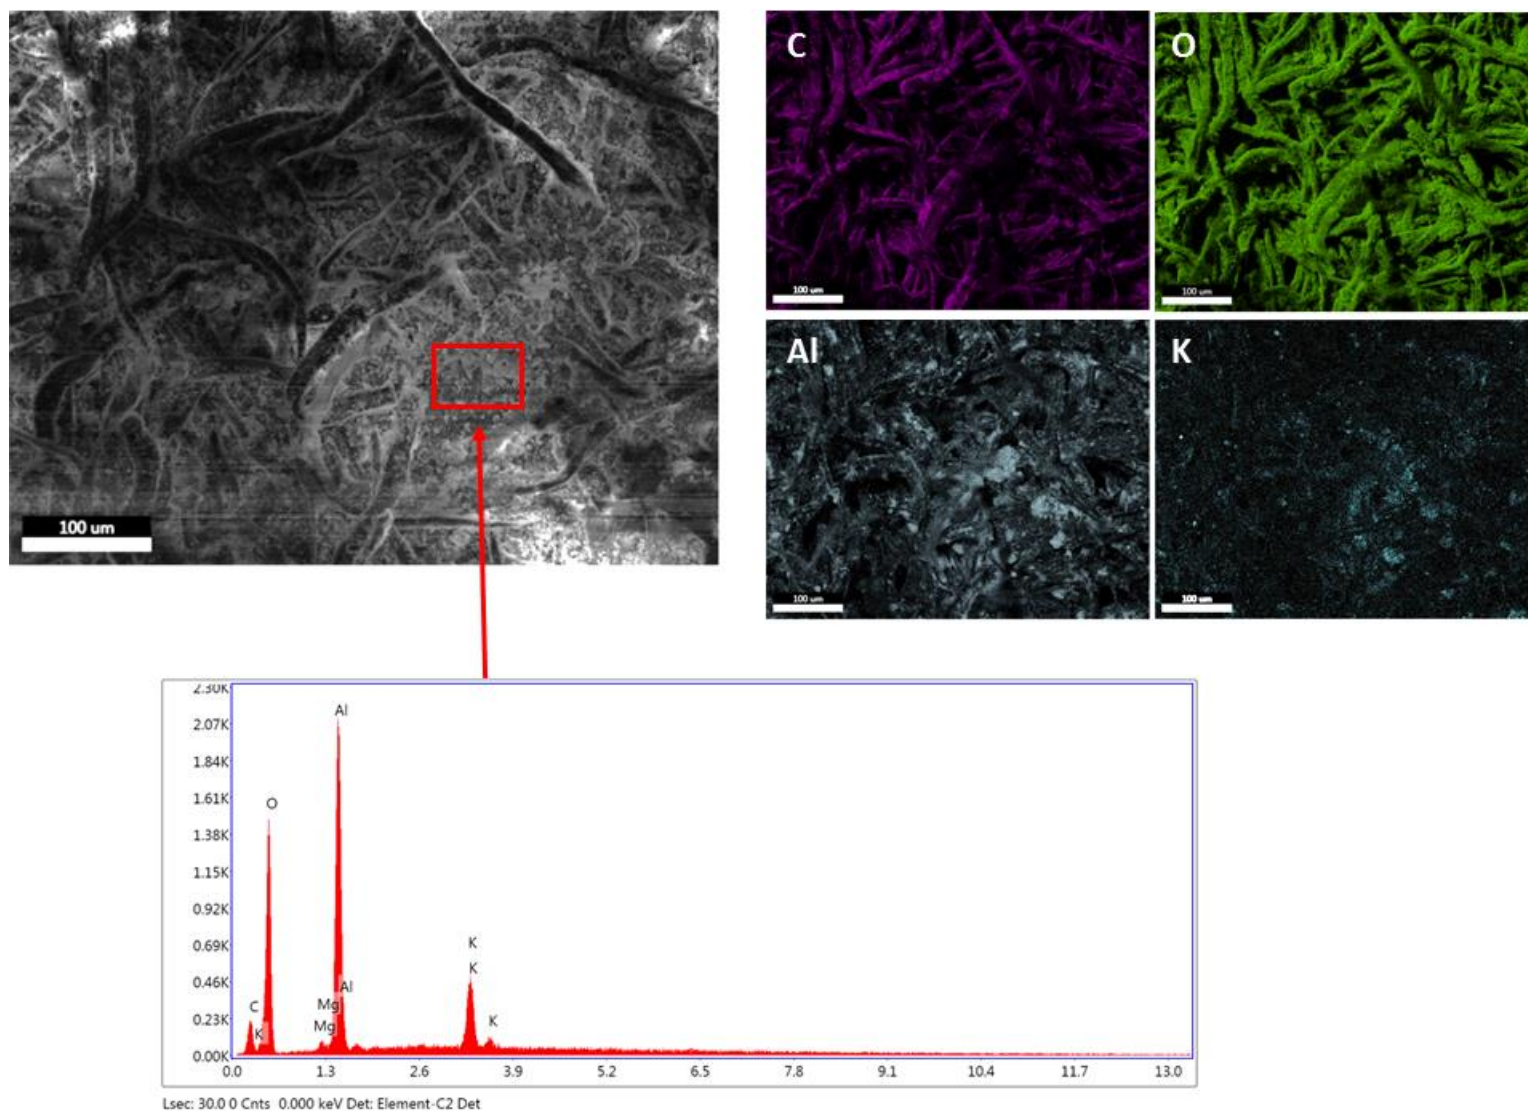
**Figure 9. SEM SE image, element maps, and EDS X-ray spectrum of particulates on the surface of the dry swipe from the debris location.**

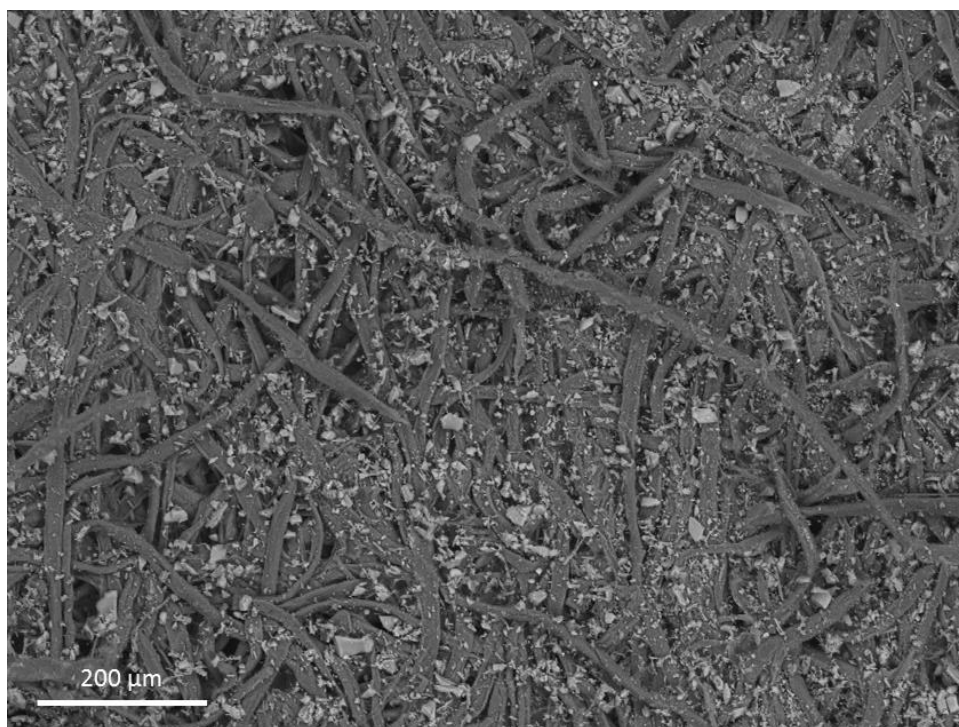
SEM images of the dry swipe from the residue location are shown in Figures 10 and 11. As with the other dry swipe, this sample had a brown stain consisting of loose particles. The particles consist mostly of aluminum hydroxide, but a small amount of potassium is also present. X-ray element maps are shown in Figure 12, and indicate that small amounts of phosphate and magnesium are also present, at least in part as discrete grains. Once again, no discrete iron phase is present, once again suggesting that the brown coloration is due to organic compounds formed by fungal degradation of the wood. Relatively high concentrations of iron were observed in the chemical analyses of these samples (Section 3.3); the absence of an iron phase indicates that it was bound into the organic phase.

**Figure 10.** SEM BSE image of the dry swipe from the residue location, showing the aluminum hydroxide particles adhering to the filter.

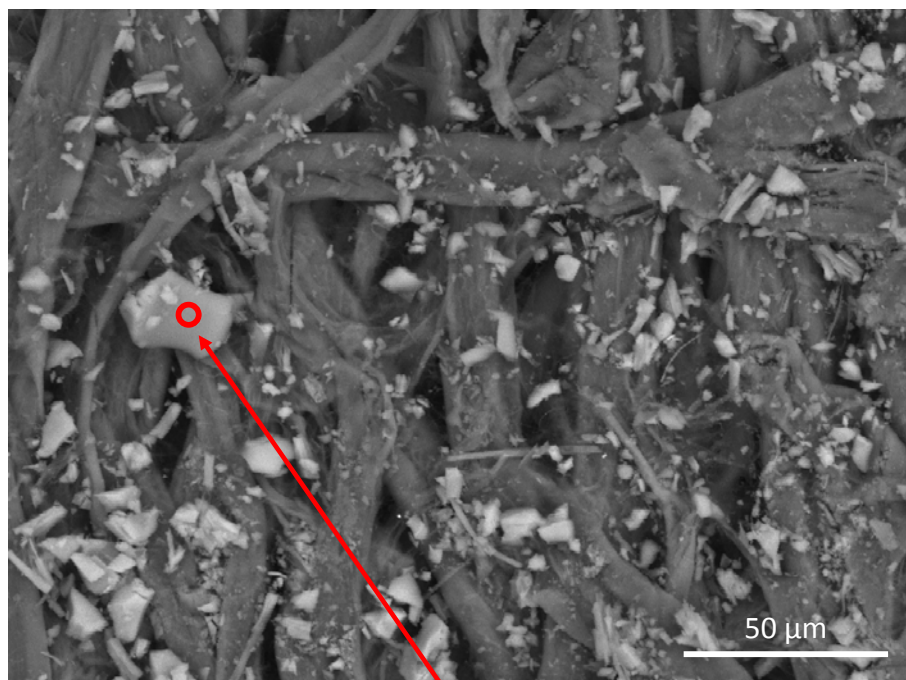
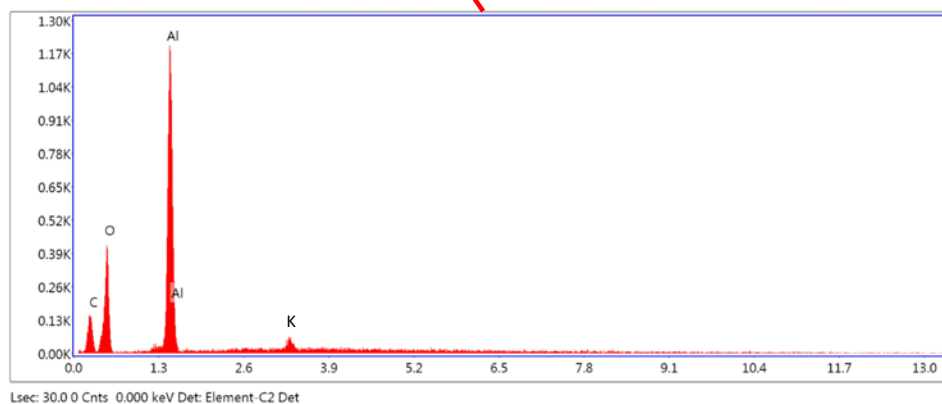
**Figure 11. SEM BSE image and EDS X-ray spectrum of the dry swipe from the residue location.**

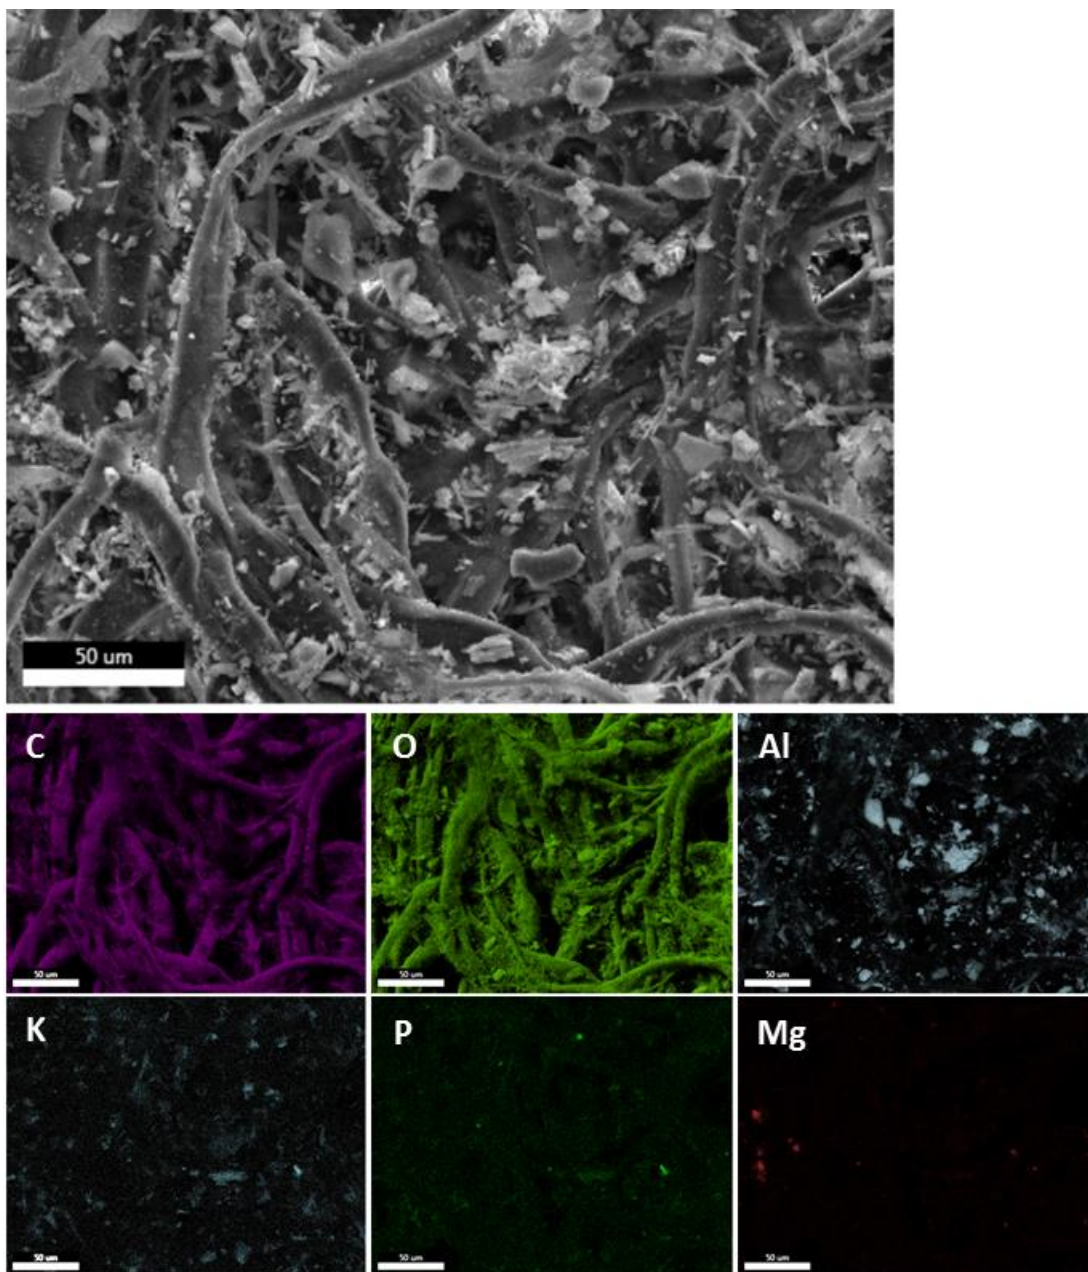
Figure 12. SEM SE image and element maps of the dry swipe from the residue location.

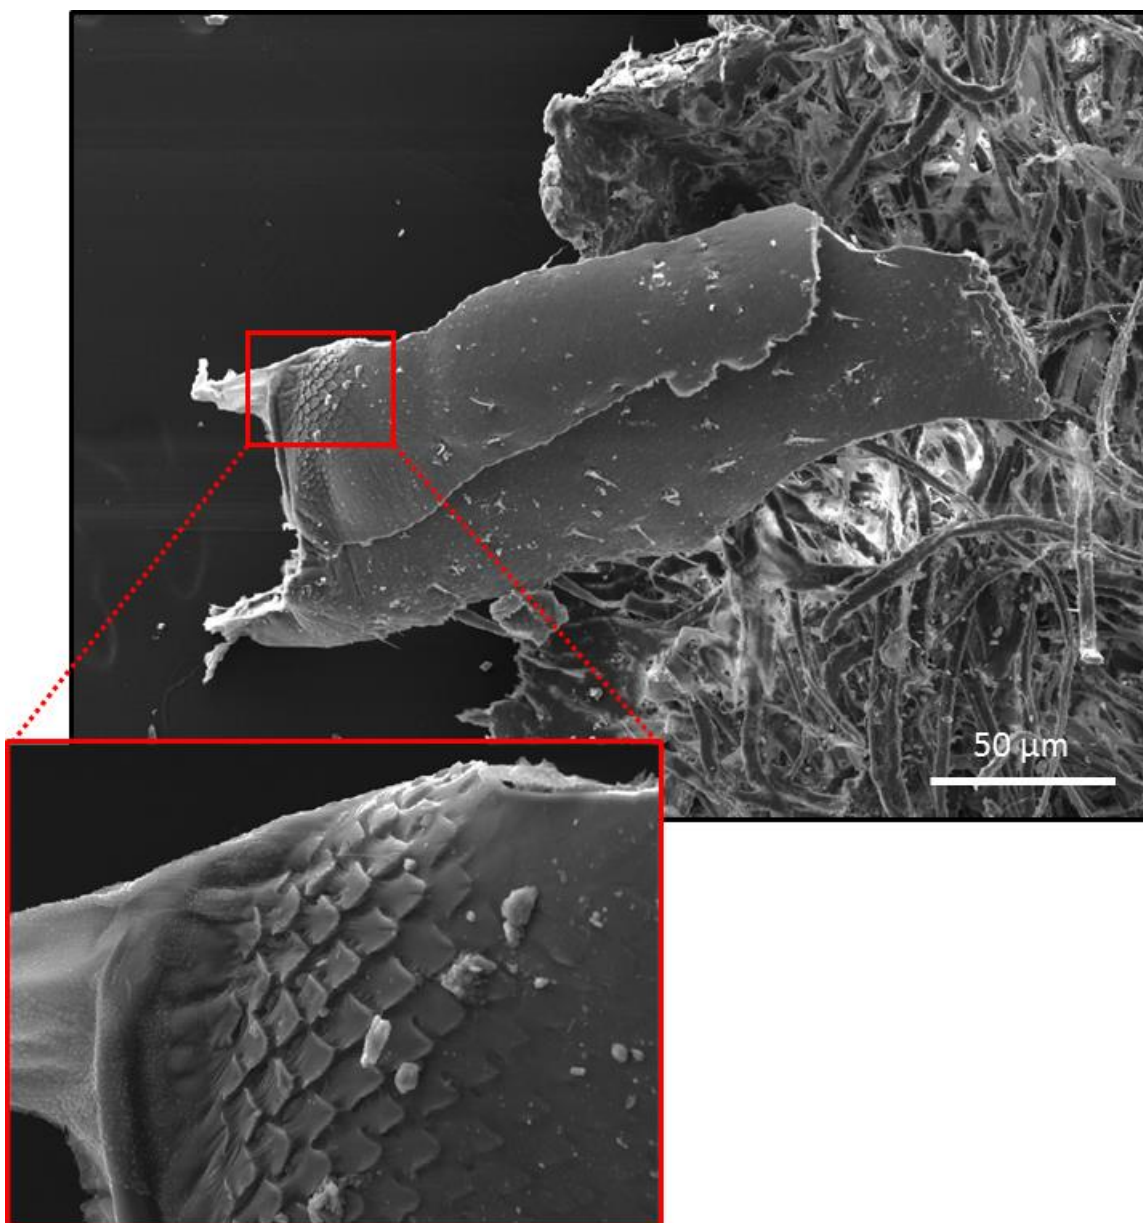
Also present on the dry swipe from the residue location is fragment of insect matter (Figure 13). The fragment consists of a small piece of material, covered with hairs and in some locations, scales. It is insufficient to identify the organism that it represents.

**Figure 13. SEM SE images of insect fragment on the dry swipe sample from the residue location.**

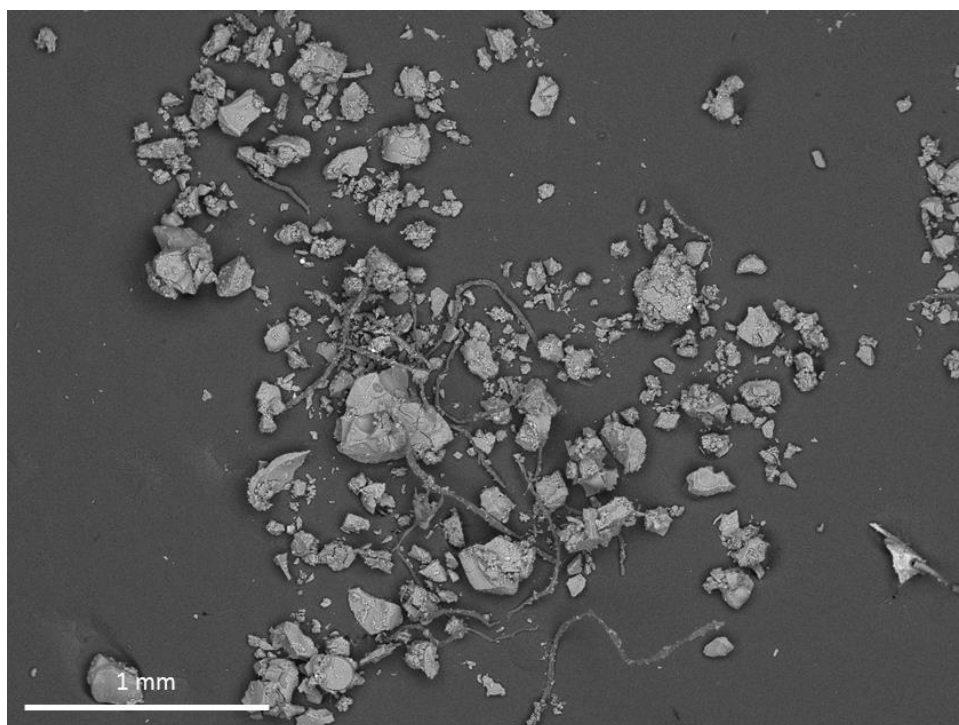
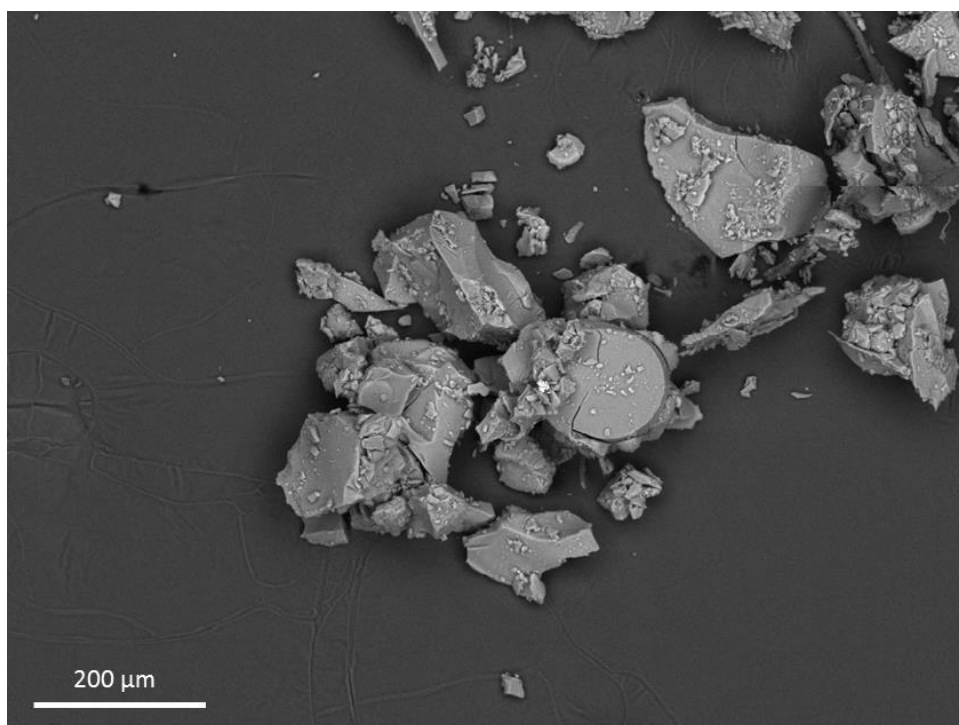
Two wet swipes were taken from the residue location. Both had brown staining; however, the first swipe also had coarse, sand-sized white particles adhering to it. Some of these were brushed off of the filter and mounted on carbon tape for SEM analysis. The particles are shown in Figure 14, and element maps are provided in Figure 15. The particles are aluminum hydroxide, with no detectible impurities, and have a similar morphology (shrinkage cracks) to the grains of aluminum hydroxide on the debris sample (Section 3.1.1). Note that in these clean, large grains of the amorphous material, it is clear that any organic component is very small, as the carbon peak is insignificant. An insect fragment was also present on this sample (Figure 16). The fragment appears to be part of an insect head; however, it is too incomplete to identify the type of insect.

**Figure 14.** SEM BSE images of the particles from the wet swipe of the residue location.

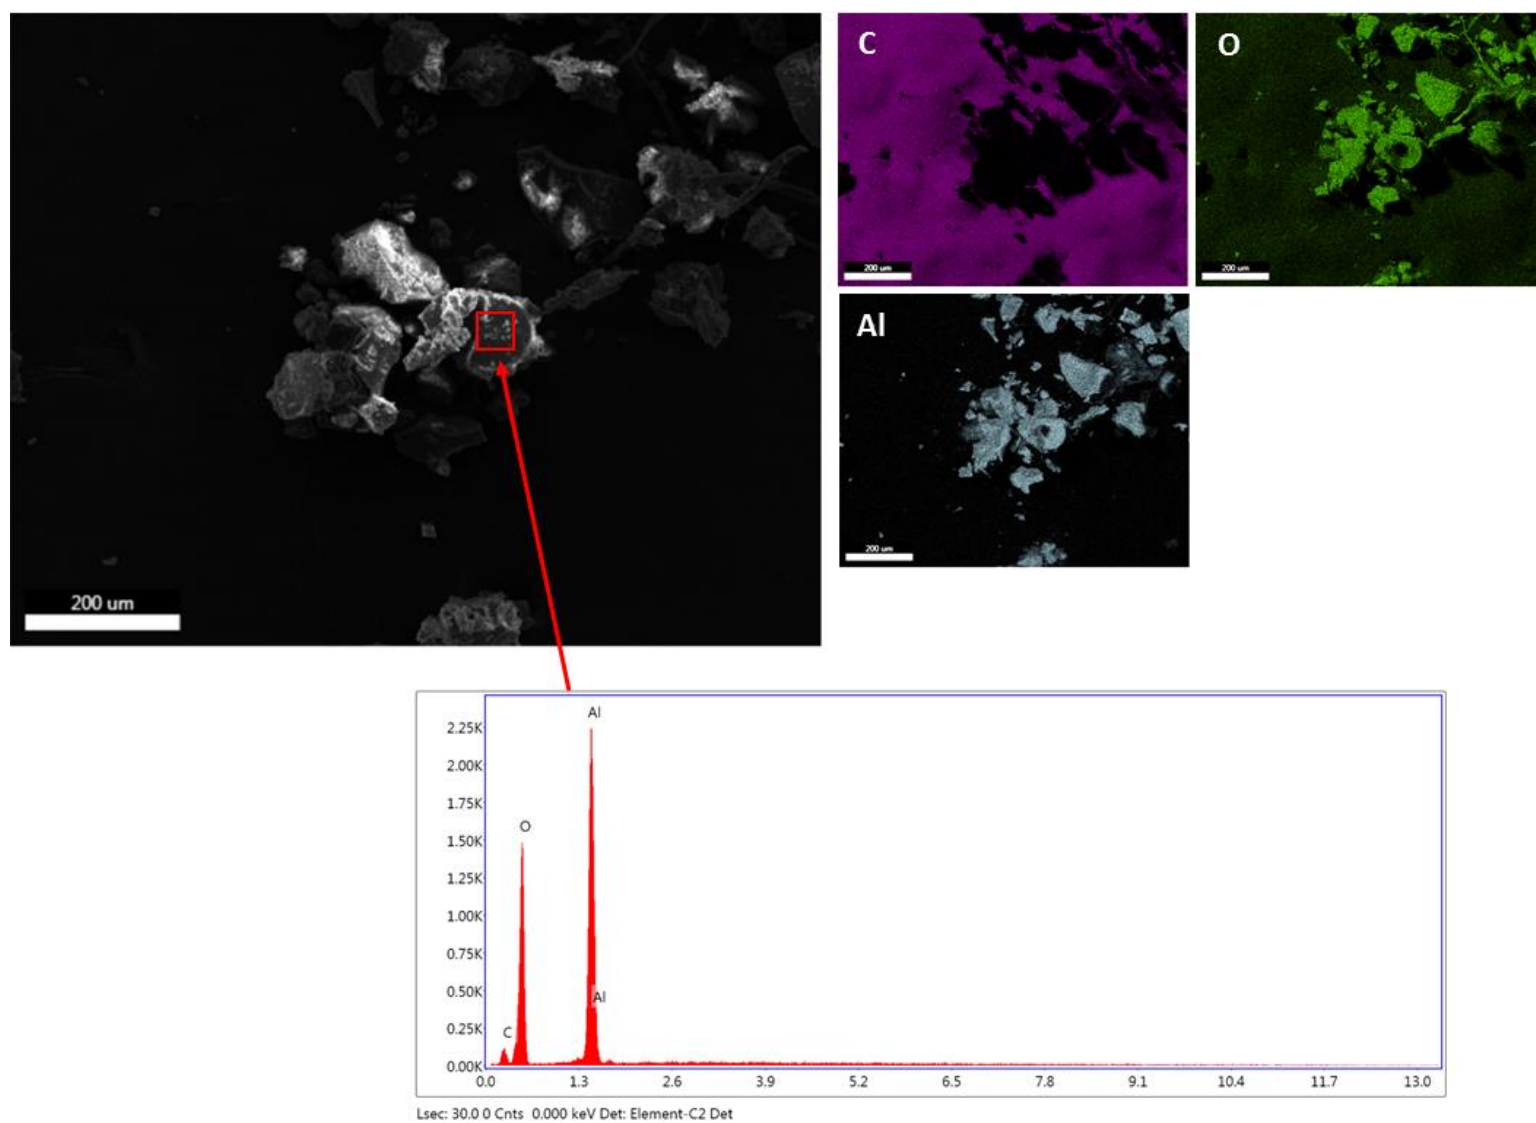
**Figure 15. SEM SE image, element map, and X-ray spectrum of the particles from the wet swipe of the residue location.**

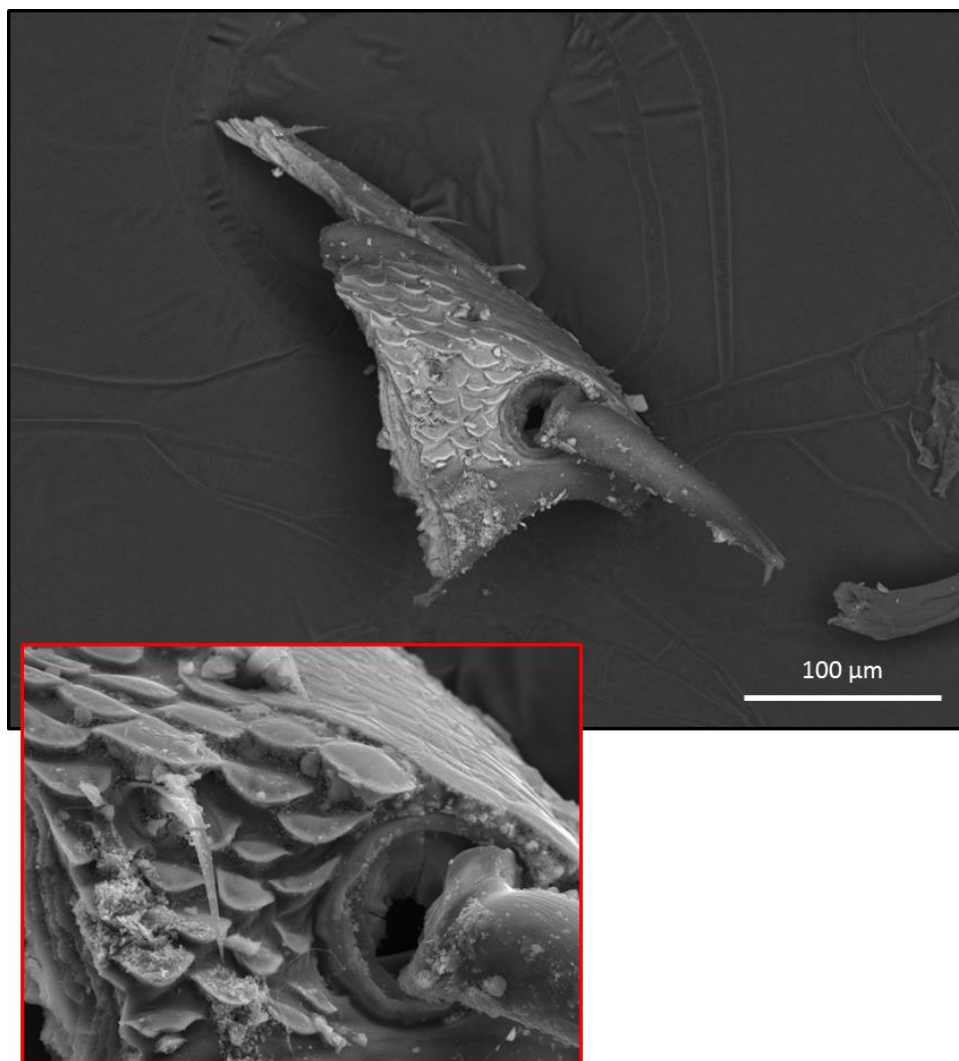
**Figure 16. SEM BSE images of the insect fragment on the wet swipe of the residue location.**
