SAND2017-2306

## **Analysis of Corrosion Residues Collected from the Aluminum Basket Rails of the High-Burnup Demonstration Cask**

Charles R. Bryan

On September, 2015, an inspection was performed on the TN-32B cask that will be used for the high-burnup demonstration project. During the survey, wooden cribbing that had been placed within the cask eleven years earlier to prevent shifting of the basket during transport was removed, revealing two areas of residue on the aluminum basket rails, where they had contacted the cribbing. The residue appeared to be a corrosion product, and concerns were raised that similar attack could exist at more difficult-to-inspect locations in the canister. Accordingly, when the canister was reopened, samples of the residue were collected for analysis. This report presents the results of that assessment, which determined that the corrosion was due to the presence of the cribbing. The corrosion was associated with fungal material, and fungal activity likely contributed to an aggressive chemical environment. Once the cask has been cleaned, there will be no risk of further corrosion.

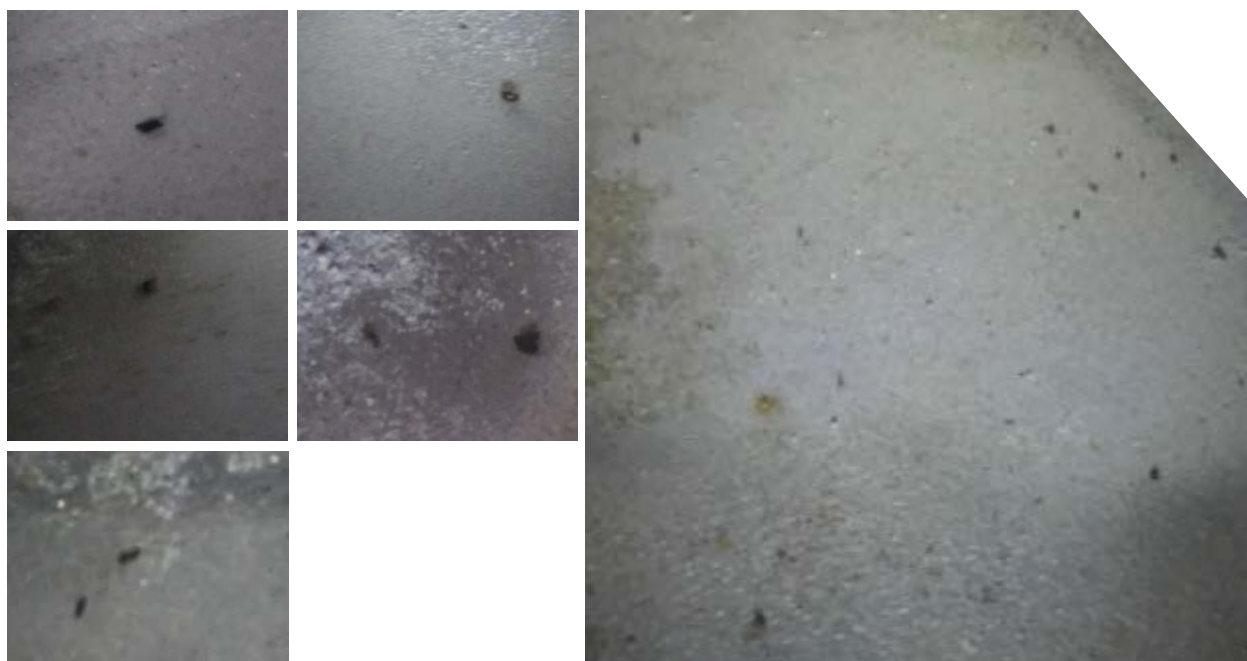
SEM analyses of the debris and the swipe samples indicate that most of the residue on the aluminum basket and rails consists of aluminum hydroxide, and indeed represents corrosion of the aluminum. The aluminum hydroxide corrosion residue is present as an amorphous material, that may have formed as a gel. The locations where corrosion occurred appear to be associated with biological activity. Debris present on the aluminum has been identified as fungal matter, and insect fragments have also been identified. These may be related. Several insects exist in a symbiotic relationship with fungi, including bark and wood-boring (ambrosia) beetles, and some species of tower termites and ants (Vega and Blackwell, 2005). The insects help disperse the fungi by transporting it to new locations. The beetles disseminate the fungi in their tunnels and brood galleries, where it grows on the exposed wood surface. The beetles and/or their larvae feed on the fungi growing on the wood surface and on fungus-colonized, partially degraded wood (Licht and Biedermann, 2012). Although other explanations are possible, it seems likely that wood or bark beetles were present in the cribbing when it was placed in the cask, and they inoculated the wood with the observed fungus. During the boroscope inspection of the cask, many small dead insects were observed on the floor of the cask. Photographs are shown in Figure 17; the photographs are of insufficient quality to identify the insects, but the identity can be determined when the cask is cleaned, if the dead insects observed at the bottom of the cask can be recovered and identified.

**Figure 17. Boroscope camera images of insects on the floor of the HBU storage cask. The scale is not provided in the images, but comparison with structural features in the images (not shown), indicates that the insects are 2-4 mm in size. Note that each image is independent, the smaller images do *not* represent higher magnification views of the insects in the single larger image.**

We speculate that the association of the fungi and insects is not coincidental, but rather that wood-boring beetles, which inoculate wood with fungi and then harvest the fungi for food, were present in the wood. While the presence of wood-boring beetles is speculative, it is noted that small dead insects were observed in the bottom of the cask during the inspection. When the cask is cleaned, the insects should be collected and identified to verify the hypothesis.
